# Inspection Photos

API: 05-071-06867

Operator: ARP PRODUCTION COMPANY LLC

Inspection Date: 3/25/2019

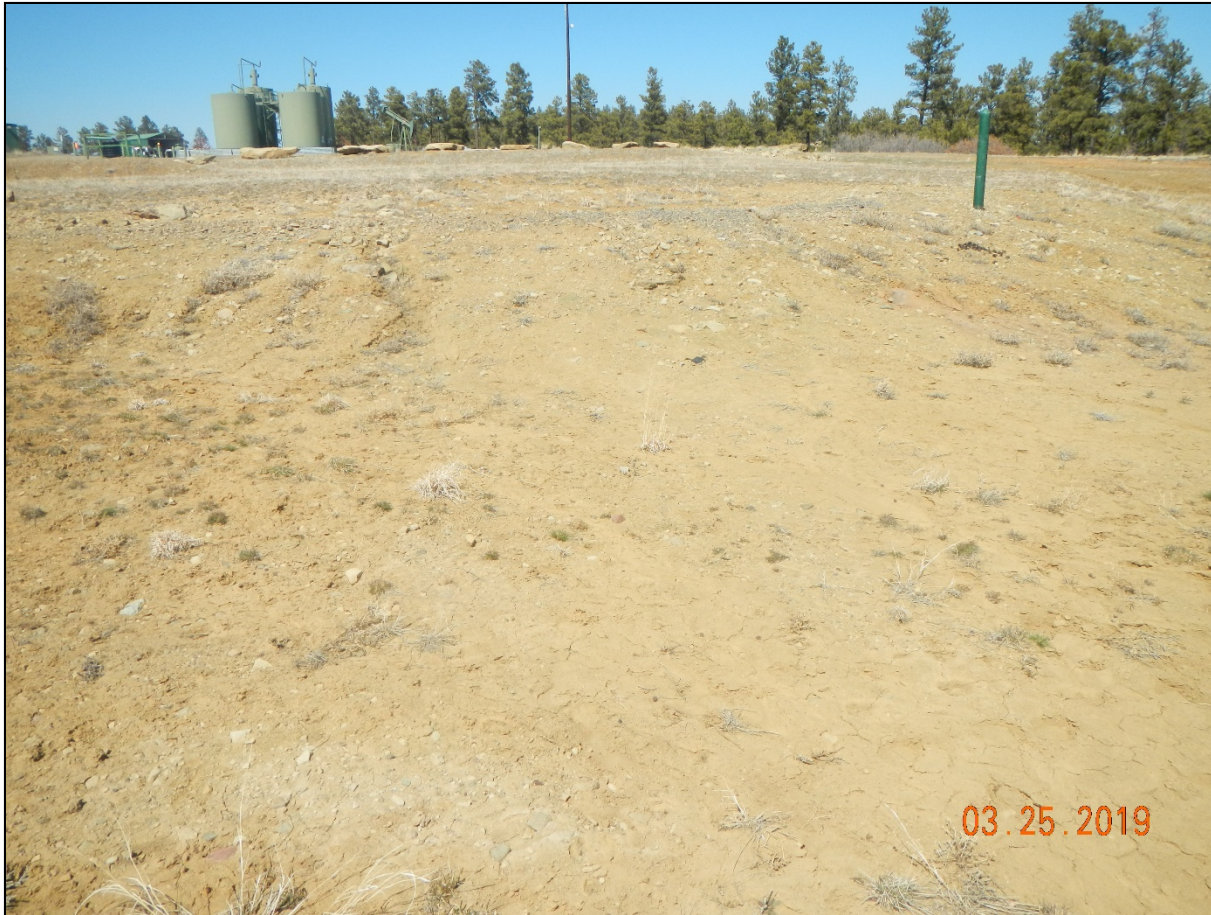
**Photo 1.** Facing northwest at the location. Vegetation has not established.

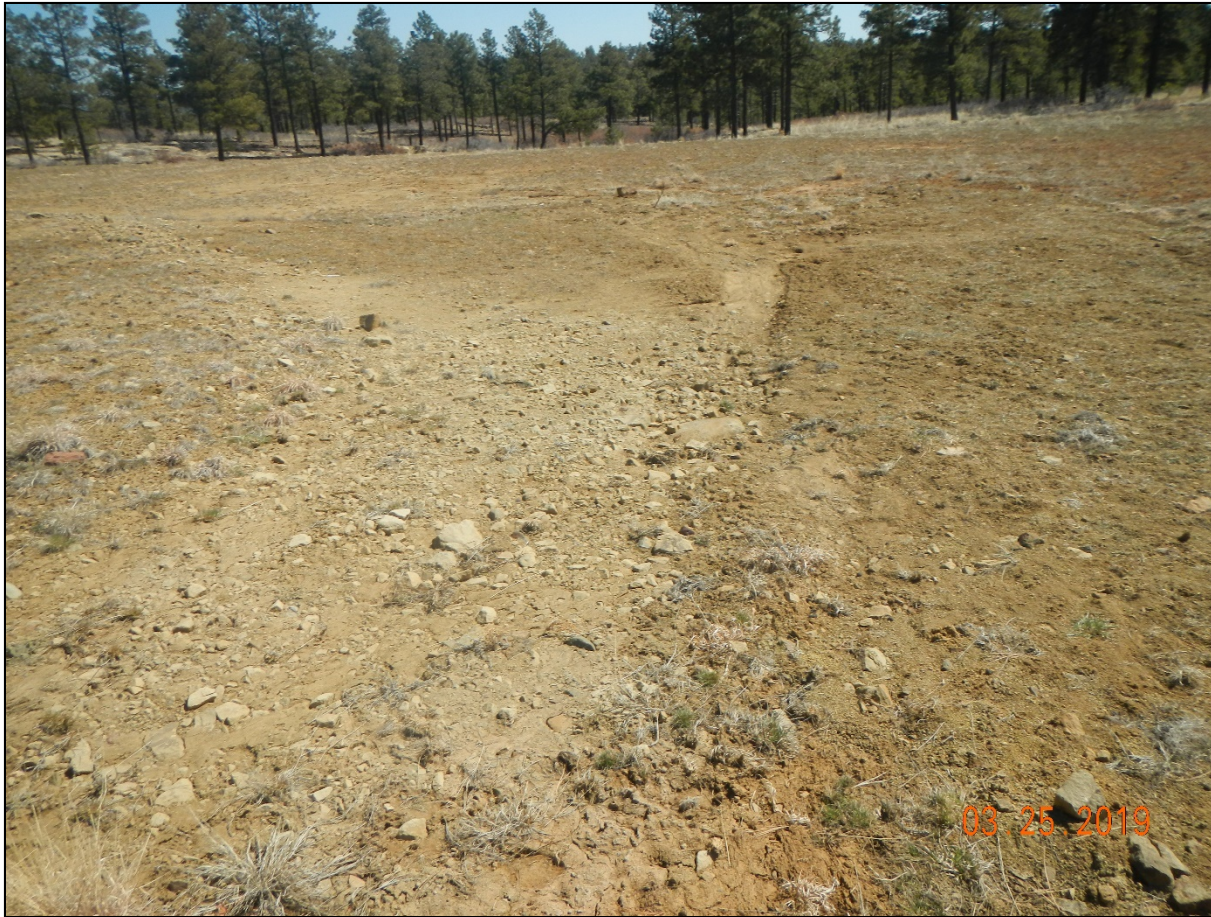
**Photo 2.** Facing east at the location. Vegetation is not established and there are signs of erosion.

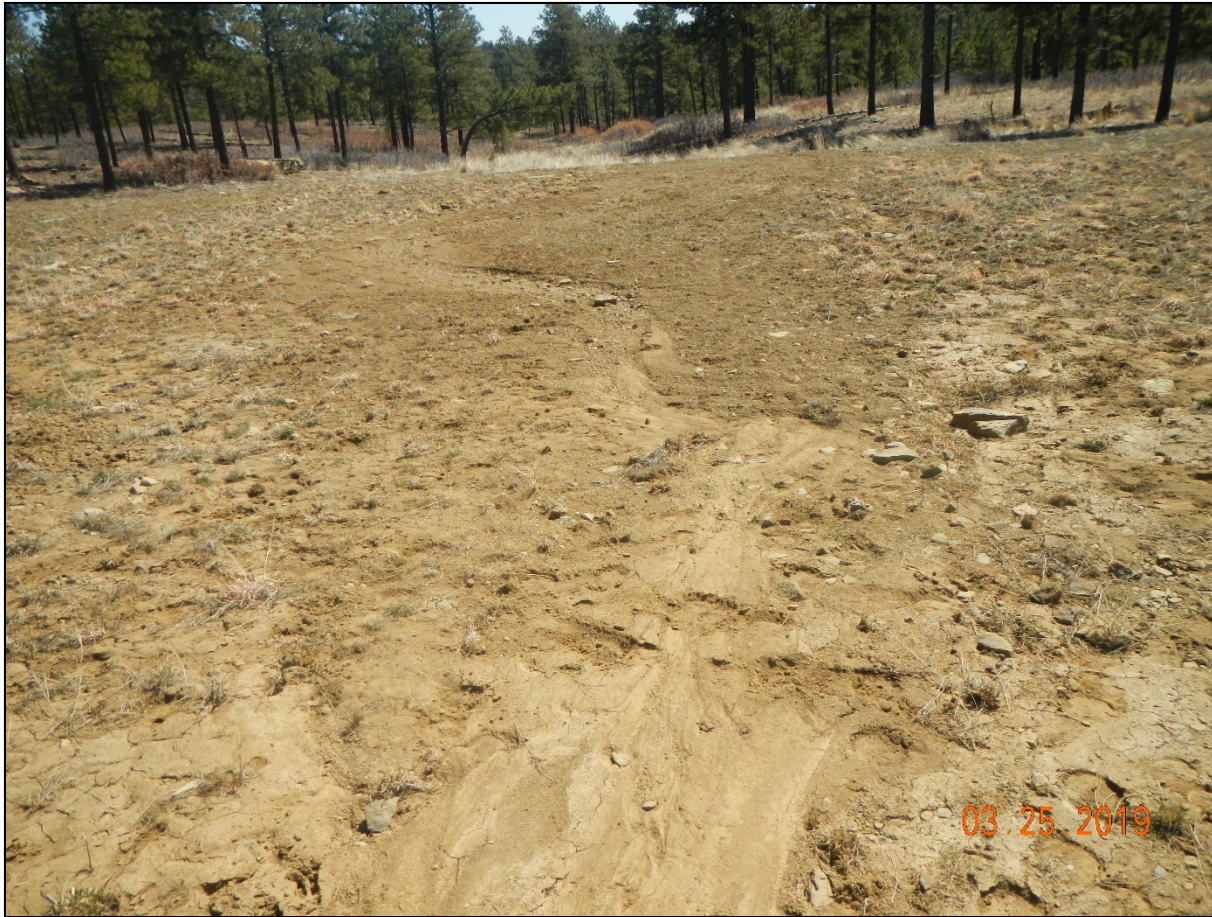
**Photo 3.** Facing towards the east side of the location. There is signs of sediment being deposited off location.

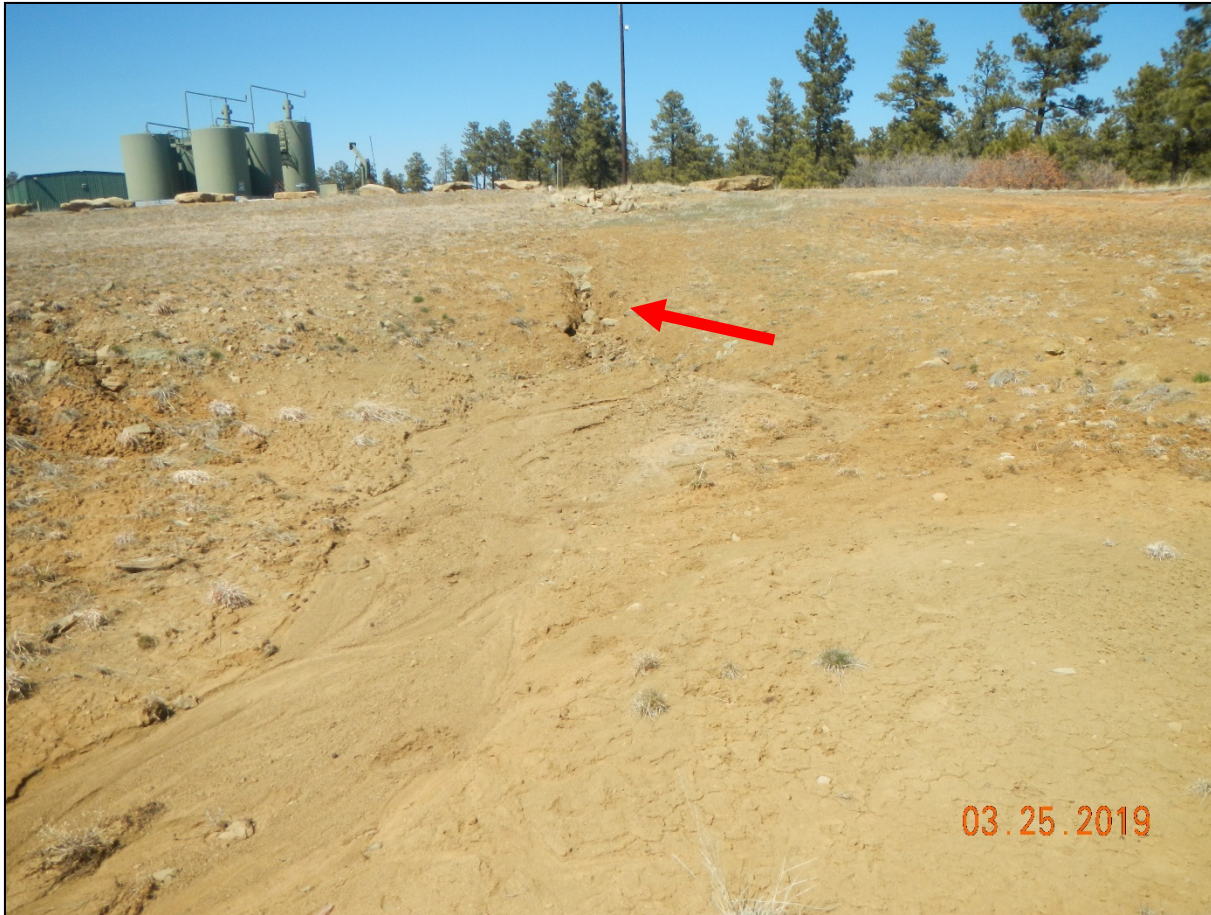
**Photo 4.** Facing west at the north side of the location. There is signs of erosion in this area.

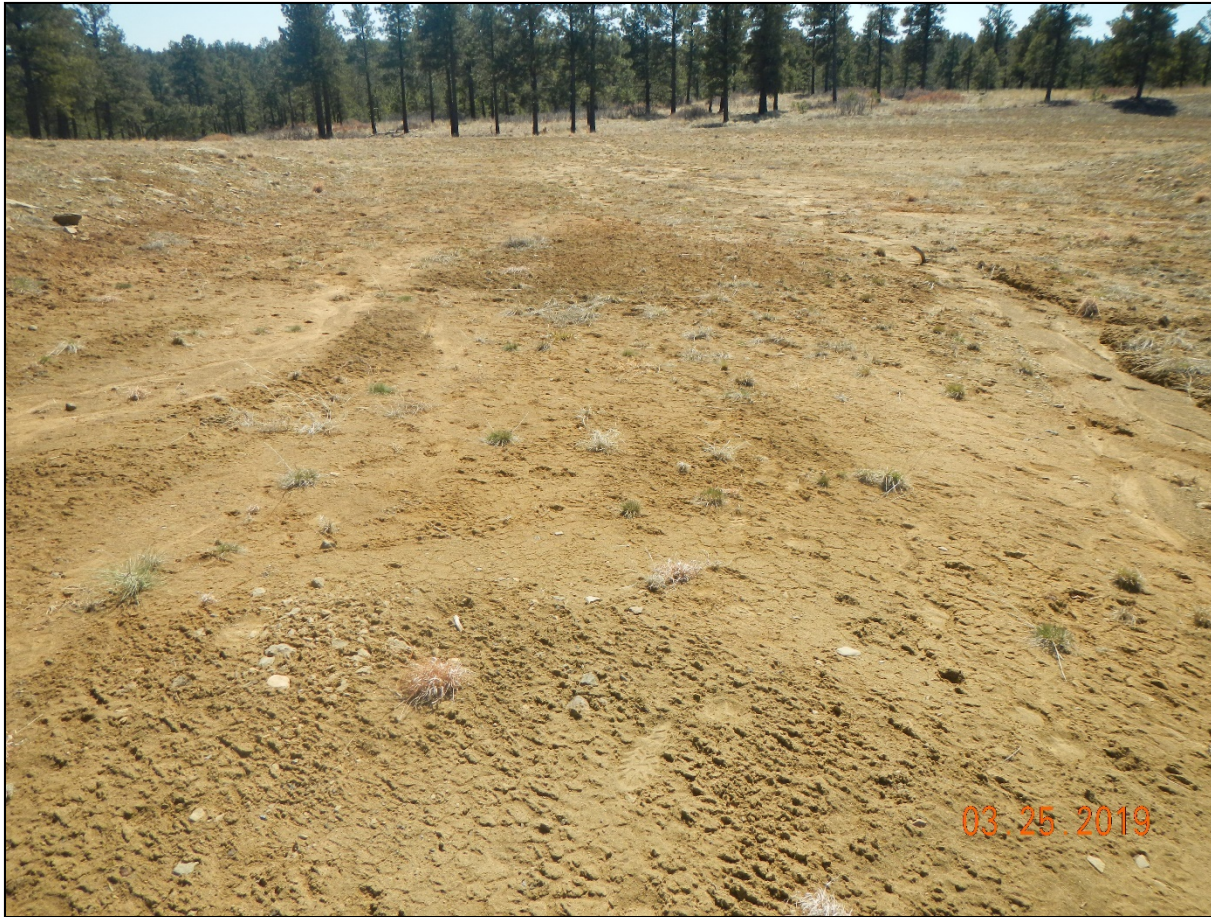
**Photo 5.** Facing southeast at the location. Vegetation has not established in this area.
