Inspection Photos

API: 05-009-06627

Operator: INVESTMENT EQUIPMENT LLC

Inspection Date: 3/27/2019

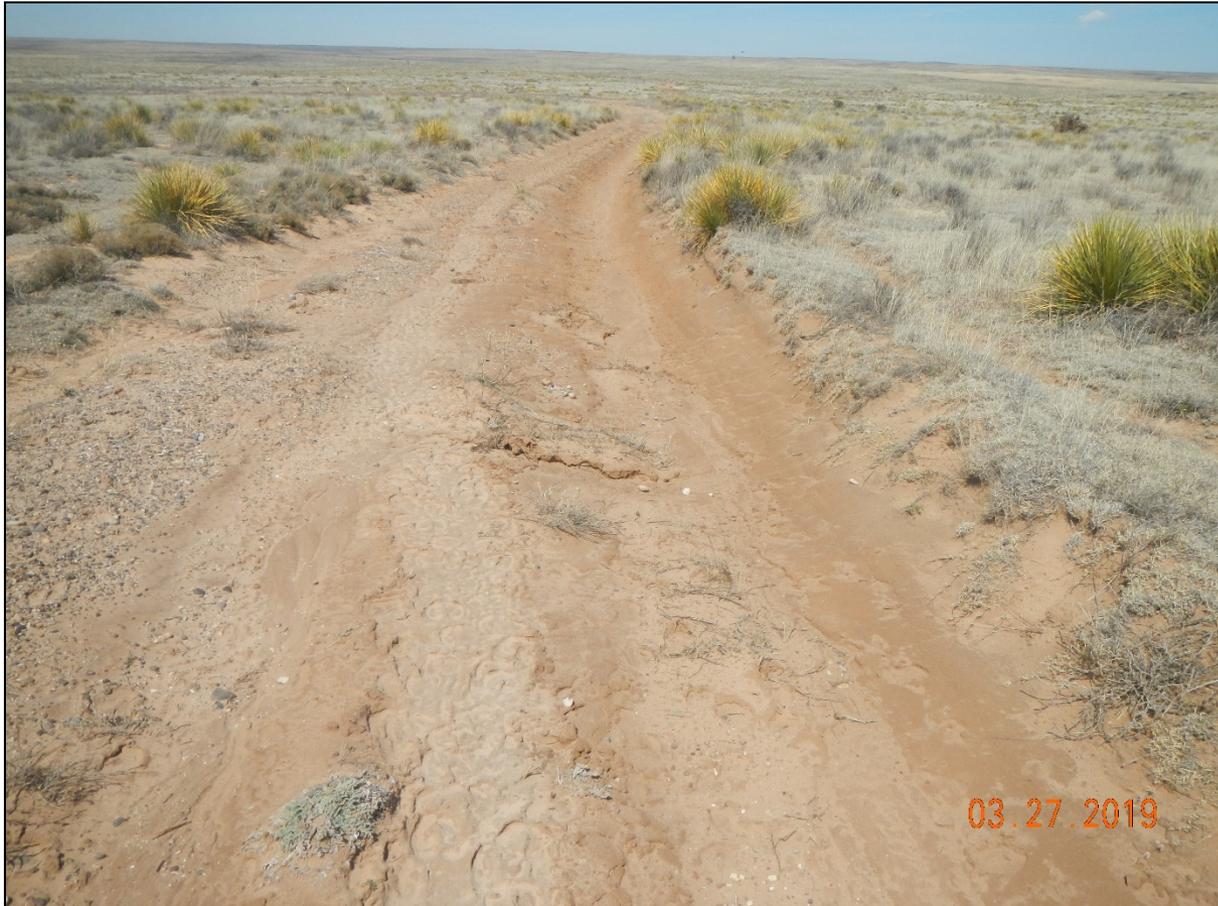
Photo 1. Facing north along the access road. Road continues past the location towards a stock tank. There is erosion along the road that need to be filled in and fixed.

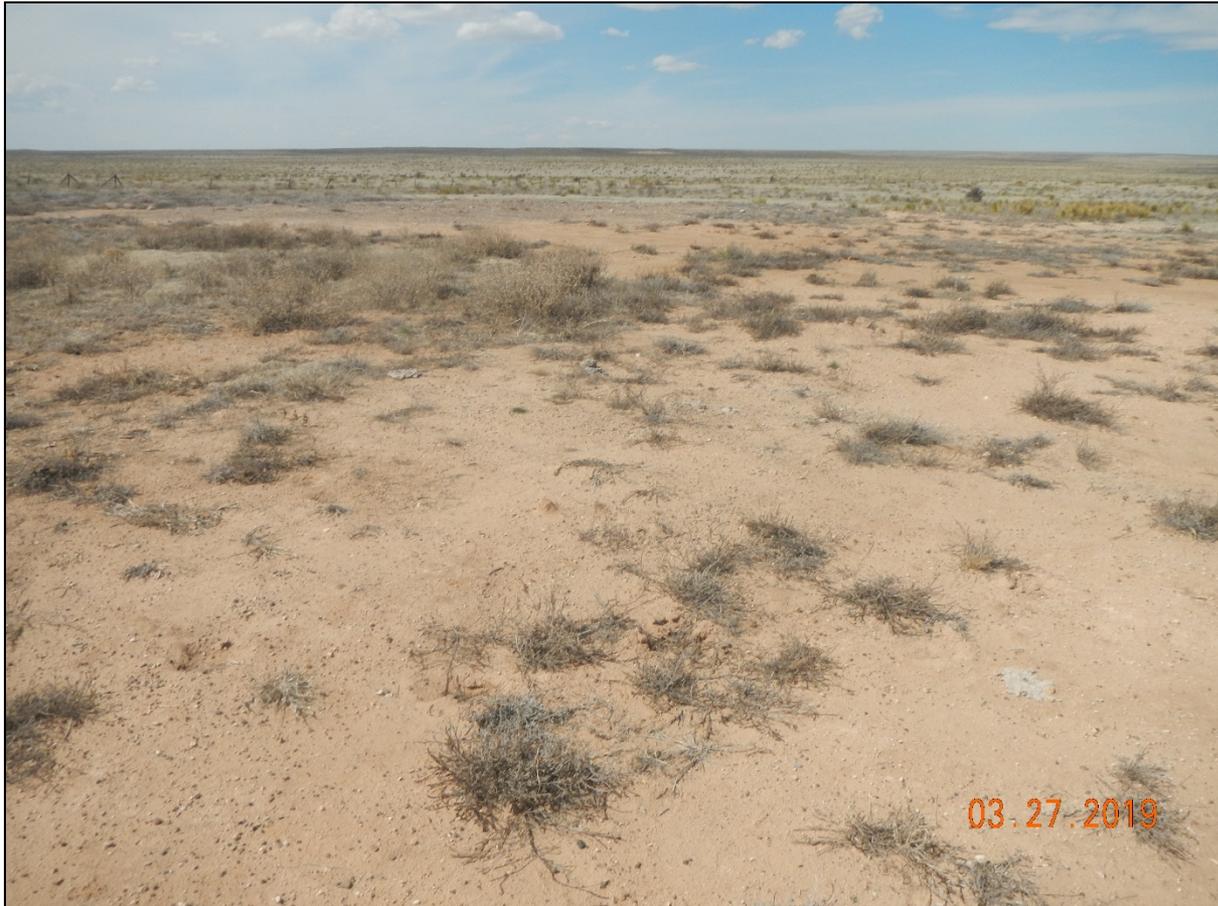
Photo 2. Facing northwest toward the location. Vegetation has not established and there are undesirable weeds.

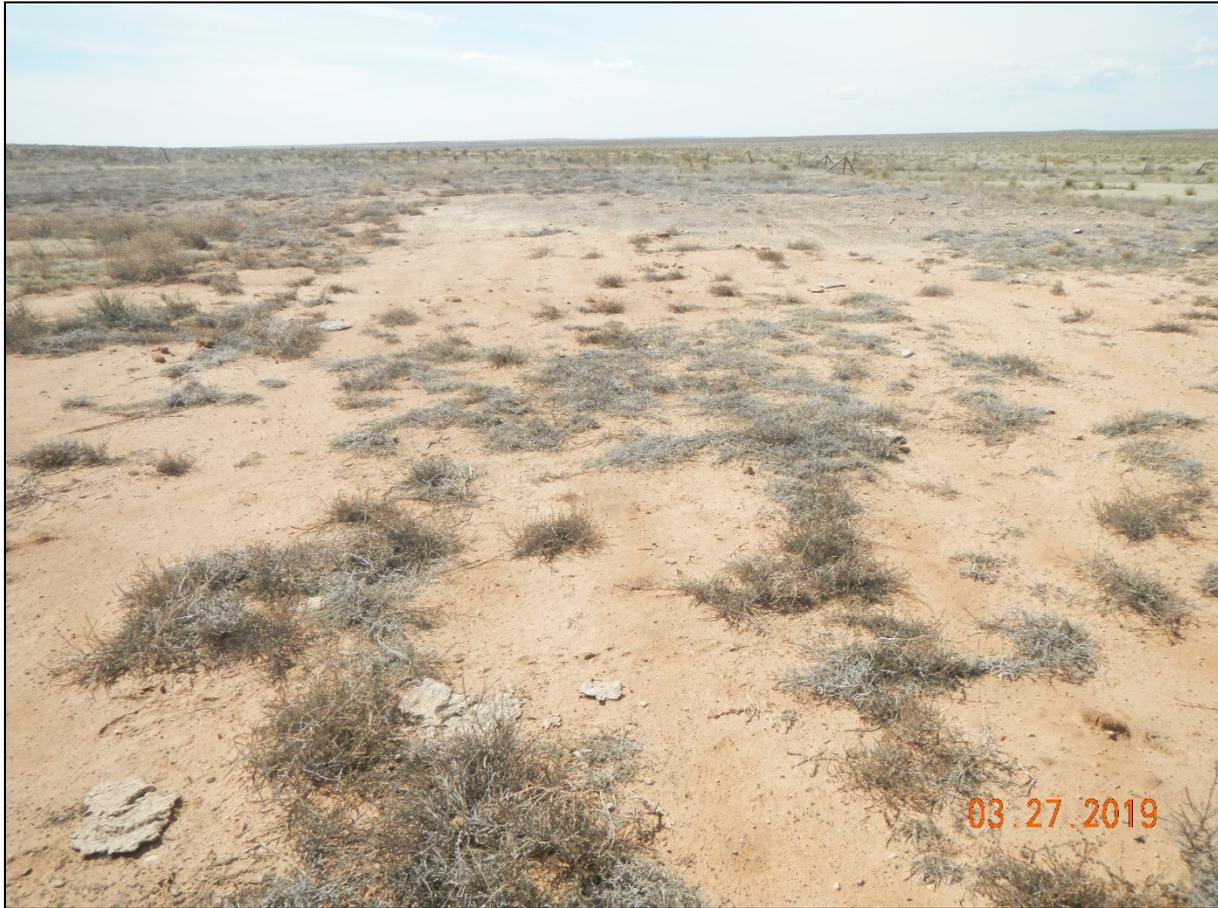
Photo 3. Facing west towards the location. There are bare areas with no vegetation establishment.

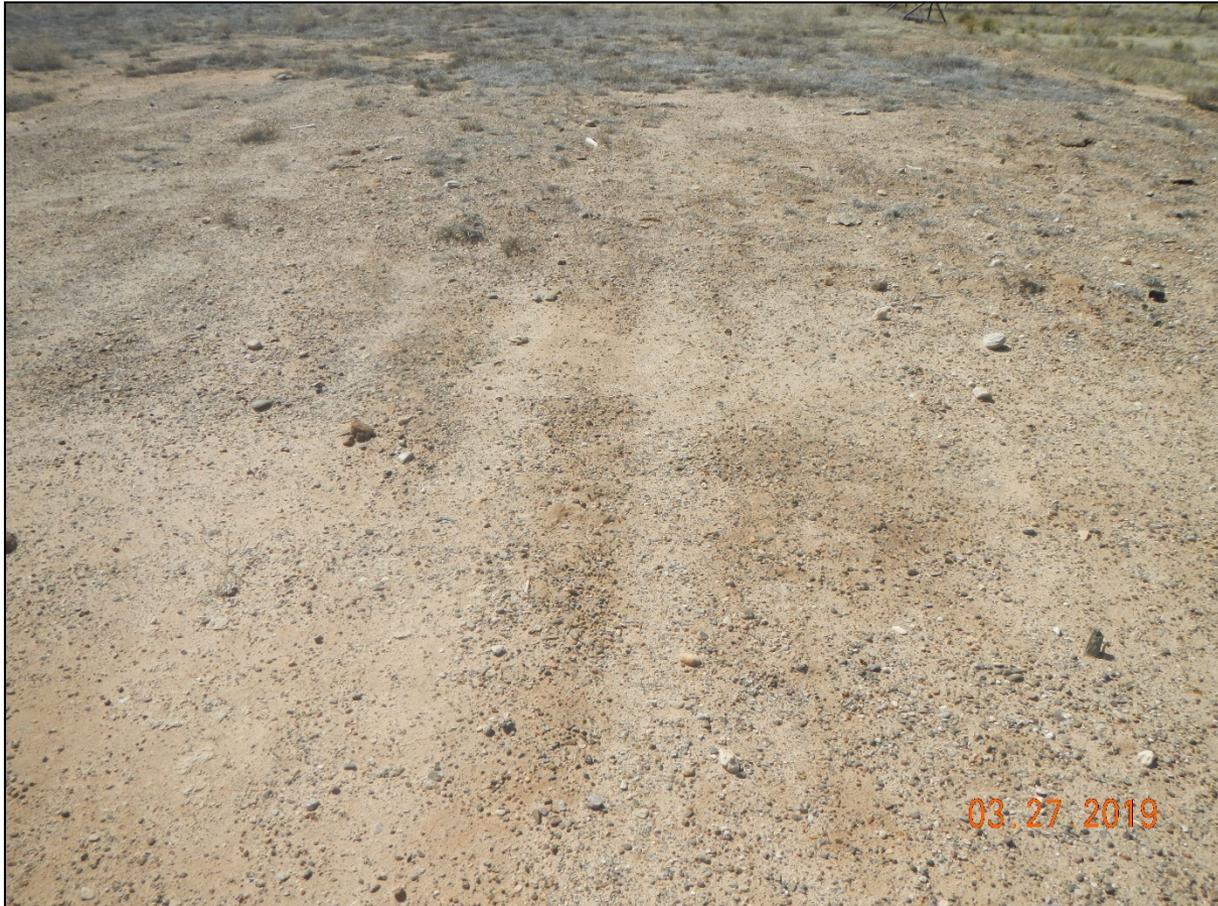
Photo 4. There are bare areas with no vegetation establishment.

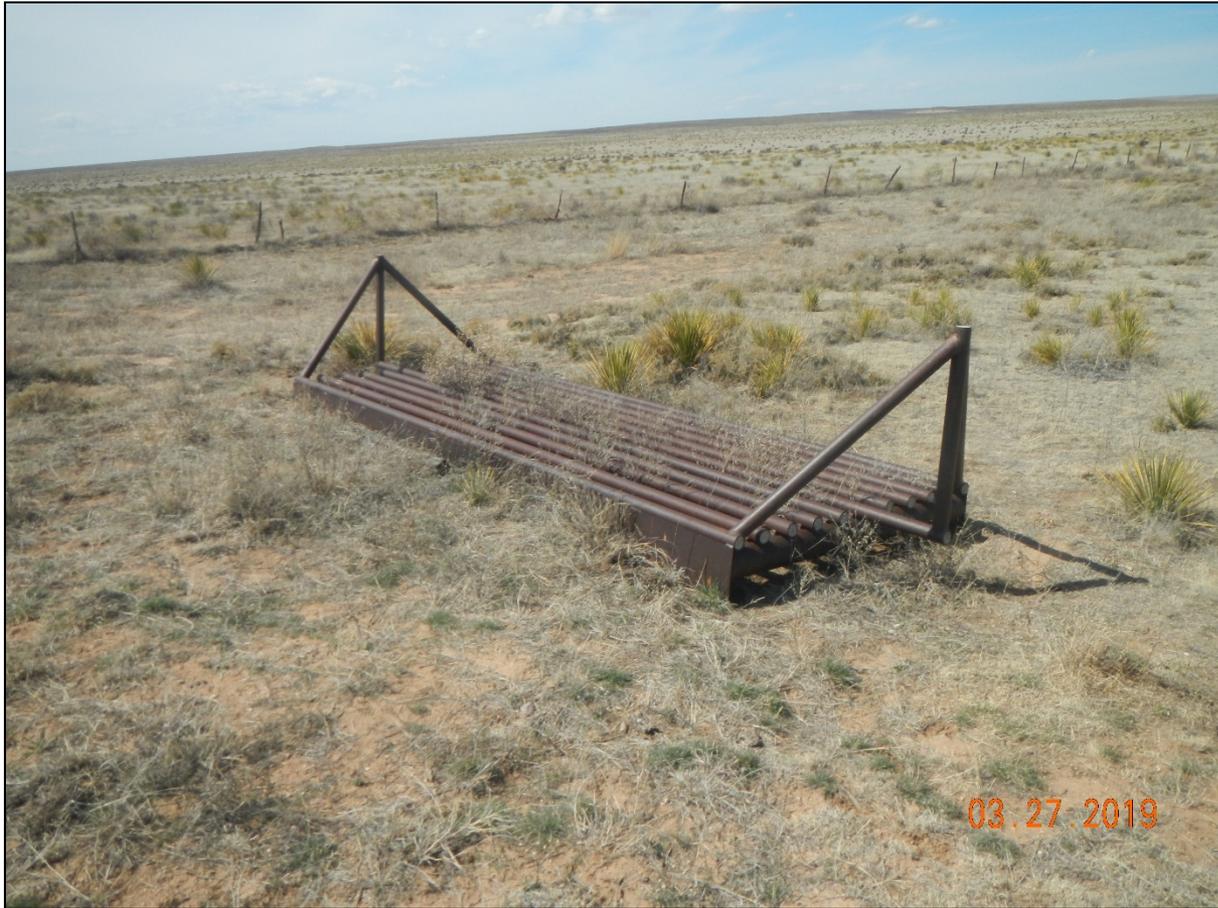
Photo 5. There is a cattle guard that remains at the west side of the location.

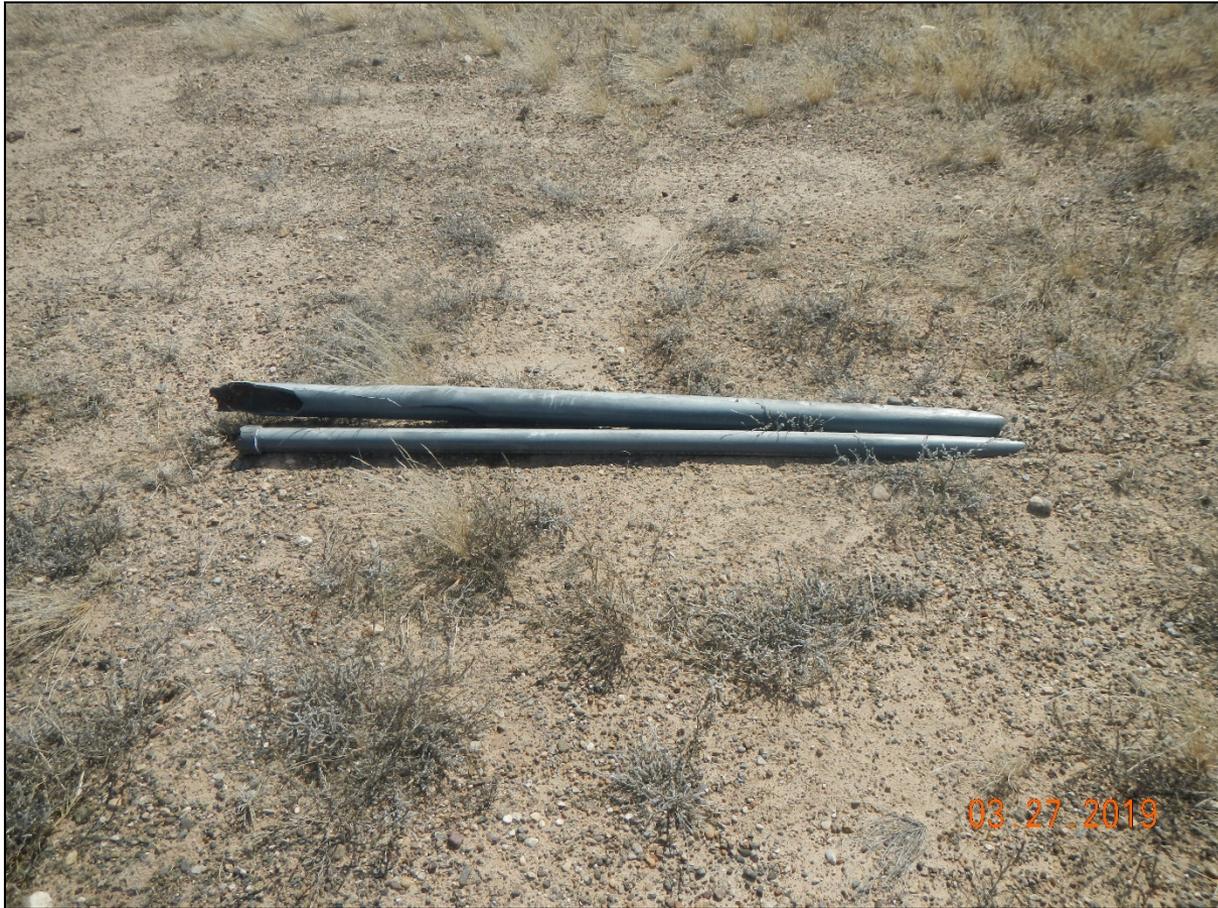
Photo 7. There is plastic pipe that remains at the center of the location.
