Inspection Photos

API: 05-009-06629

Operator: INVESTMENT EQUIPMENT LLC

Inspection Date: 3/27/2019

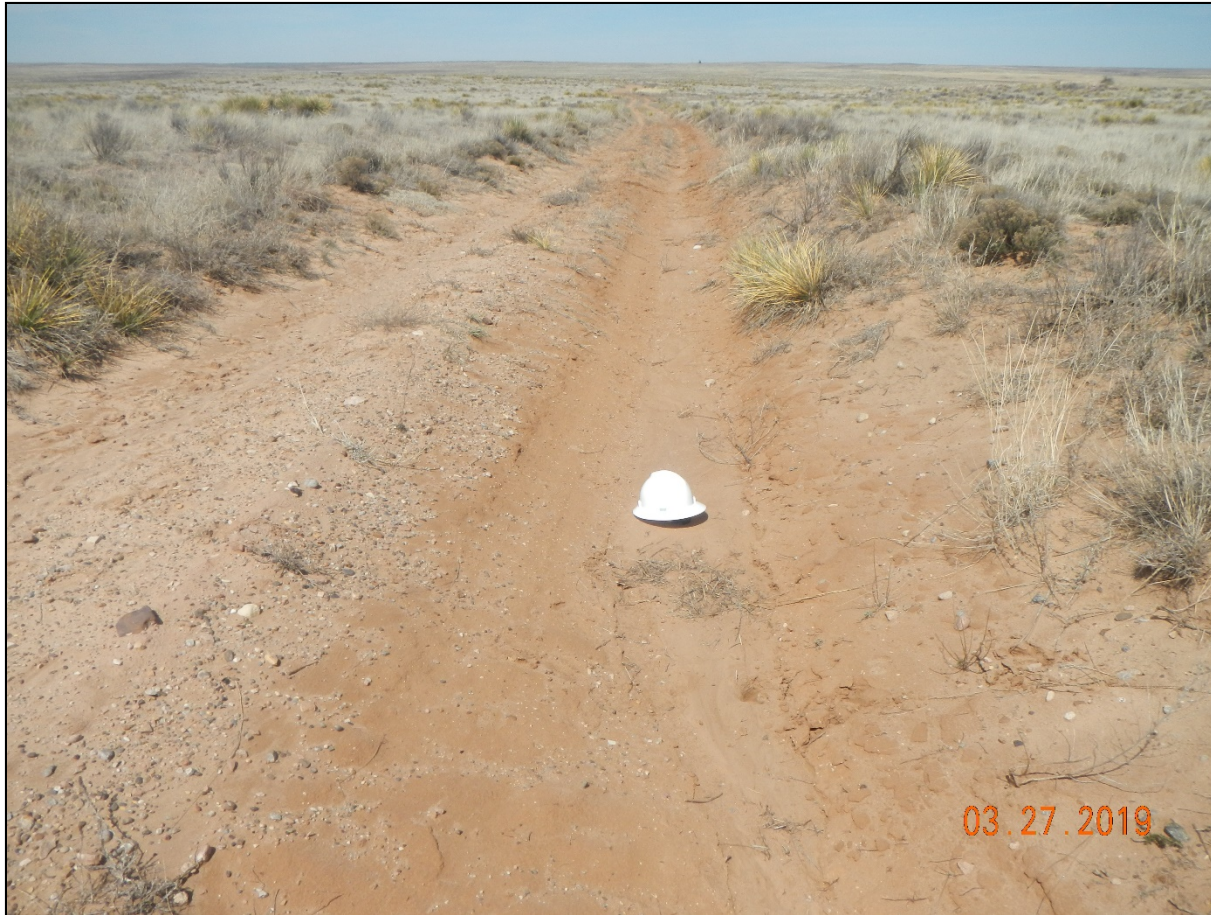
Photo 1. Facing north along the access road. Road continues past the location towards a stock tank. There is erosion along the road that need to be filled in and fixed.

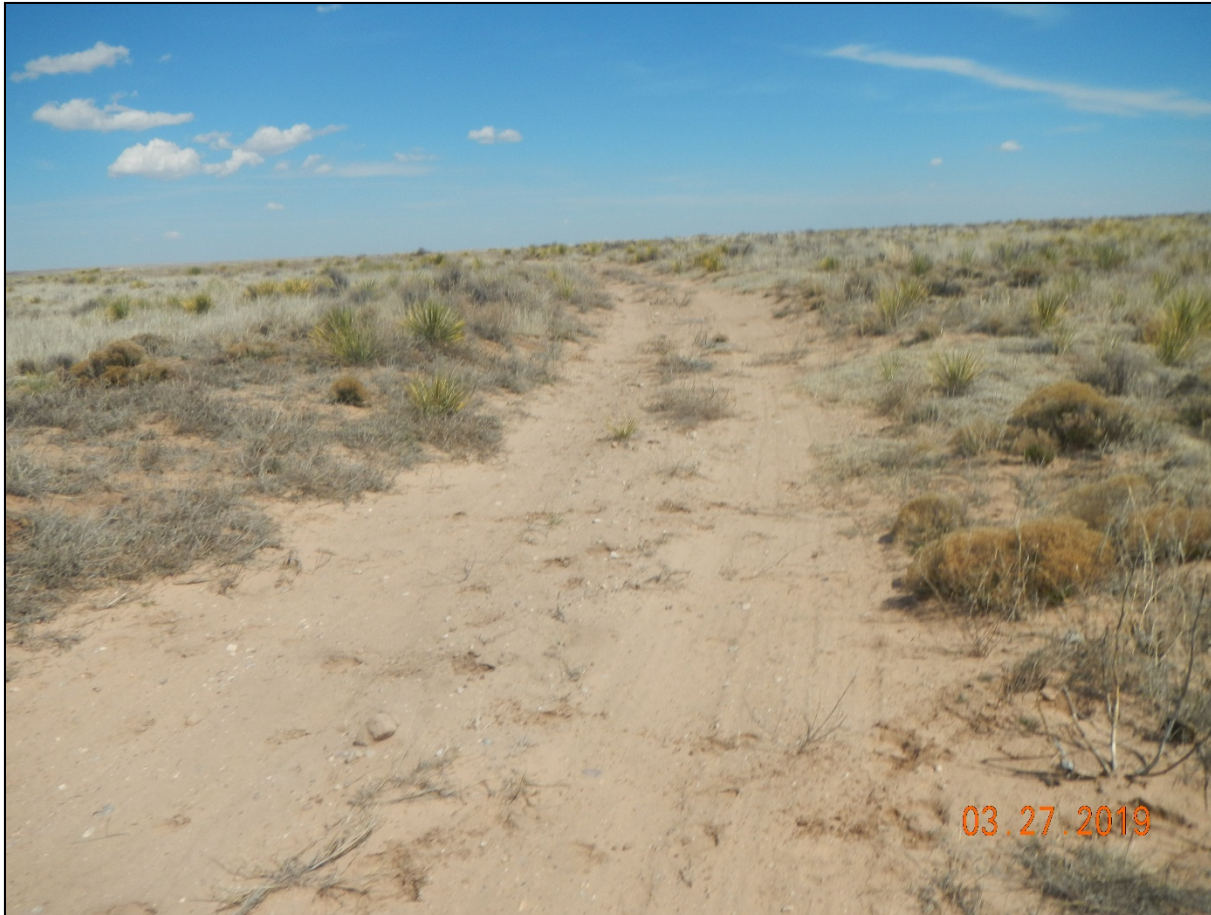
Photo 2. Facing northeast toward the access road. This access road need to be reclaimed.

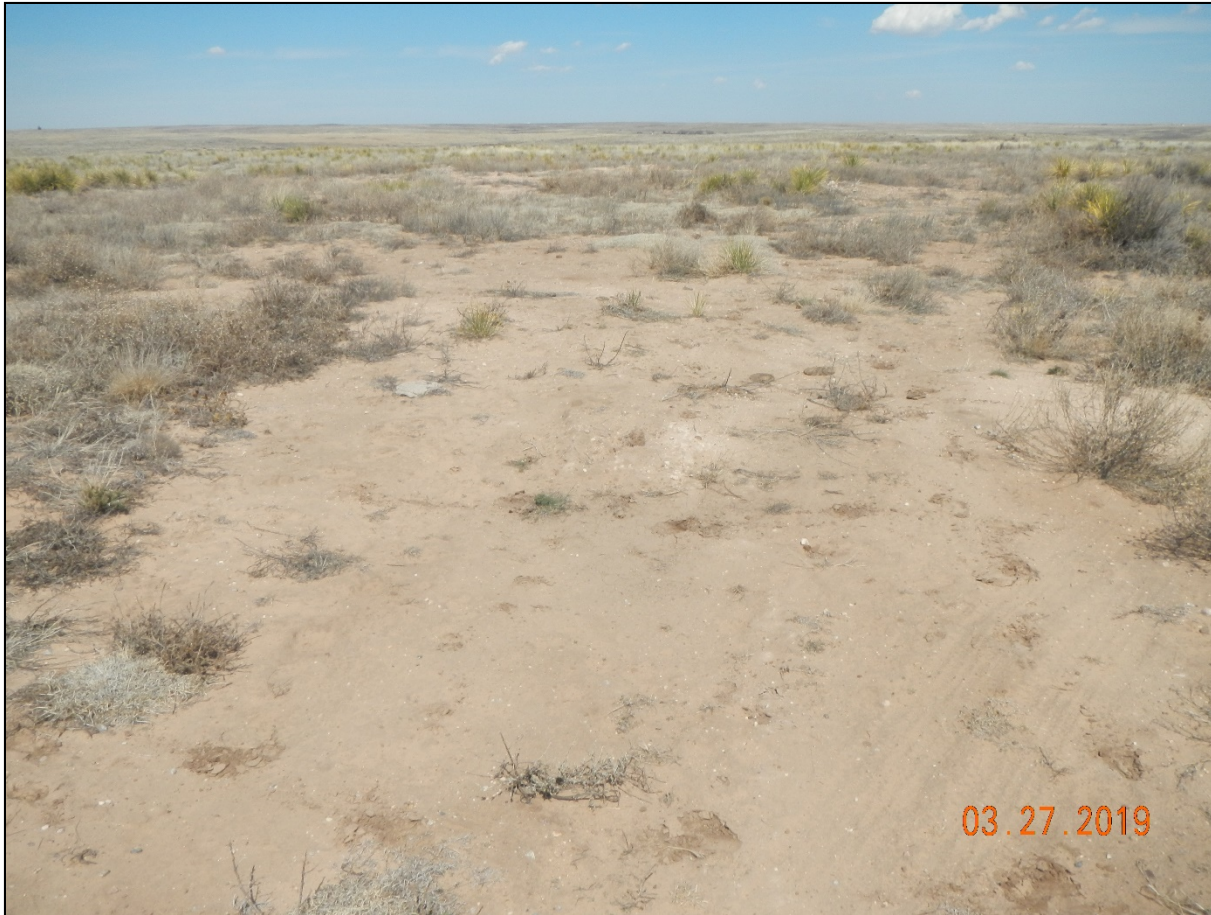
Photo 3. Facing northeast towards the location. There are bare areas with no vegetation establishment.
