# Inspection Photos

API: 05-009-06637

Operator: INVESTMENT EQUIPMENT LLC

Inspection Date: 3/27/2019

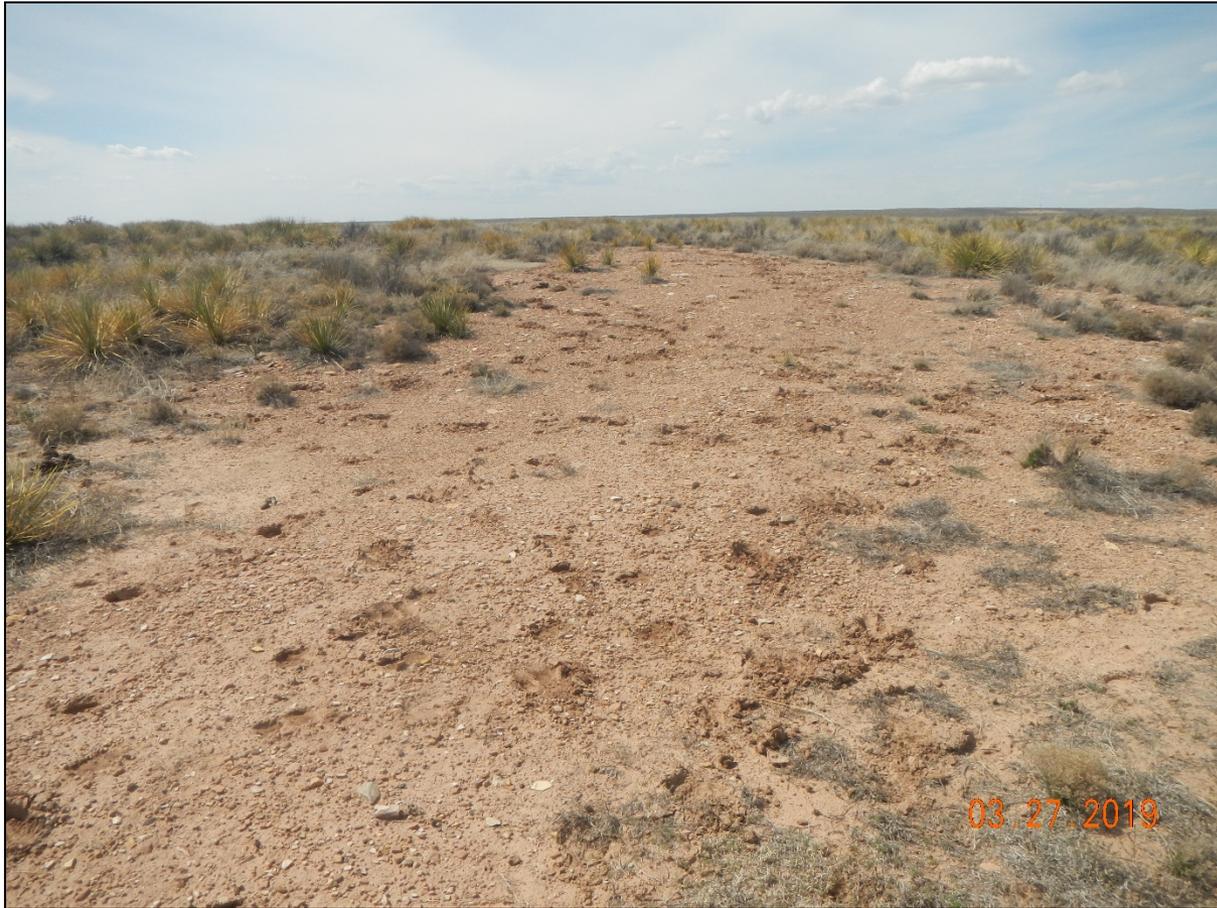
**Photo 1.** Facing west at the beginning of the access road. Vegetation has not re-established in this area.

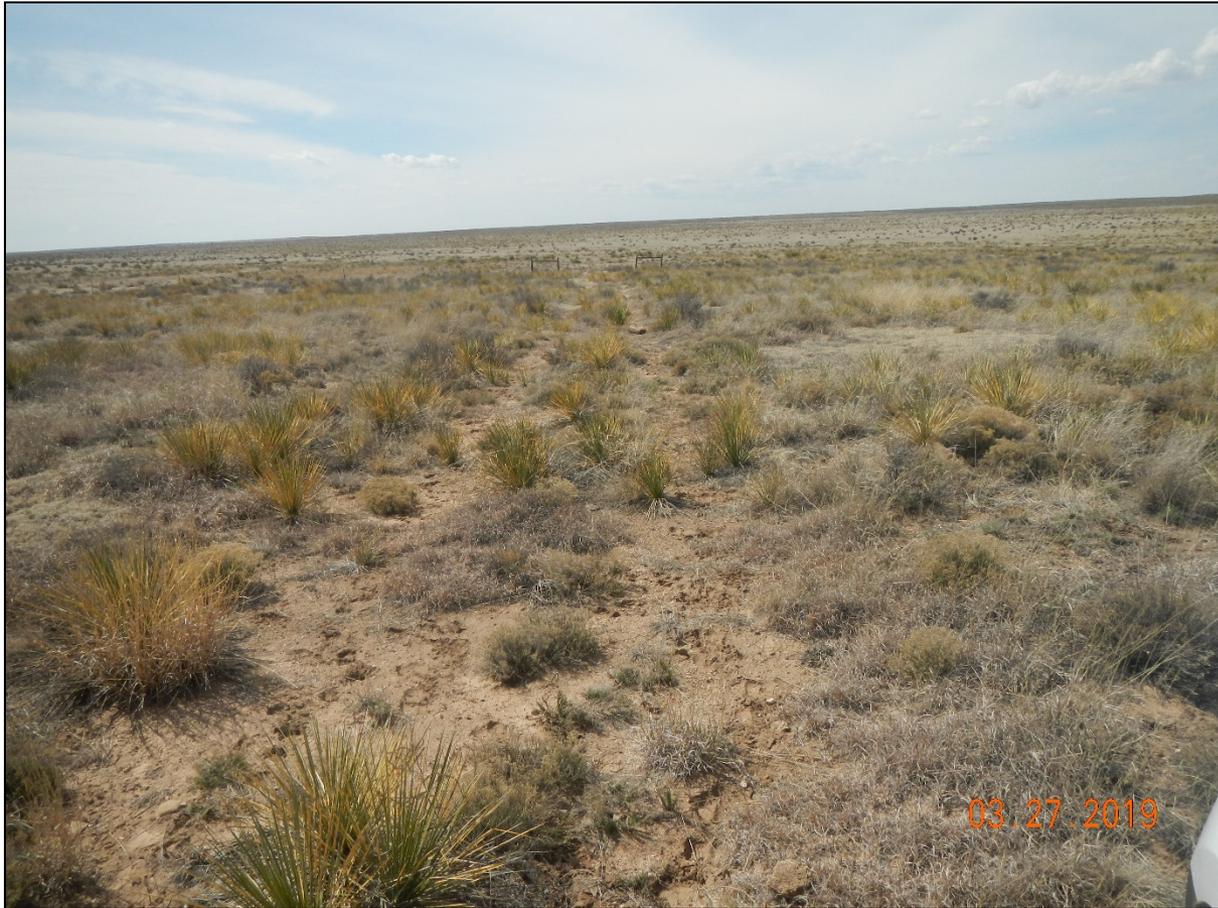
**Photo 2.** Facing west along the access road. Vegetation has established along this portion of the road.

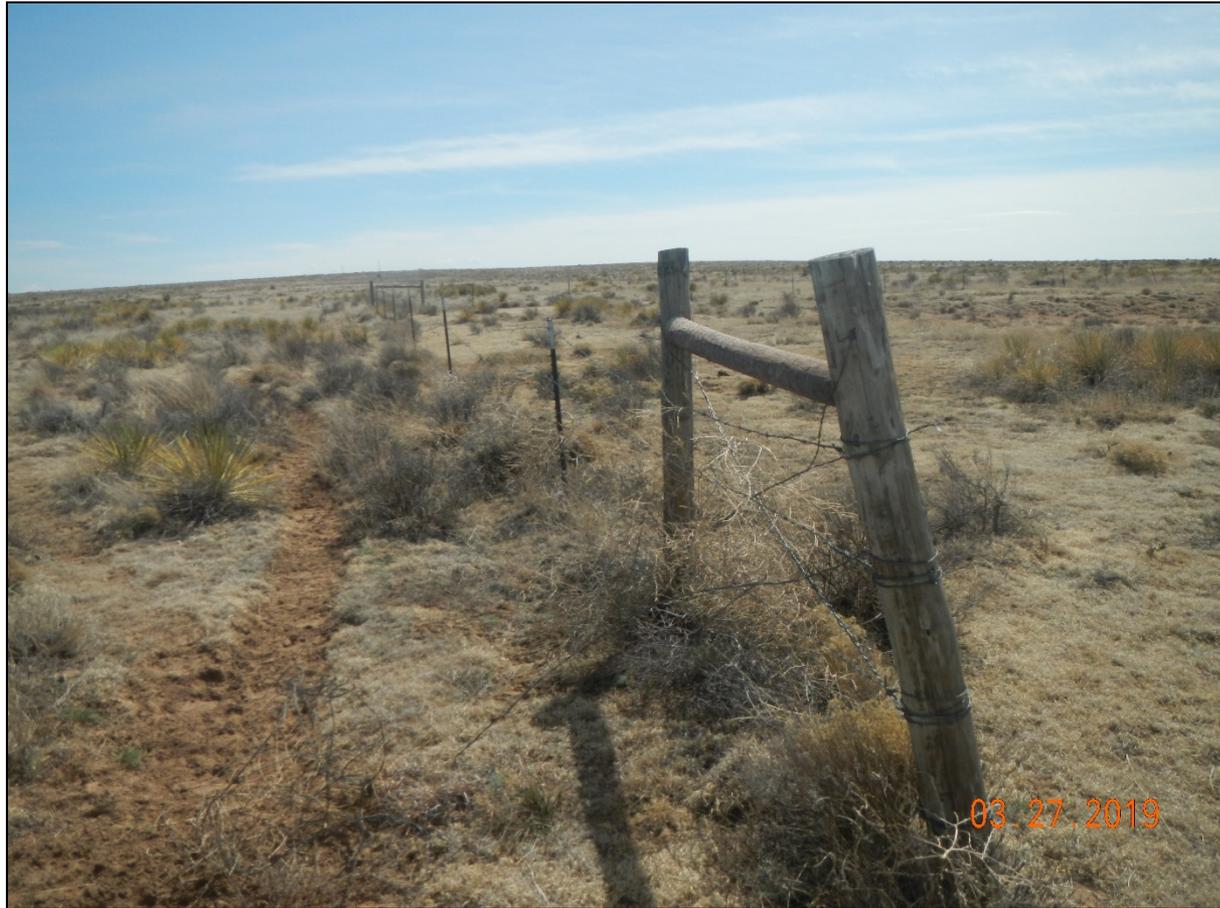
**Photo 3.** There is a perimeter fence that remains in disrepair around the location.

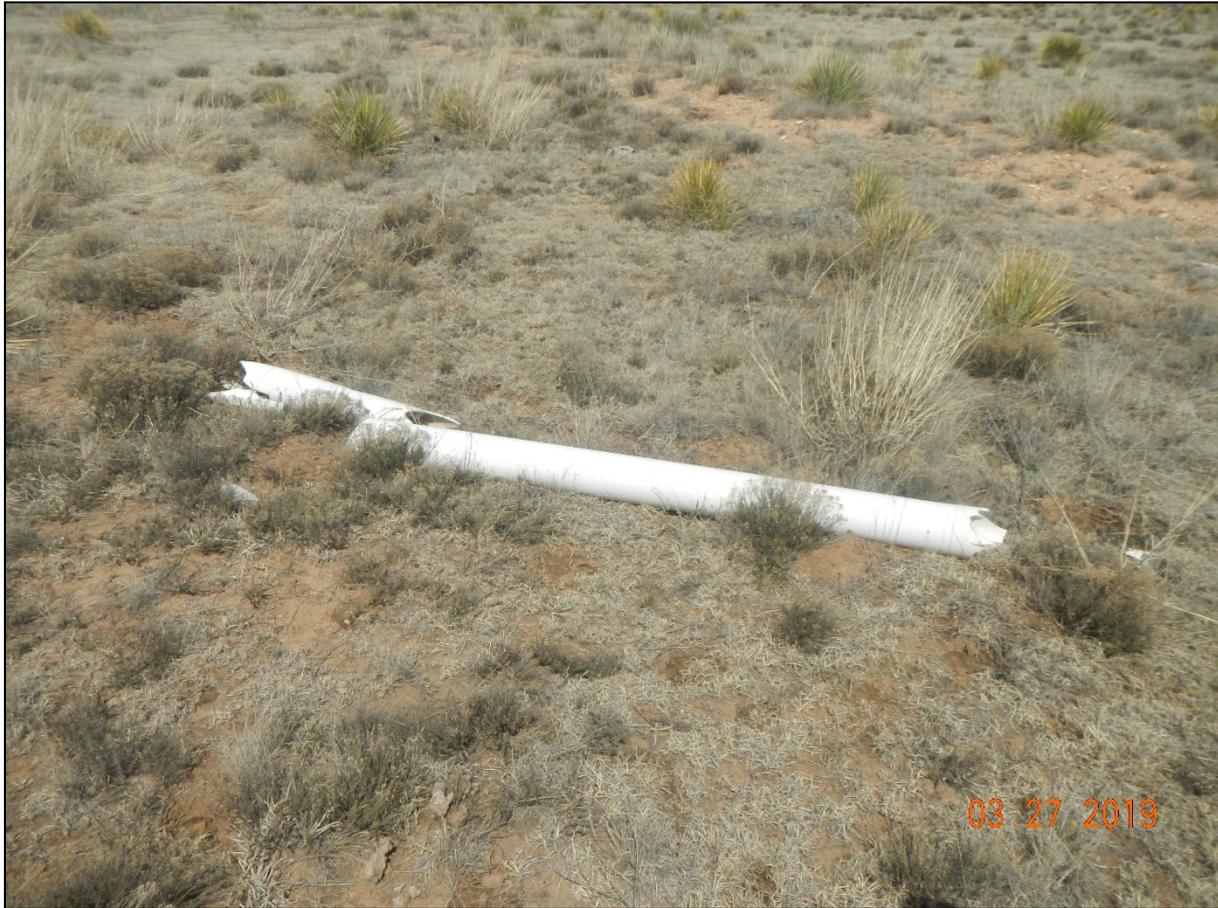
**Photo 7.** There is plastic pipe debris that remains at the center of the location.
