Inspection Photos

API: 05-009-06628

Operator: INVESTMENT EQUIPMENT LLC

Inspection Date: 3/27/2019

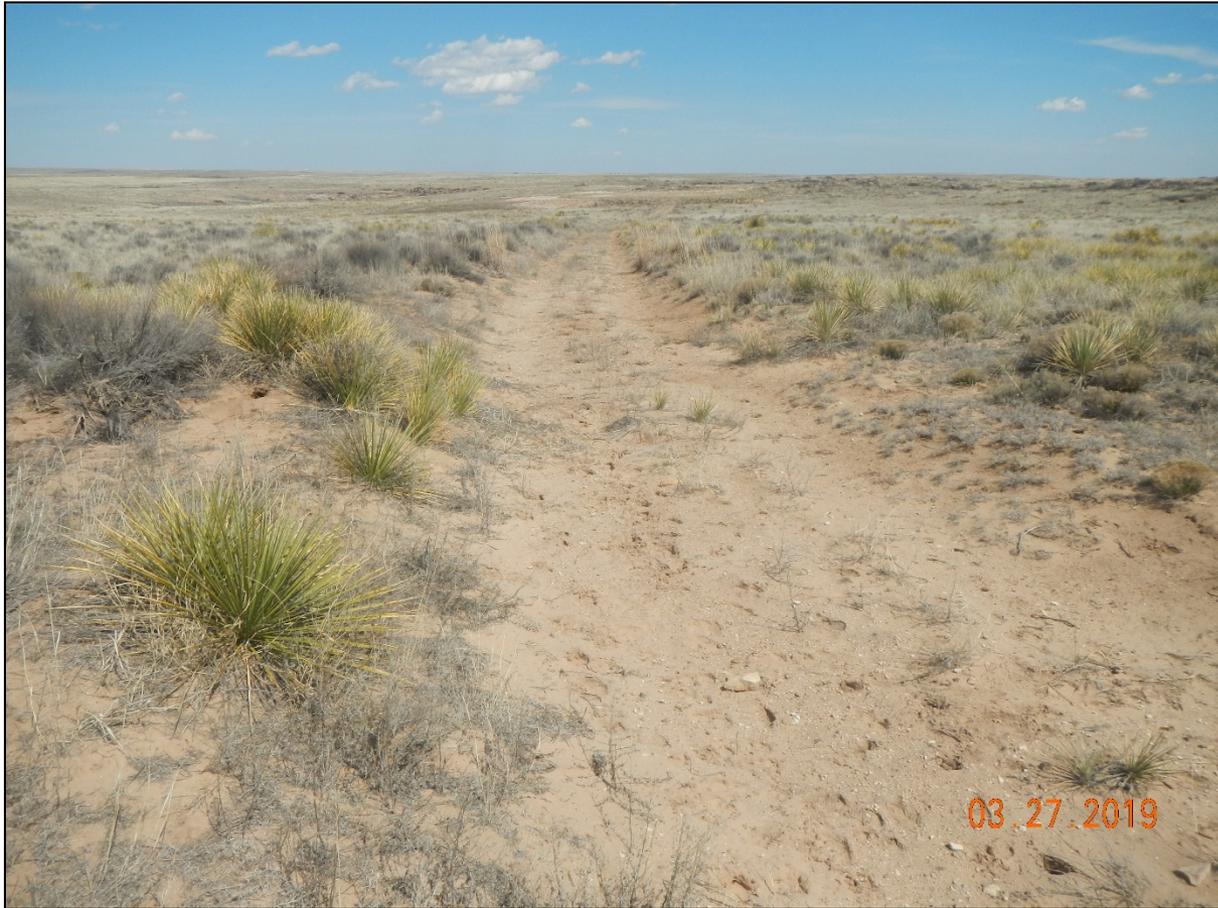
Photo 1. Facing east toward the access road which has not been recontoured and reclaimed.

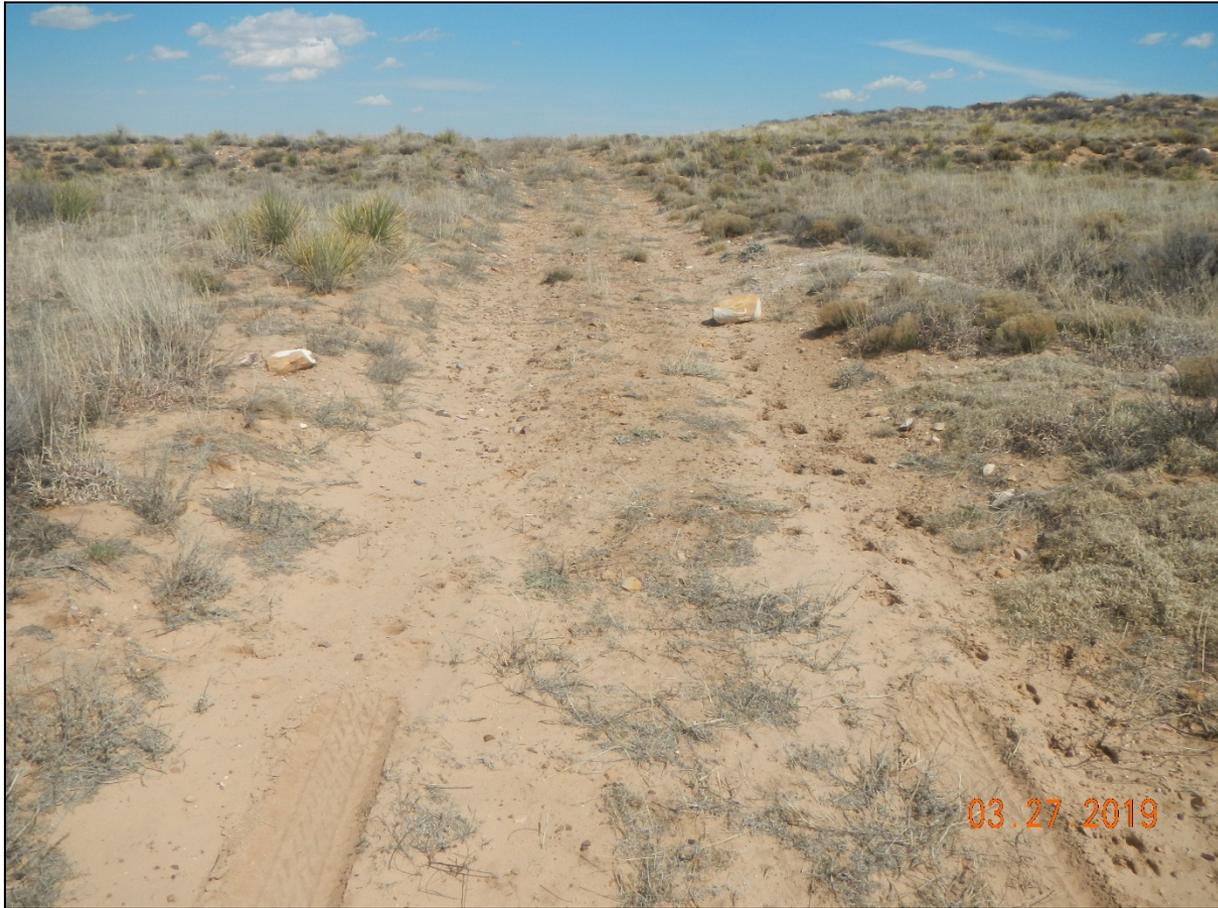
Photo 2. Facing east along the access road. Vegetation has not established along the road.

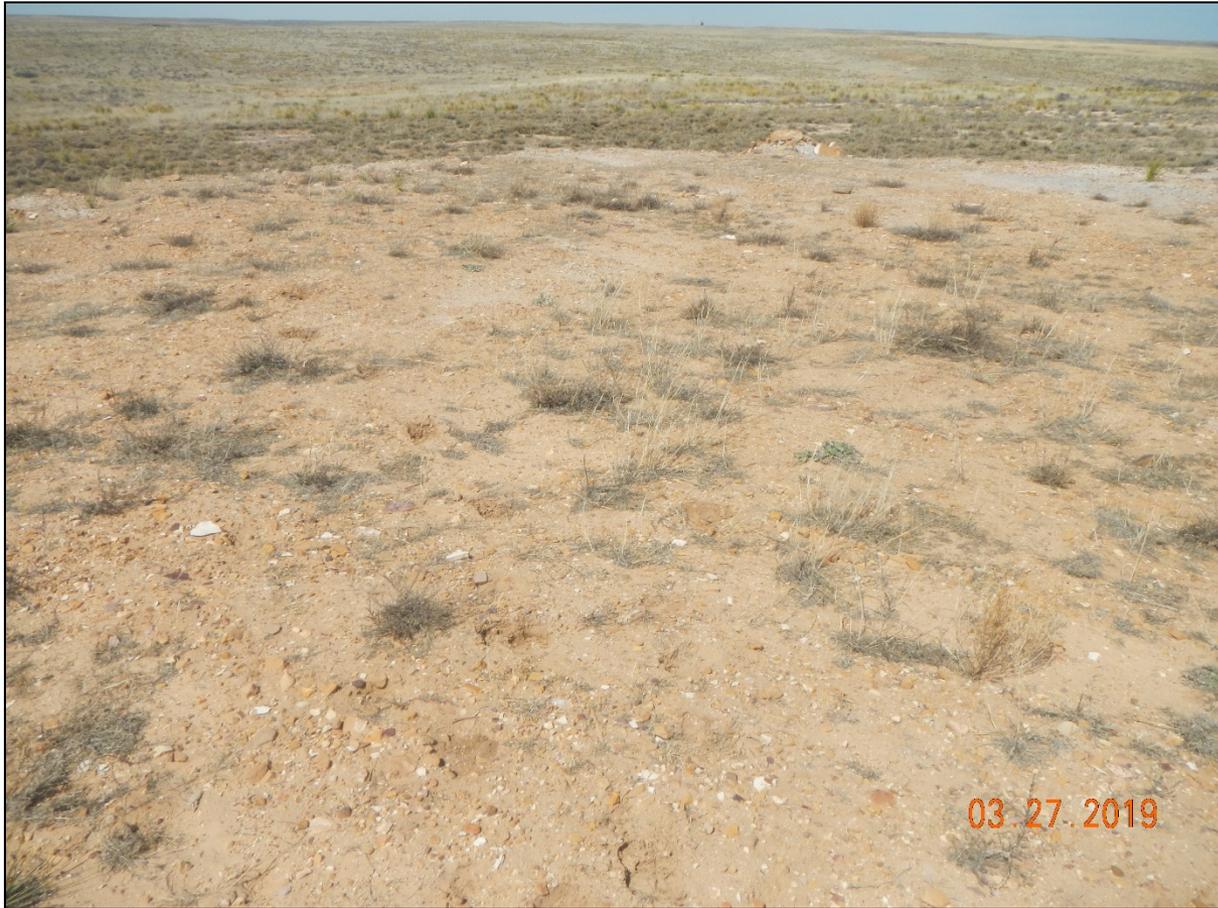
Photo 3. Facing north toward the northwest area of the location. Vegetation has not established in this area.

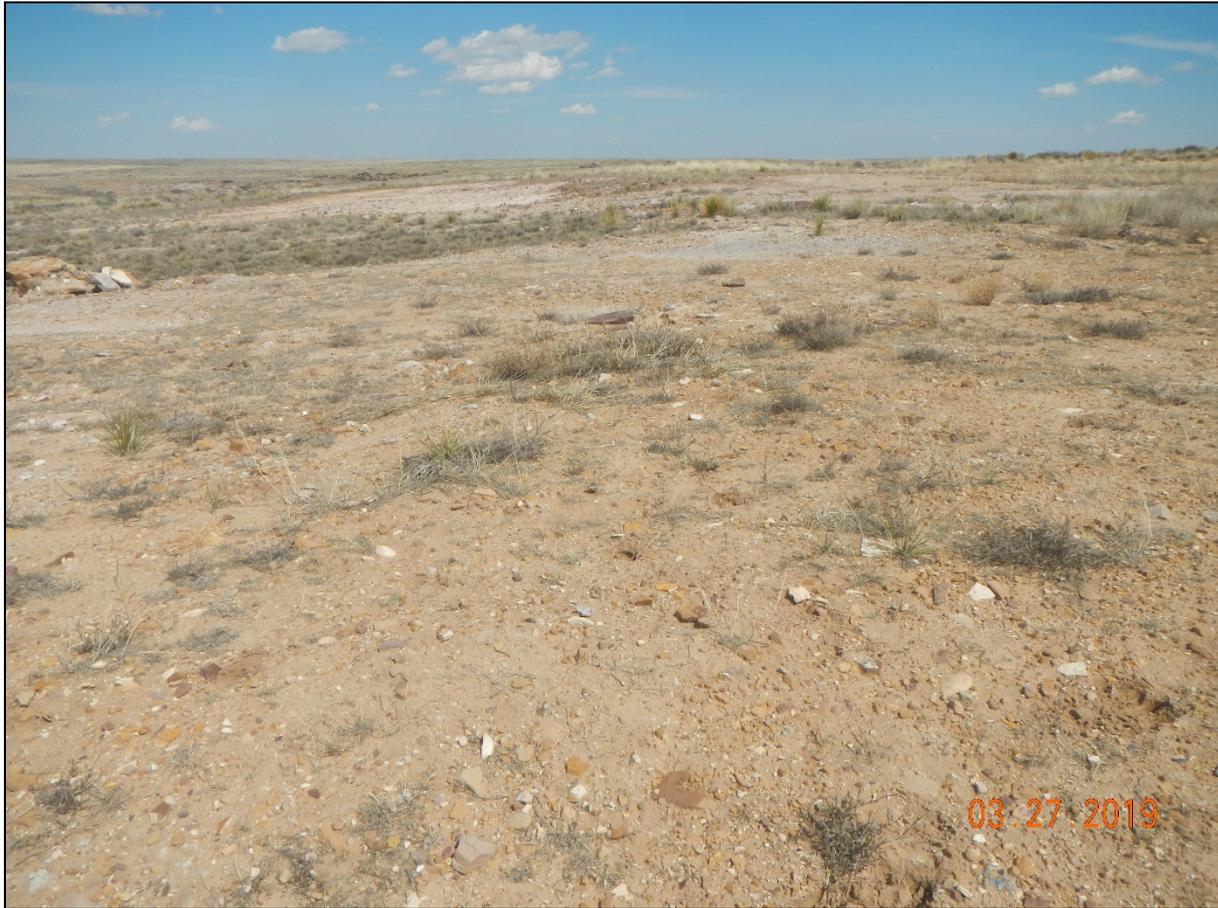
Photo 4. Facing east at the north side of the location. Vegetation has not established in this area.

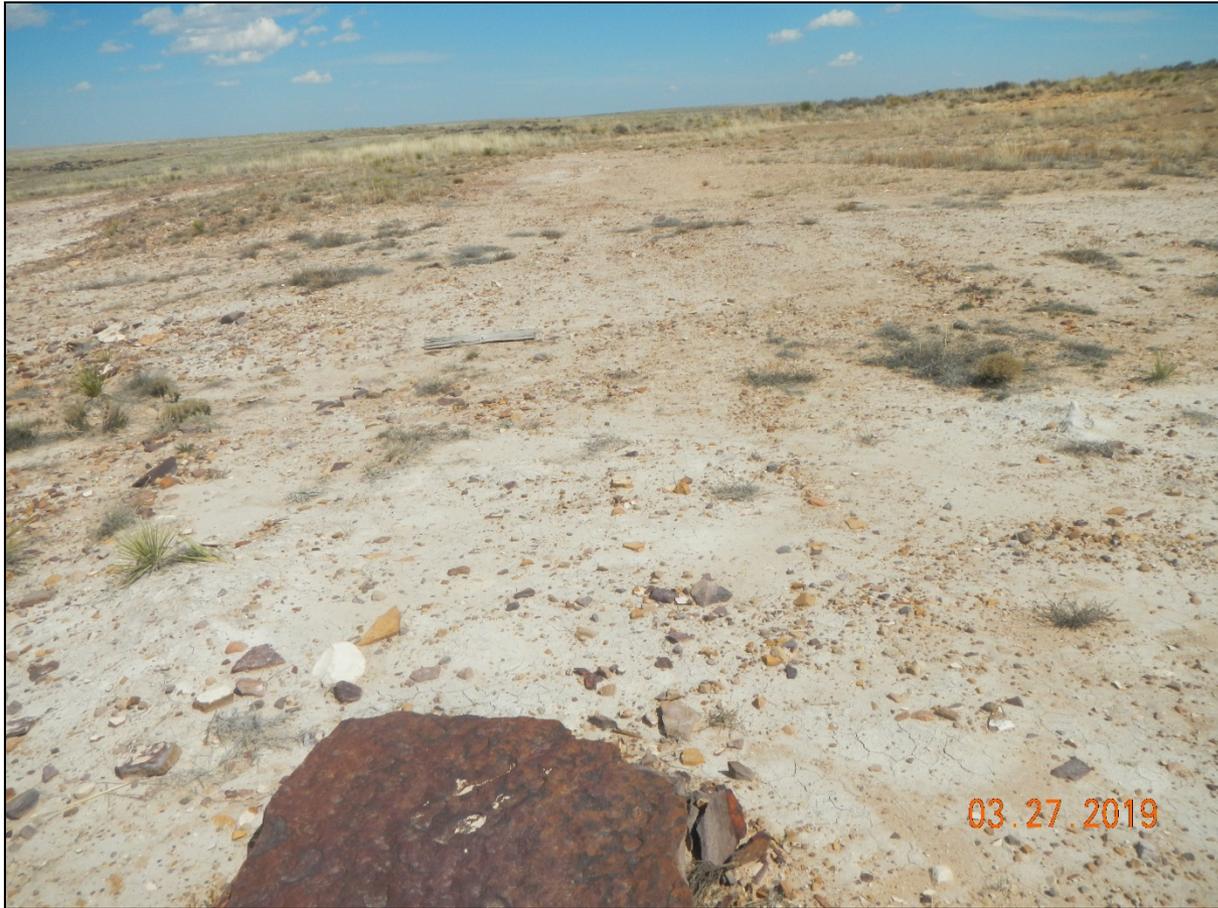
Photo 5. Facing east at the north side of the location. Vegetation has not established in this area.

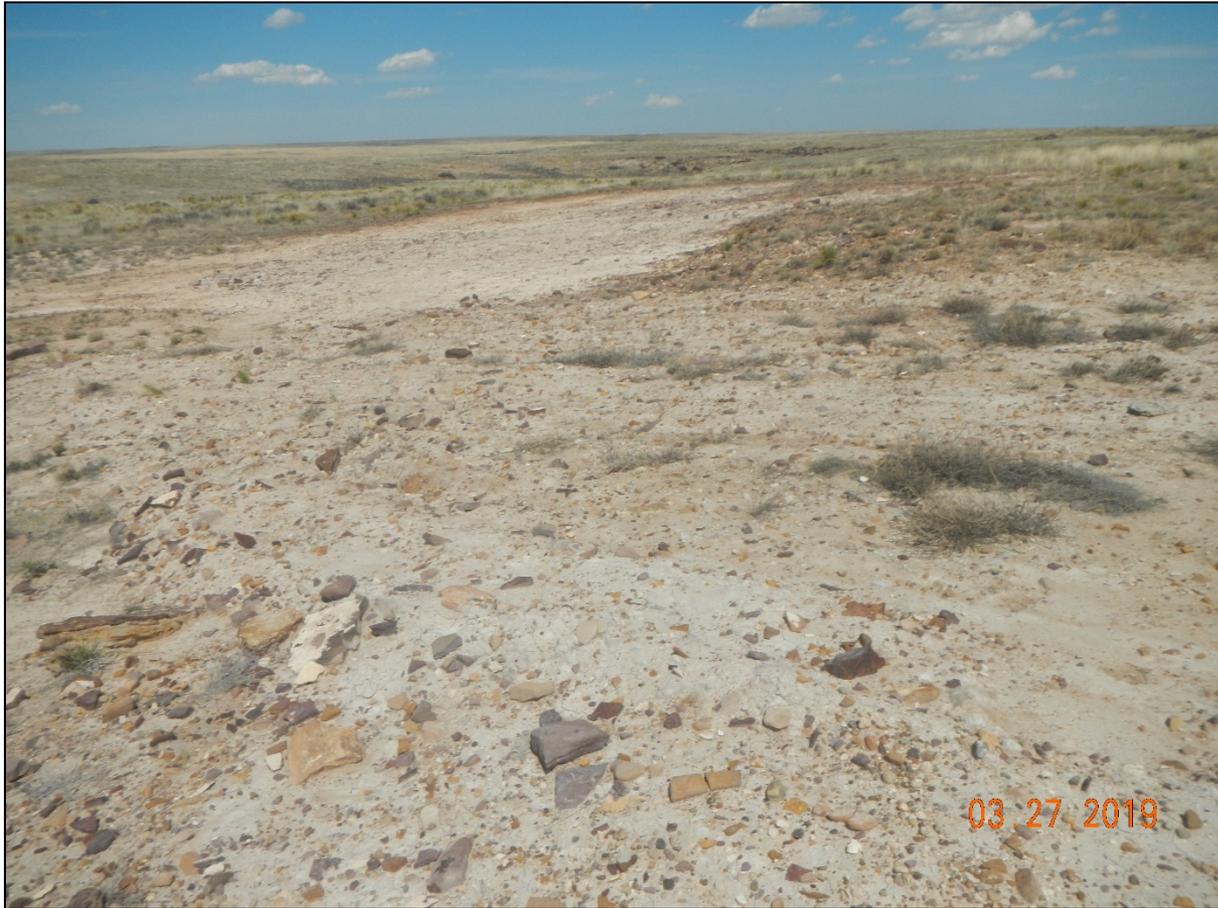
Photo 6. Facing northeast at the location. Vegetation has not established in this area.

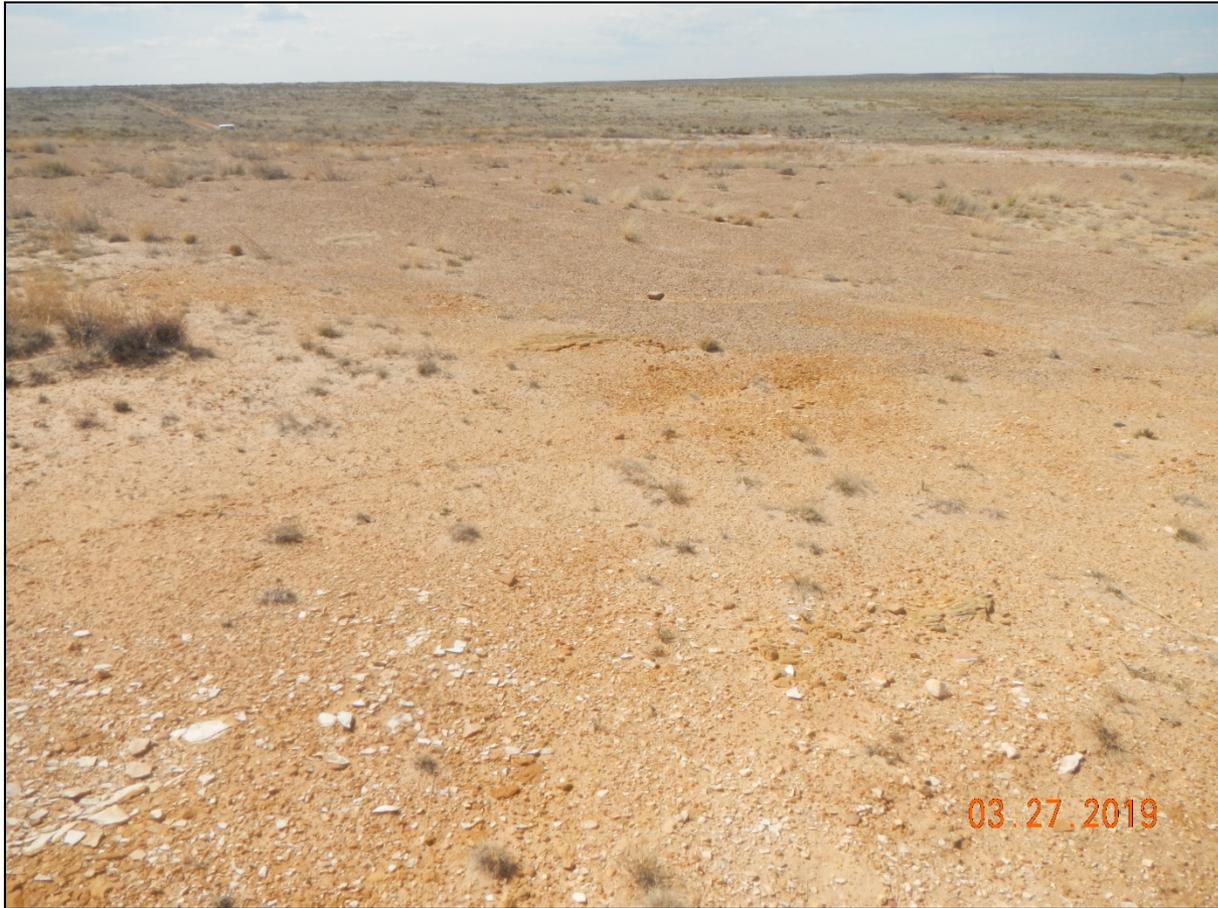
Photo 8. South side of the location facing northwest. Vegetation has not established in this area.
