Inspection Photos

Operator: VERDAD RESOURCES LLC # 10651

Location ID: 462872

Inspection Doc. Number: 682504684

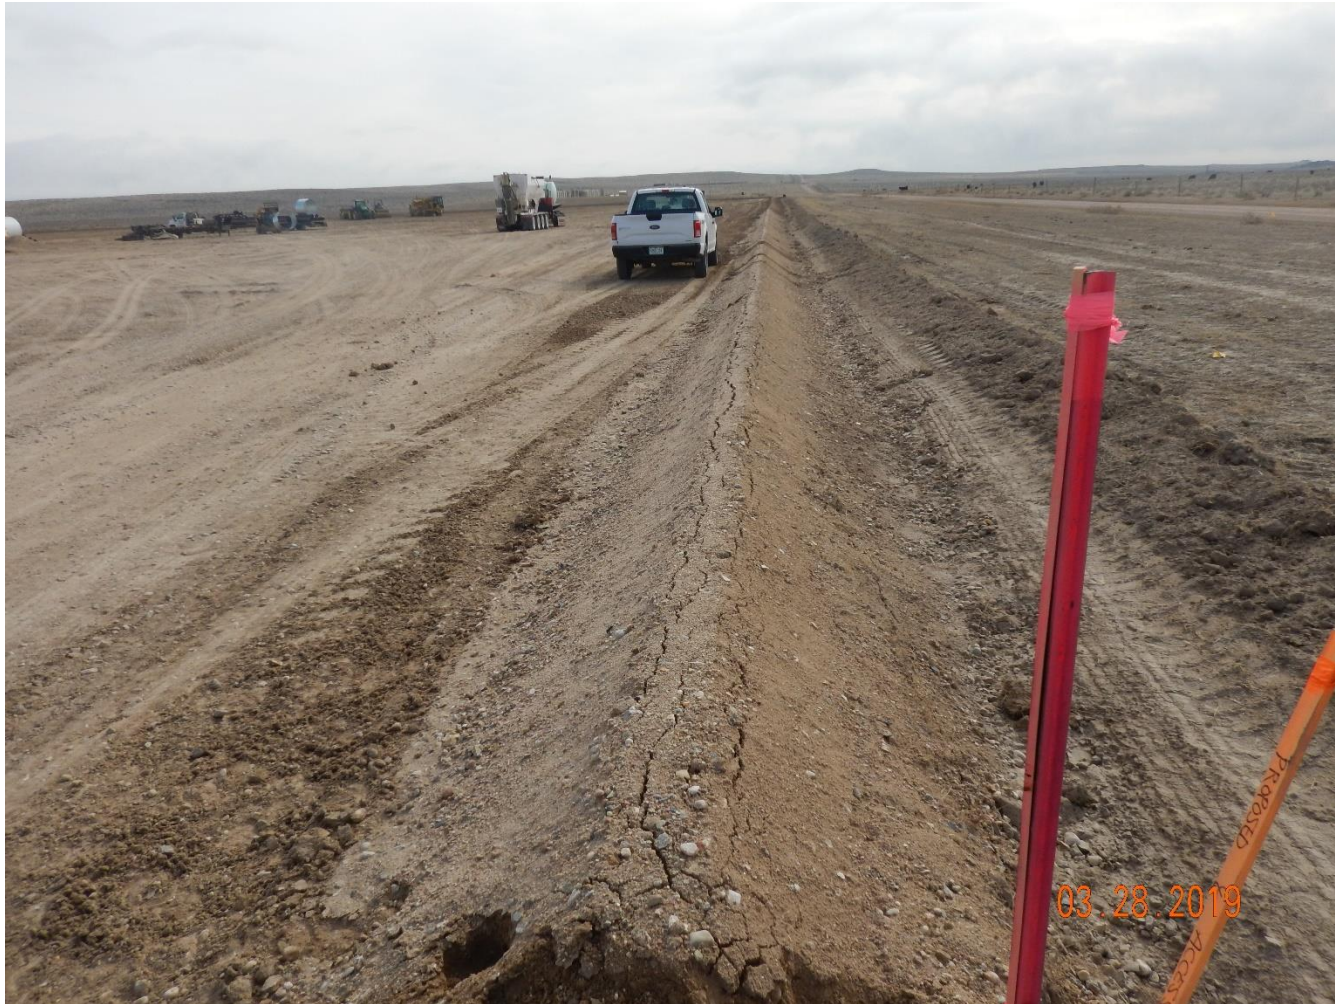
Photo 1: Photo taken from the southwest corner of the location, facing east. Photo shows operator has installed a ditch/berm BMP along perimeter of the location. BMP does not appear to have been constructed in accordance with good engineering practices; BMPs have not been sufficiently compacted, remains unconsolidated materials and a potential source for sediment laden stormwater discharge.

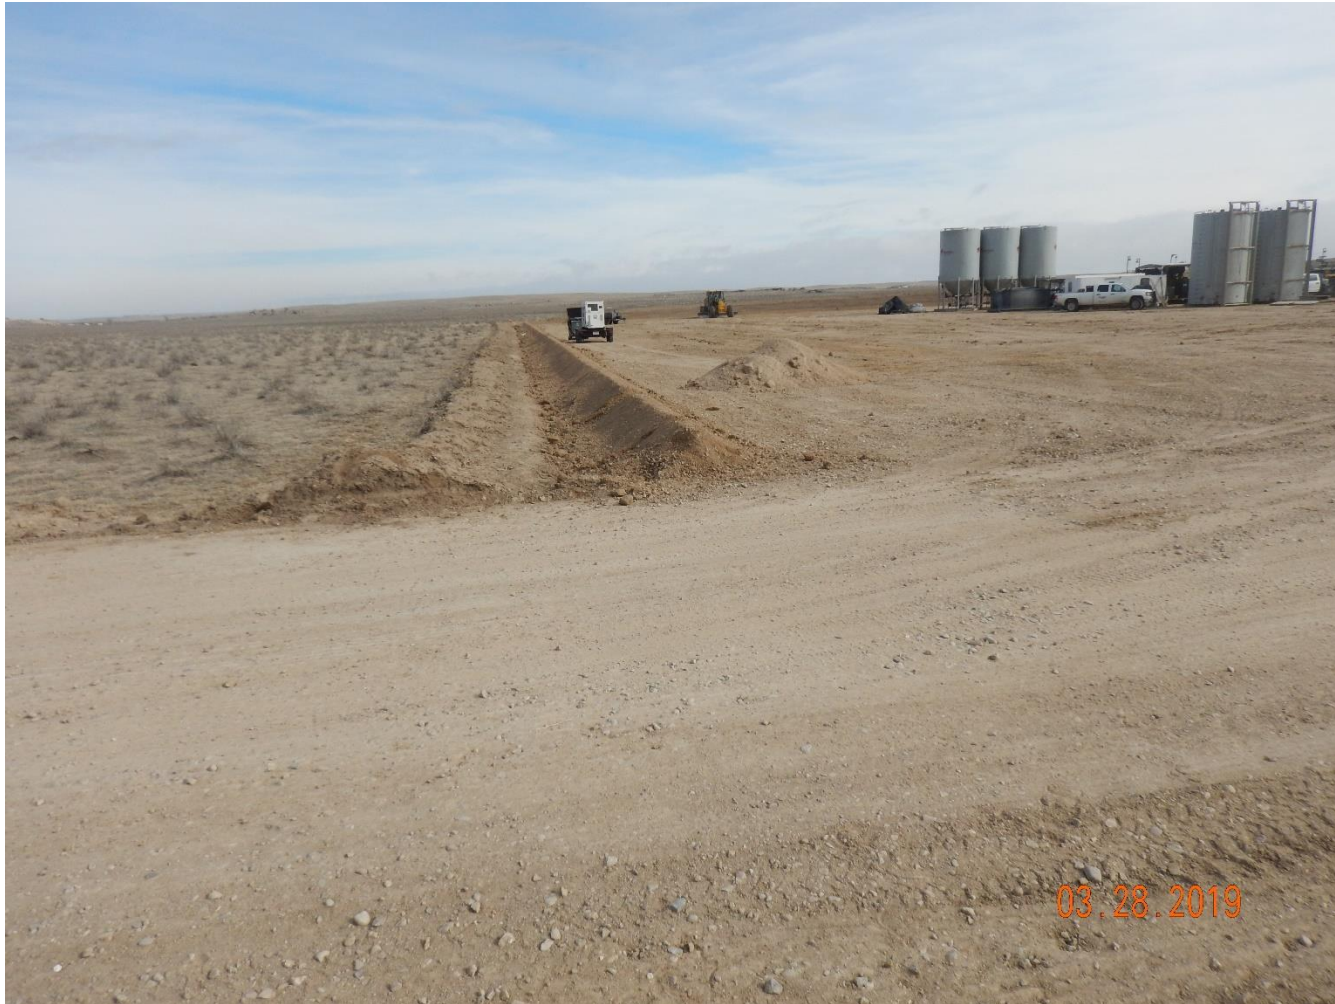
Photo 2: Photo taken from the southwest corner of the location, facing north. See comments under photo 1.

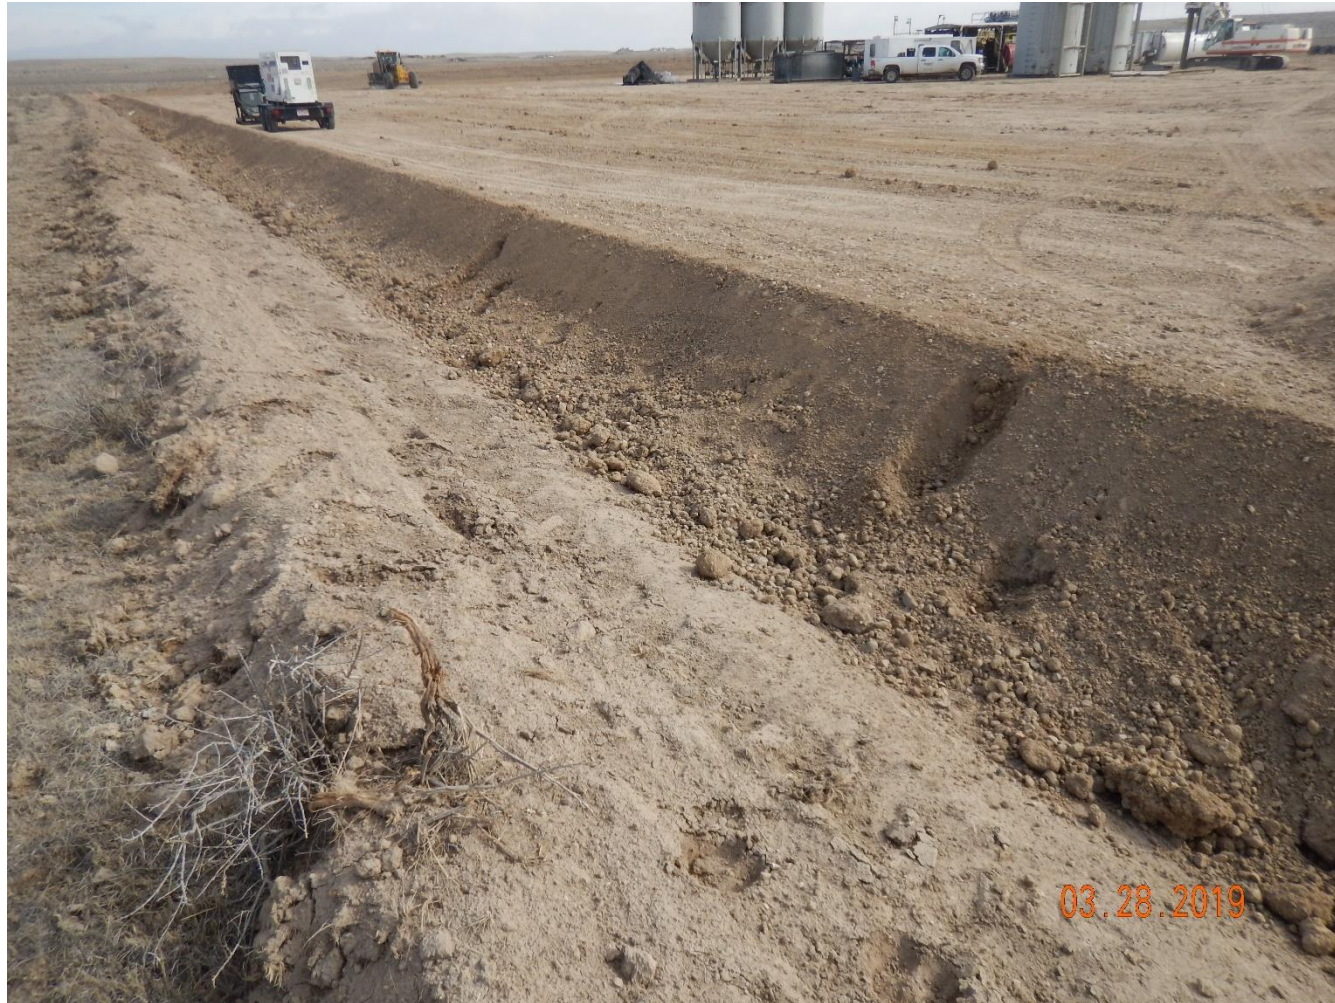
Photo 3: Photo taken from the ditch/berm on the west end of the location, facing northeast. Photo shows operator has installed a ditch/berm BMP along perimeter of the location. BMP does not appear to have been constructed in accordance with good engineering practices; BMPs have not been sufficiently compacted, remains unconsolidated materials and a potential source for sediment laden stormwater discharge.

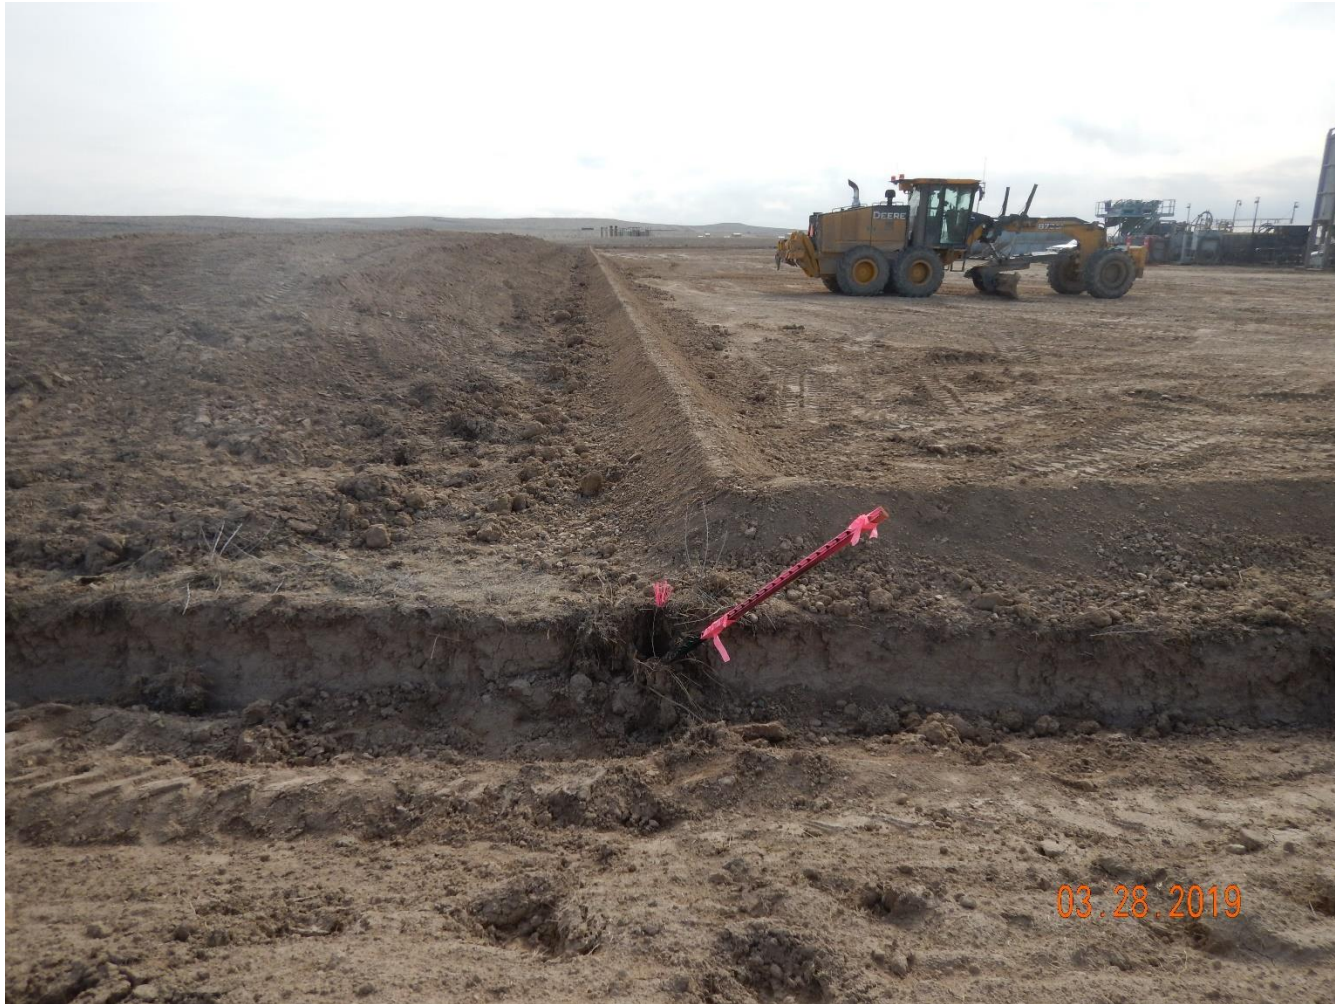
Photo 4: Photo taken from the northwest corner of the location, facing east. Photo shows ditch/berm along perimeter of location. Photo also shows berm along perimeter of the pad.

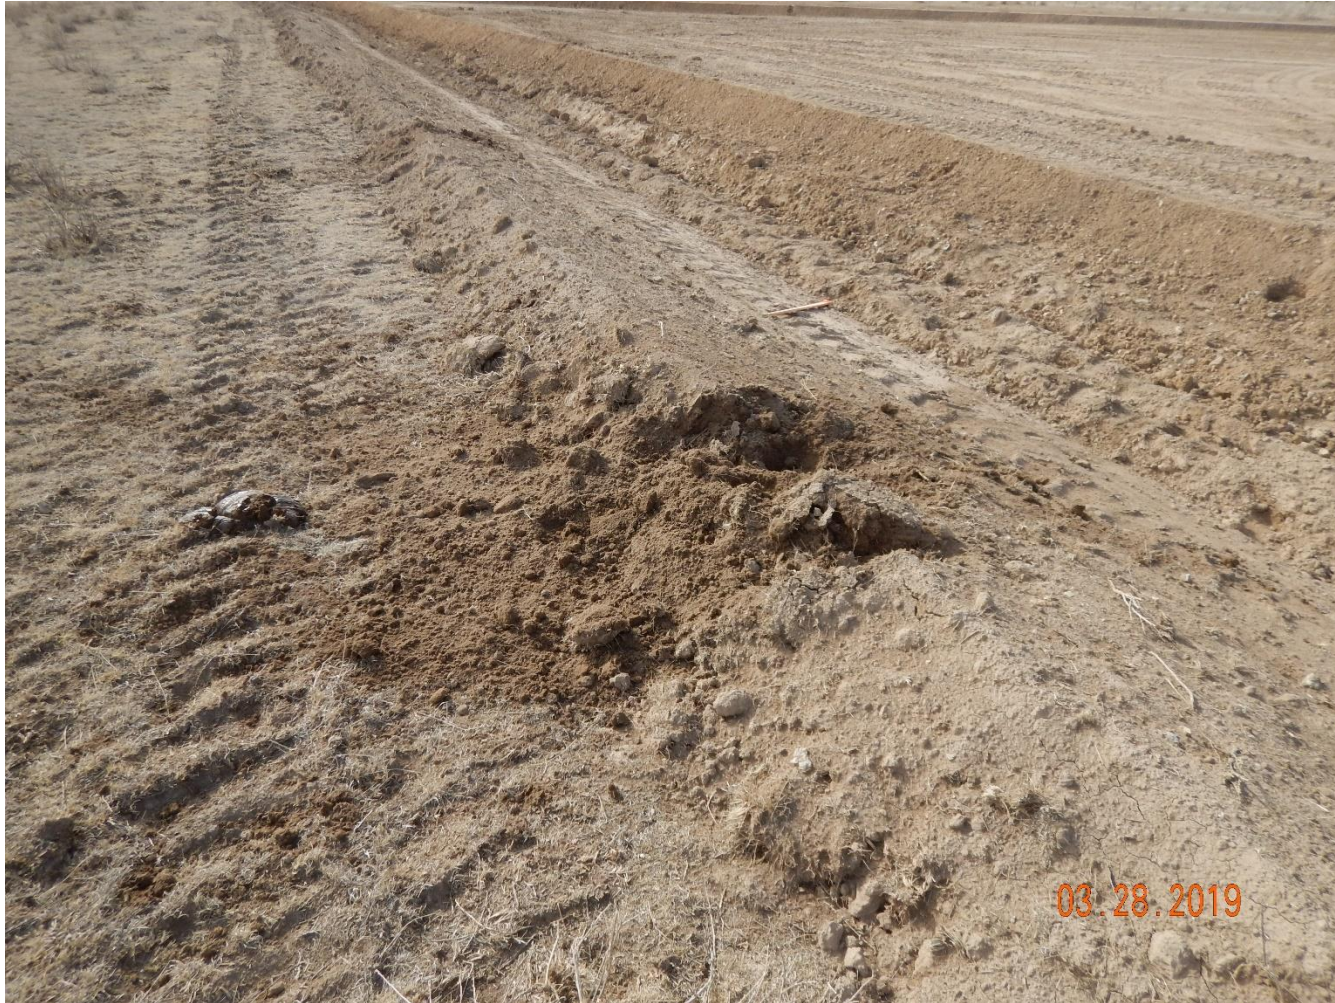
Photo 5: Photo taken from the ditch/berm on the east end of the location. Photo shows operator has installed a ditch/berm BMP along perimeter of the location. BMP does not appear to have been constructed in accordance with good engineering practices; BMPs have not been sufficiently compacted, remains unconsolidated materials and a potential source for sediment laden stormwater discharge.

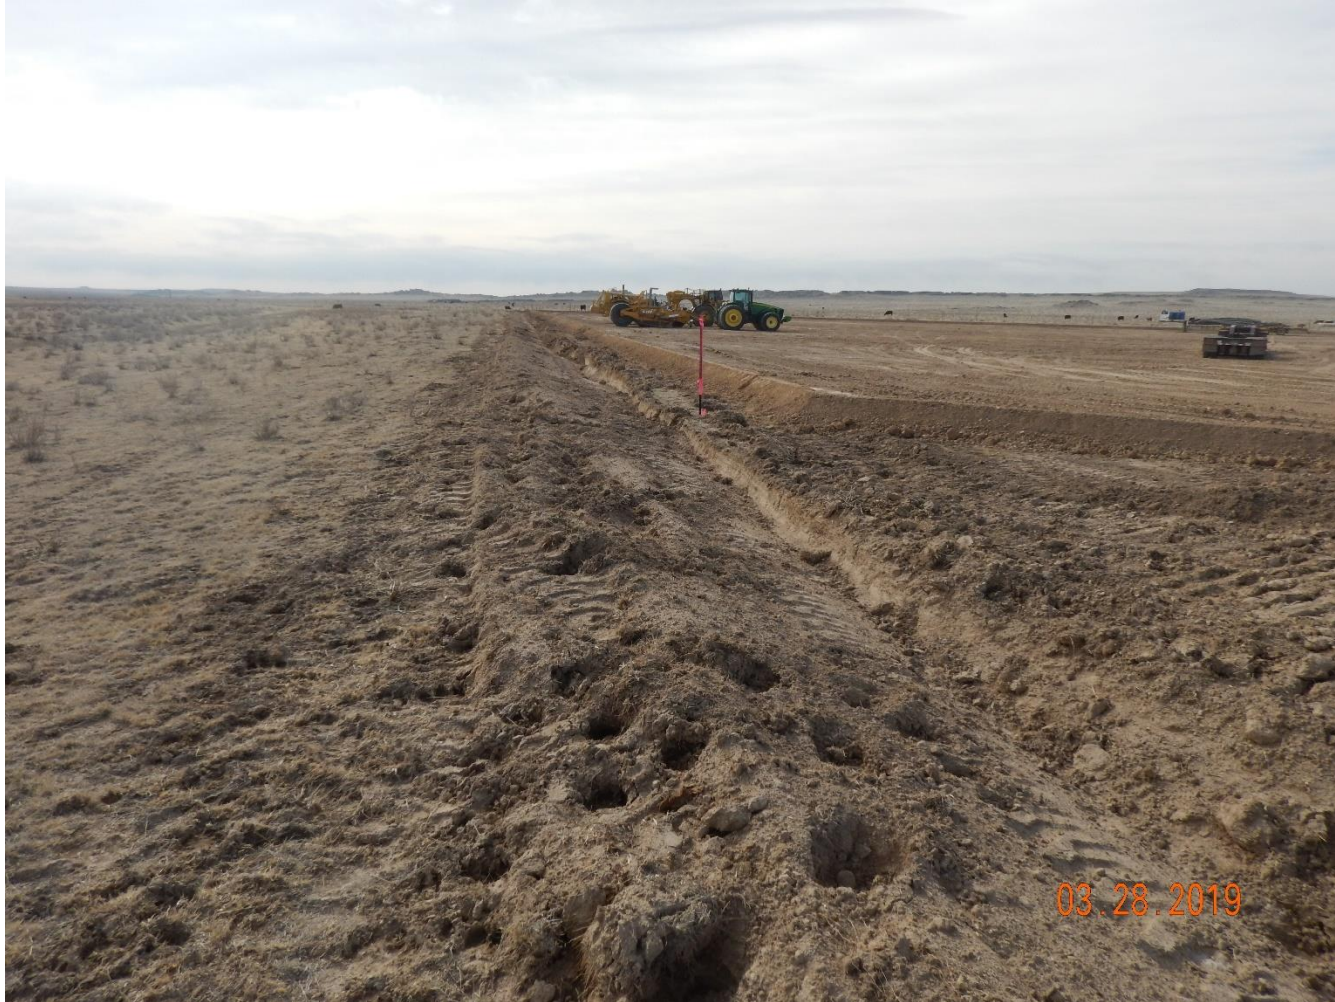
Photo 6: Photo taken from the northeast corner of the location, facing south. See comments under photo 5

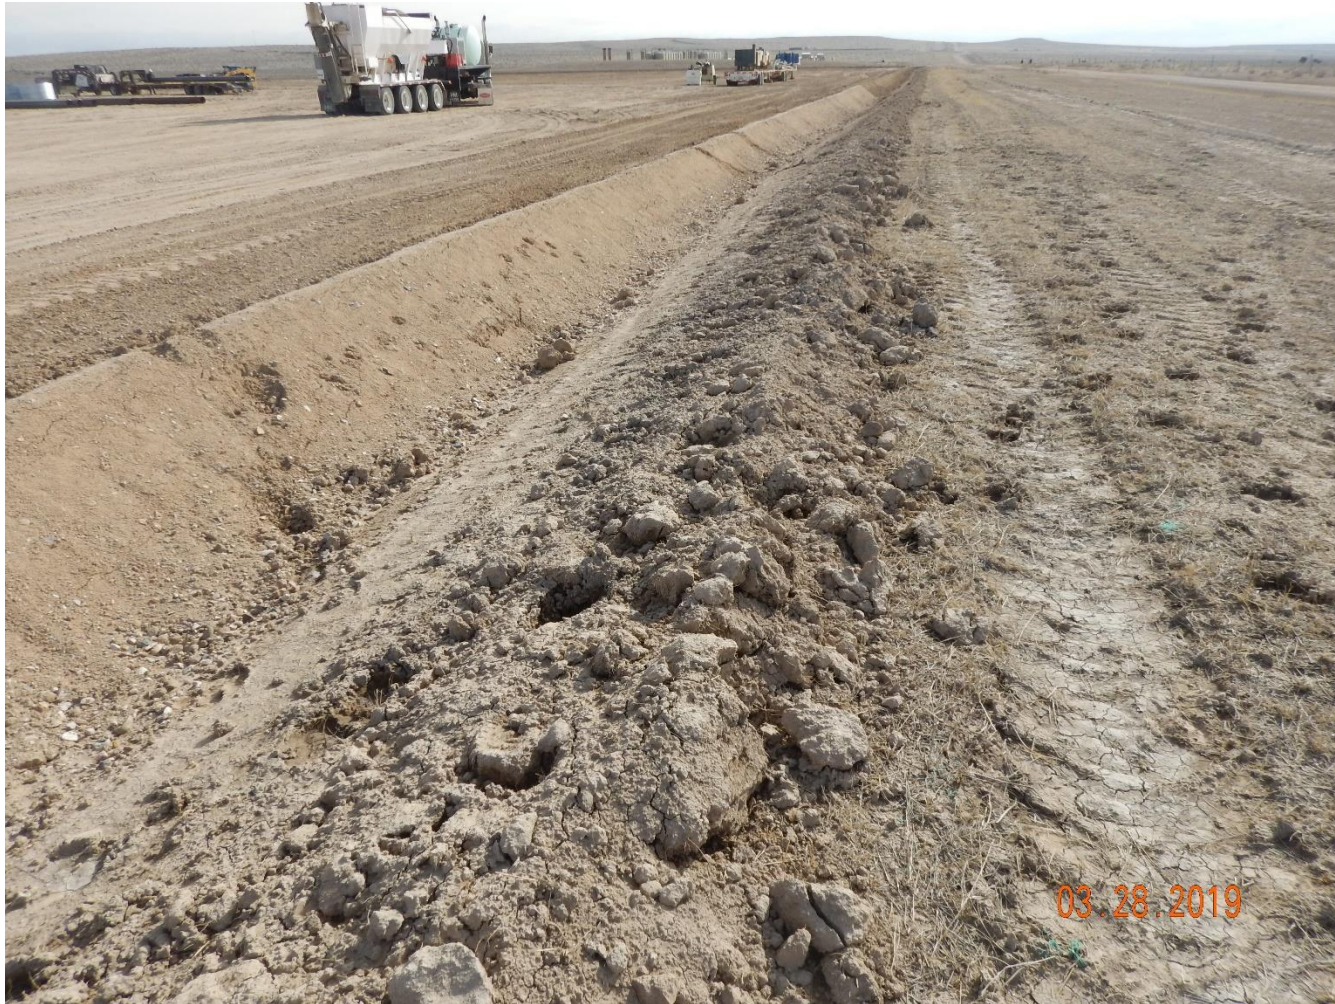
Photo 7: Photo taken from the south end of the location, facing east. See comments under photo 5.

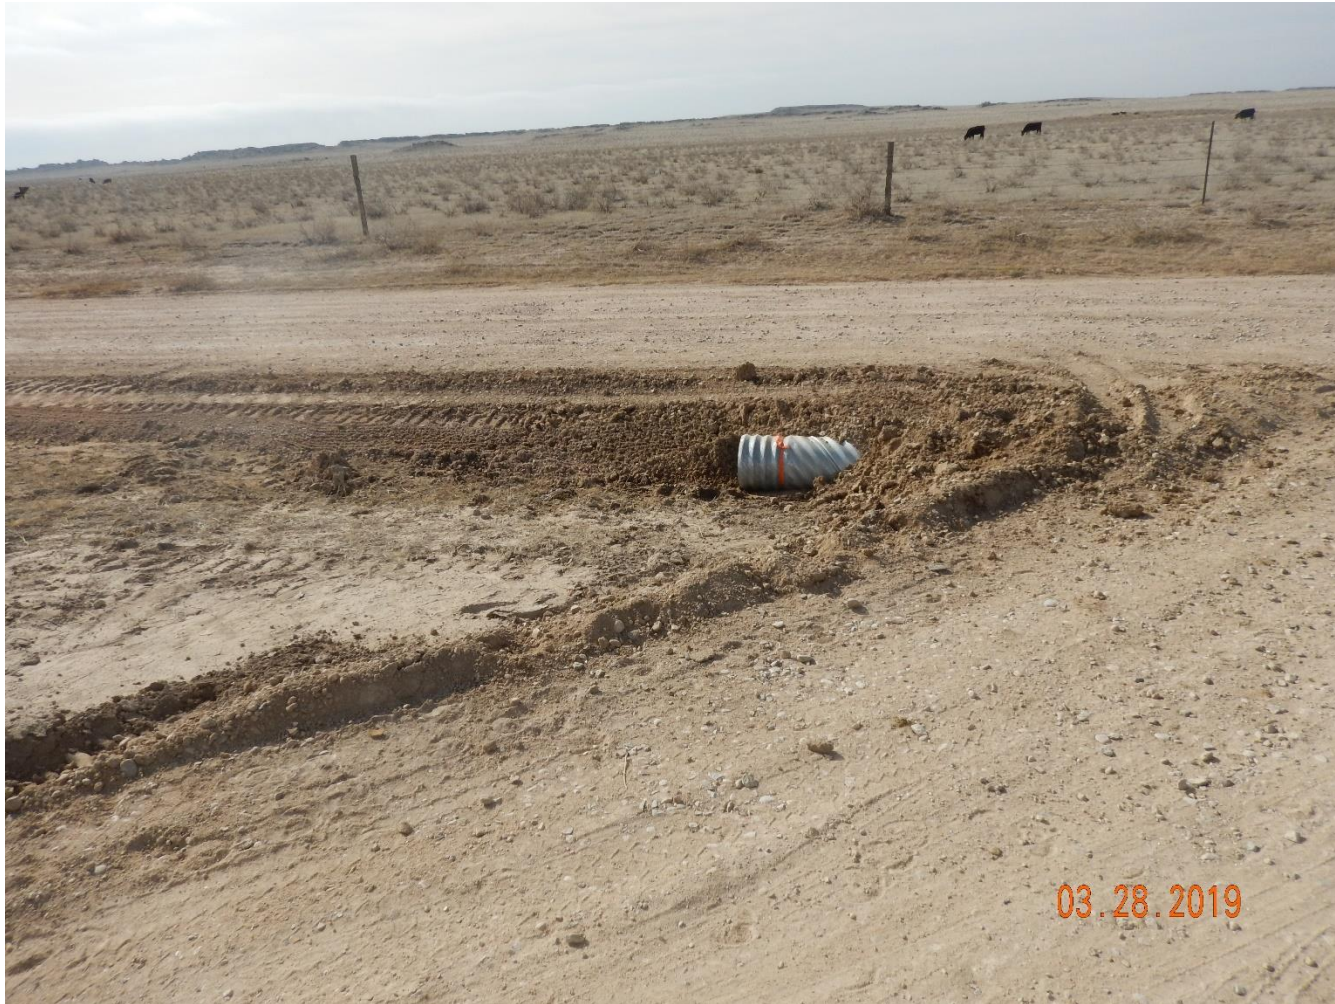
Photo 8: Photo shows culvert installed and access road.
