Inspection Photos

API: 05-009-06014

Operator: JONES ENERGY LTD

Inspection Date: 3/27/2019

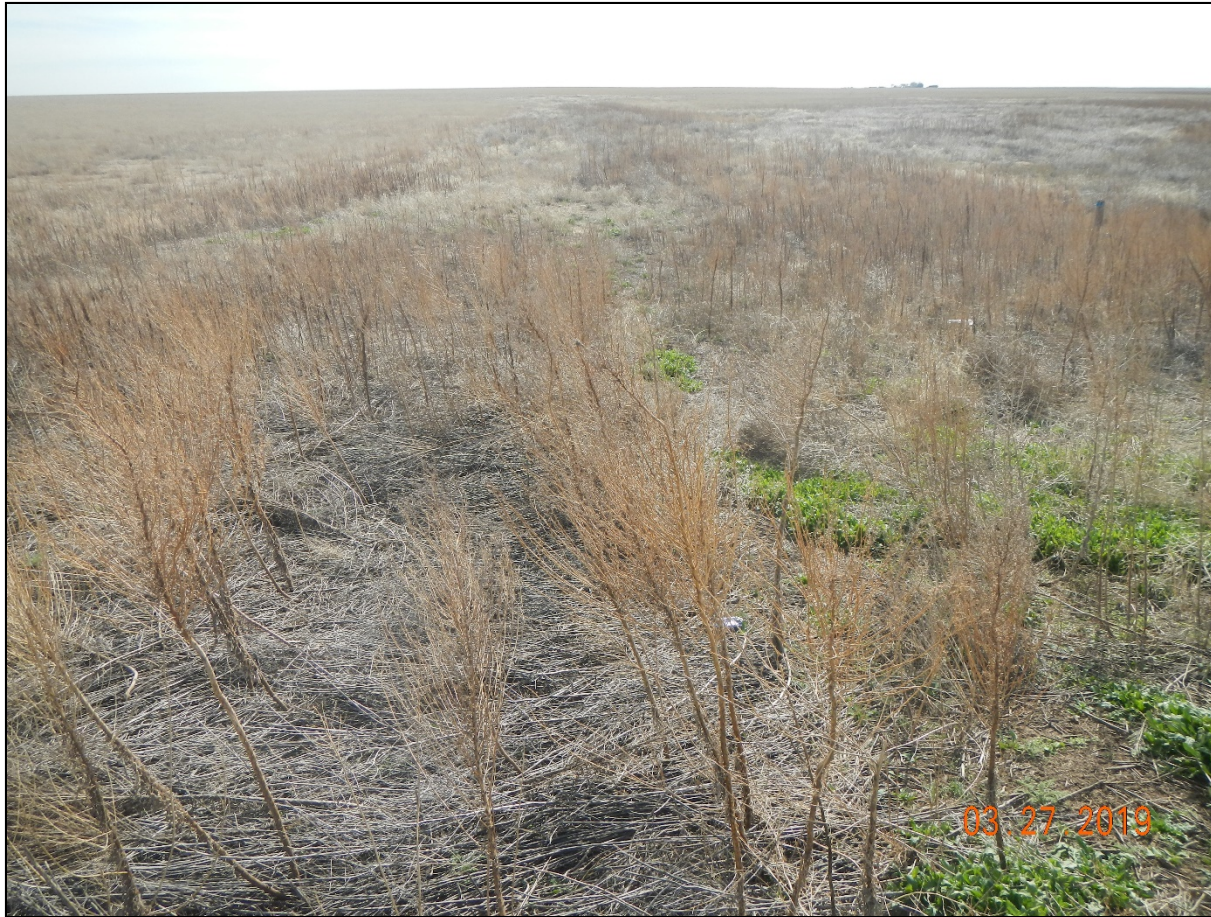
Photo 1. Facing southwest at the beginning of the access road. There are undesirable weeds along the road and desirable vegetation has not established.

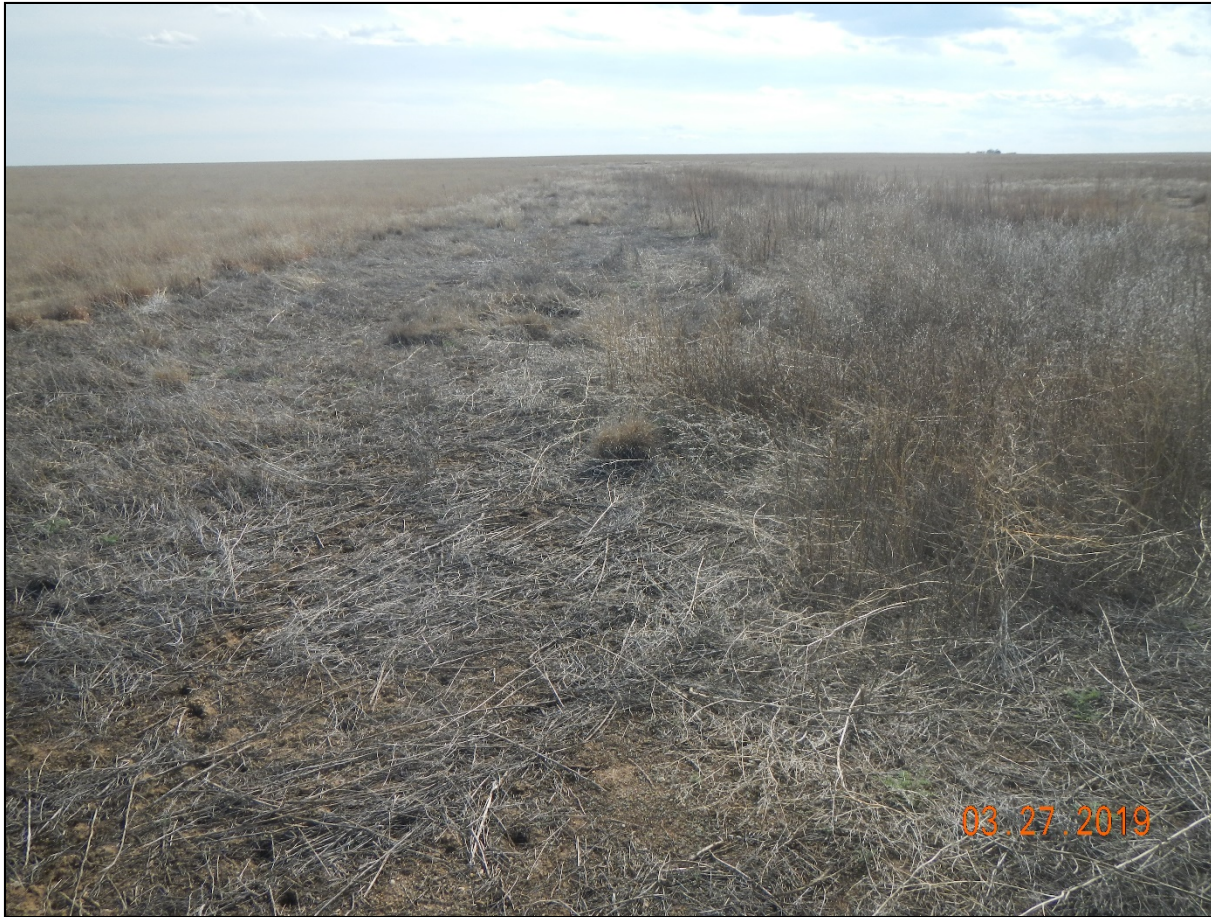
Photo 2. Facing southwest at the beginning of the access road. There are undesirable weeds along the road and desirable vegetation has not established.

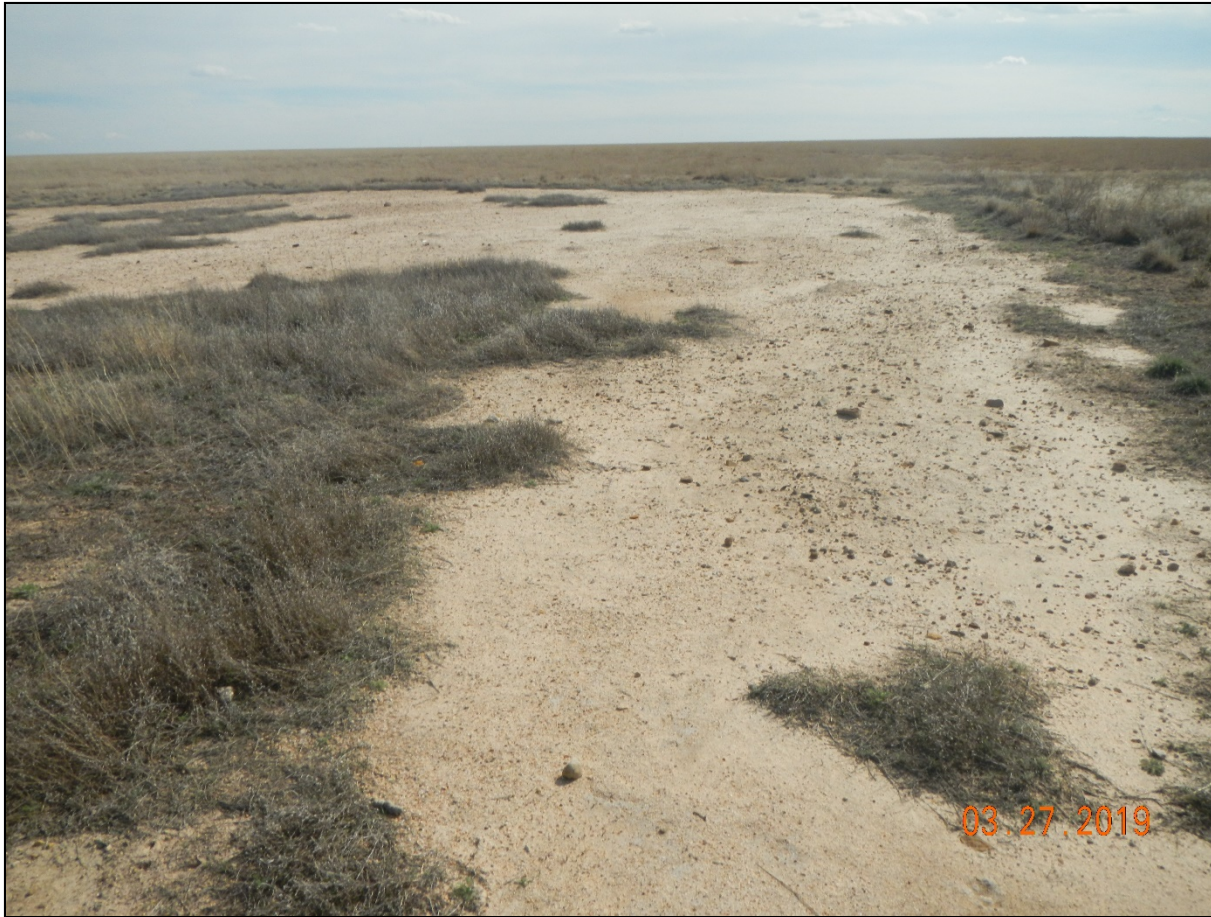
Photo 3. The location is mostly bare of vegetation. It does not appear that any effort has been made at reclamation.

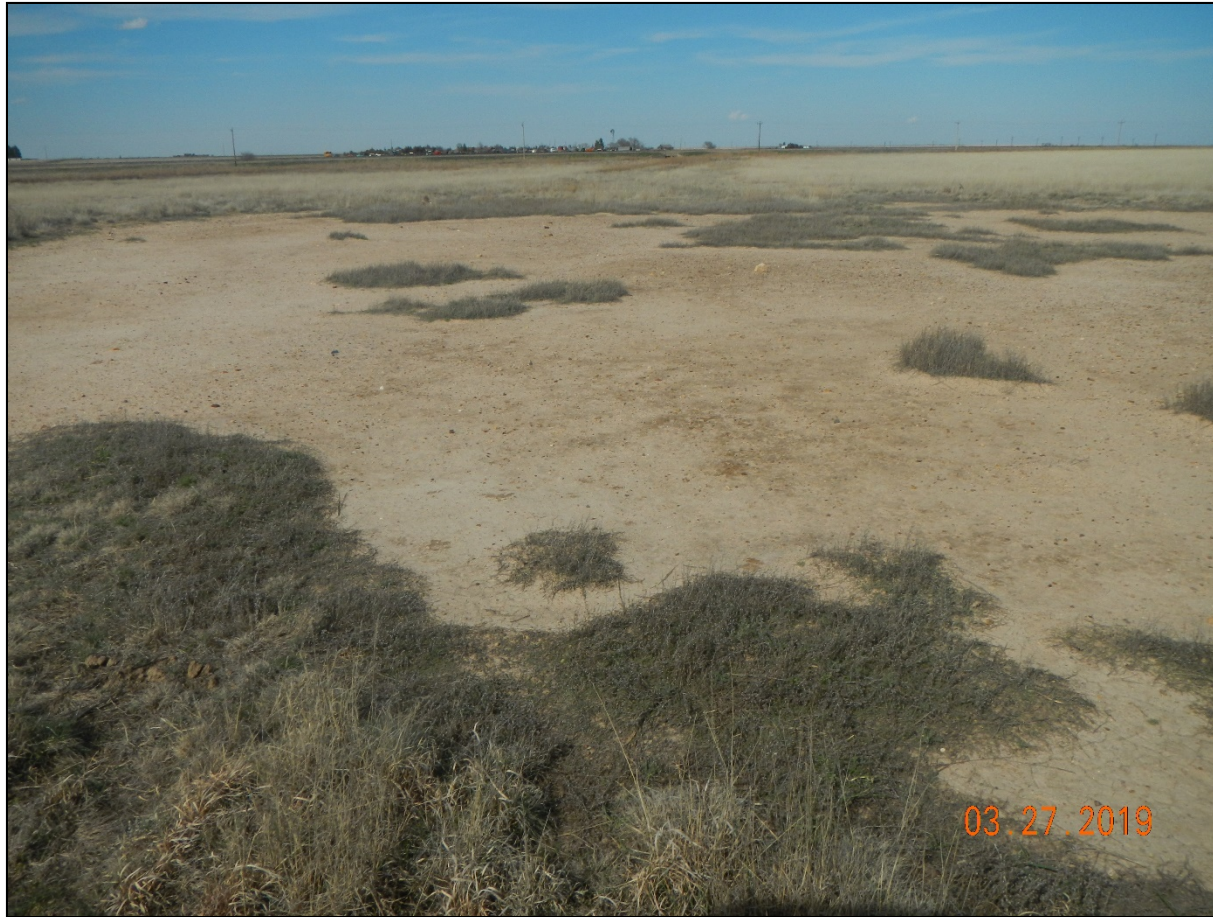
Photo 4. Facing northeast at the location. The location is mostly bare of vegetation. It does not appear that any effort has been made at reclamation.
