Maralex Resources Inc.

Api # 05-077-089853

Inspection # 675002099

COLORADO
Oil & Gas Conservation
Commission
Department of Natural Resources

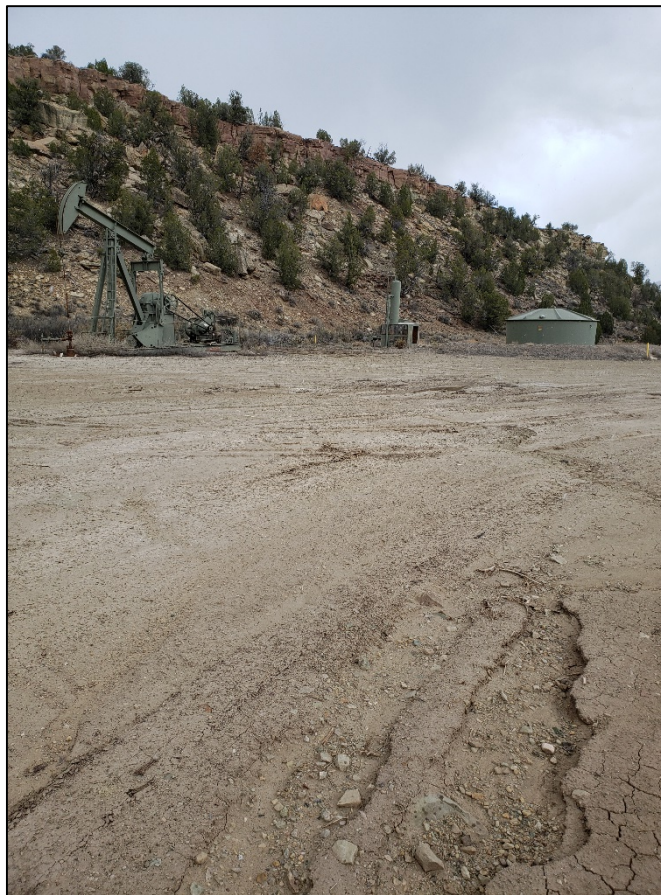
Photo of location

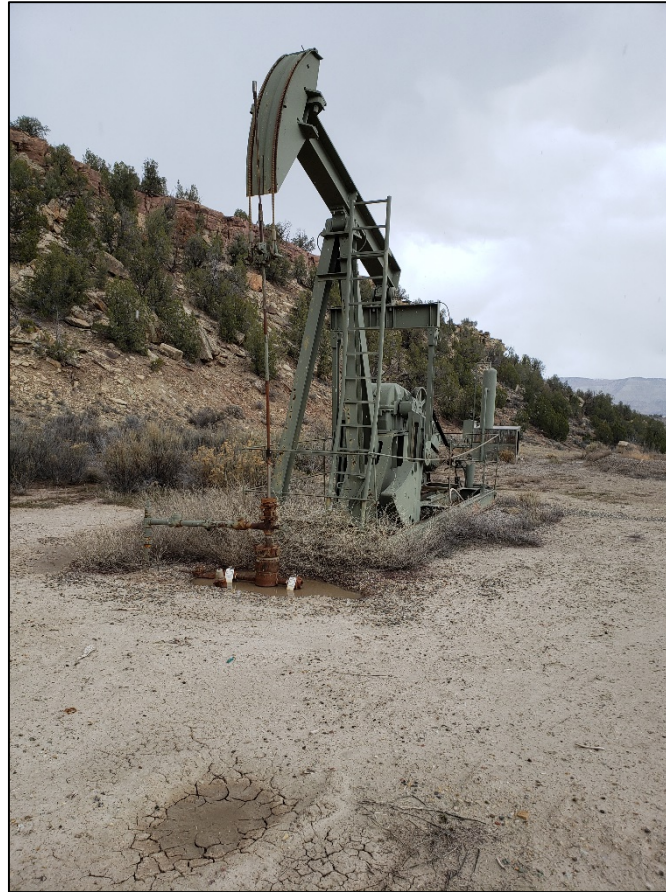
No Wellhead sign debris around pump jack

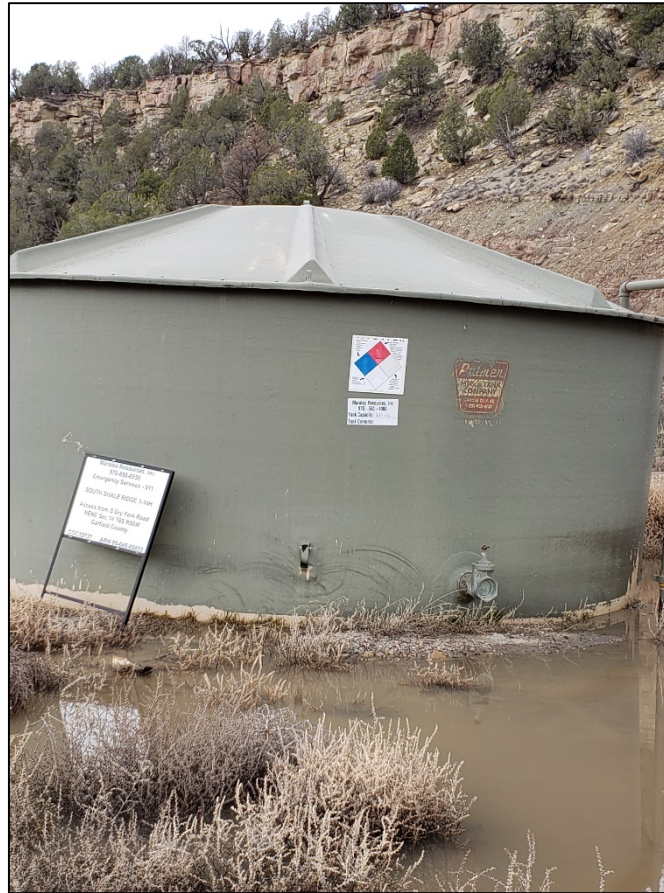
Photo of Tank Battery. Berm has debris around it and fluid in containment

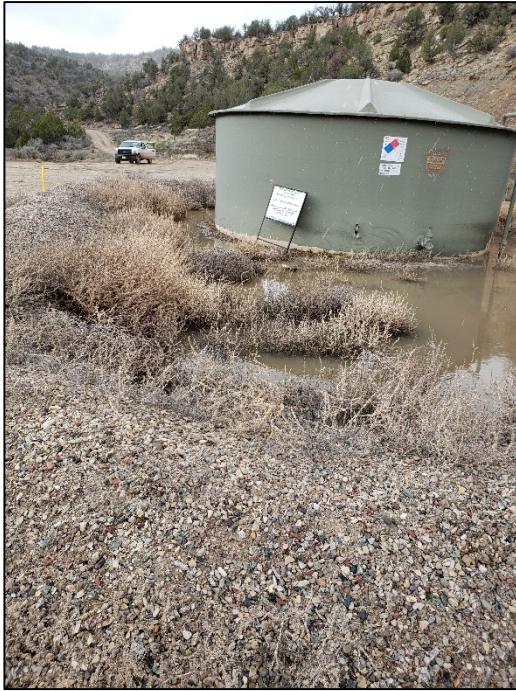
Debris around tank and containment

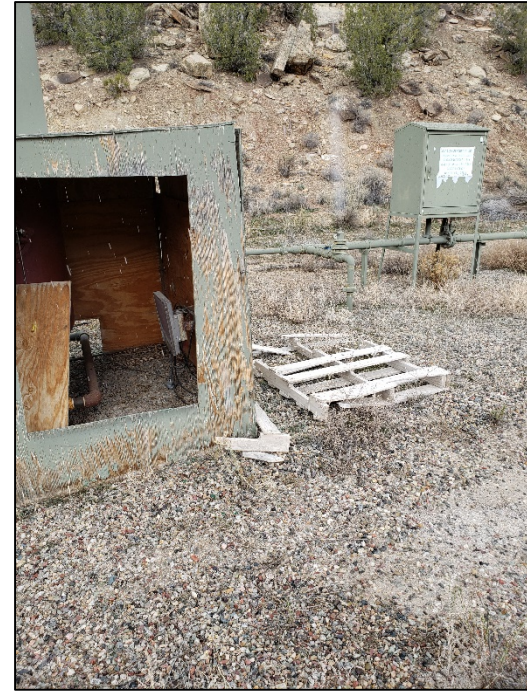
Debris and trash on location

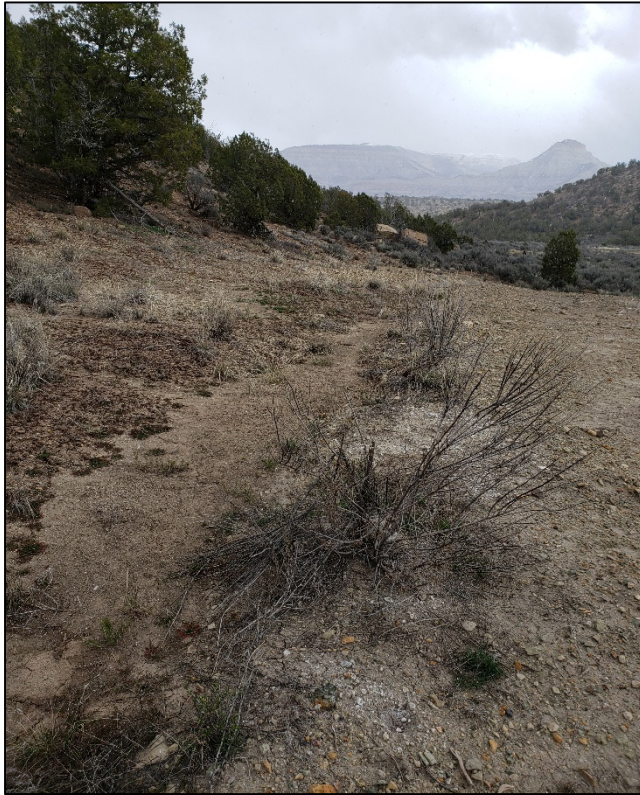
Sediment running on and off location

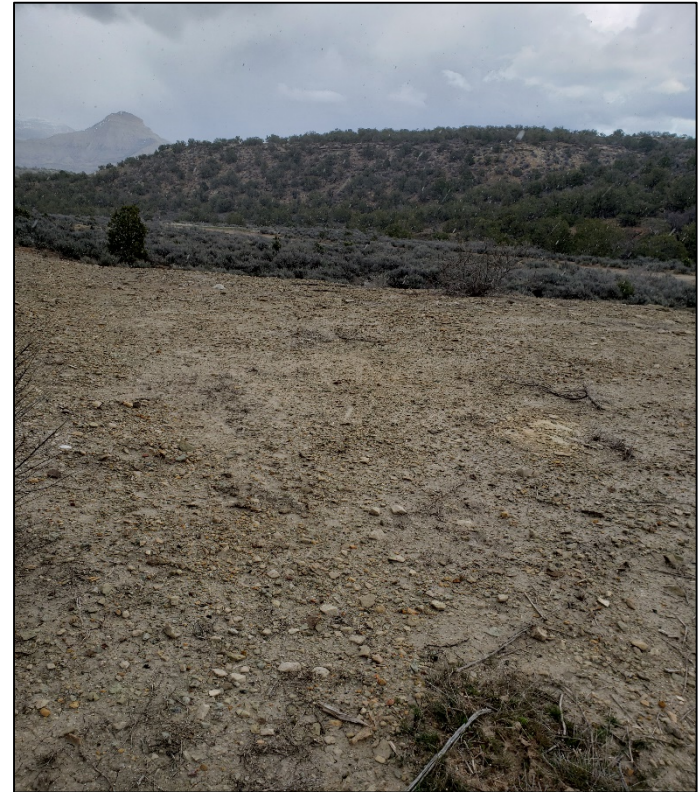
Sediment running off location

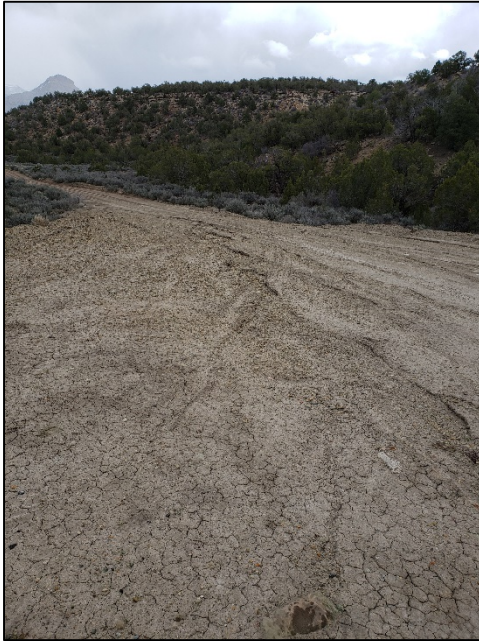
Erosion on location

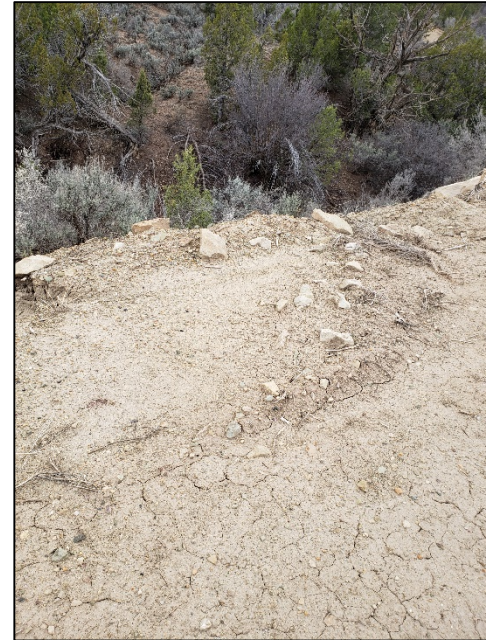
Erosion from location moving sediment off location

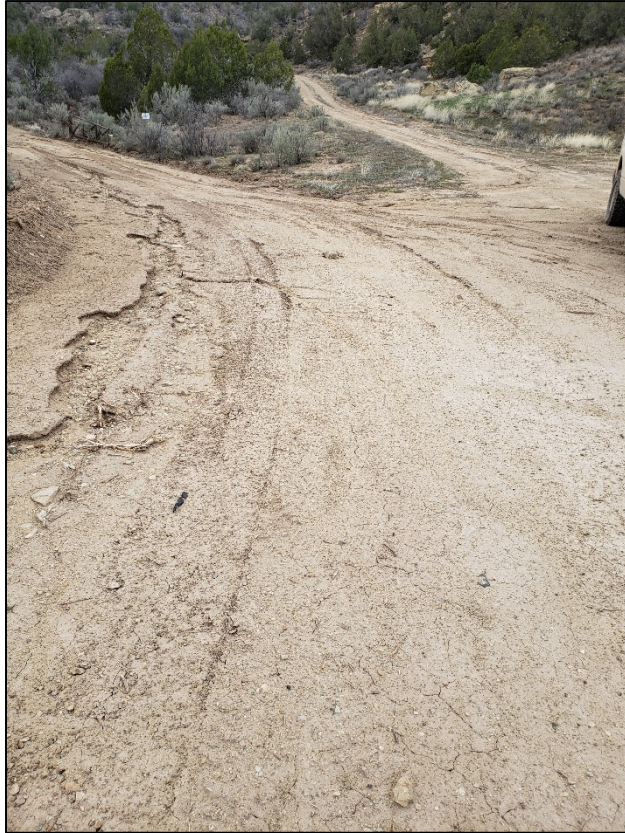
Erosion leaving location from BMP not being maintained

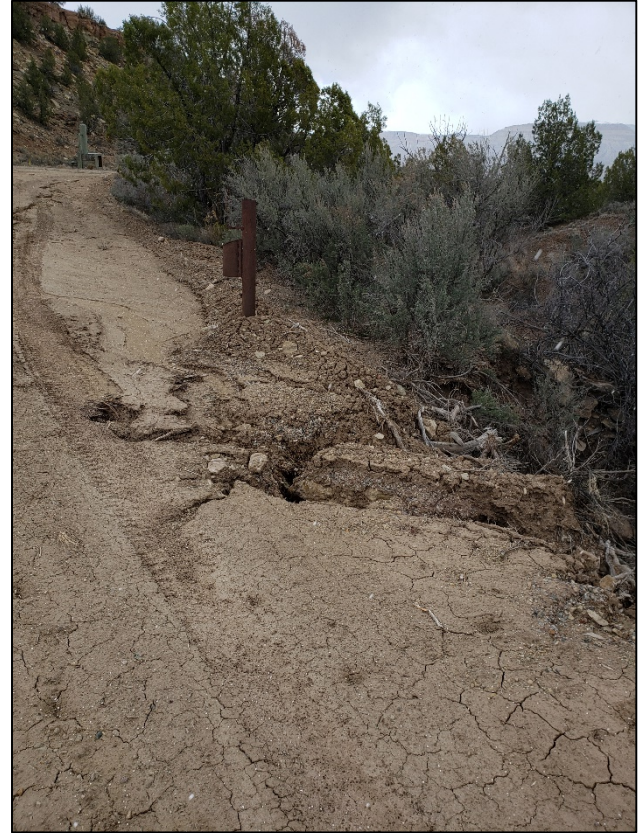
Erosion leaving location

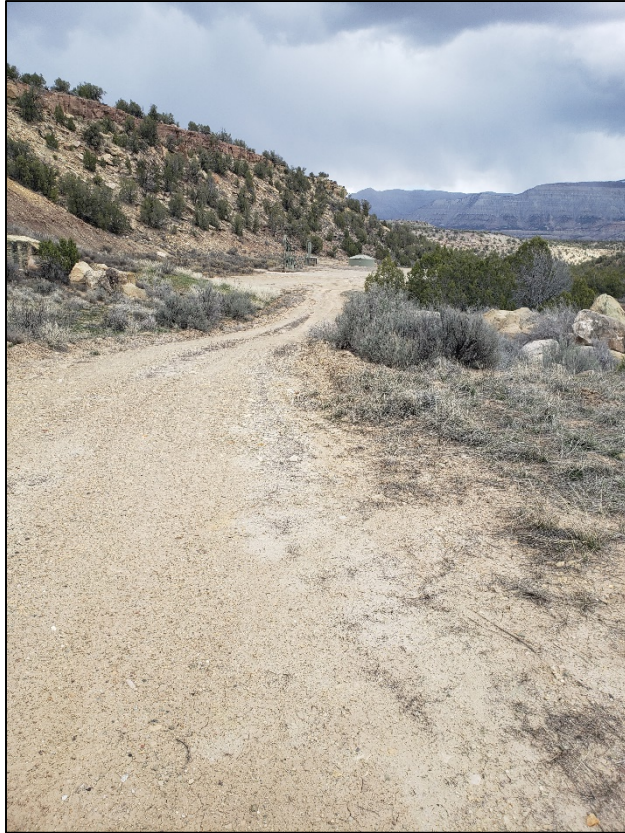
Erosion from location going down access road

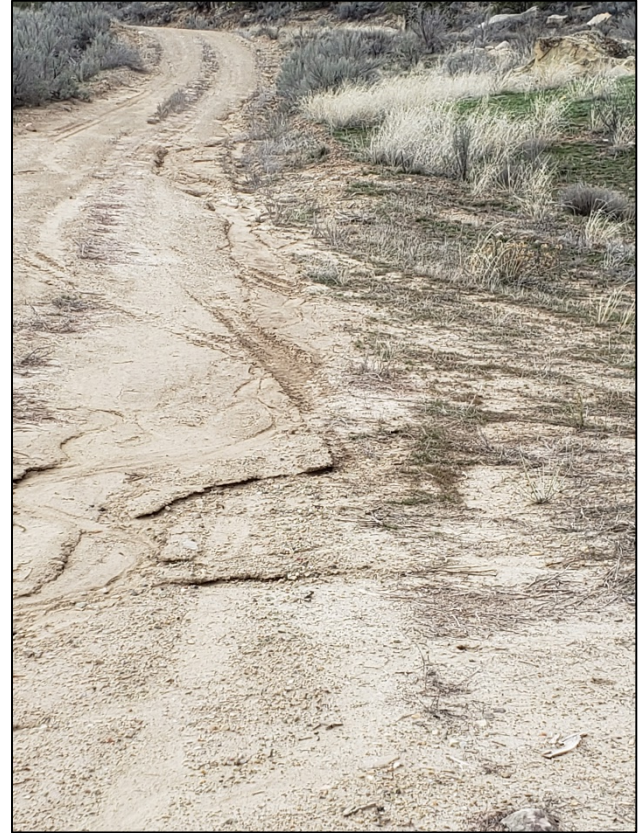
Erosion from upper location coming down access road and running onto location

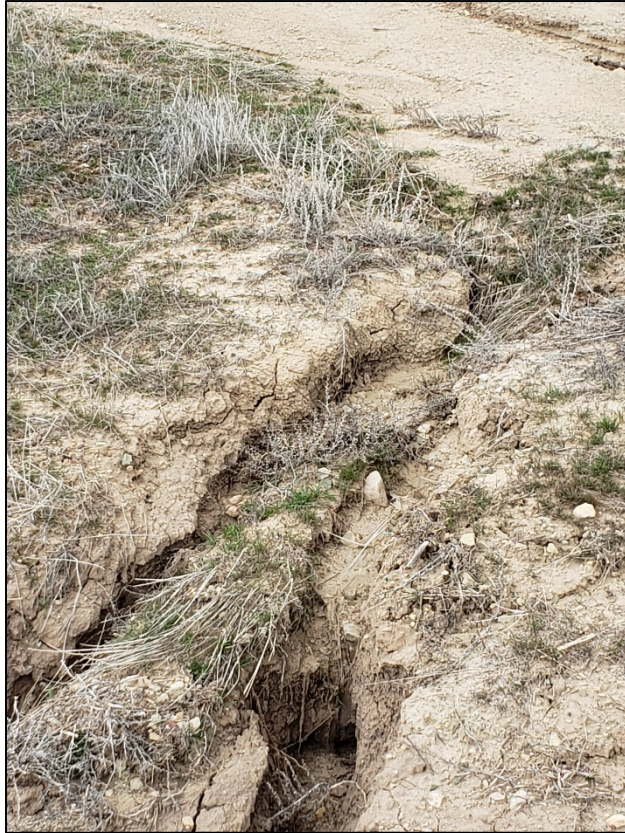
Erosion from location going down the access road

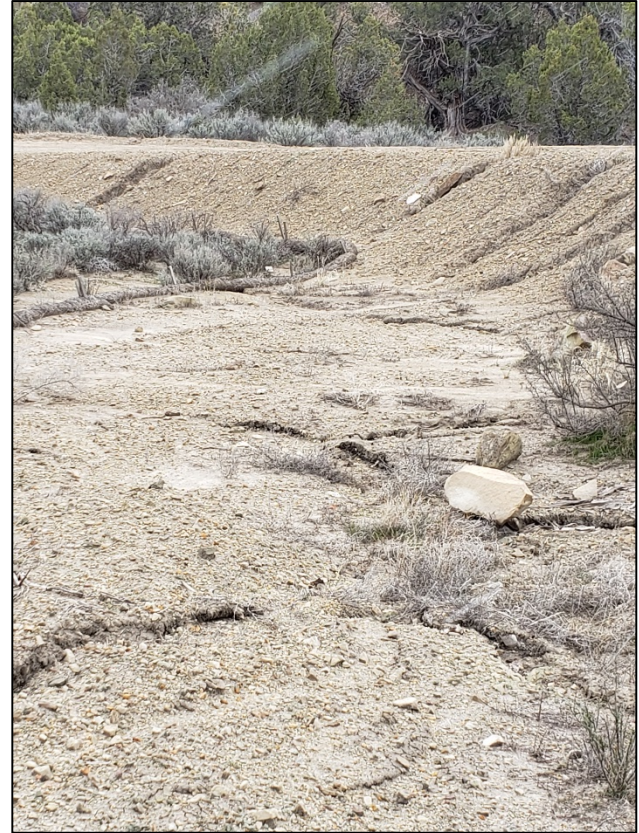
Erosion leaving location on entrance side of location
