**Inspection Photos**  
**Location Name: VPR C 120**  
**API #: 05-071-07792**  
**Insp. Doc. # 695100385**

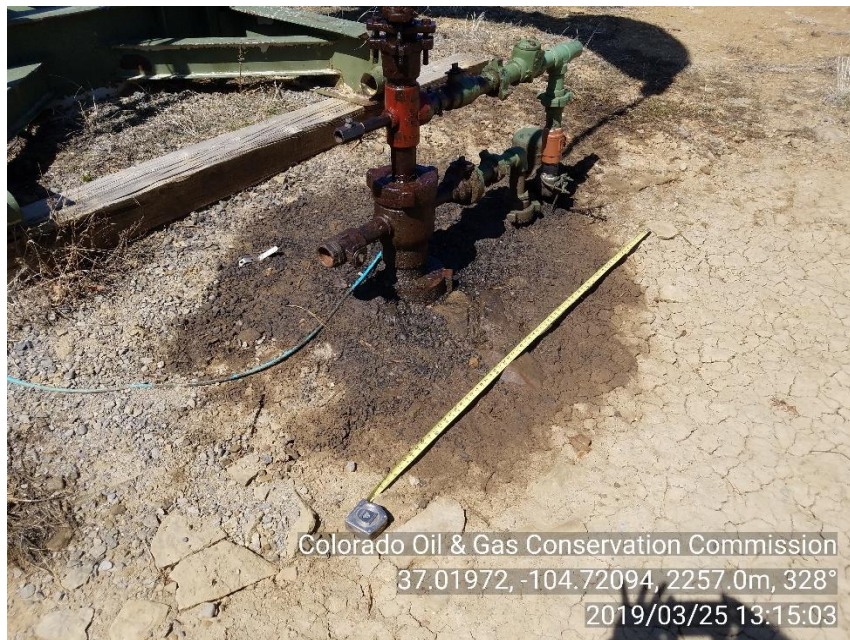
**PHOTO 3: WELLHEAD IS SOAKED WITH AN OILY SUBSTANCE THAT IS IMPACTING A 5' BY 4' RADIUS AROUND WELLHEAD**

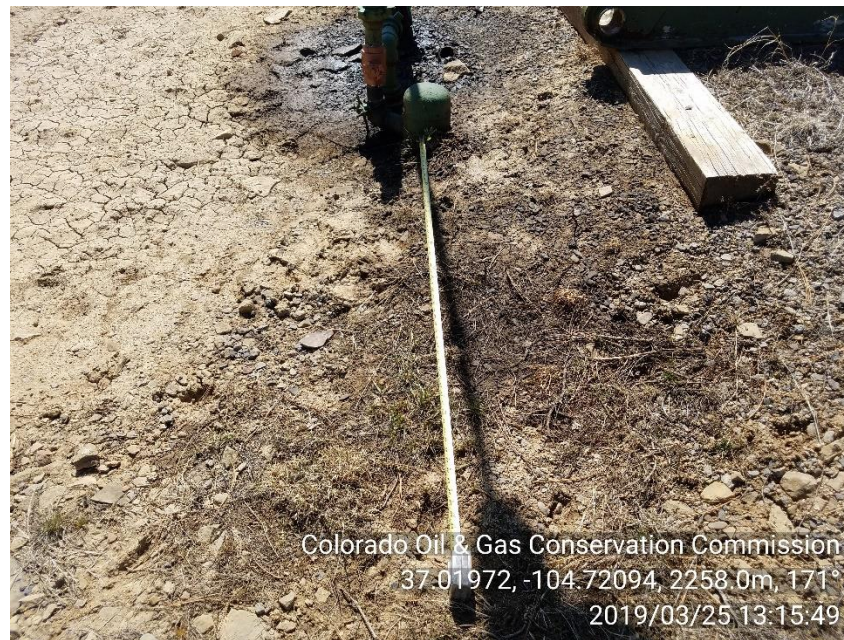
**PHOTO 4: IMPACTED SOIL APP. 4' BY 3' TO THE NORTH OF WELLHEAD**

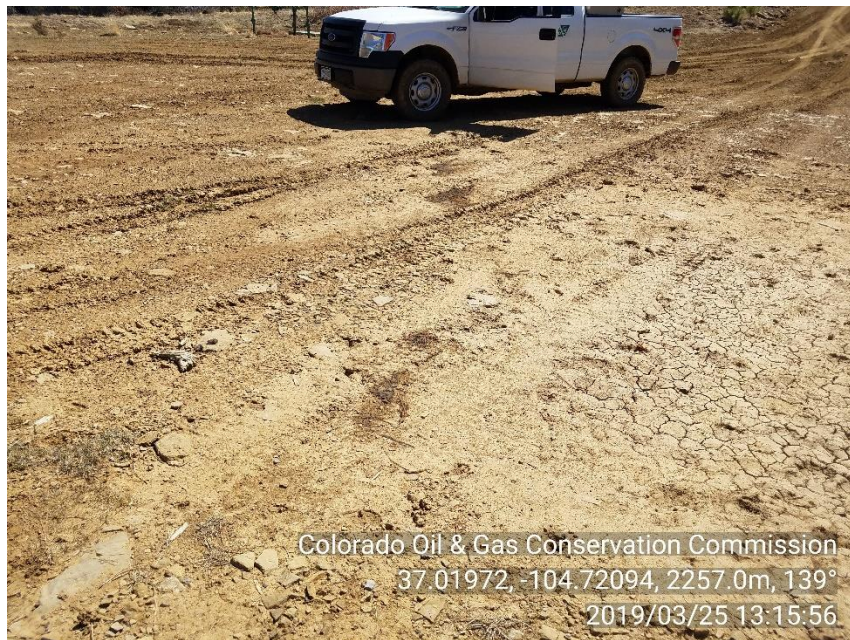
**PHOTO 4: SPOT OF IMPACTED SOIL AWAY FROM WELLHEAD  
TO THE EAST APP. 25'.**
