Inspection Photos

Location: Vaneta 1-32D

Inspection Date: 3/11/19

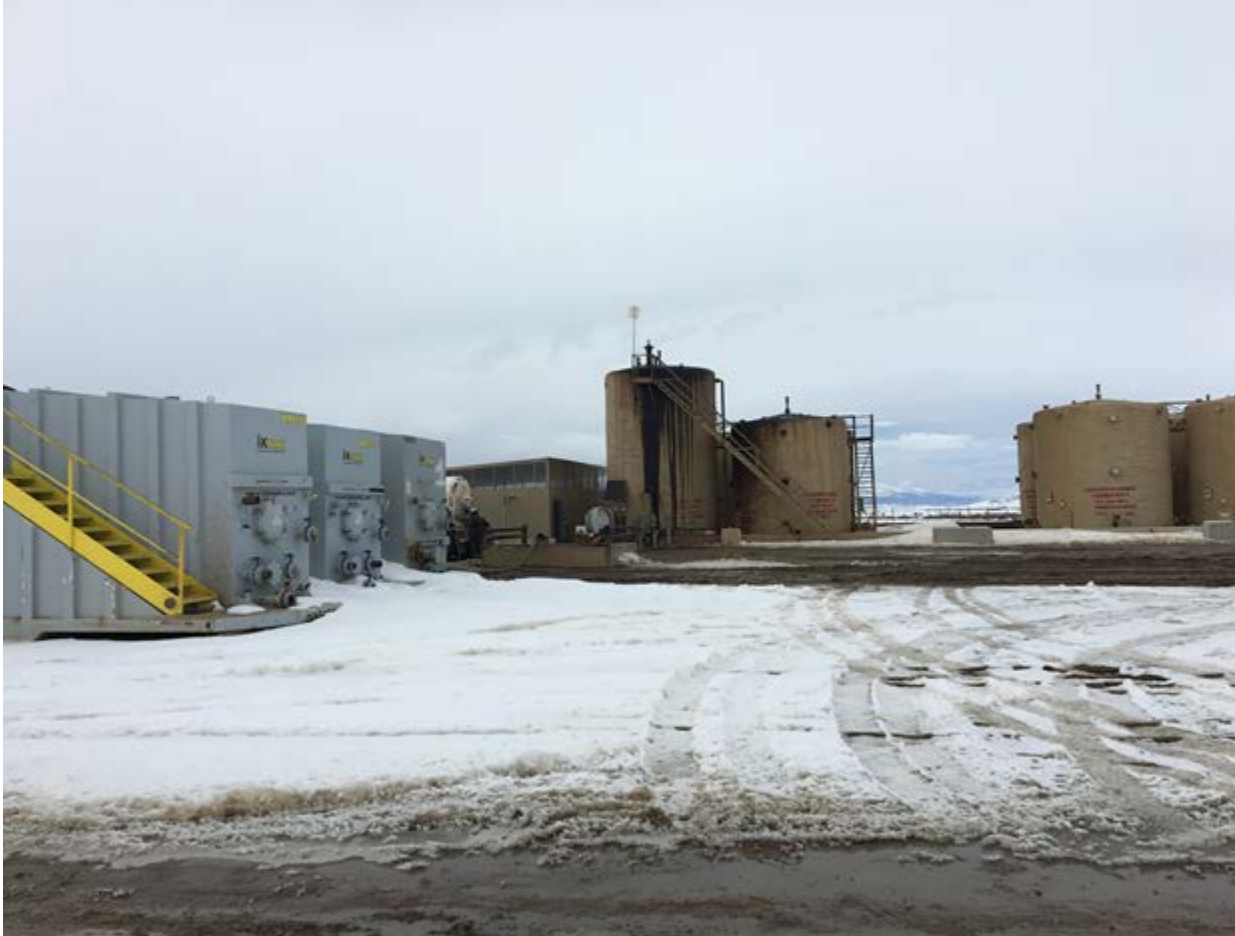
Photo 1- Vaneta injection well, 057-06467 load area. Note truck present, it was actively unloading. Tanks have oil staining where they have overflowed. Staff was present to inspect the area of spill number 463151. The area of impact appears to be the area where the frac tanks were set

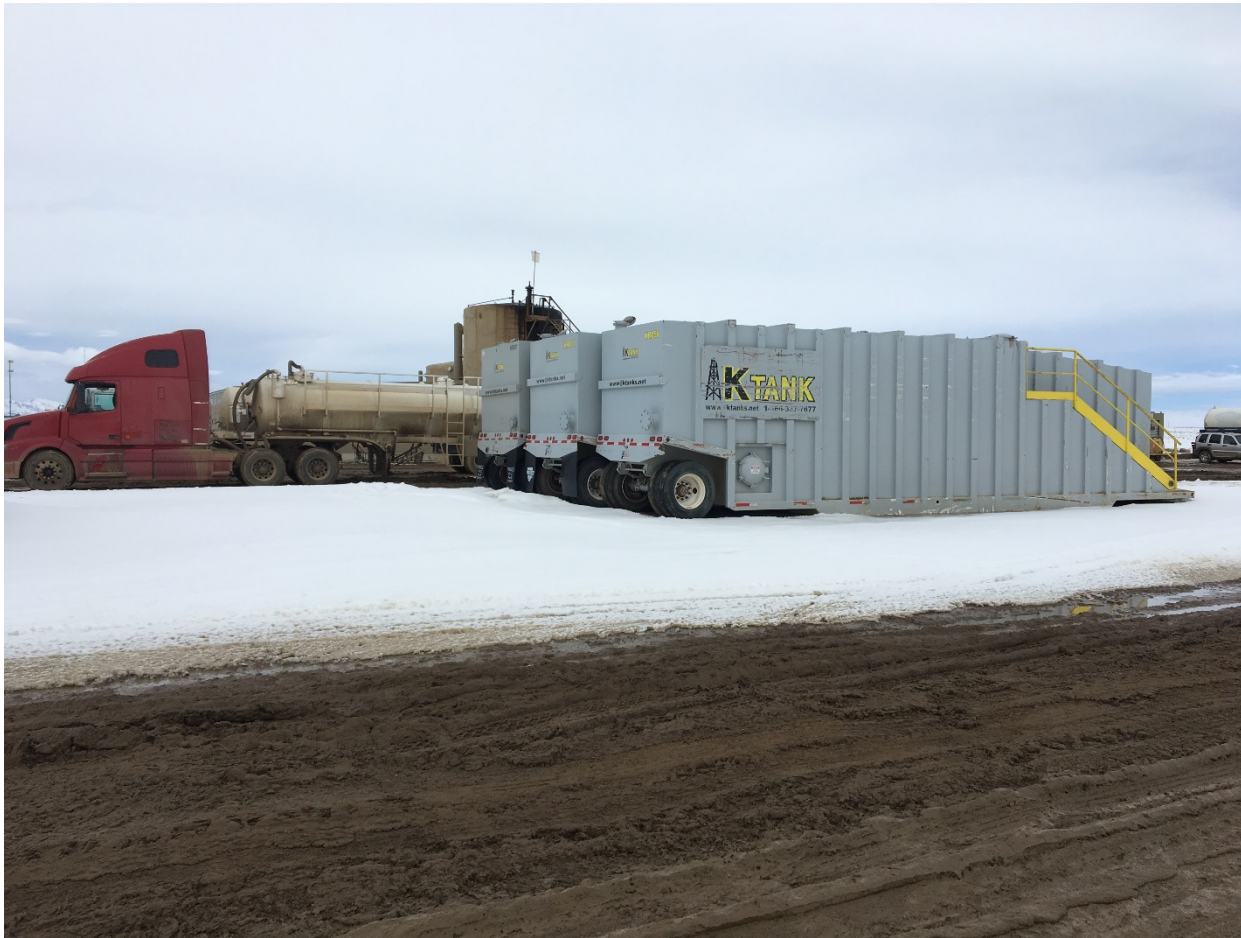
Photo 2- Vaneta injection well, 057-06467 load area. Note truck present, it was actively unloading. Tanks have oil staining where they have overflowed. Staff was present to inspect the area of spill number 463151. The area of impact appears to be the area where the frac tanks were set
