Inspection Photos  
Location: Vaneta 1-32D, DAF  
Inspection Date: 3/11/19  
Photos taken by Kris Neidel

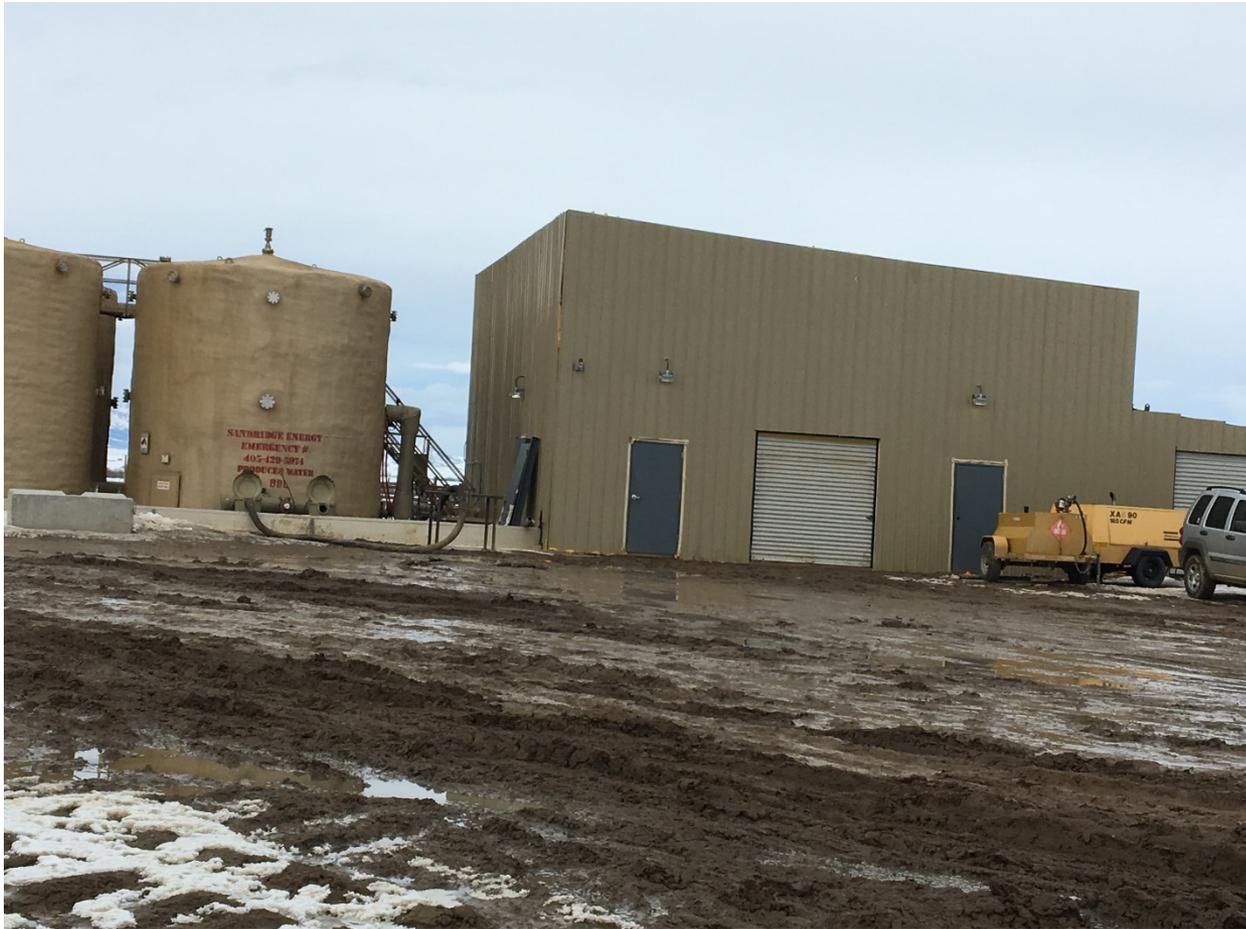
**Photo 1-The building contains the DAF unit. The tanks on the left of photo contain fluid that has been brought to location by truck, prior to treatment. Note the building built around the secondary containment.**
