**Response to March 8, 2019 Inspection
Document Number: 682504592**

COGCC conducted an inspection of the LD07-01 pad (Location ID 460414) on March 8, 2019 (Document 682504592) and submitted the inspection on March 13, 2019. During that inspection, COGCC made the following observations:

Name: LD07-01 Pad
Location ID: 460414

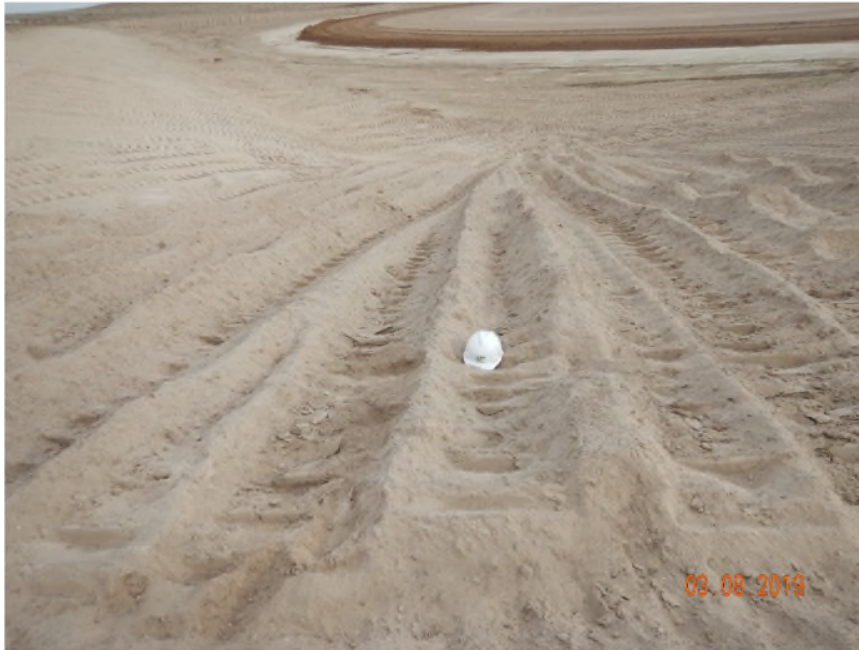
COGCC Photo 5. Photo taken from the northwest corner of the pad. Photo shows operator has implemented tracking along the cute slopes. Photo shows BMP has not been sufficiently installed. Soils remain loose material at risk to erosion degradation.

Noble made efforts to track the slope throughout construction (as shown in COGCC Photo 5); however, the very fine, powdery soils that are present at this location are not amenable to compaction. Nonetheless, vehicle tracking remains the best management practice available for these working conditions and Noble applied them as practicable. A water truck was also used on the pad, and evidence of the water application is shown COGCC Photo 7.

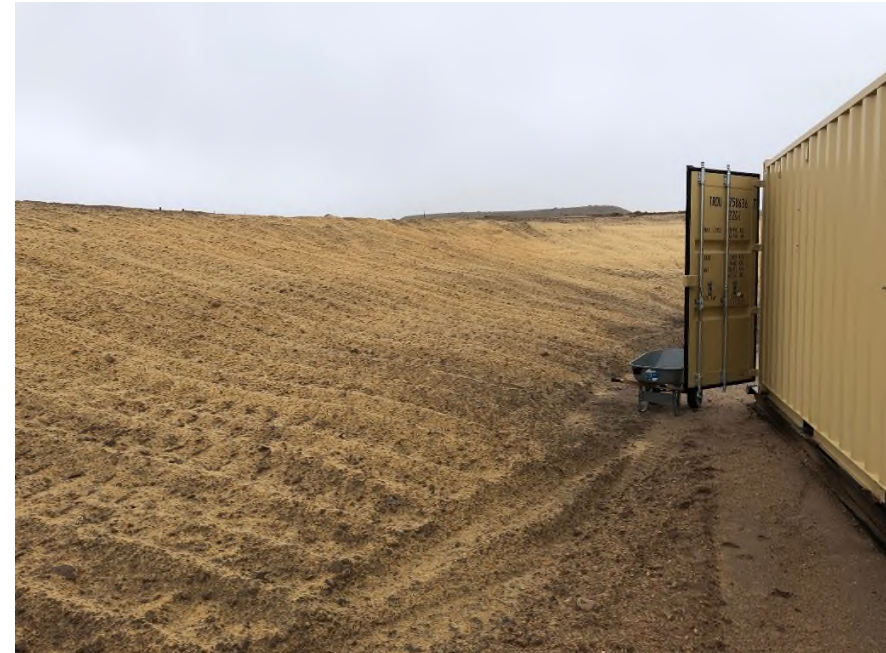
NBL Photo 1, West side of pad looking North. The photo above, taken on 3/31/2019, shows the current condition of this slope. Once grading was complete, Noble applied water to the slope, tracked in the soil, then covered it with hydromulch. The hydromulch was in place on or before 3/18/2019. Water and hydromulch could not be applied prior to this date, because the slope was actively being constructed and graded.

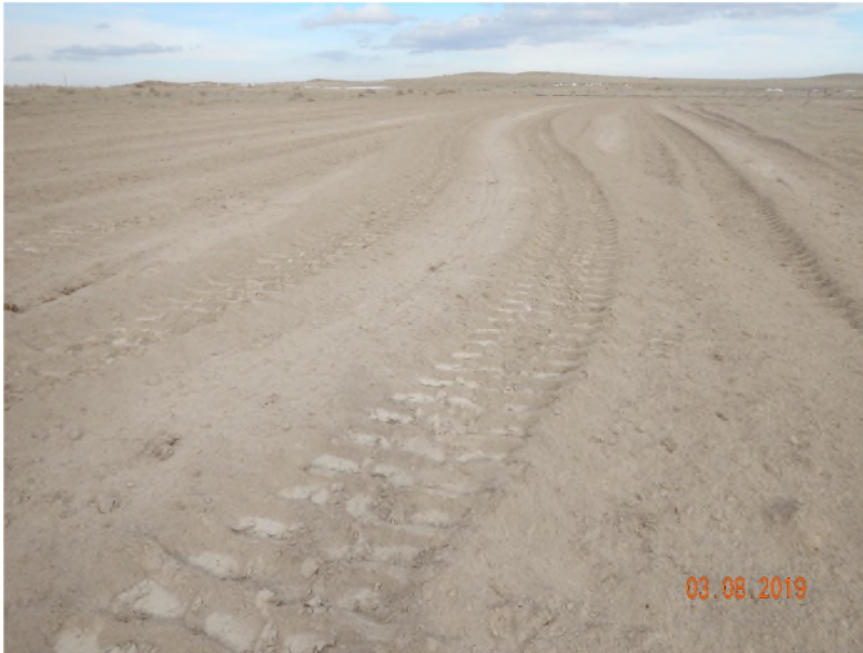
COGCC Photo 6. Photo taken from the north end of the location. Photo shows area where topsoil stockpile was stored. Operator appears to have removed topsoil stockpiles from the location.

This topsoil previously located where COGCC Photo 6 was taken was placed on the pad cut and fill slopes to facilitate growth and stabilization (west, south and east slopes). Topsoil that remains stockpiles on location will be used later for reclamation of the north side of the pad.

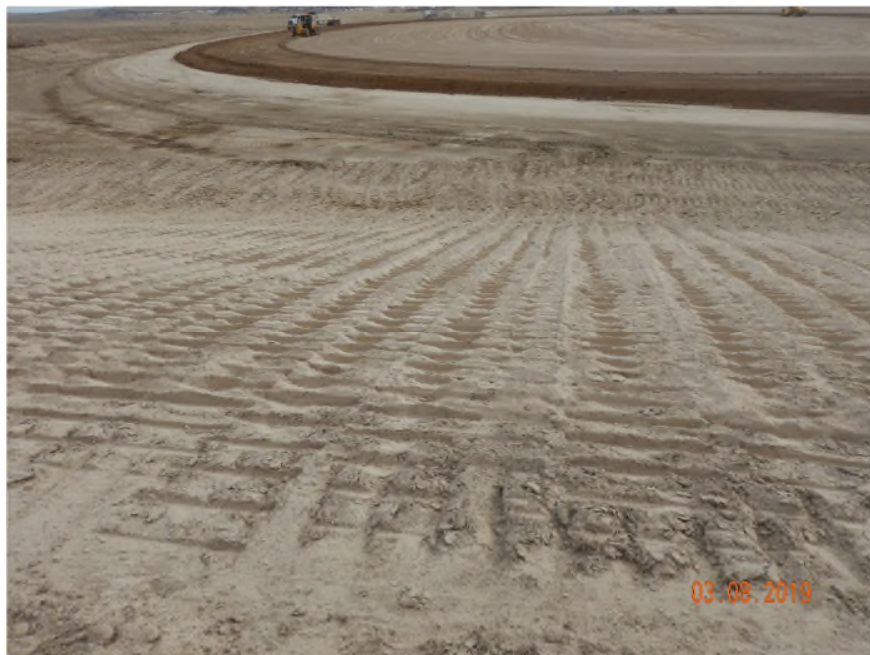
COGCC Photo 7. Photo taken from the cut slopes on the northeast corner of the pad. Photo shows areas where operator appears to have sufficiently tracked and stabilized the slopes.

COGCC Photo 7 shows an area where grading and contouring were complete and water had been applied to the slope prior to tracking. COGCC Photo 7 also shows evidence of the water truck that was used at this location. Note the darker “stained” soils located between the dark brown road base being spread and the tracked slope.

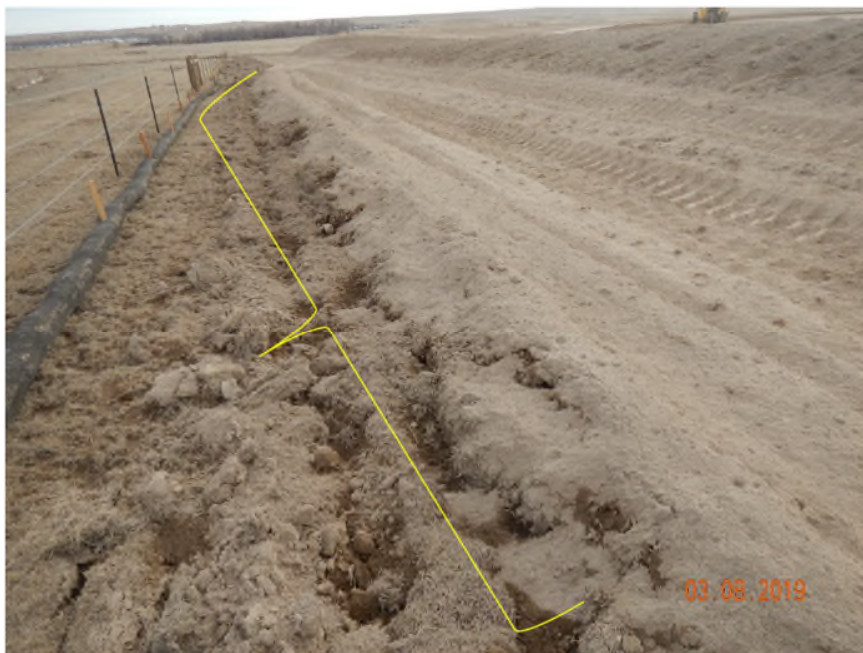
COGCC Photo 8. Photo taken from the east end of the location. Photo shows surface roughening (ripping) BMP has filled with sediment and is not longer in proper functioning condition.

Ripping is maintained at this location at the end of each day, or sooner, if conditions warrant. The scraper visible in COGCC Photo 8 had pushed material onto the ripping during active construction and the repair was made promptly that same day. There was no loss of sediment or potential loss of sediment, given the conditions on site that day and the additional BMP in place at the perimeter (Filtrexx). Noble will continue to evaluate and maintain ripping, as needed.

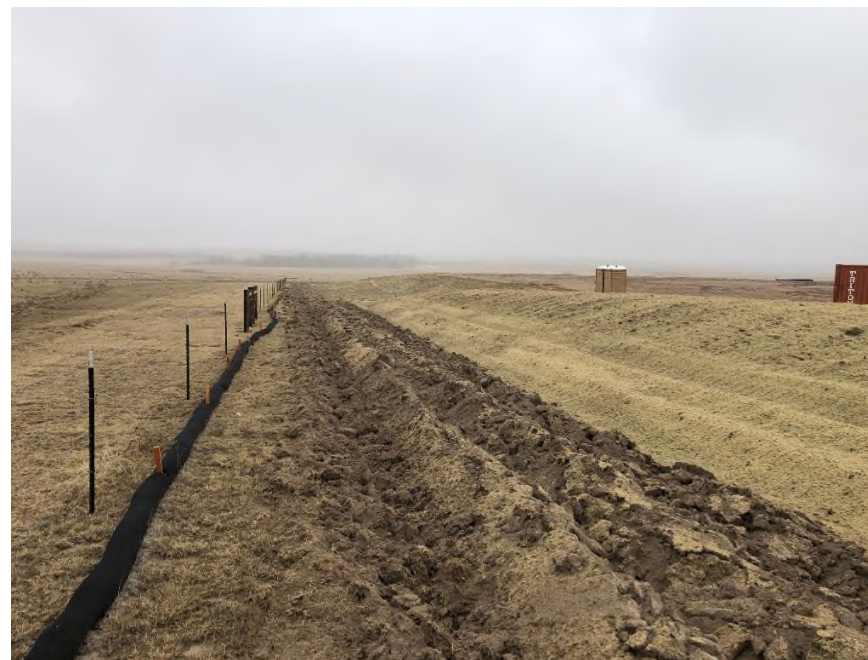
NBL Photo 2, East side of pad looking South. The photo above, taken on 3/31/2019 shows the current condition of this ripping.

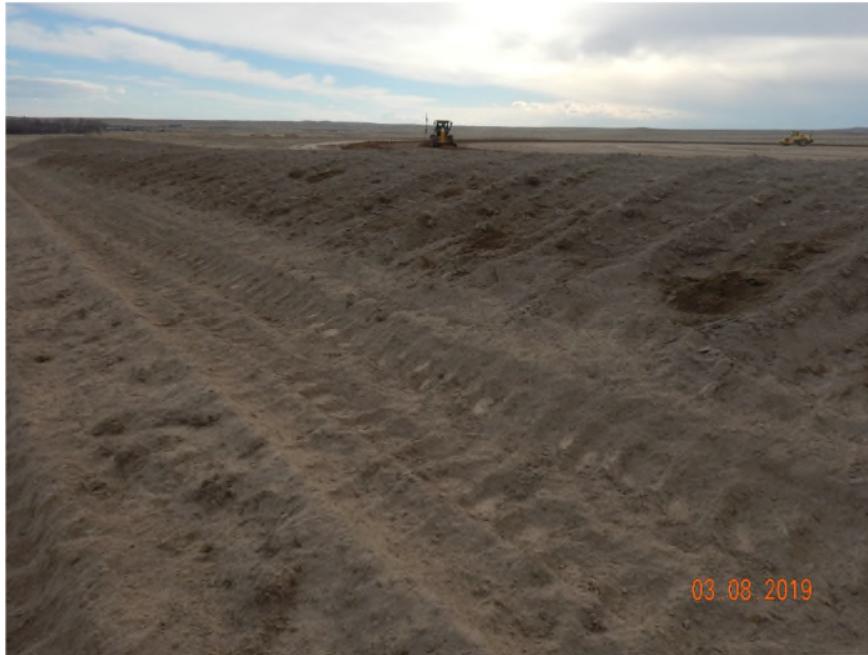
COGCC Photo 9. Photo taken from the east end of the location, facing southwest. Photo shows operator has implemented tracking along the slopes. Photo shows BMP has not been sufficiently installed. Soil remain loose material at risk to erosion degradation.

Noble made efforts to track the pile throughout construction (as shown in COGCC Photo 9); however, the very fine, powdery topsoil that is present is not amenable to compaction. Nonetheless, vehicle tracking remains the best management practice available for these working conditions and Noble applied them as practicable. A water truck was also used on the pad, and evidence of the water application is shown COGCC Photo 7.

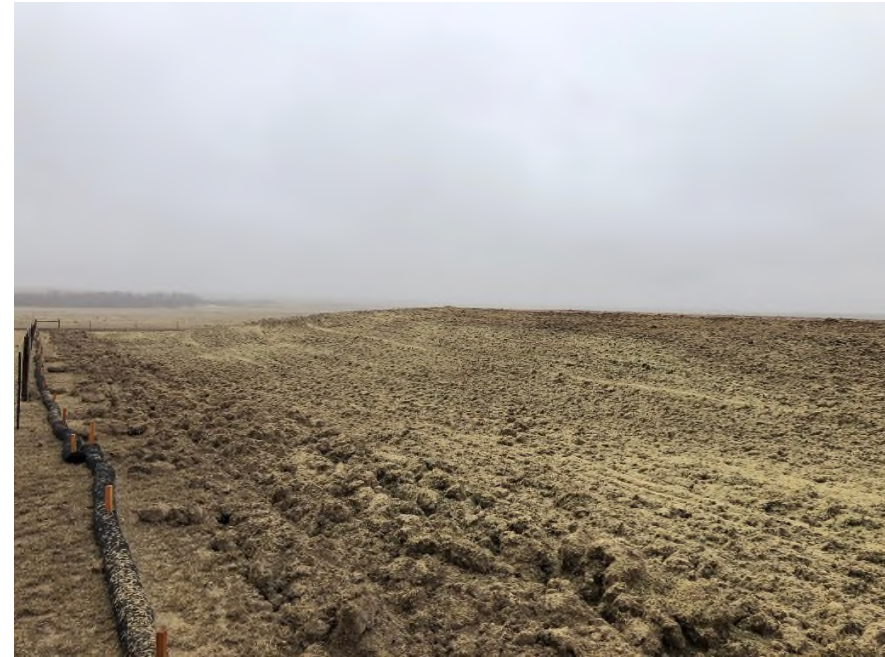
NBL Photo 3, East side of pad looking South. The photo above, taken on 3/31/2019 shows the current condition of this stockpile. Once construction and grading of this topsoil pile was completed, Noble applied water to it, tracked the soil, then covered it with hydromulch. The hydromulch was in place on or before 3/18/2019. Water and hydromulch could not be applied prior to this date, because the pile was actively being constructed and graded.

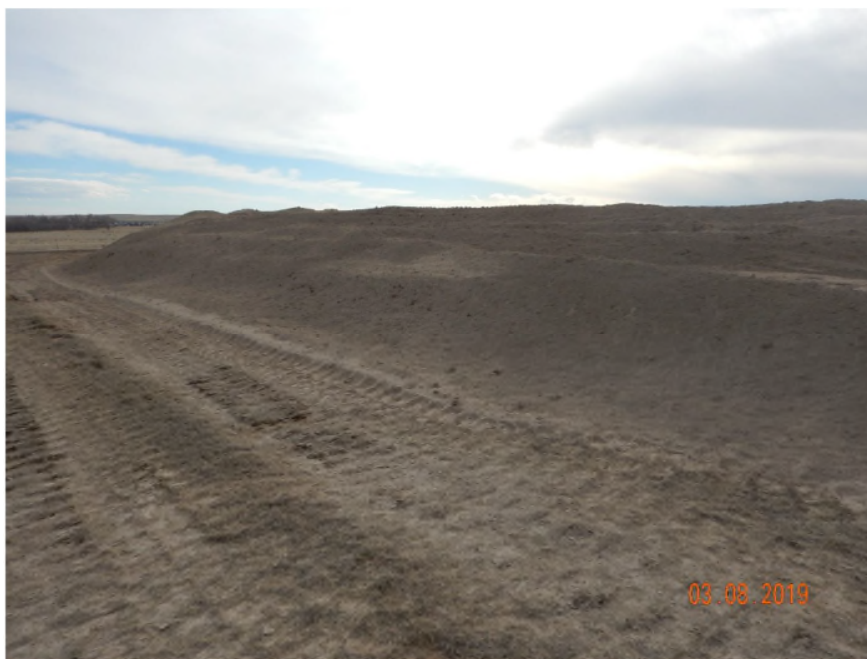
COGCC Photo 10. Photo taken from the east end of the location, facing southwest. Photo shows unstabilized soils on location at risk of erosion degradation.

During this inspection, this pile was actively being built. It is not practicable for operators to track soils before they are pushed into position. See additional comments under NBL Photo 5.

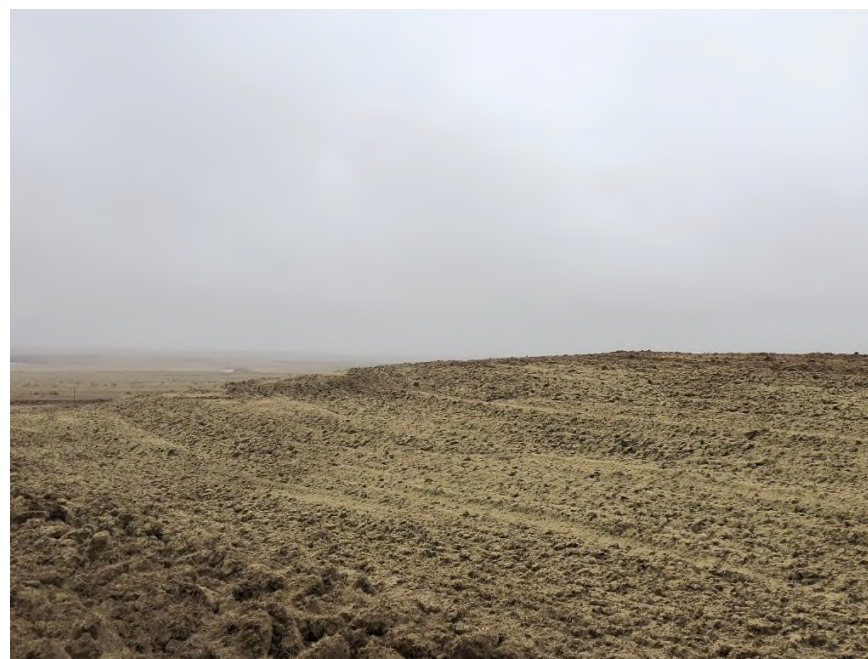
NBL Photo 4, East side of pad looking Southwest. The photo above, taken on 3/31/2019 shows the current condition of this stockpile. Once constructed and graded, water was applied to the pile, the soils were tracked, and hydromulch was applied. The hydromulch was in place on or before 3/18/2019.

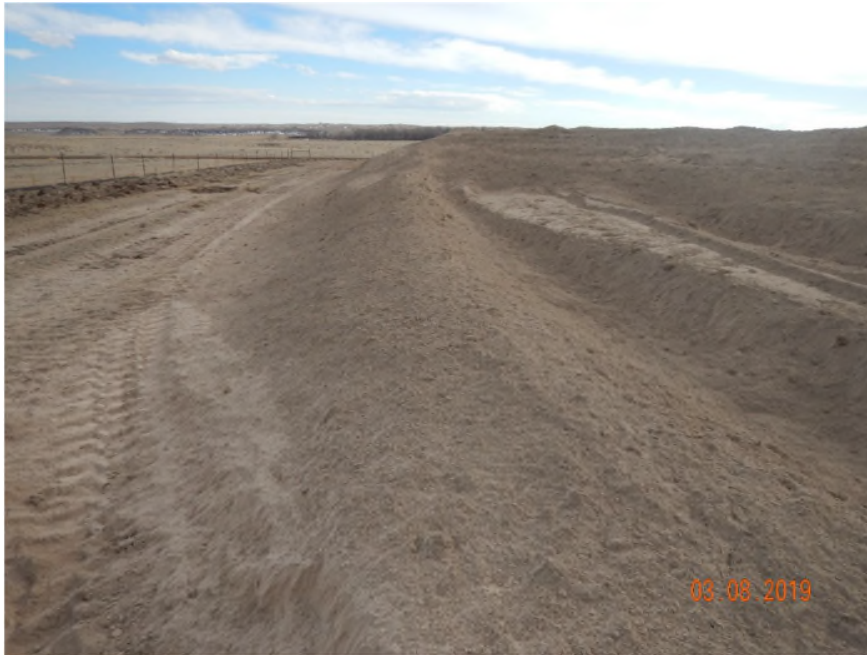
COGCC Photo 11. Photo taken from the east end of the location, facing south. Photo shows unstabilized soils on location at risk to erosion degradation.

In COGCC Photo 11, this pile was actively being constructed. The differing elevations and track marks can be seen where the operator is pushing material into position. During these activities, it is not practicable for operators to track soils. However, stockpiles are tracked once material is in place and roughly shaped.

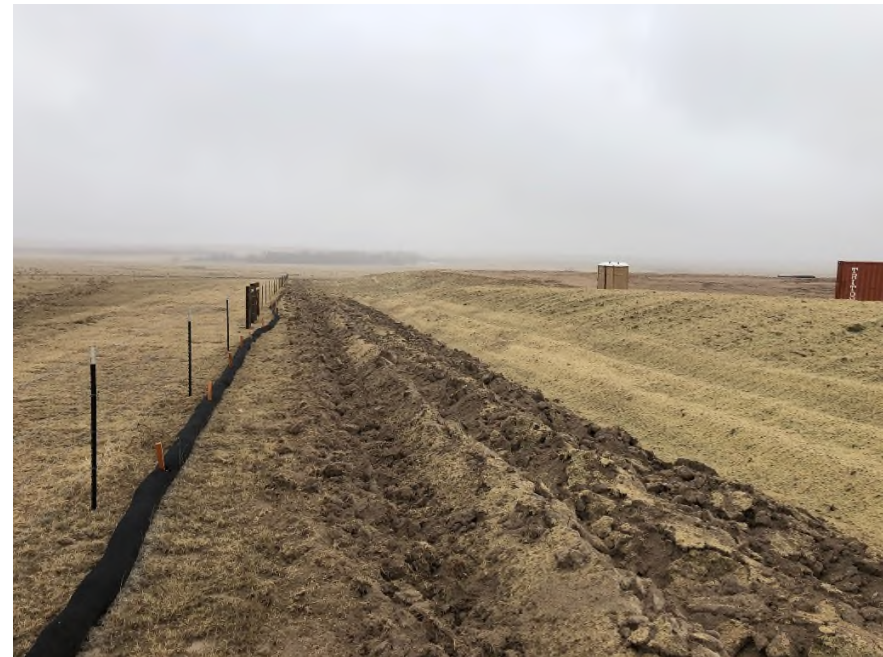
NBL Photo 5, East side of pad looking South. The photo above, taken on 3/31/2019 shows the current condition of this stockpile.

Once the stockpile contouring was completed, water was applied to the stockpile, the stockpile was tracked, and hydromulch was applied. The hydromulch was in place on or before 3/18/2019.

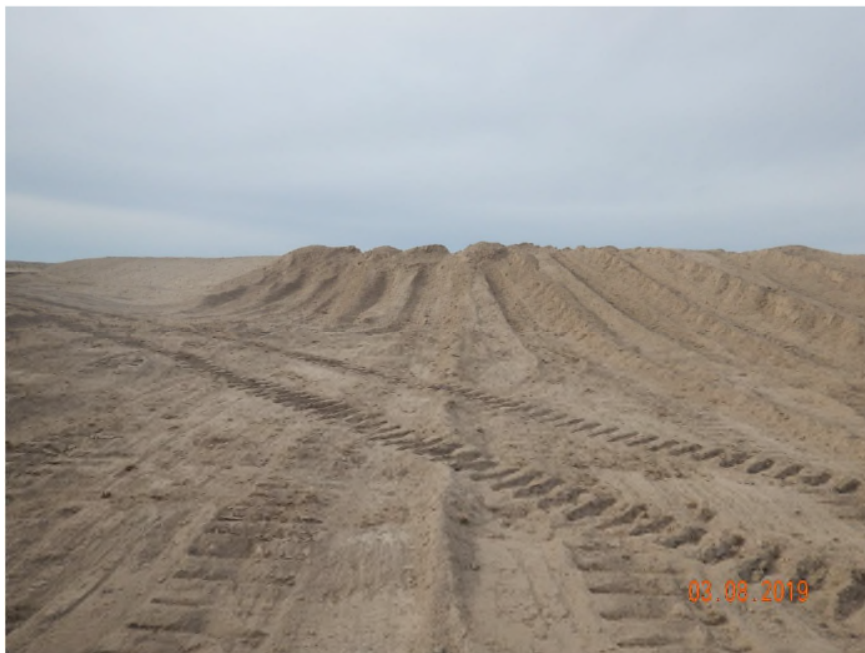
COGCC Photo 12. Photo taken from the south end of the location, facing north. Photo shows unstabilized soils on location at the risk to erosion degradation.

During the COGCC inspection, this pile was actively being constructed. In COGCC Photo 12 the differing elevations and track marks can be seen where the operator is pushing material into position. During these activities, it is not practicable for operators to track soils. However, stockpiles are tracked once material is in place and roughly shaped.

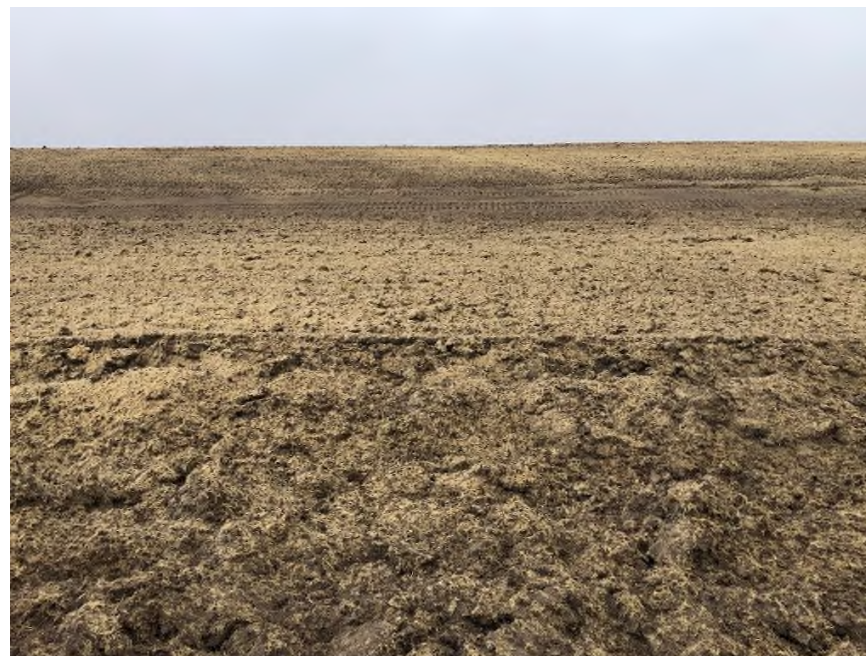
NBL Photo 6, South fill slope looking North. The photo above, taken on 3/31/2019 shows the current condition of this stockpile

Once the final stockpile contouring was complete, water was applied to the stockpile, the stockpile was tracked, and hydromulch was applied. The hydromulch was in place on or before 3/18/2019.

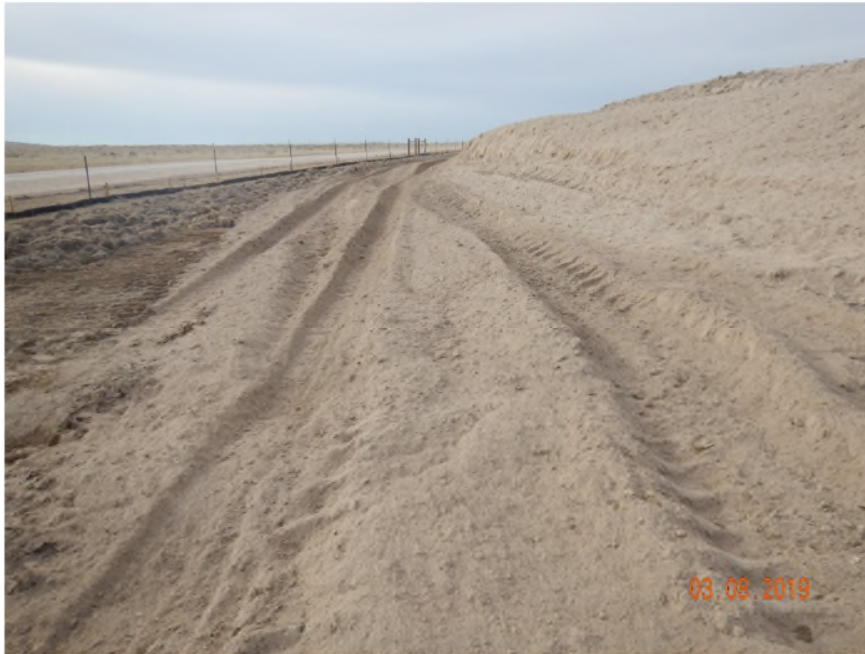
COGCC Photo 13. Photo taken from the south end of the location, facing west. Photo shows unstabilized soils on location at risk to erosion degradation.

During the COGCC inspection, this pile was actively being constructed. In COGCC Photo 12 the differing elevations and track marks can be seen where the operator is pushing material into position. During these activities, it is not practicable for operators to track soils. However, stockpiles are tracked once material is in place and roughly shaped.

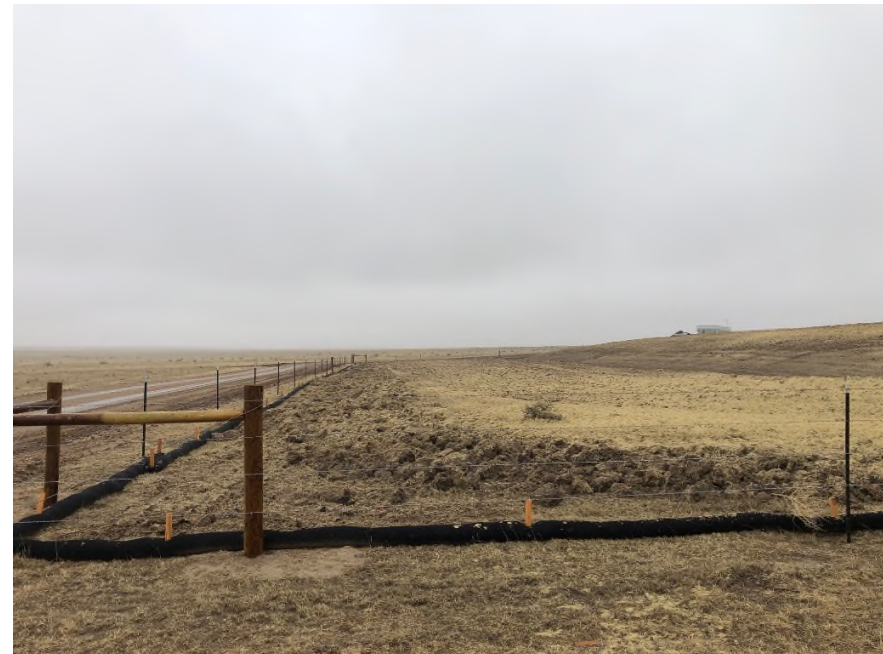
NBL Photo 7, Southeast corner looking West. The photo above, taken on 3/31/2019 shows the current condition of this stockpile.

Once the final stockpile contouring was complete, water was applied to the stockpile, the stockpile was tracked, and hydromulch was applied. The hydromulch was in place on or before 3/18/2019.
