Caerus Piceance LLC .
Api # 05-045-14157
Inspection # 675002104

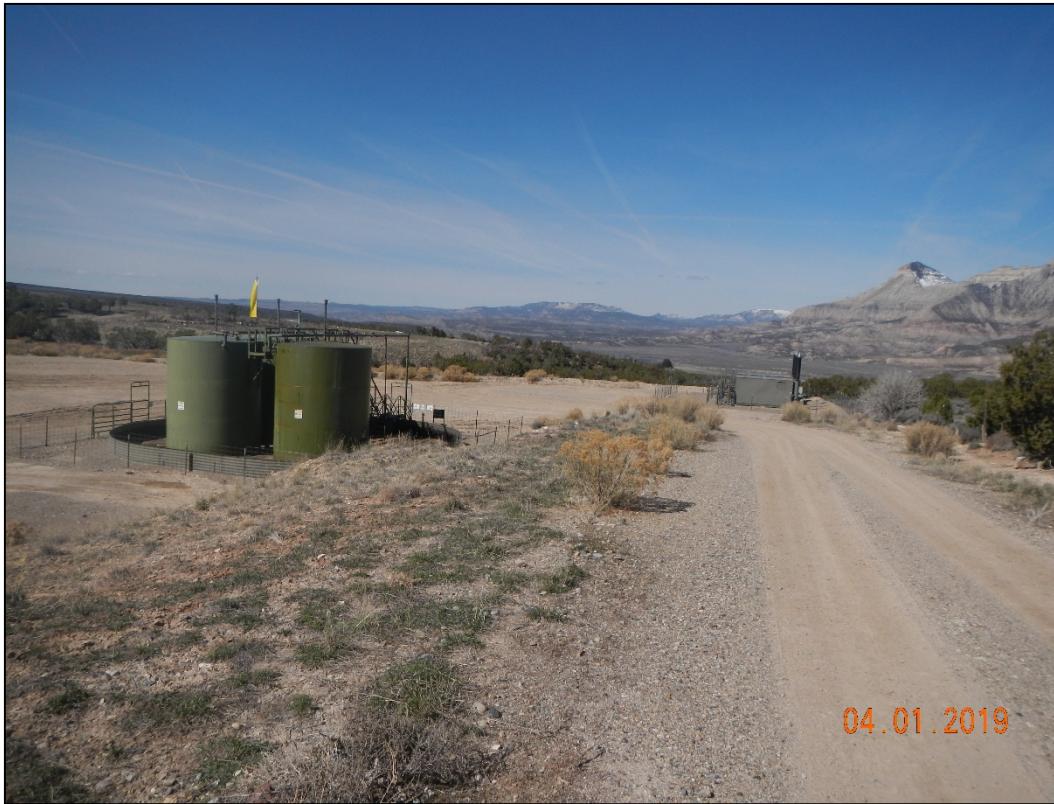
Photo of location

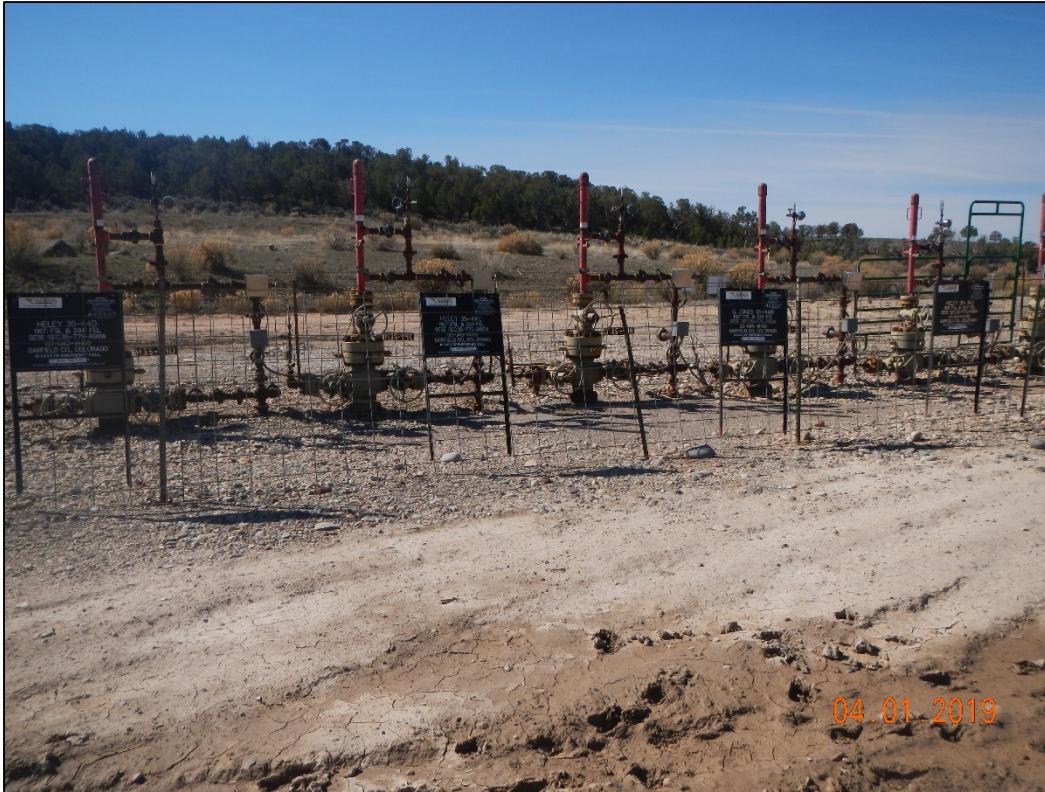
Wellhead signs heavy rutting, loss of compaction

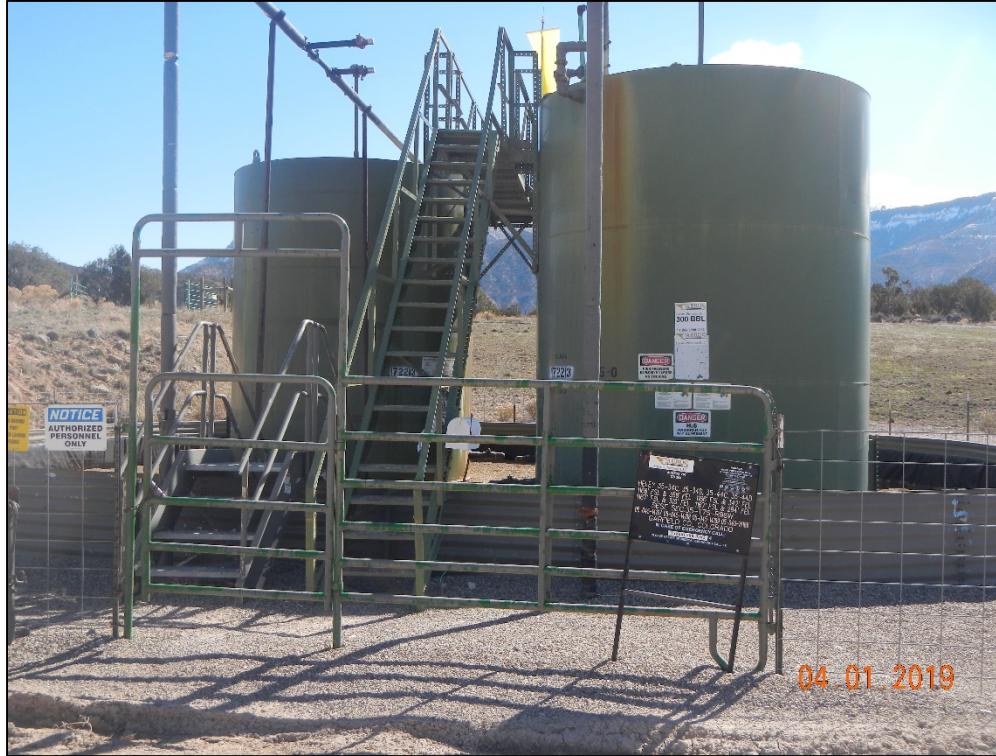
Photo of Tank Battery.

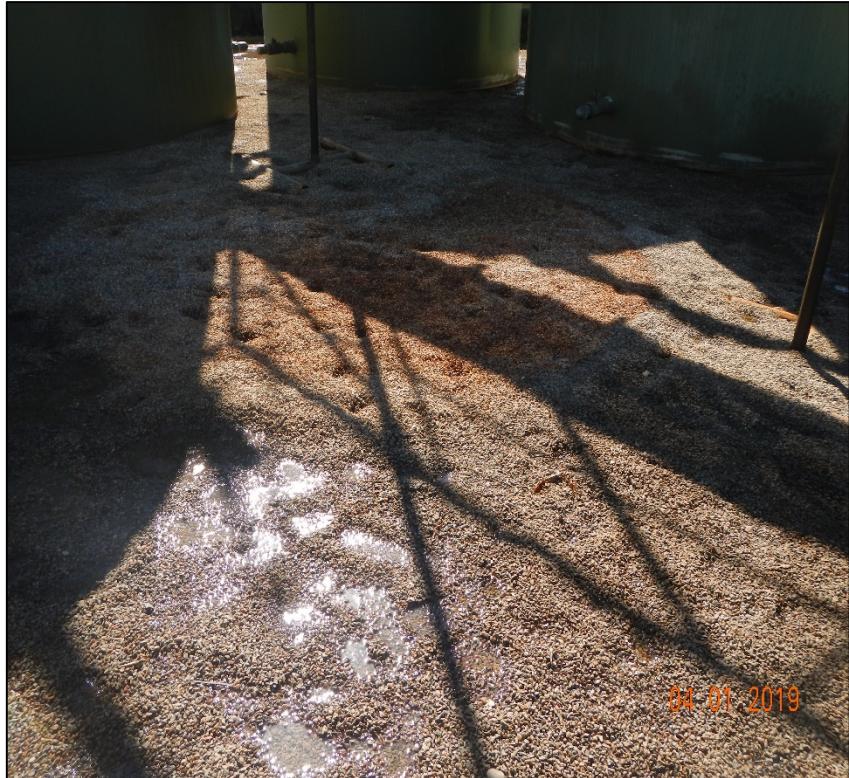
Stained gravel inside containment

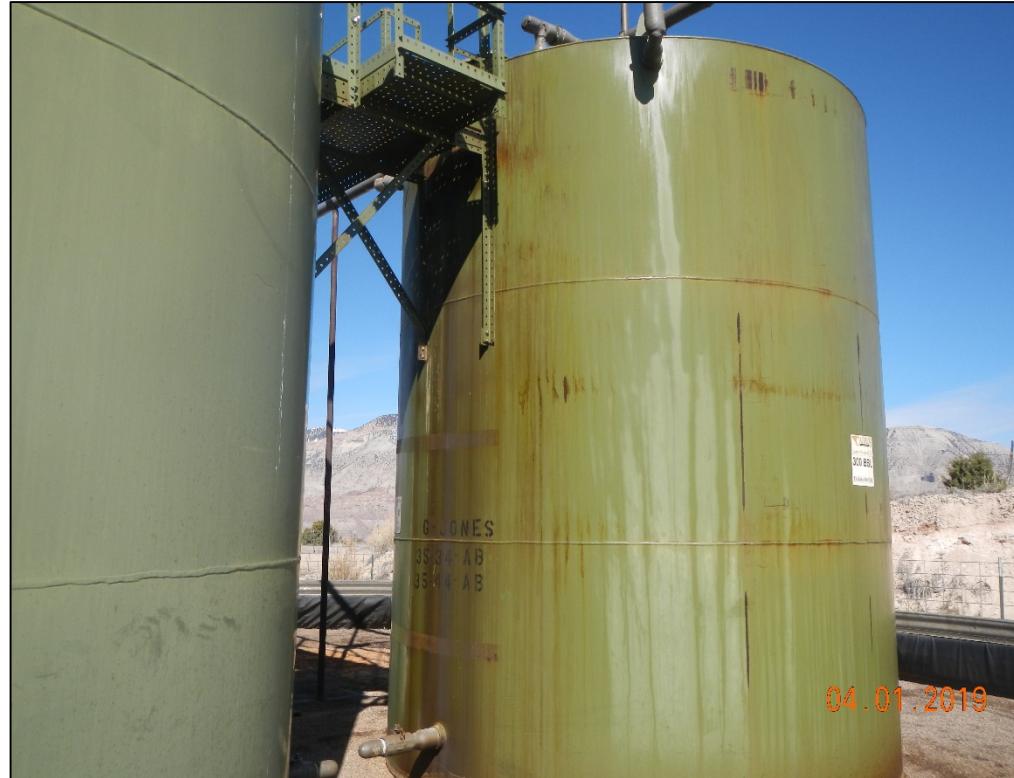
Oily substance staining outside of tank

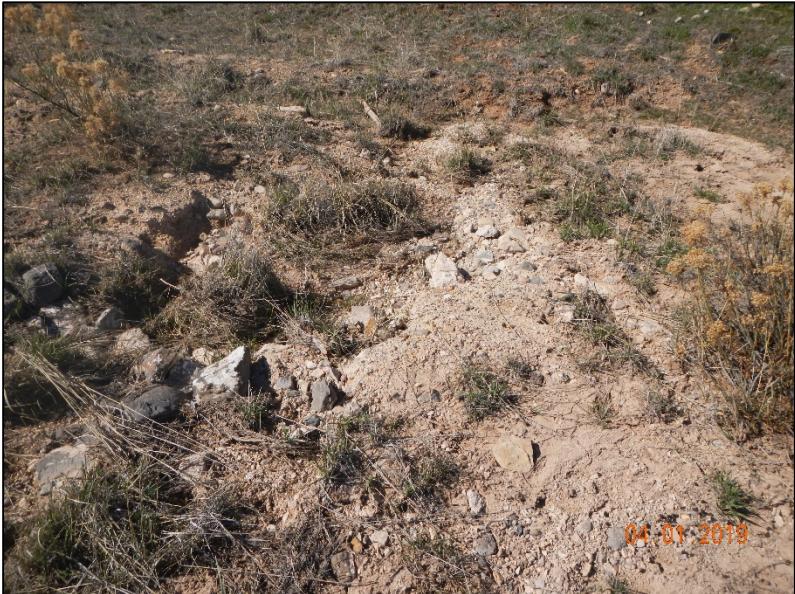
Heavy erosion on sw corner of location

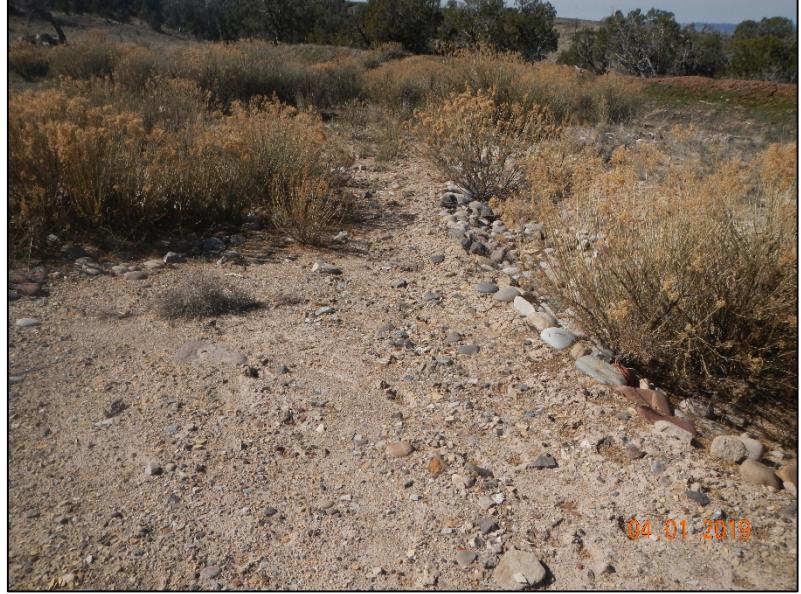
Sediment running off west side of location outside of ditch

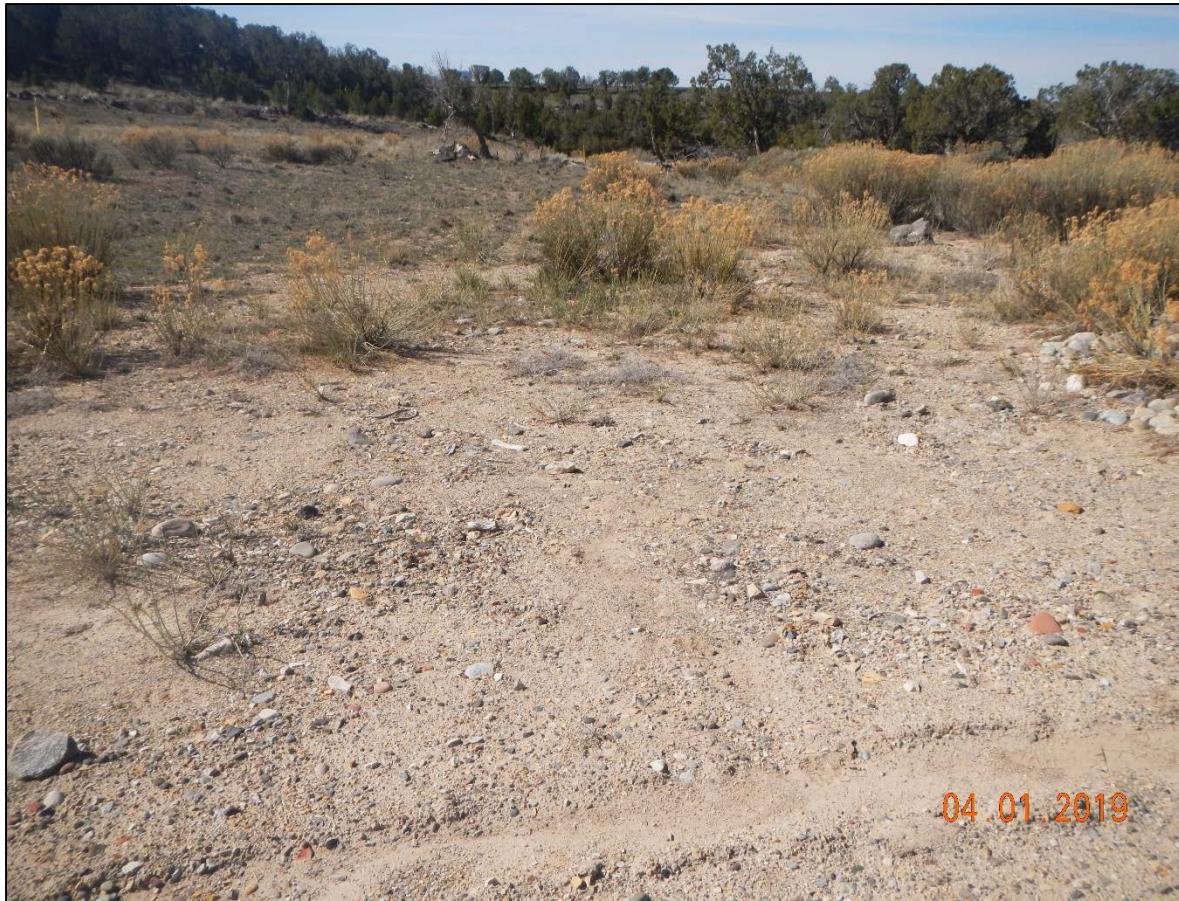
Sediment moving off South side of location
