Caerus Piceance LLC .
Api # 05-045-09548
Inspection # 675002106

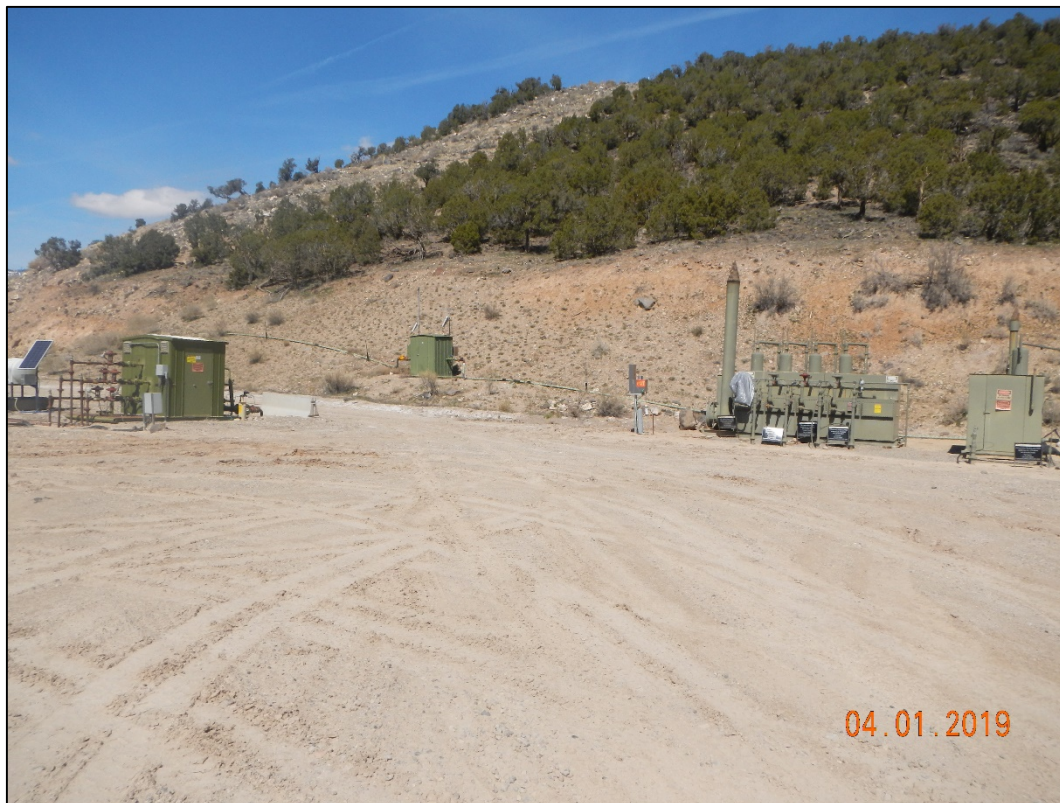
Photo of location at entrance

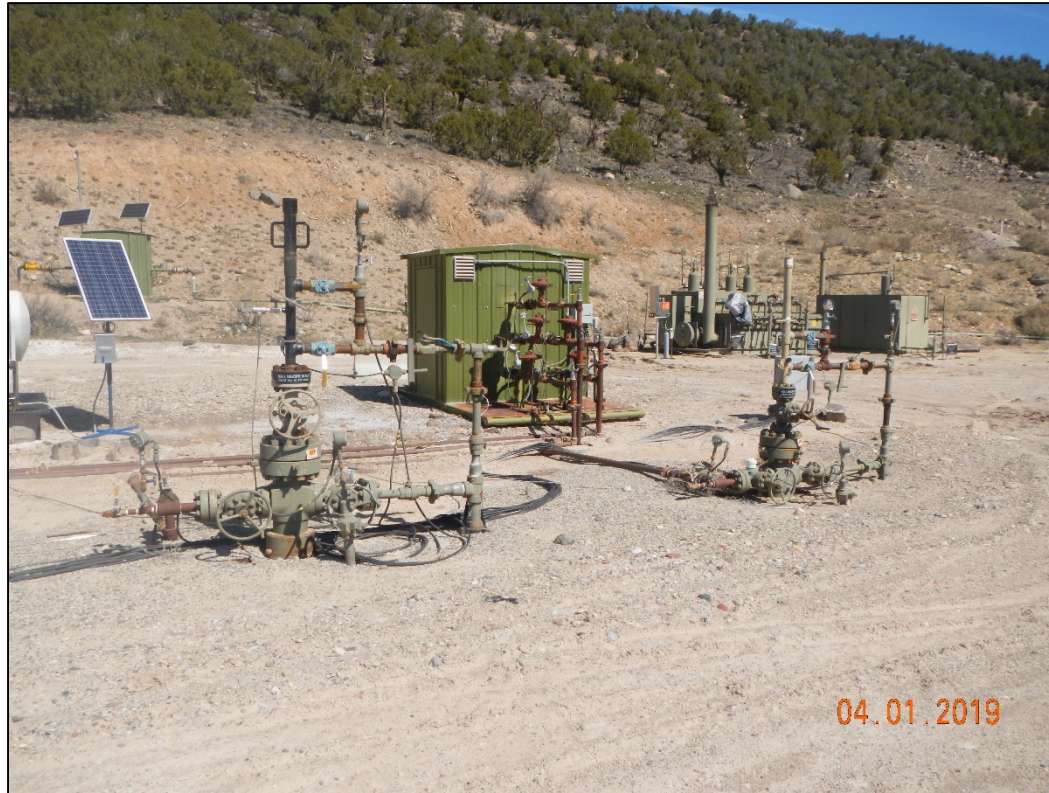
Wellhead signs heavy rutting, loss of compaction

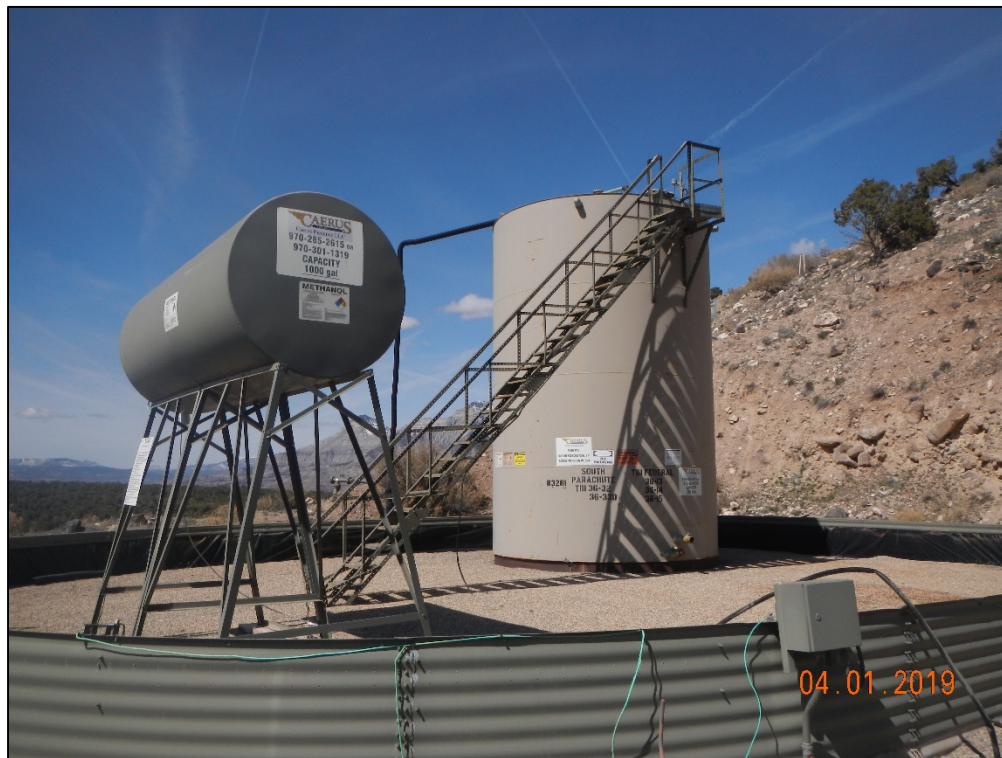
Photo of Tank Battery.

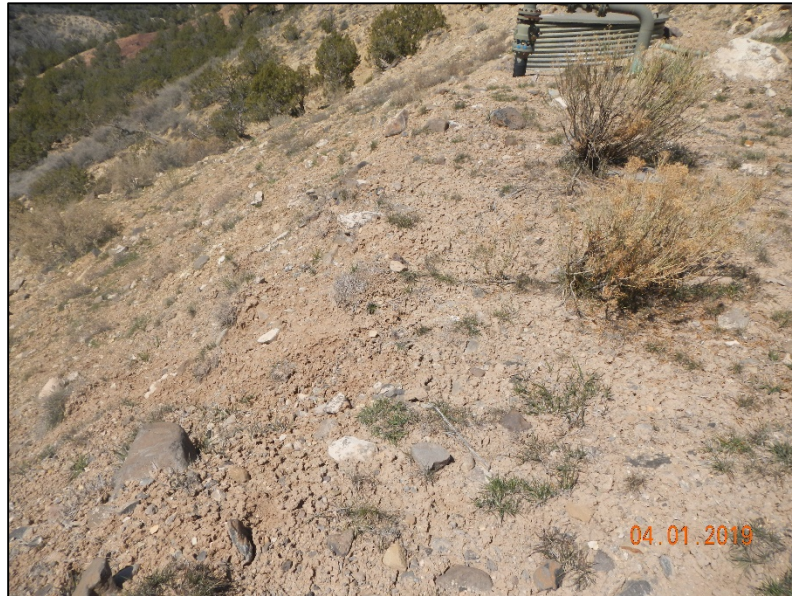
Erosion on SW side of tank battery

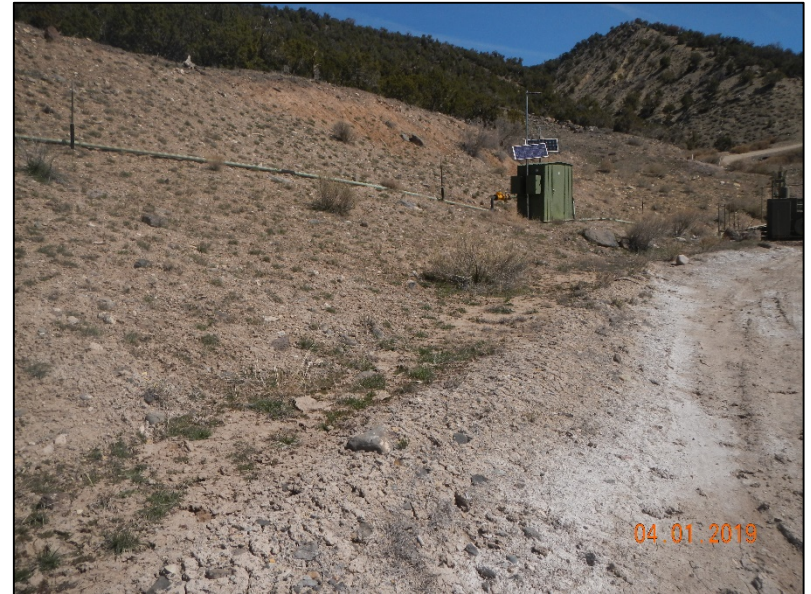
Erosion is evident along unsterilized slope at the north side of location .
