Caerus Piceance LLC .
Api # 05-045-10411
Inspection # 675002112

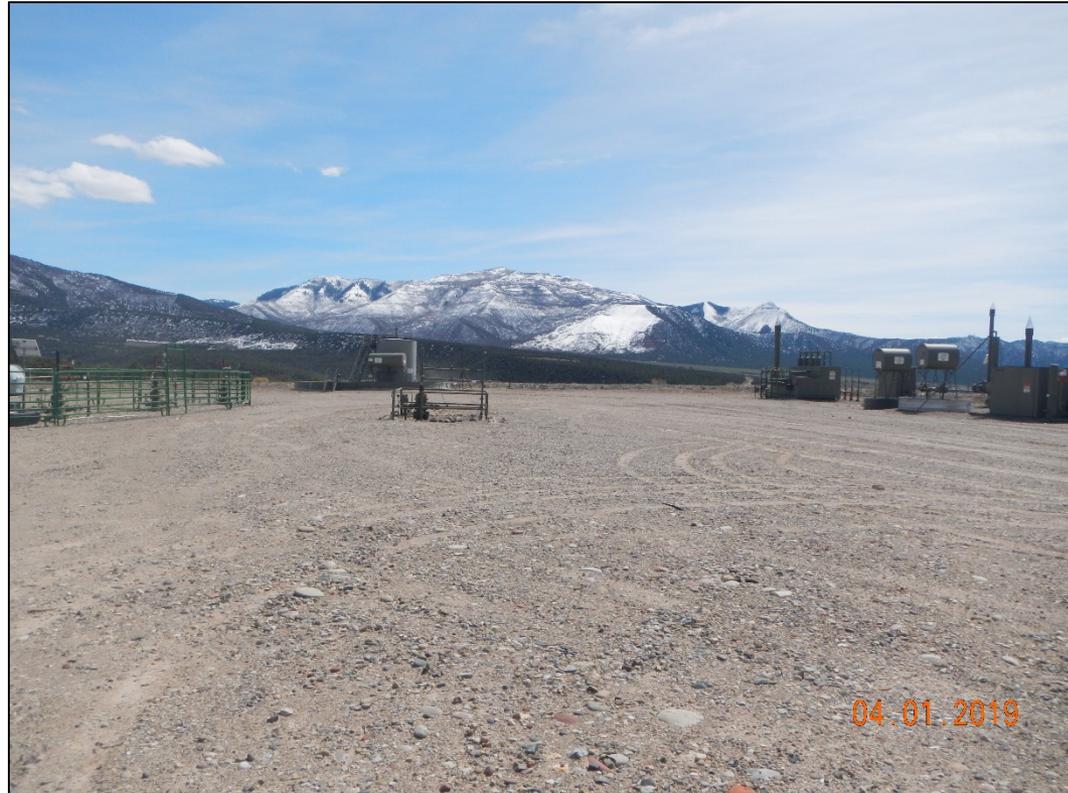
Photo of location at entry

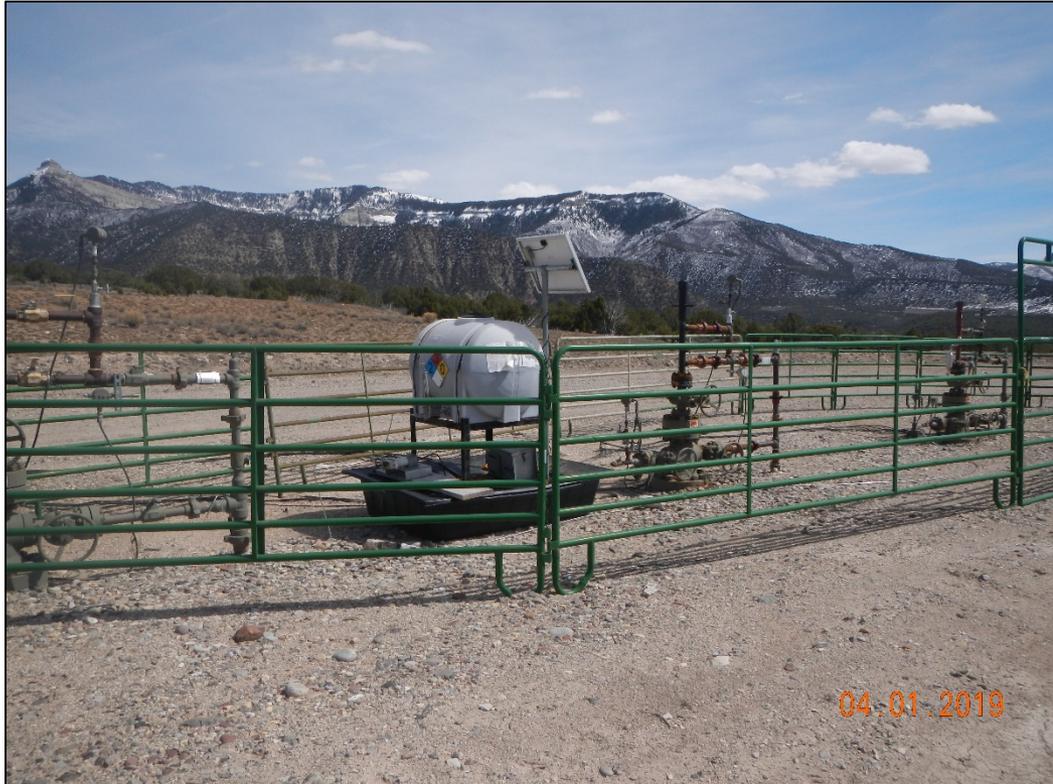
Wellhead signs

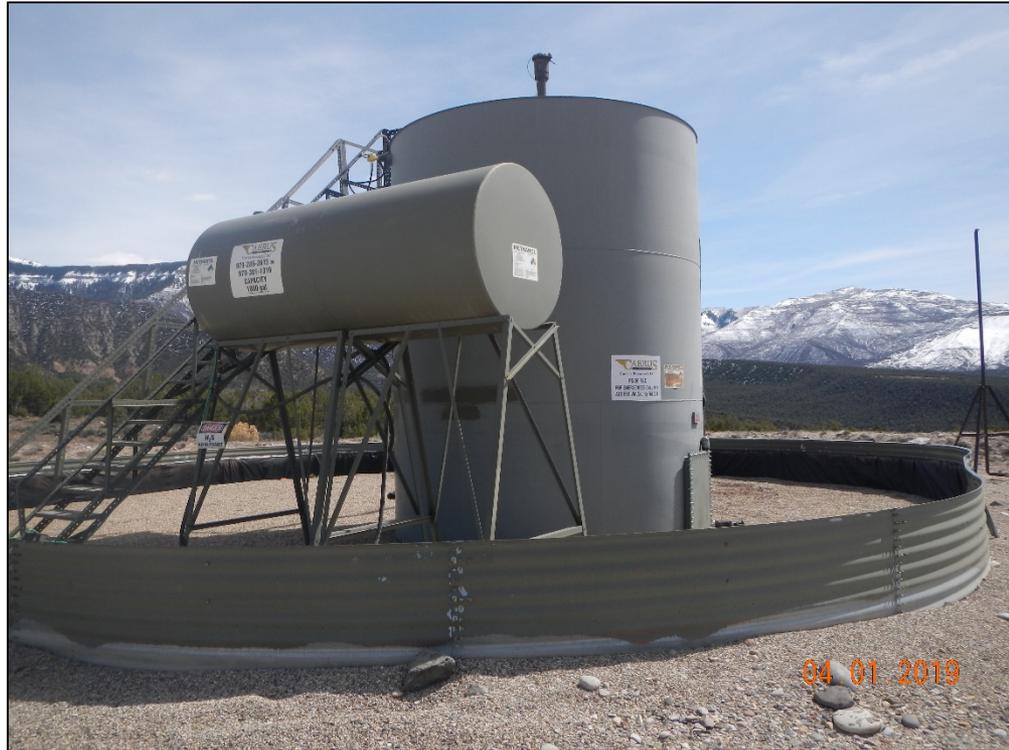
Photo of Tank Battery.

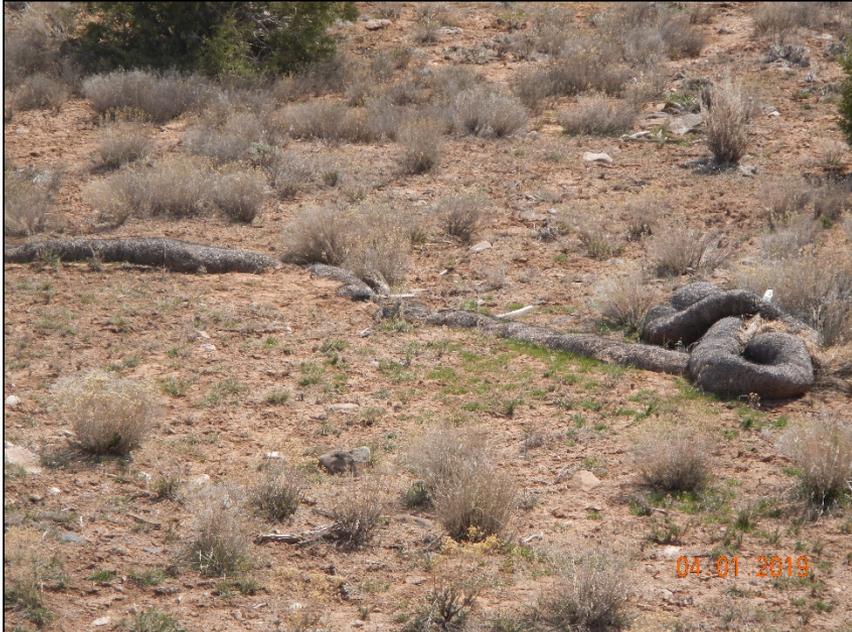
Waddles on south side of location

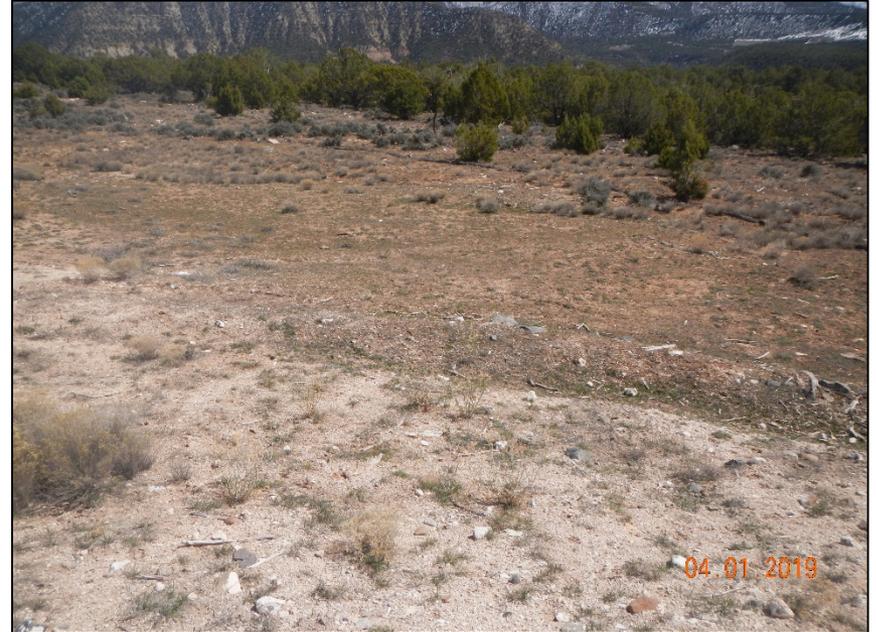
Erosion is evident along unsterilized slope on the east side of location .
