Construction and Stormwater Inspection

April 2, 2019

Operator: BAYSWATER EXPLORATION AND PRODUCTION LLC - #10261

Inspection Photos
Location Name: EAST AULT 18-C PAD
Location ID: 455456

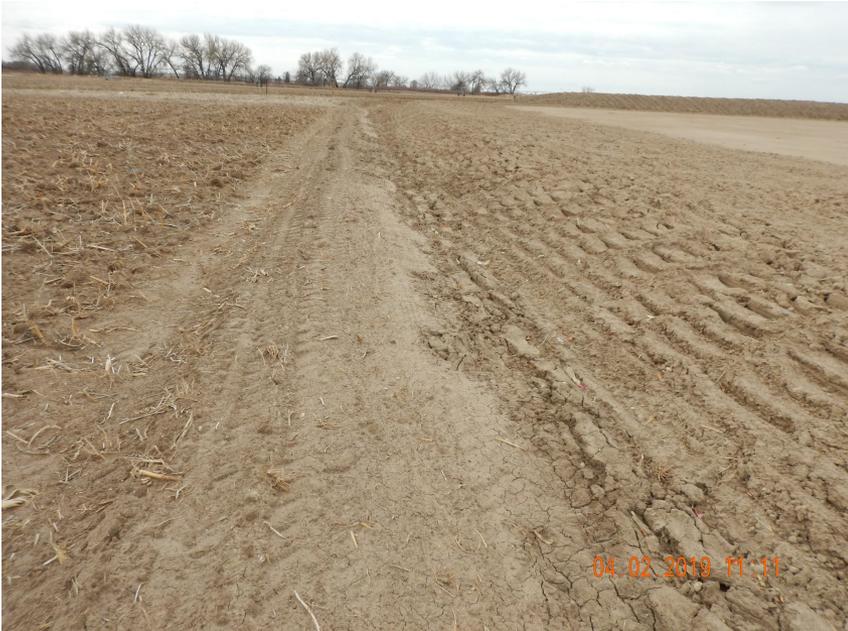
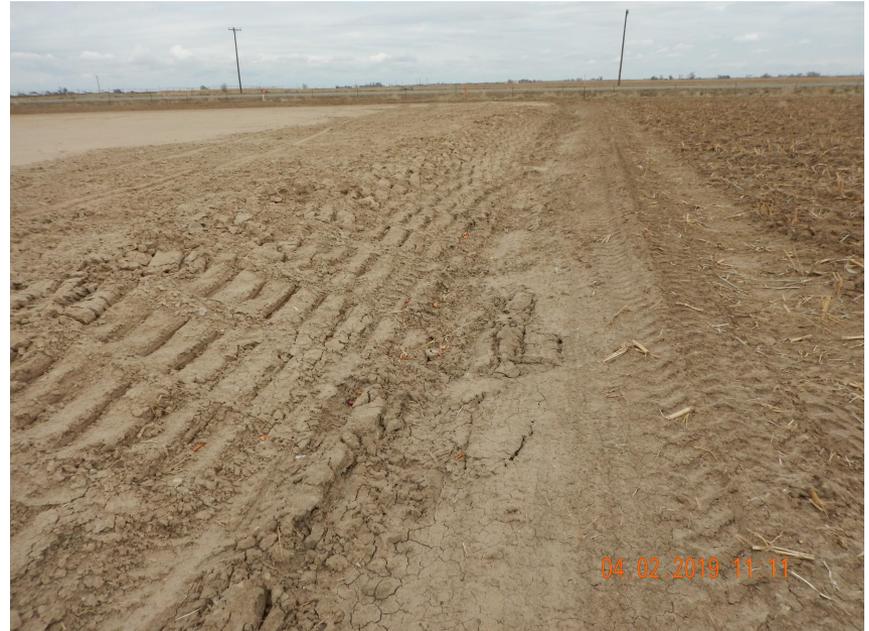
Photo 1. Photo taken from the eastern location, facing South. Photo illustrates a ditch and berm BMP, and the fill slope has been tracked.

Photo 2. Photo taken from the eastern location, facing North. See comments under Photo 1.

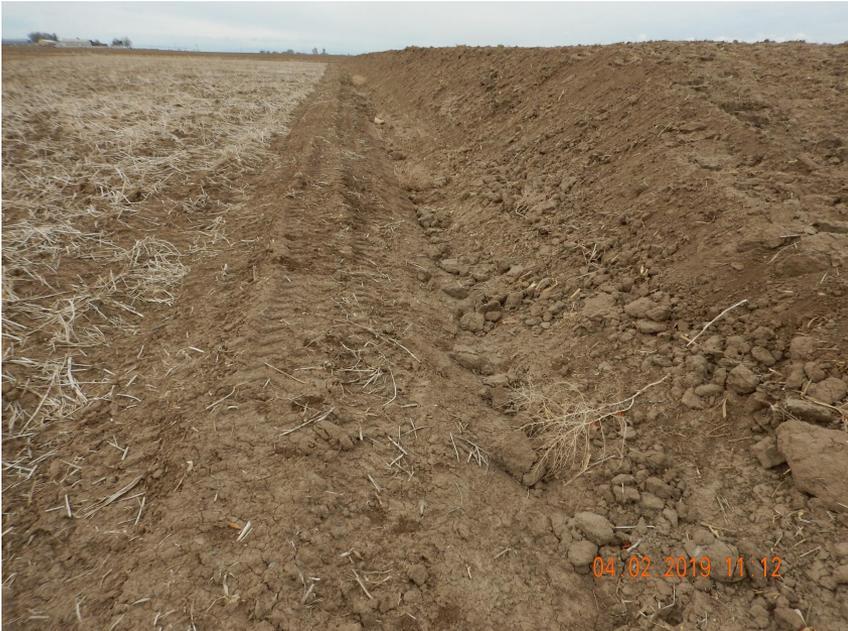
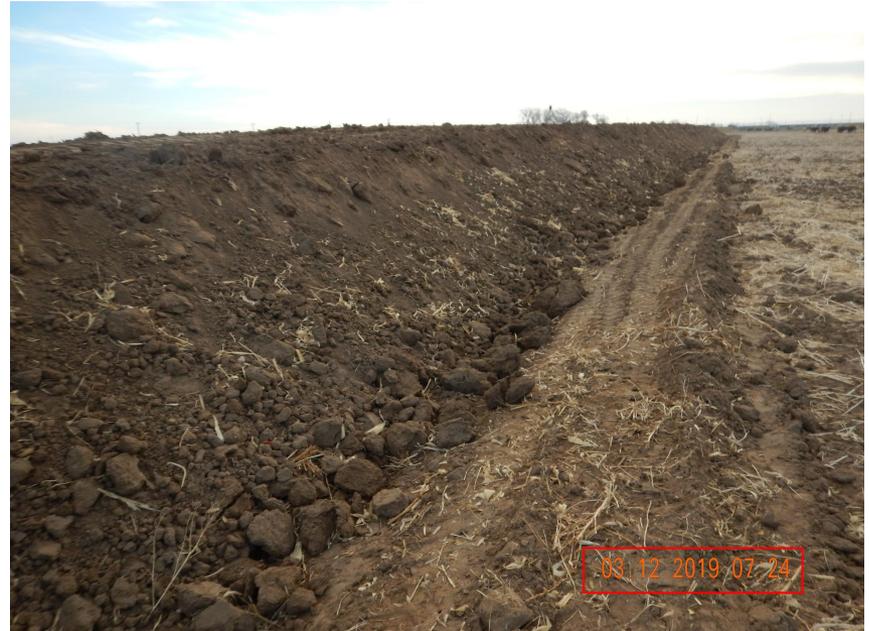
Photo 3. Photo taken from the eastern topsoil stockpile on April 2, 2019, facing West. Operator has failed to stabilize the south-facing topsoil stockpile side since the previous inspection on 3/12/19. Also, leaving the stockpile steep like this would make it difficult to manage weed establishment.

Photo 4. Photo taken from the western topsoil stockpile on March 12, 2019, facing East. See comments under Photo 3.

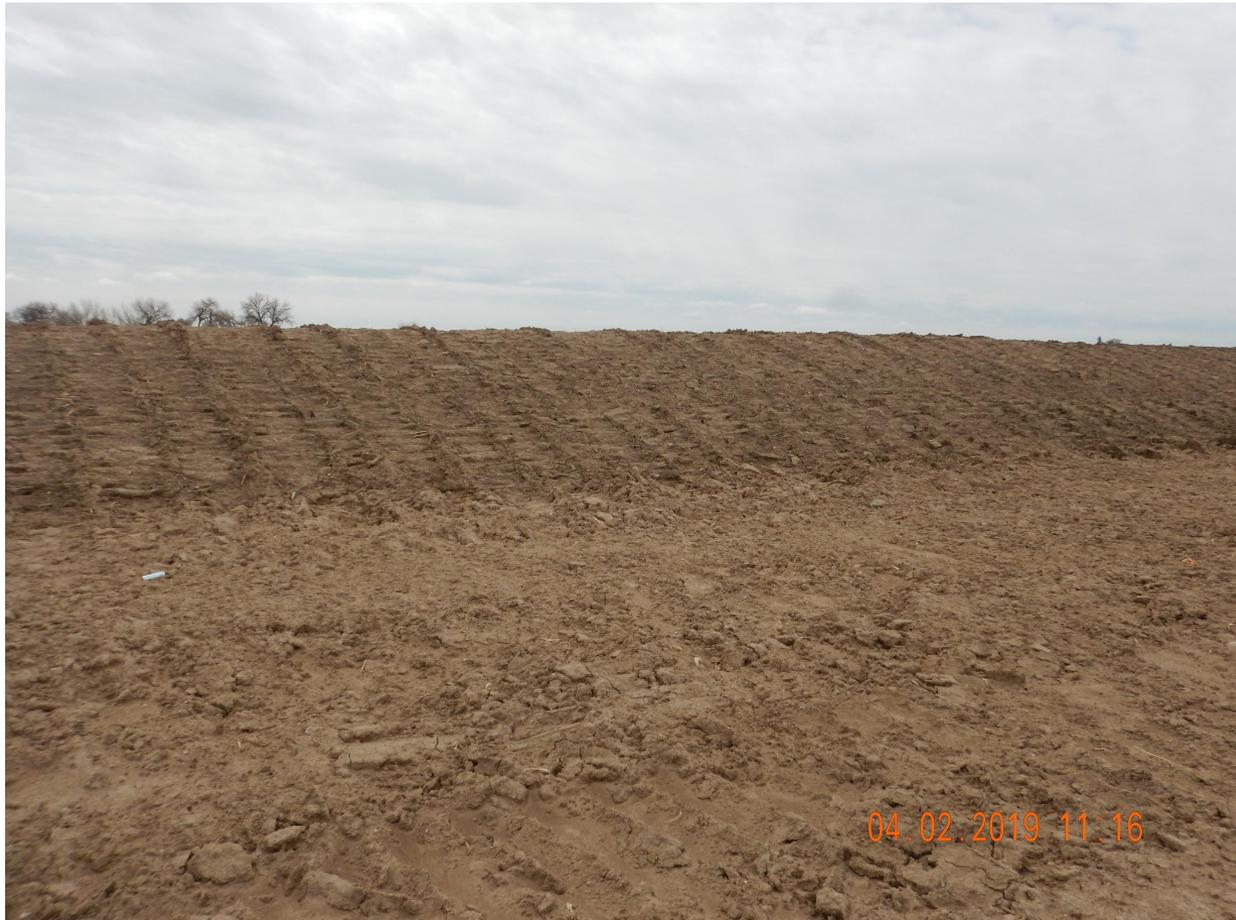
Photo 5. Photo taken from the north-facing topsoil stockpile side on April 2, 2019, facing South. Operator has only stabilized the north-facing side and not the south-facing side.
