Inspection Photos  
Location Name: Open Range 18  
Location ID: 447512

**COLORADO**  
Oil & Gas Conservation  
Commission  
Department of Natural Resources

Inspection Number: 689802440

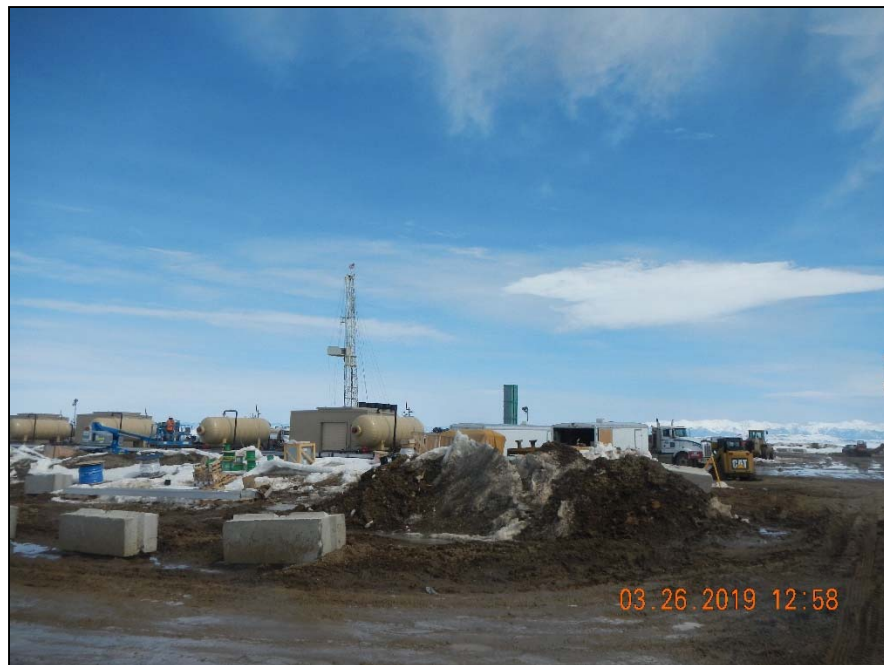
**Photo 1. Overview of location taken at entrance facing east.**

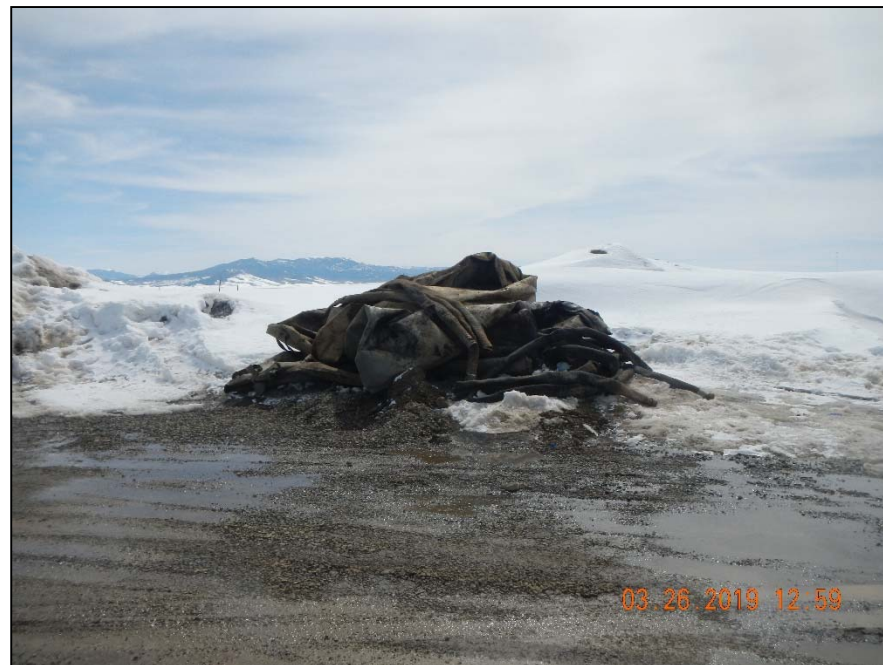
**Photo 2. Example of debris, pile of oily used secondary containment devices.**

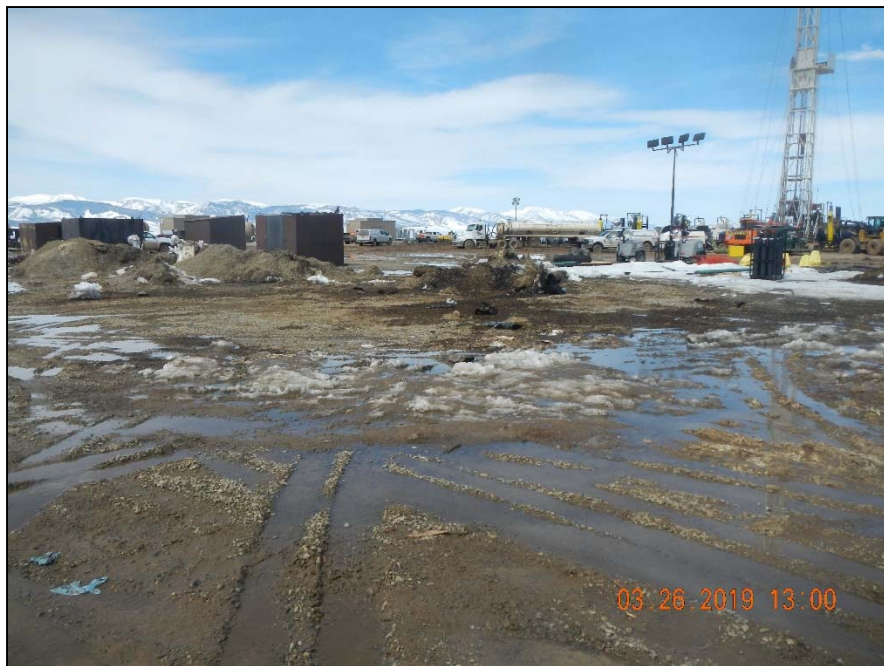
**Photo 3. Example of poor housekeeping, piles of stained soil where large volume storage tank sat during frack operations.**

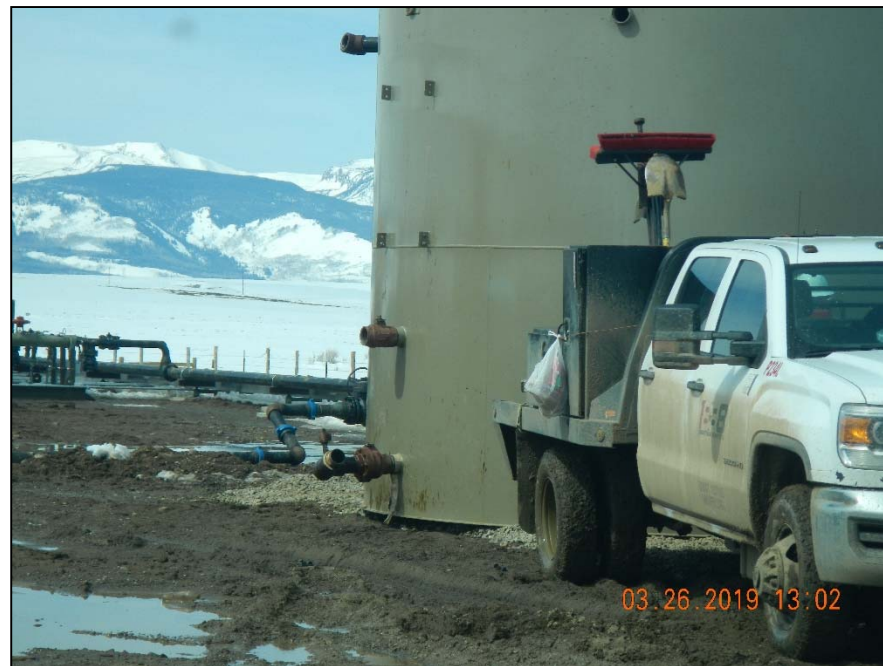
**Photo 4. No liner apparent under tank being installed.**

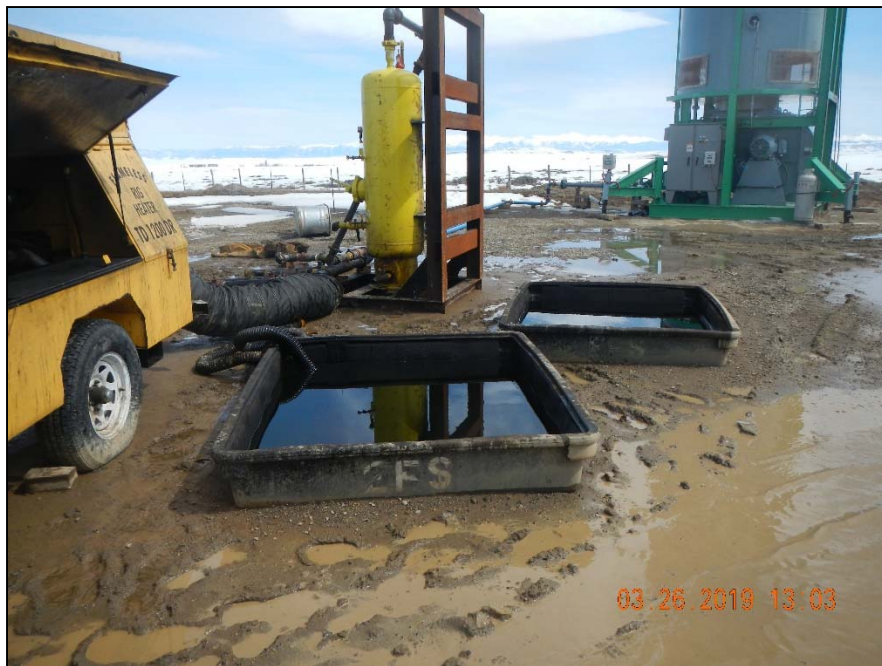
Photo 5. Example of poor housekeeping, oily fluid in secondary containments.

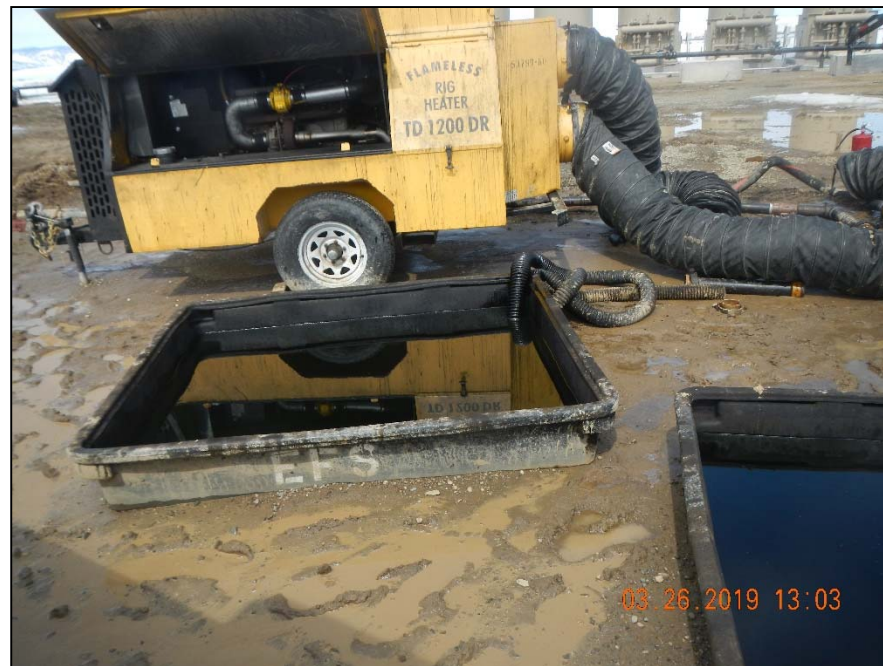
Photo 6. Close-up of Photo 5 to show hoses coming out of containment vessels.

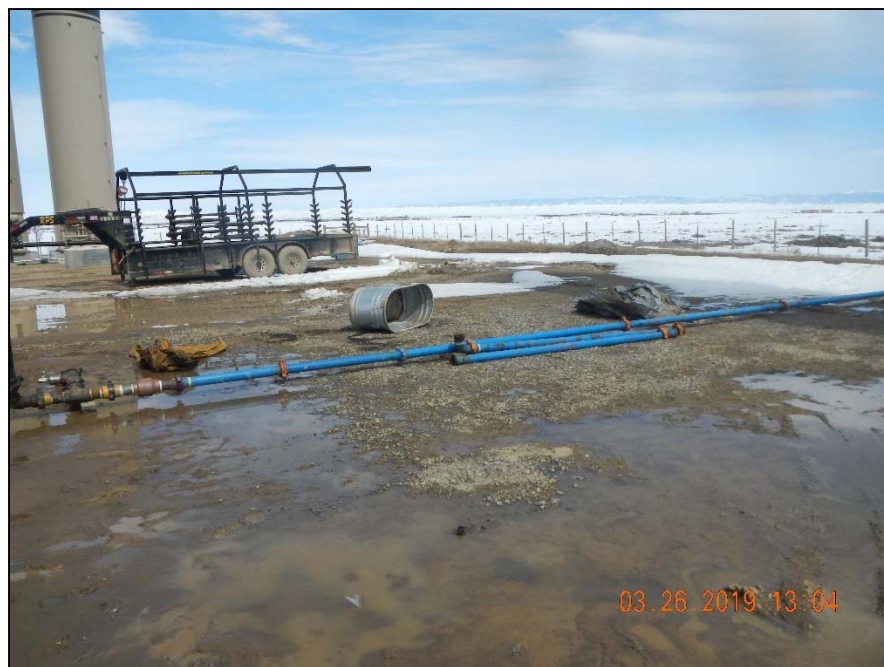
**Photo 7. Example of poor housekeeping, overturned secondary containment stock tank, stained soil, trash/debris.**

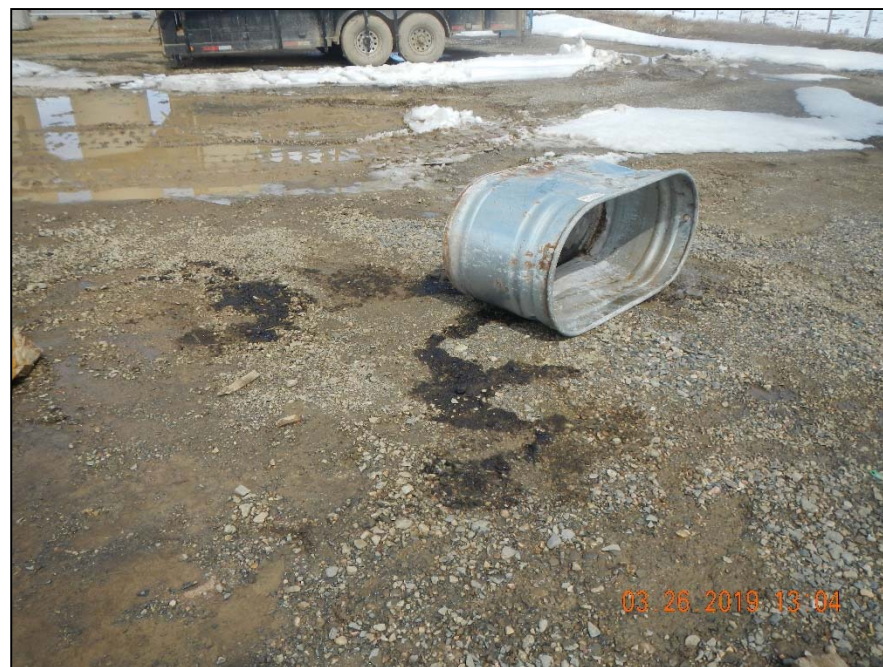
**Photo 8. Close-up of Photo 7 to show stained soil.**

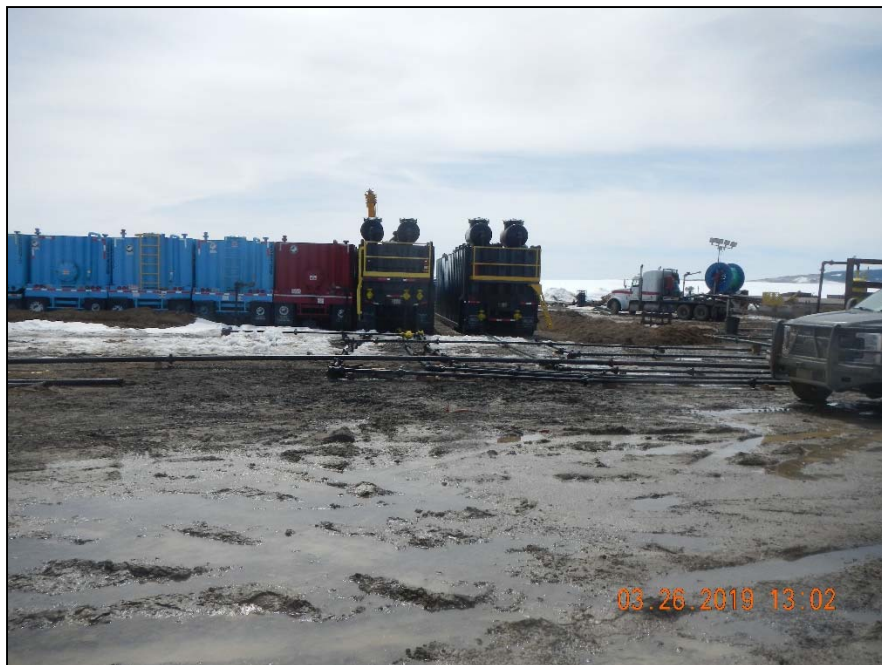
**Photo 9. Frack tanks stored with incomplete secondary containment.**

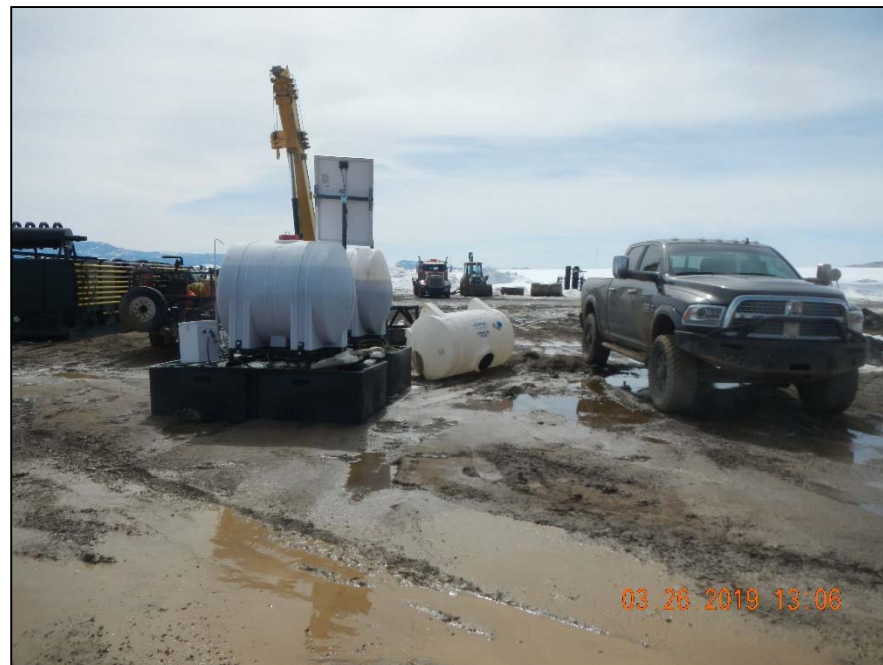
**Photo 10. Example of poor housekeeping, overturned chemical tote.**

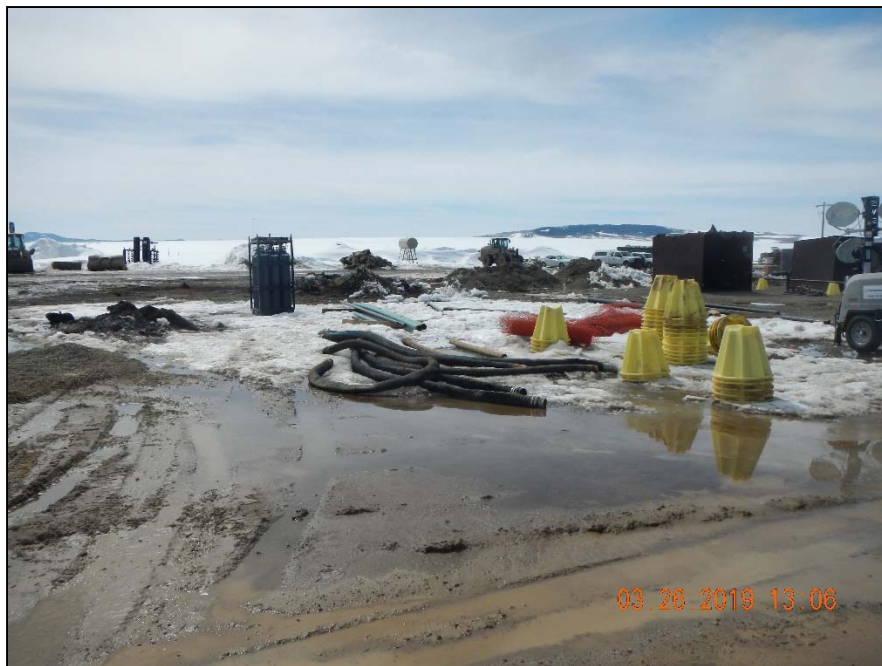
**Photo 11. . Example of poor housekeeping, hoses stored without containment.**

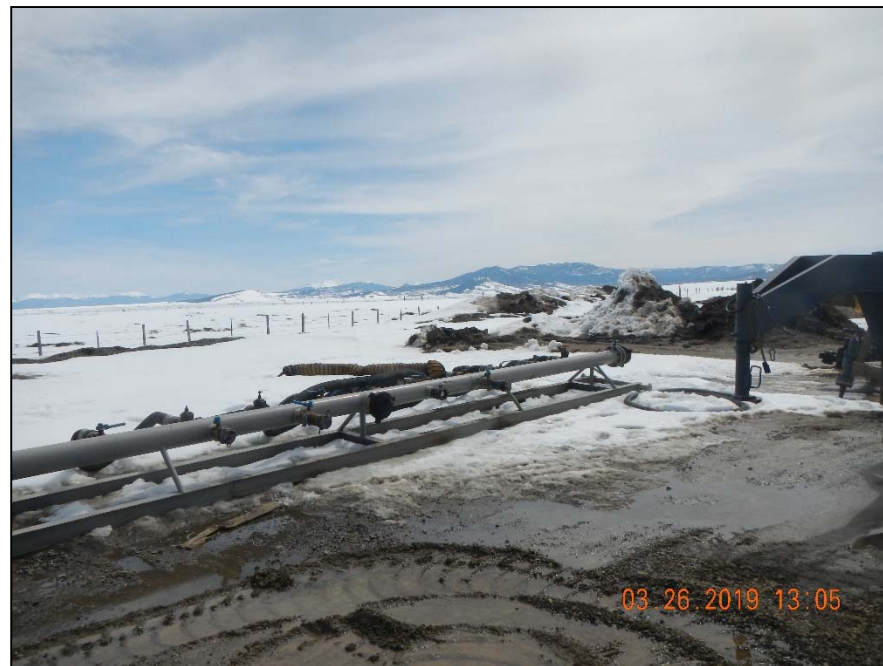
**Photo 12. Example of poor housekeeping, hoses stored without containment.**
