# Inspection Photos

API: 05-071-06340

Operator: TIMBER CREEK OPERATING LLC

Inspection Date: 4/2/2019

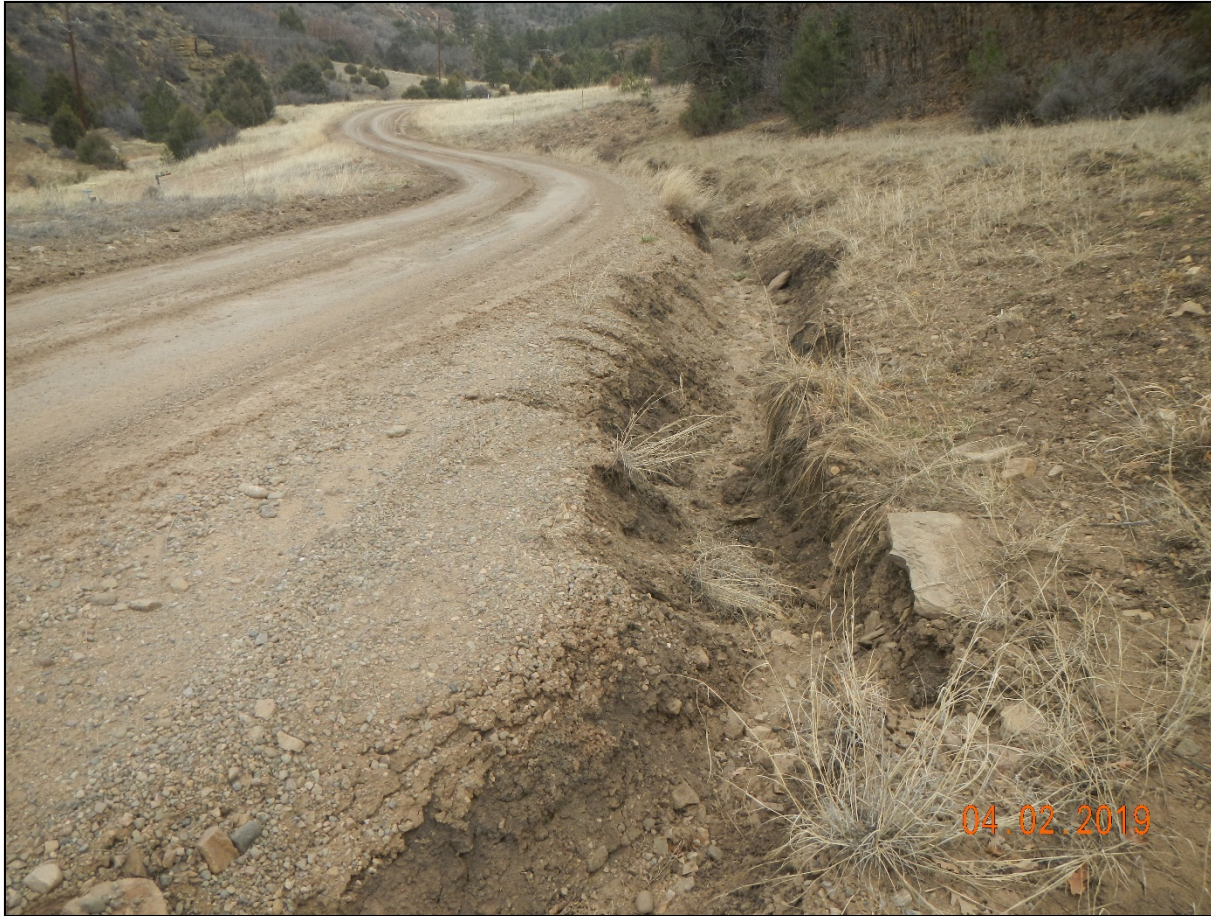
**Photo 1.** There is an erosion channel that developed at the southeast side of the location along the access road.

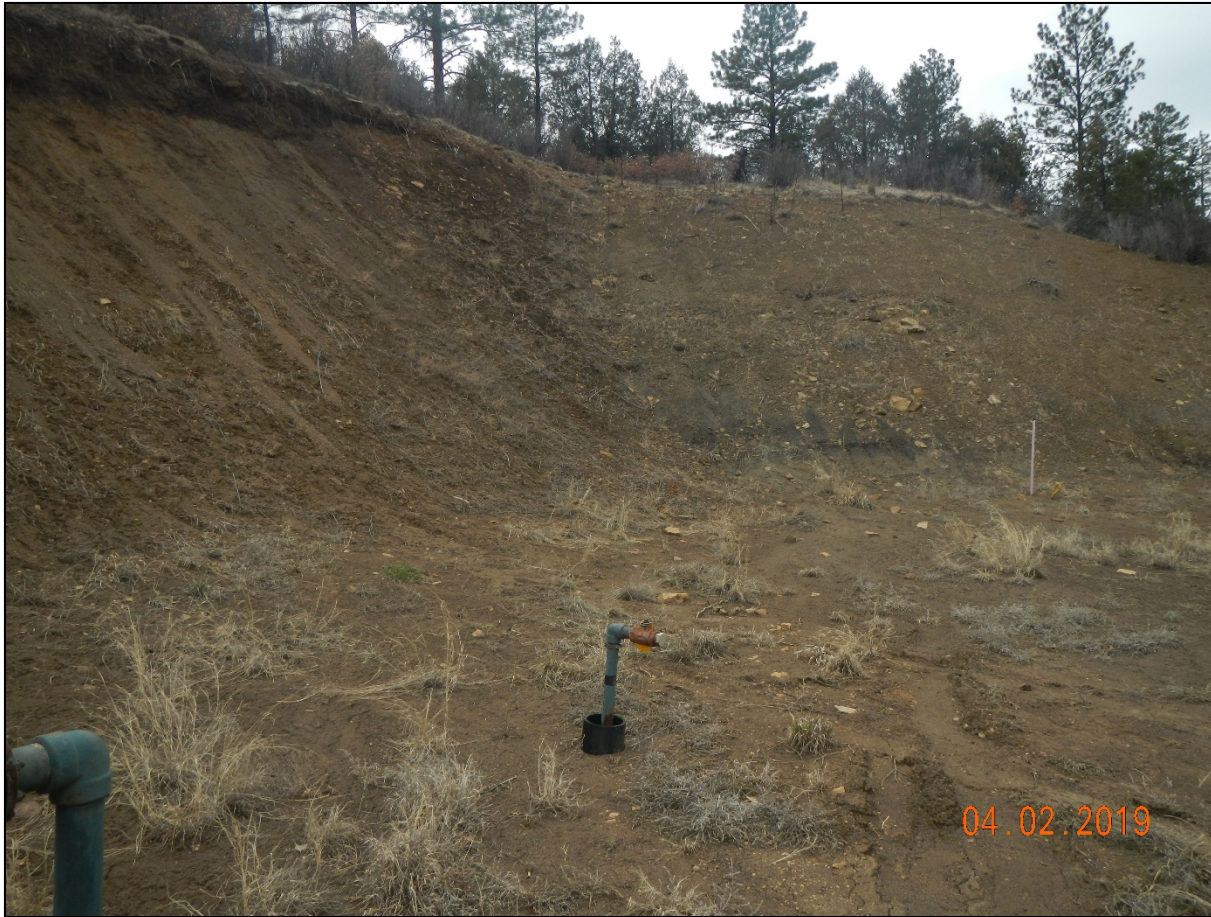
**Photo 2.** There is signs of sediment deposition on the pad. A ditch at the base of the cut slope may be needed to retain sediment.
