Inspection Photos

API: 05-071-06339

Operator: TIMBER CREEK OPERATING LLC

Inspection Date: 4/2/2019

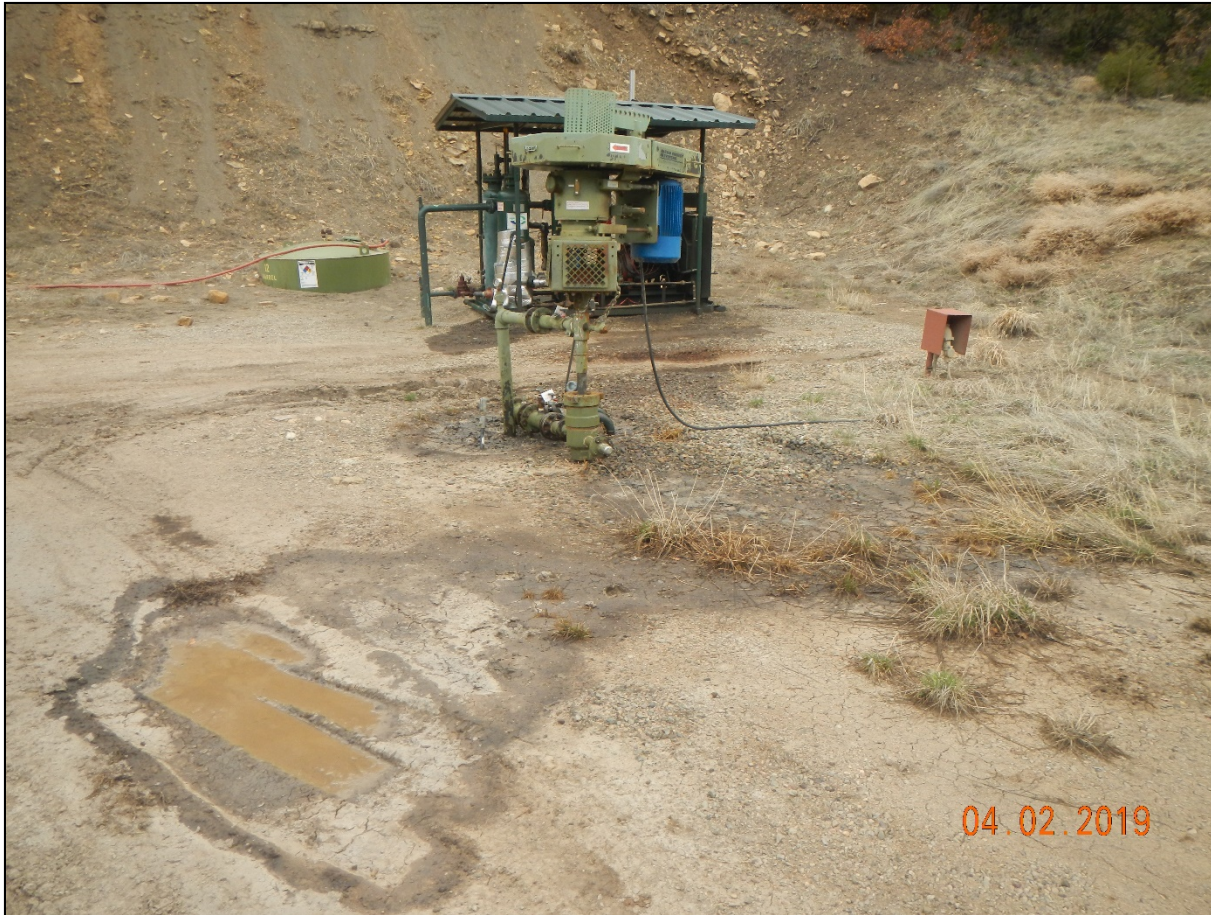
Photo 1. Facing toward the wellhead. It appears there was leakage.

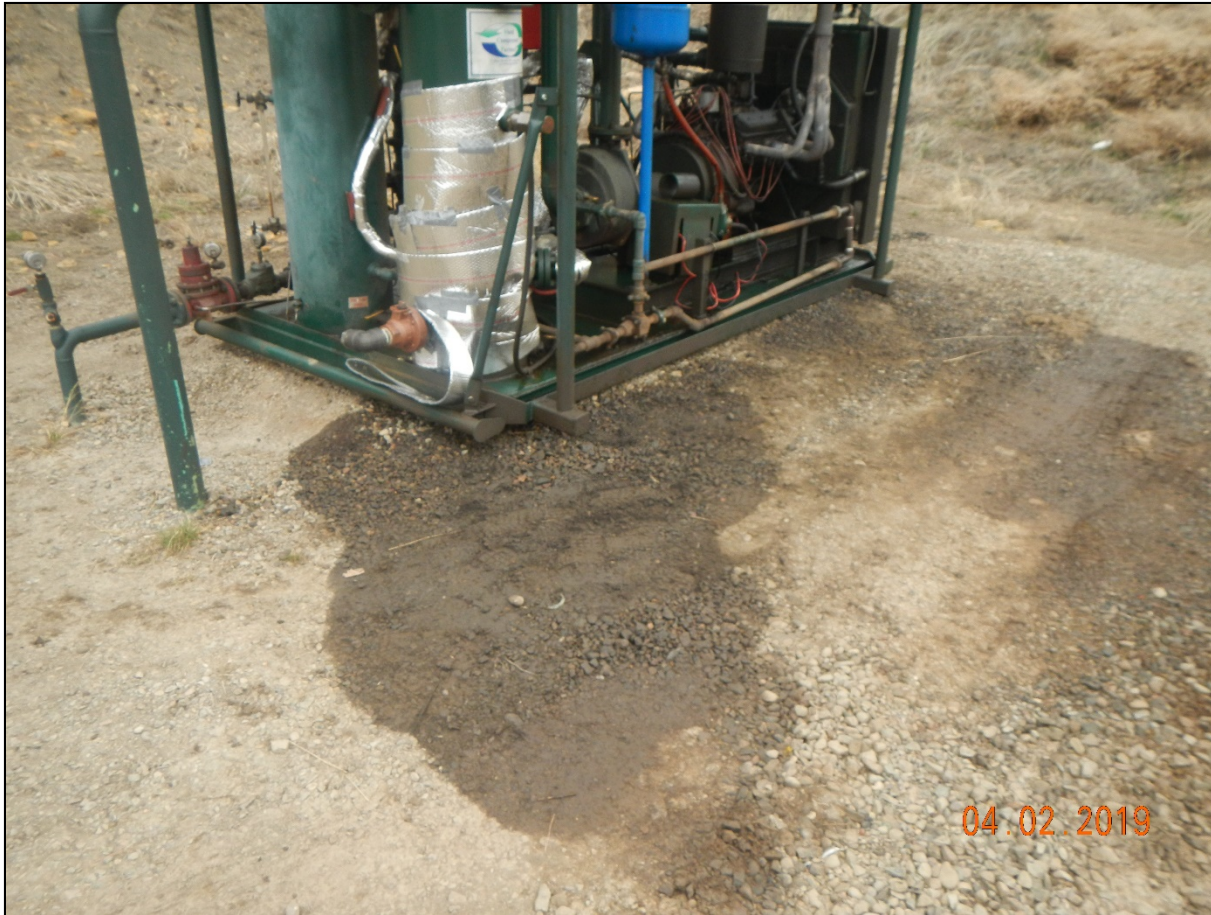
Photo 2. There is stained soil near the engine skid.

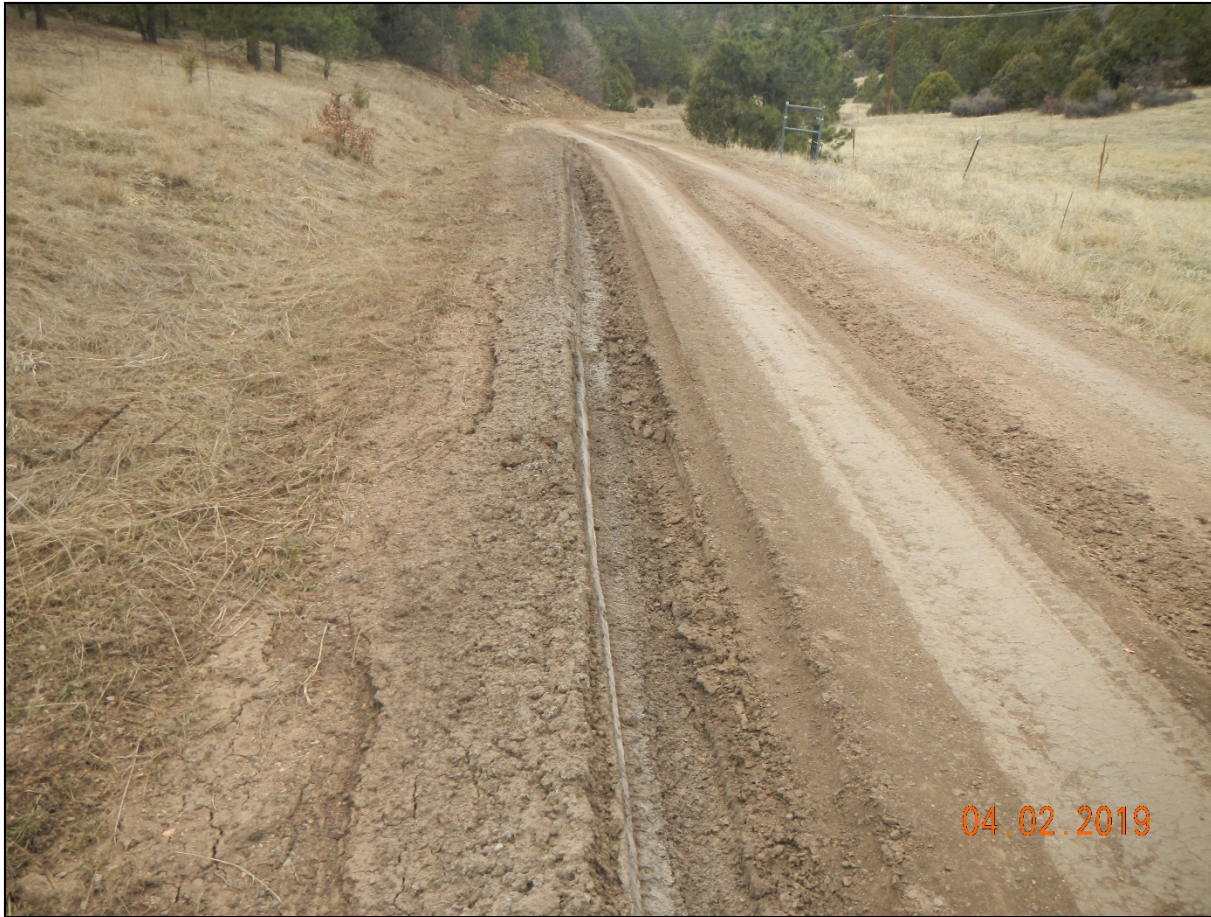
Photo 3. Past the location on the main road in the canyon there are signs of vehicle rutting and erosion.
