Inspection Photos

Location: 447512 pen Range 18 Pad

Peters 0781 wells.

Inspection Date: 3/27/19

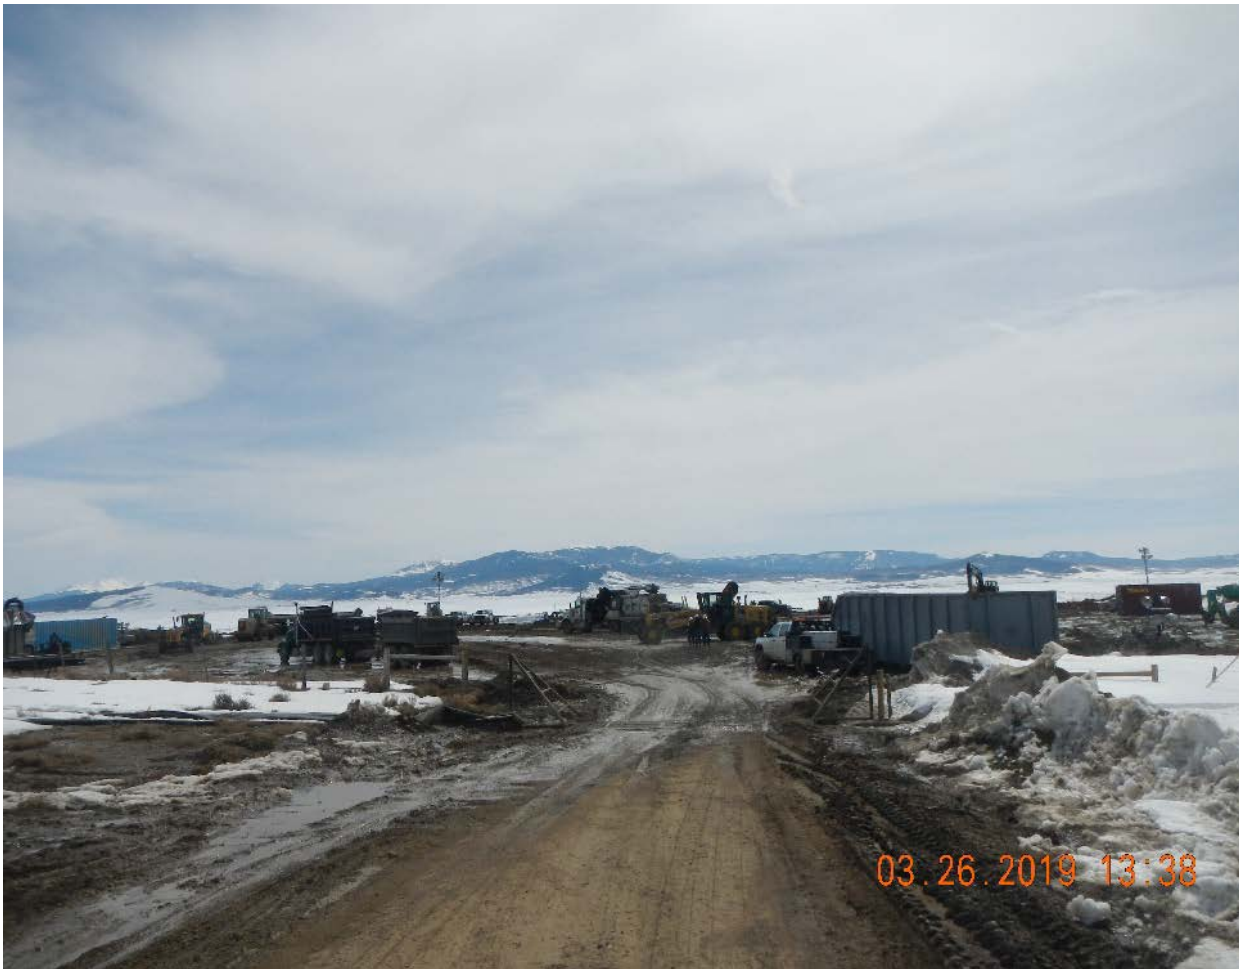
Photo 1- Overview of location

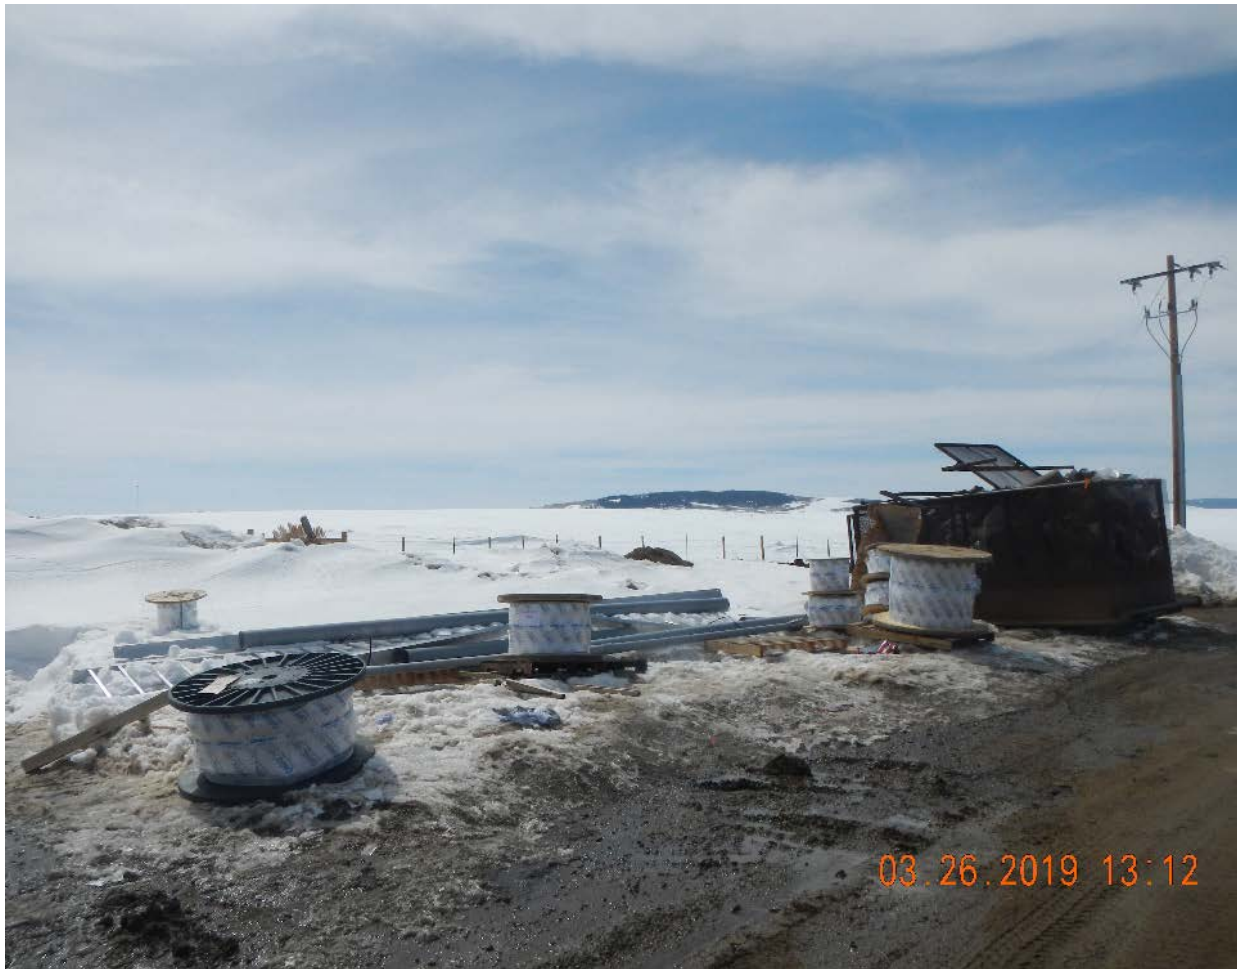
Photo 2- Trash Can

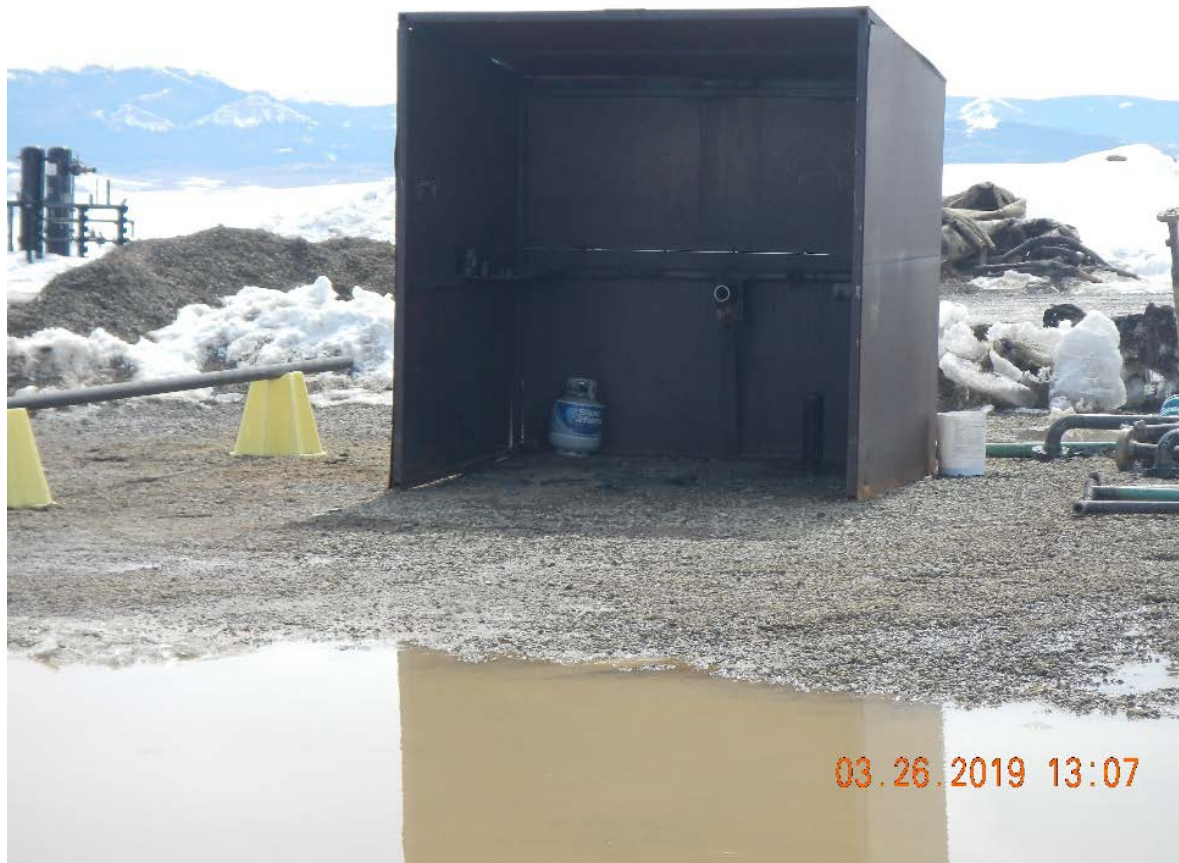
Photo 3-Welding shack, weed burner.

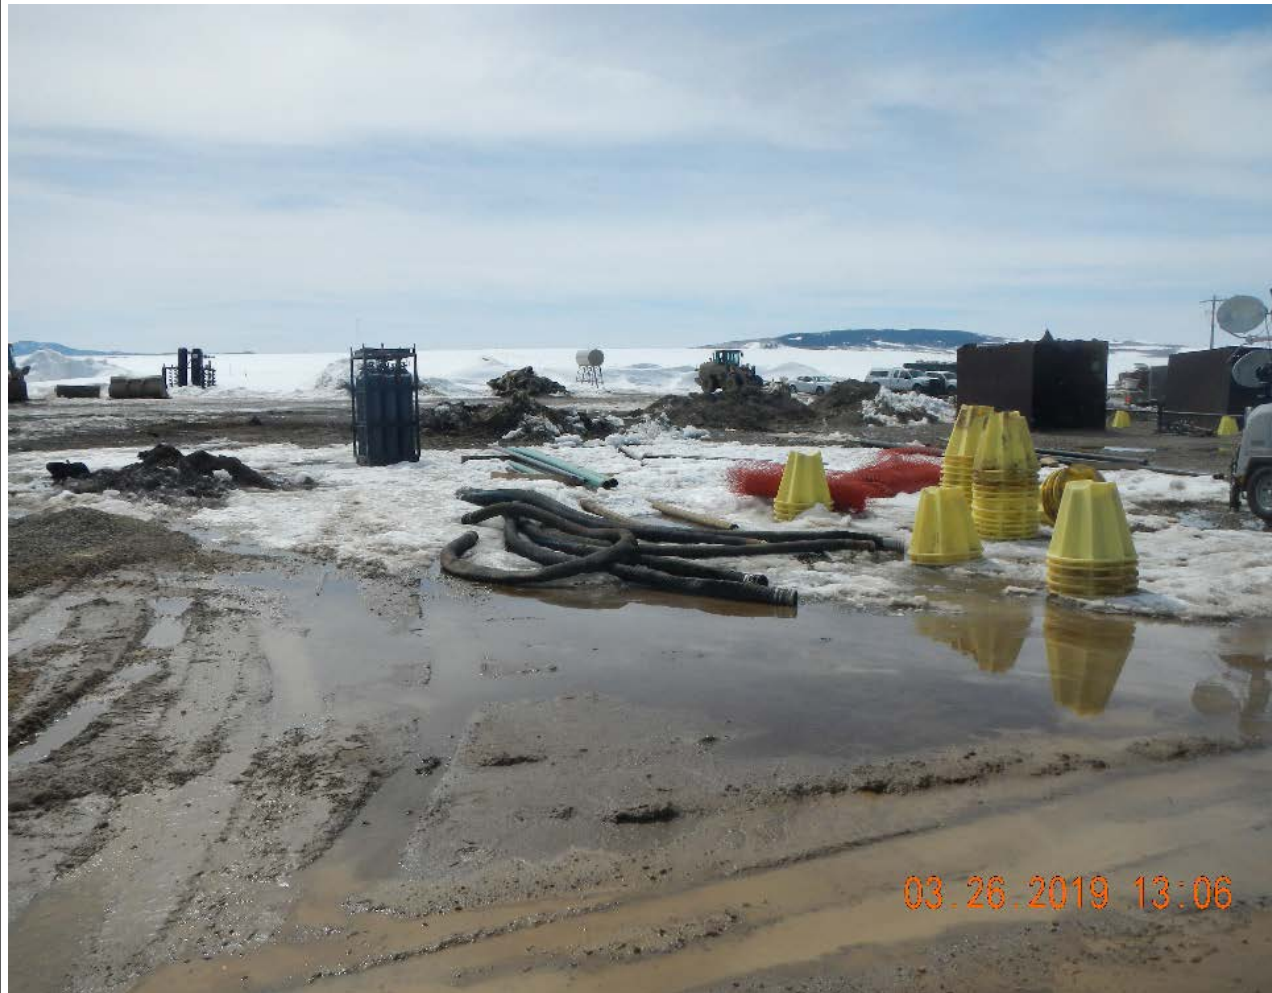
Photo 4- Hoses stored in stormwater.

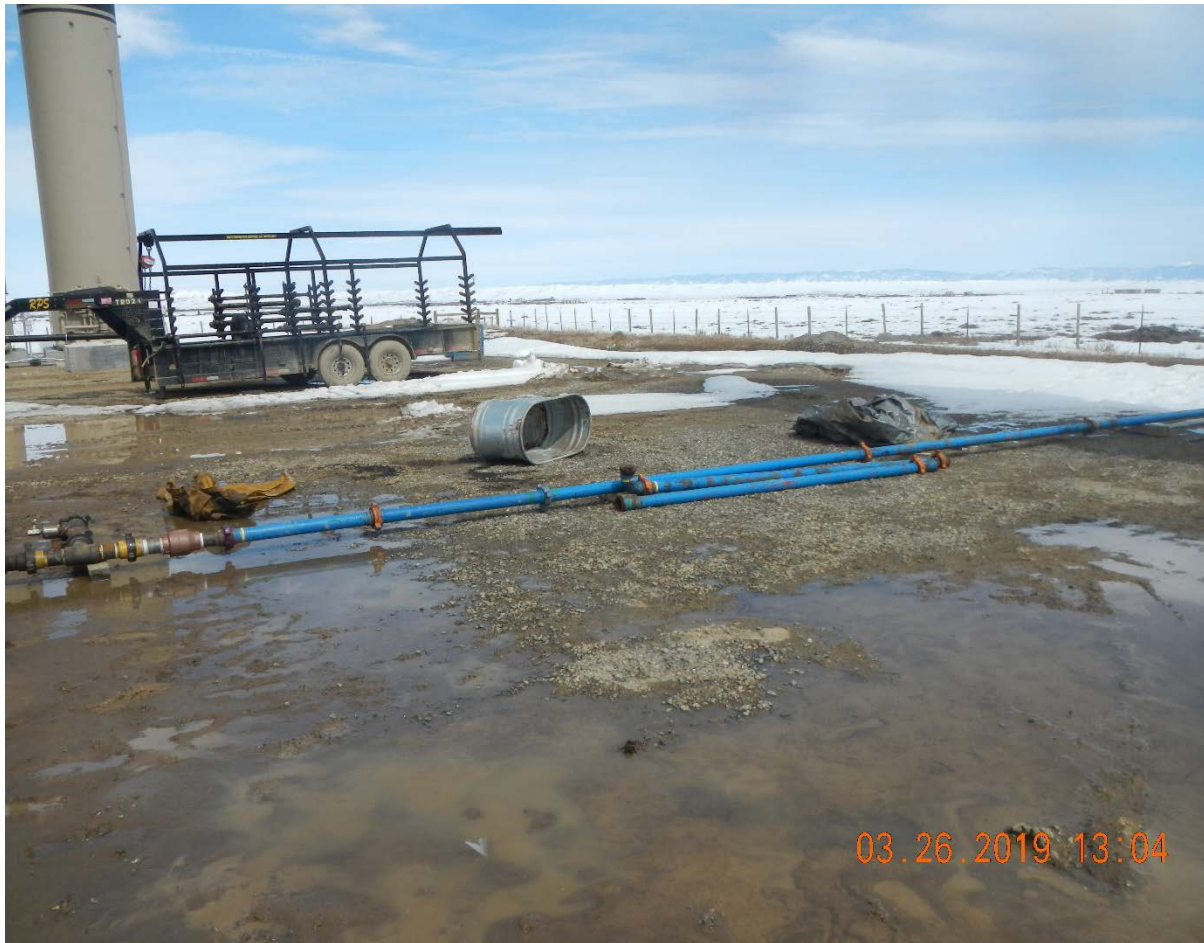
Photo 6-puddled stormwater, stock tank is in photo #7

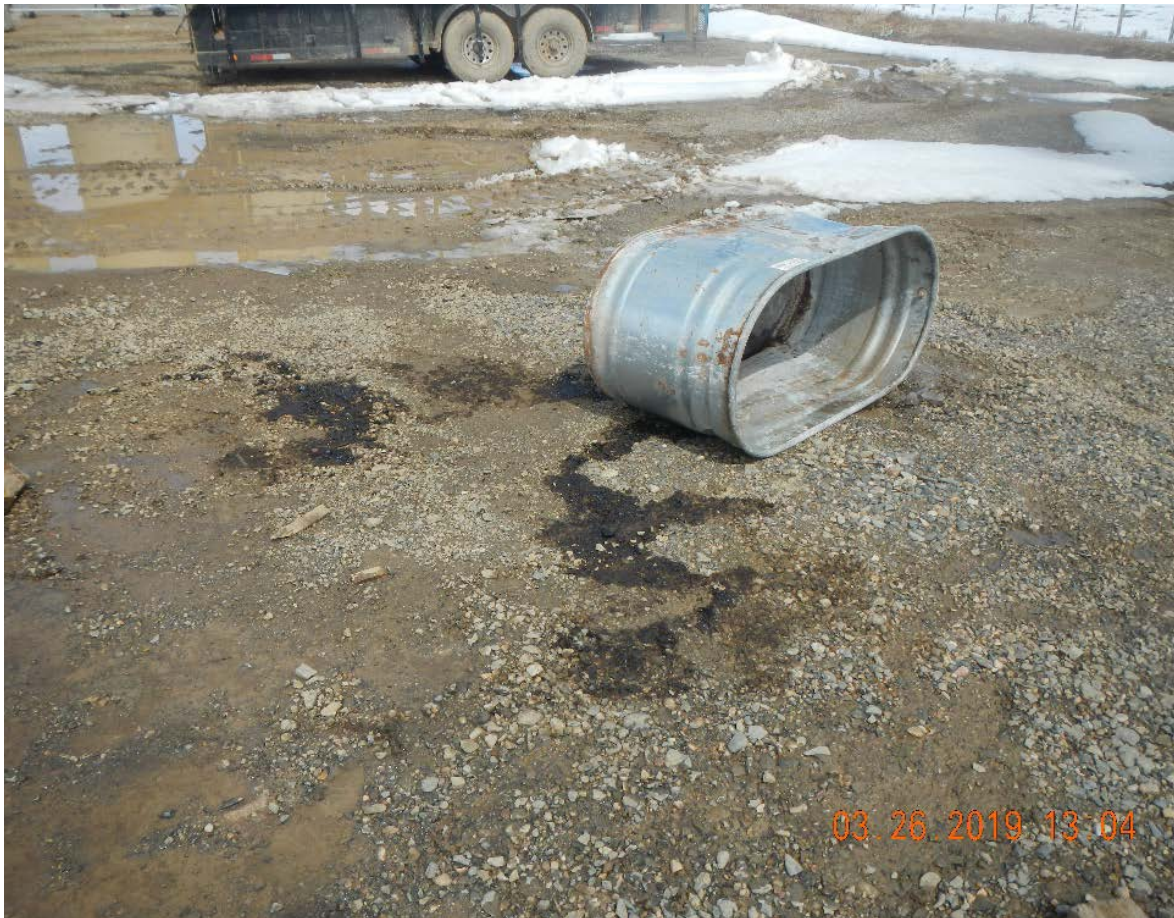
Photo 7- Overturned stock tank, stained soil. Spilled fluid and soil should be removed in 48 hrs (per COGCC Corrective Action matrix) and handled per COGCC rule 907. Note combustor in background. Photo is taken looking north, on the North east corner of pad.

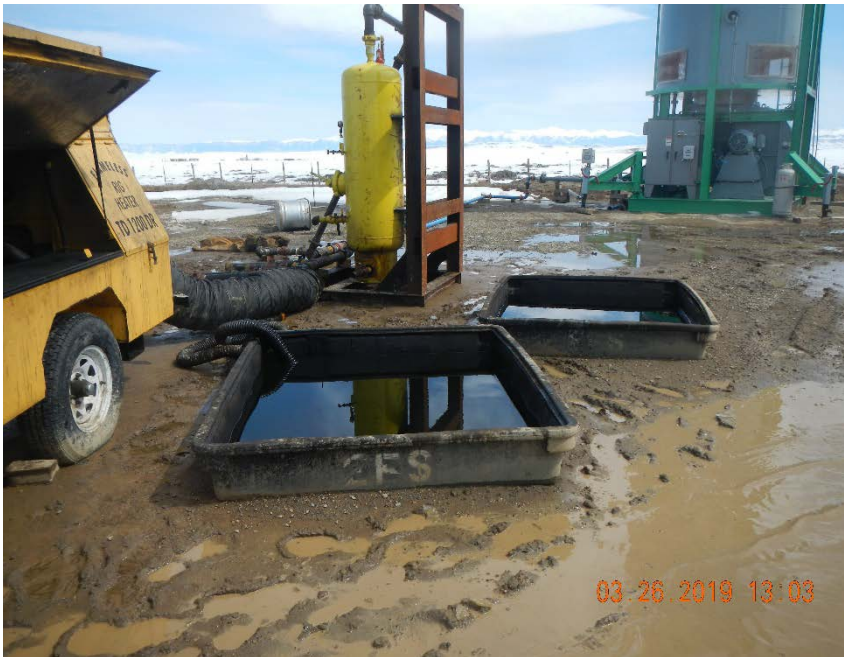
Photo 8- Fluid stored in flat tanks and stained soil. Fluid and soil should immediately be removed and handled per COGCC rule 907.

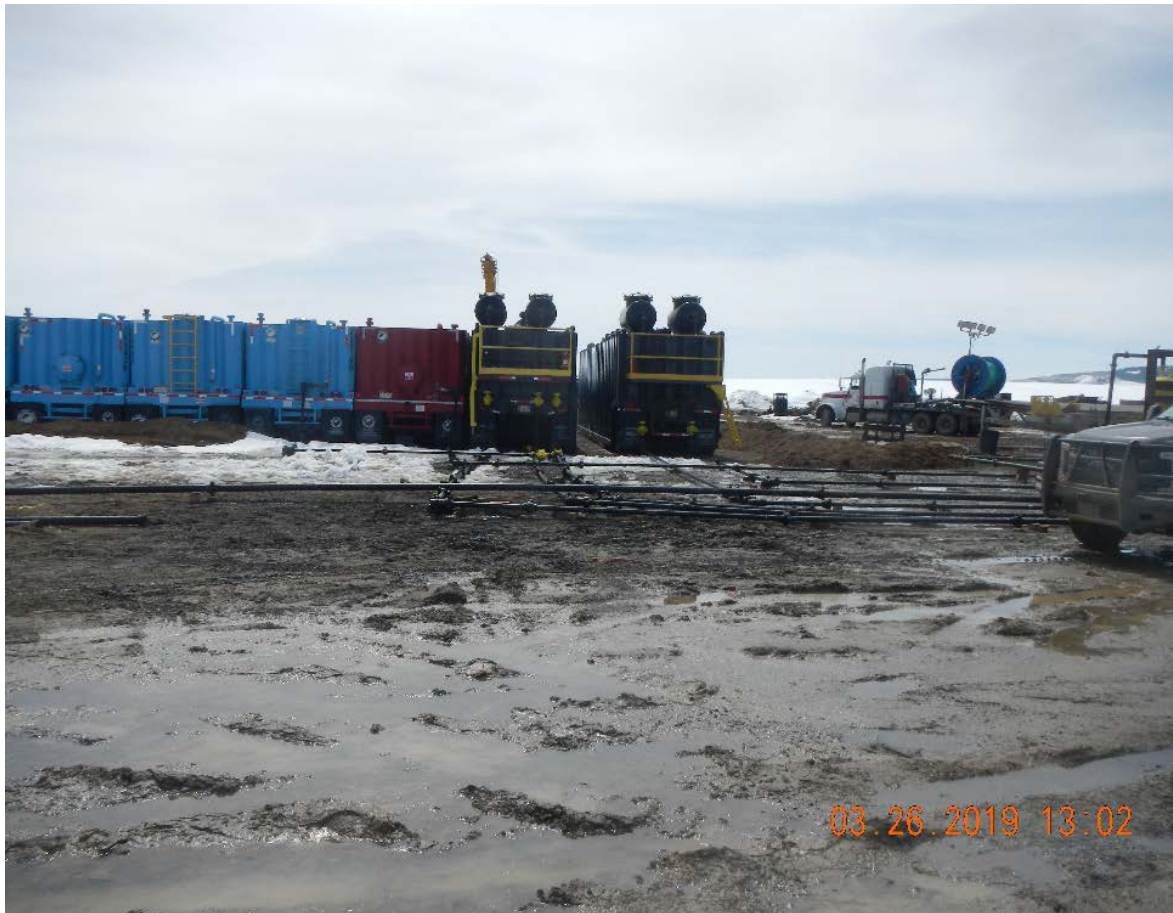
Photo 9- Frack tanks stored with incomplete secondary containment. COGCC rule 605.G should be complied with when tanks are in use

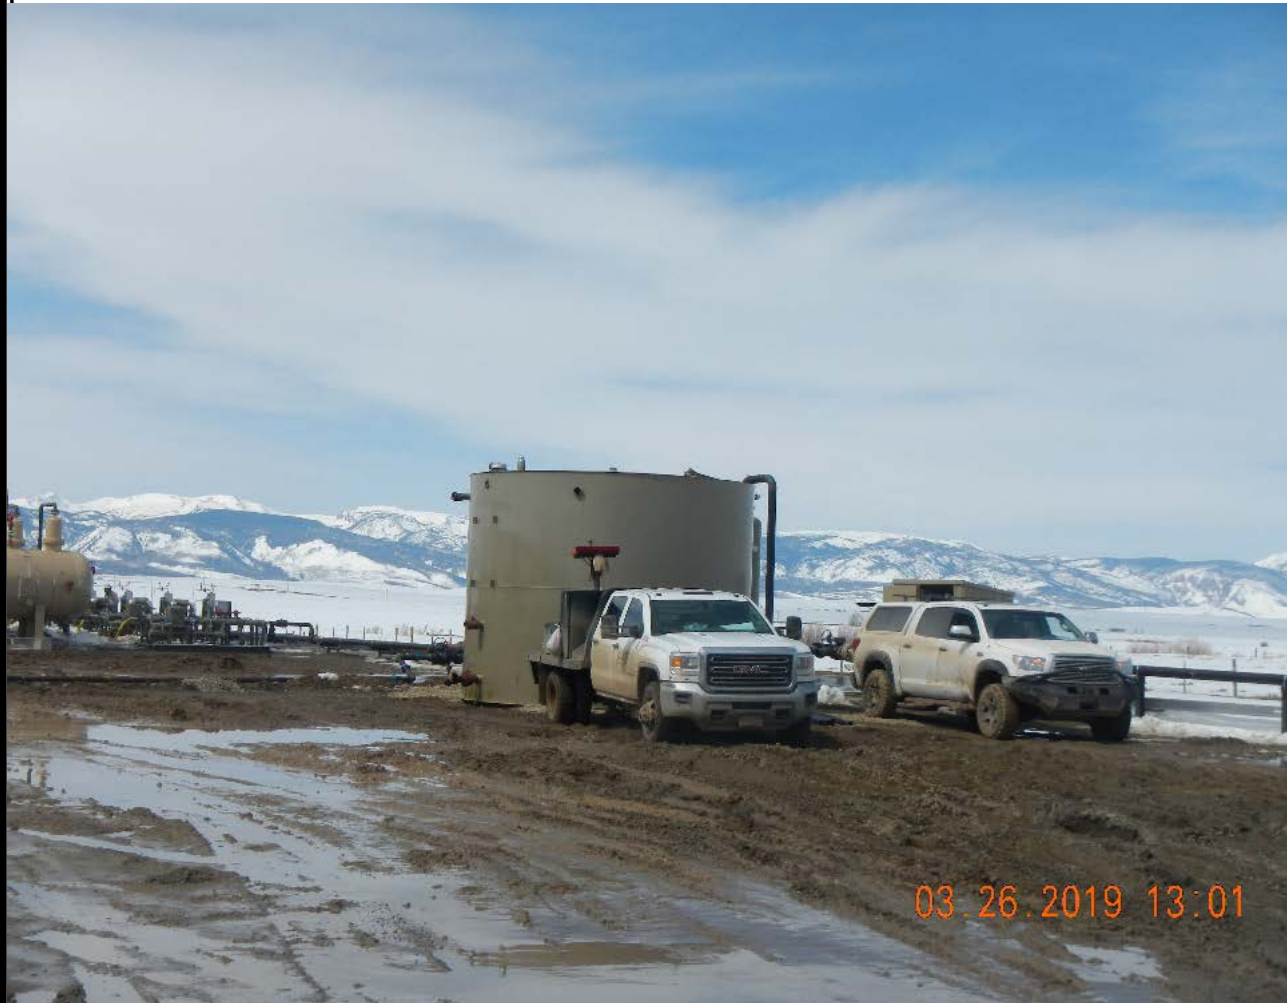
Photo 10- AGT being installed, see photo #11 for close up

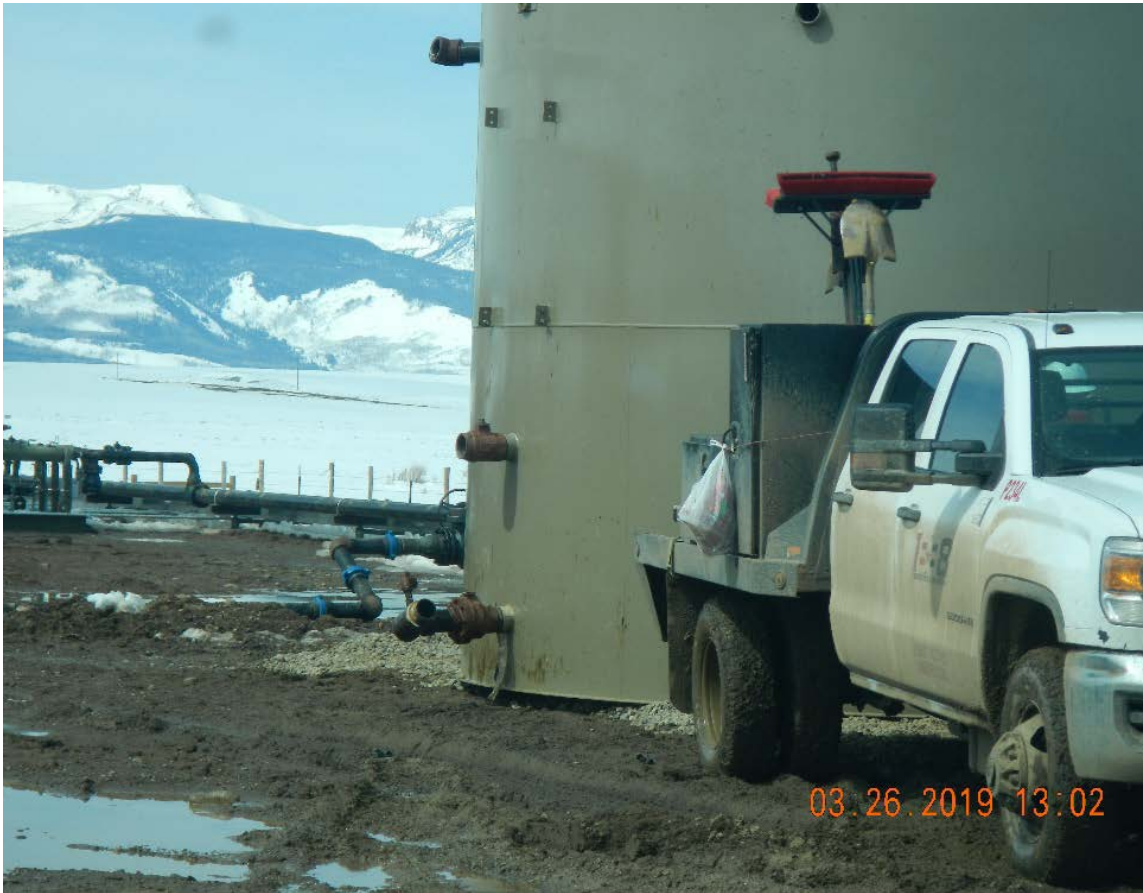
Photo 11- AGT being installed. Is COGCC rule 605.a(4) met with this install? Specifically, is there a synthetic or engineered liner placed directly beneath the tank?

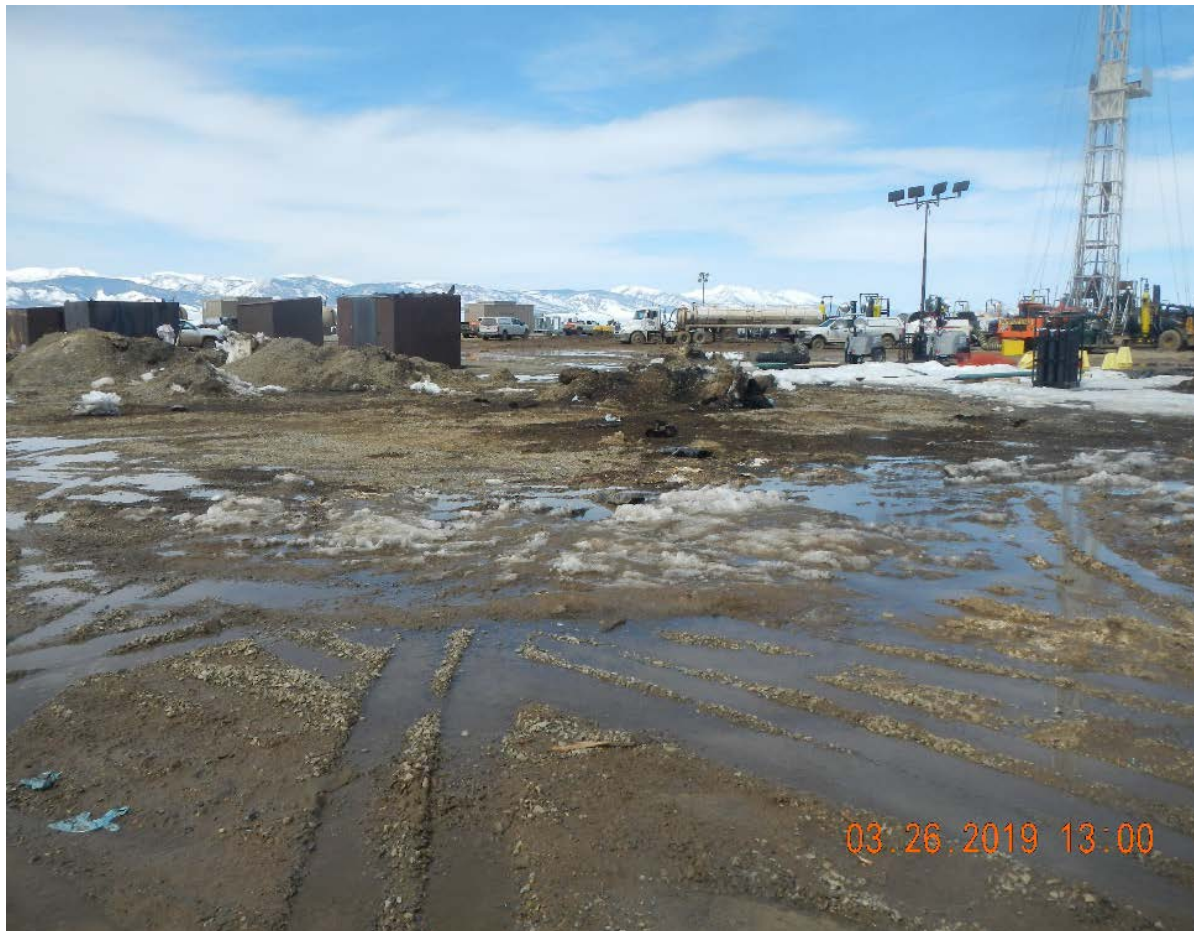
Photo 12- Overview of location taken at entrance facing east. Stained soil stockpiled were observed, soil should immediately be removed and handled per COGCC rule 907.

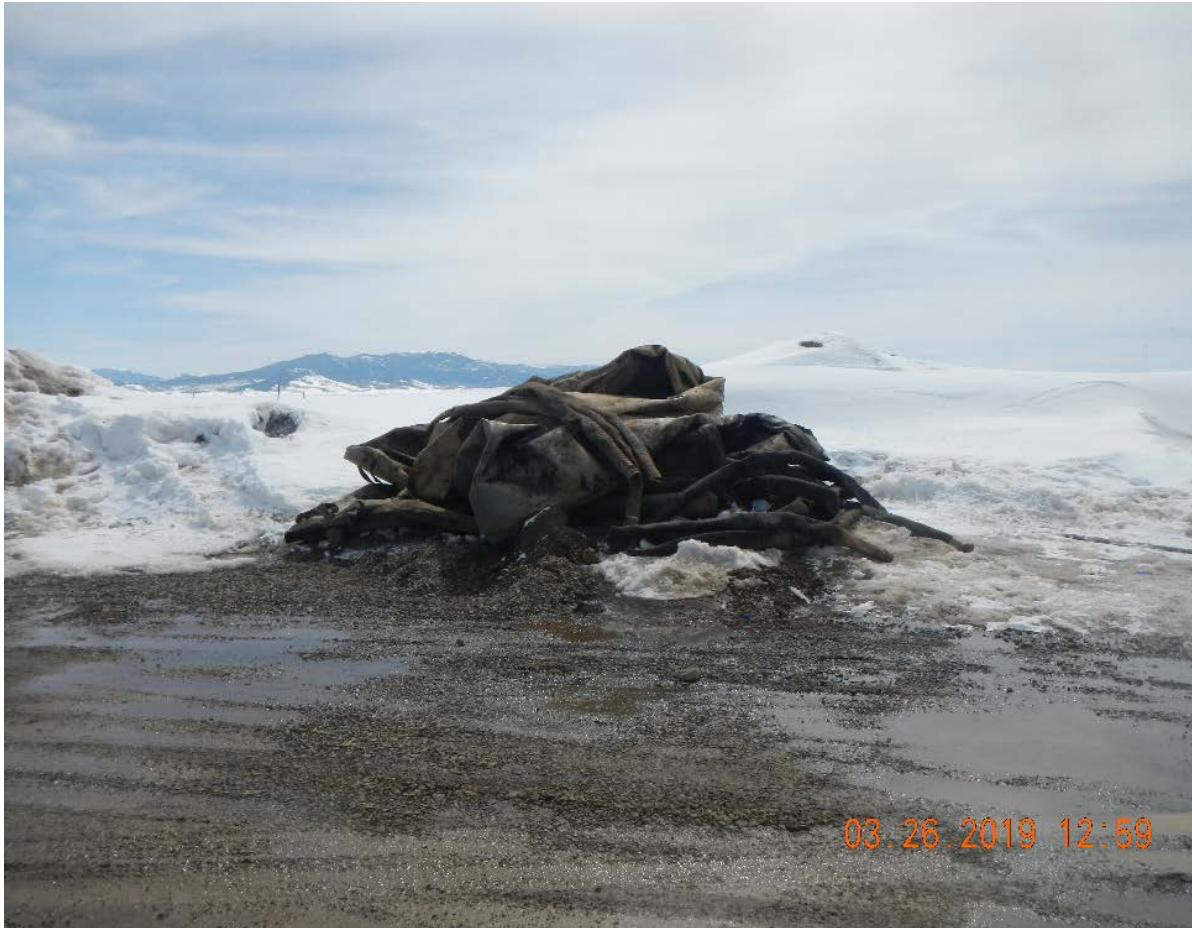
Photo 13- Stored liner material, liner should be removed in 48 hrs (per COGCC Corrective Action matrix) and handled per COGCC rule 907.A.
