**Inspection Photos**  
**Location Name: Leroy McCaw B #1**  
**API: 05-067-07009**

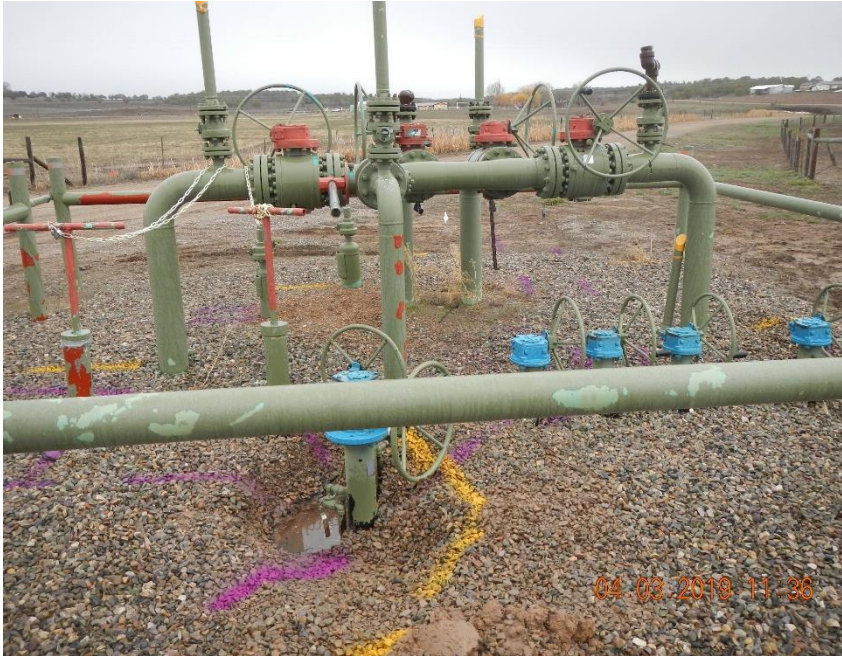
**Valve set where spill/release occurred.**

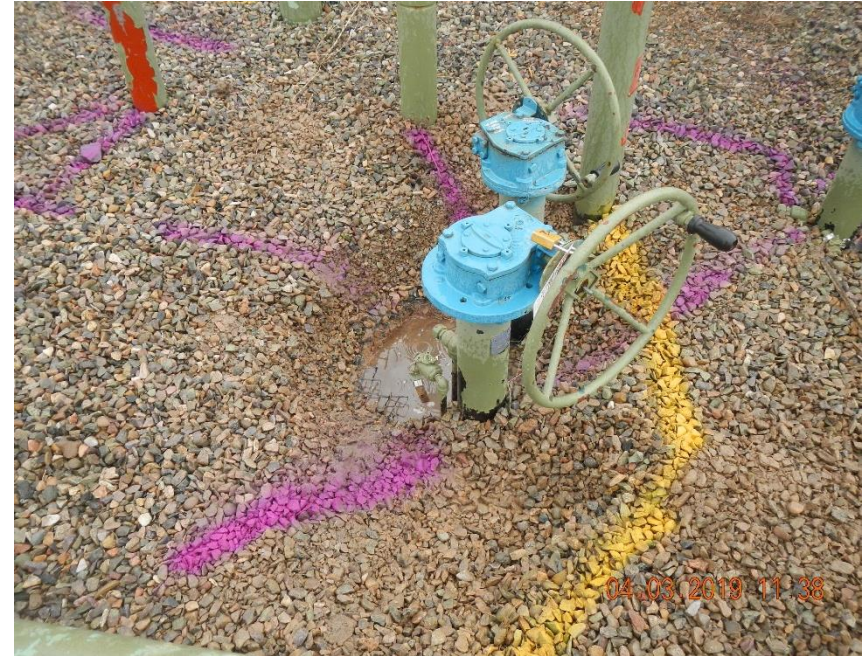
**Valve locked out.**

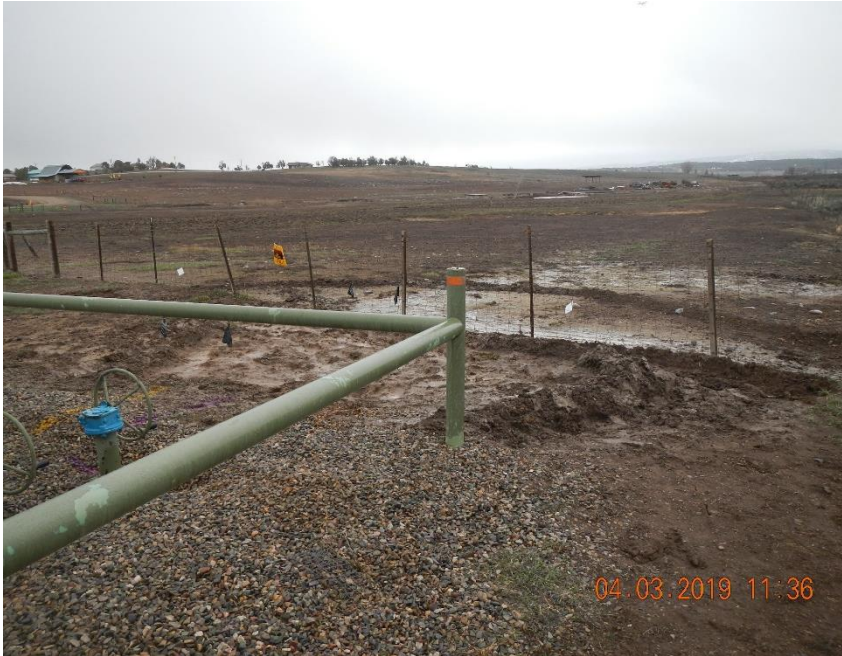
**Dirt berms constructed in an attempt to contain fluids.**

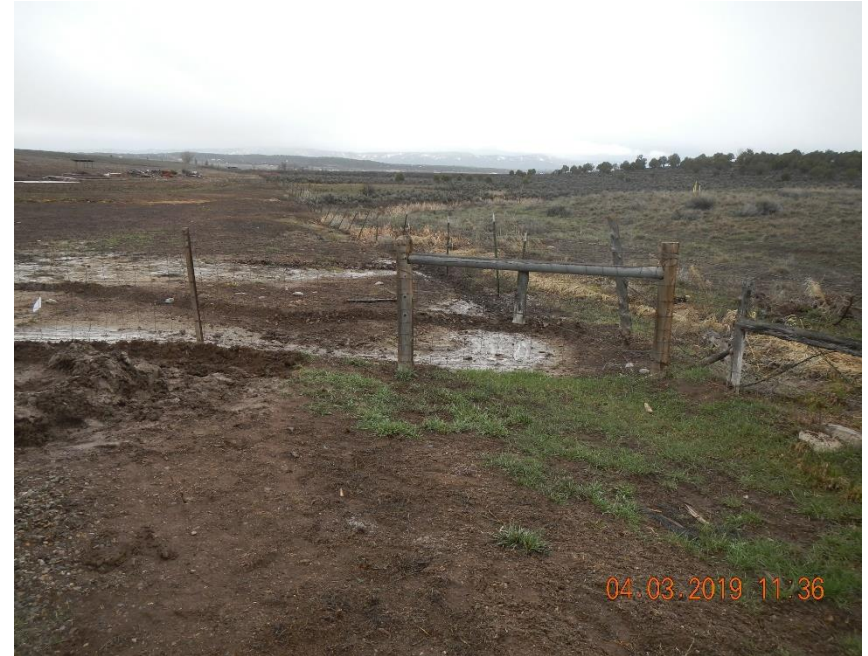
**Flow path towards irrigation ditch and ultimately freshwater emergent wetland.**

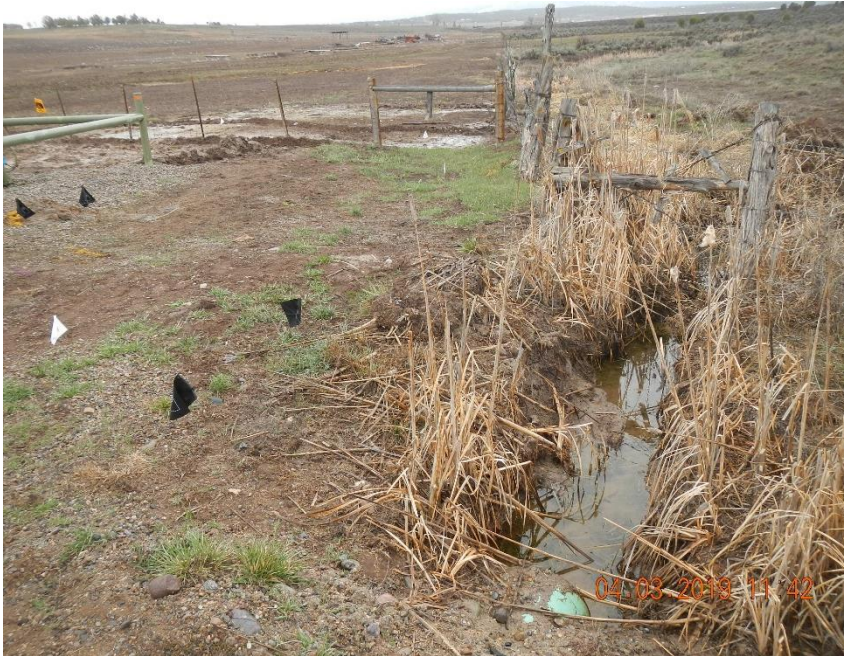
**Ditch approximately 35' to the west of the valve set.**

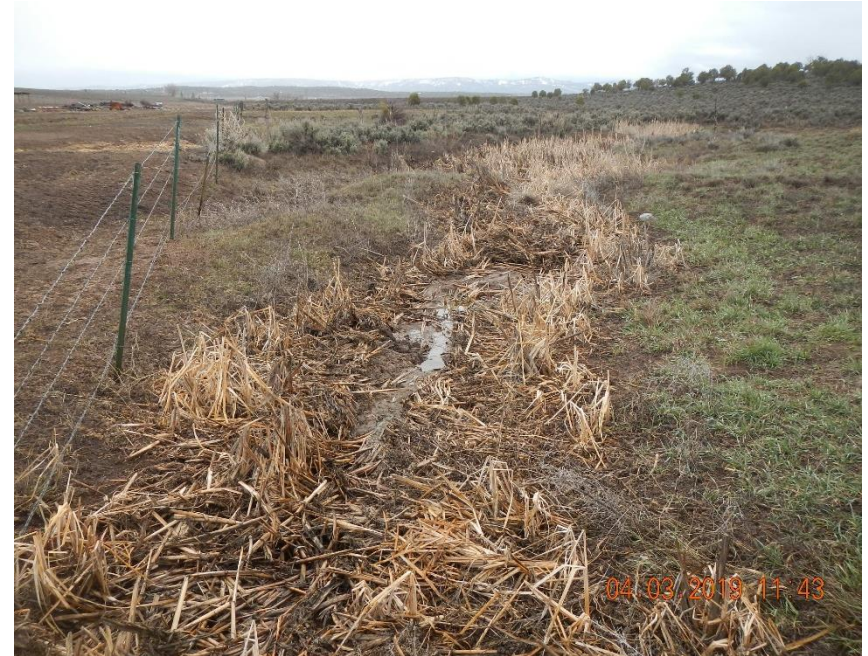
**Water course that release reportedly followed.**

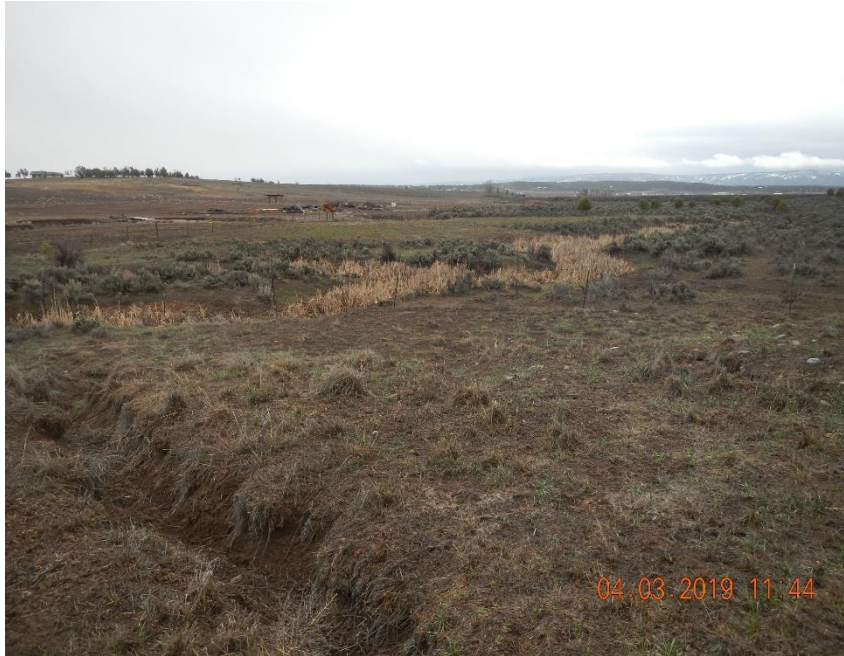
View of freshwater emergent wetland from southeastern corner of Leroy McCaw B #1 location.

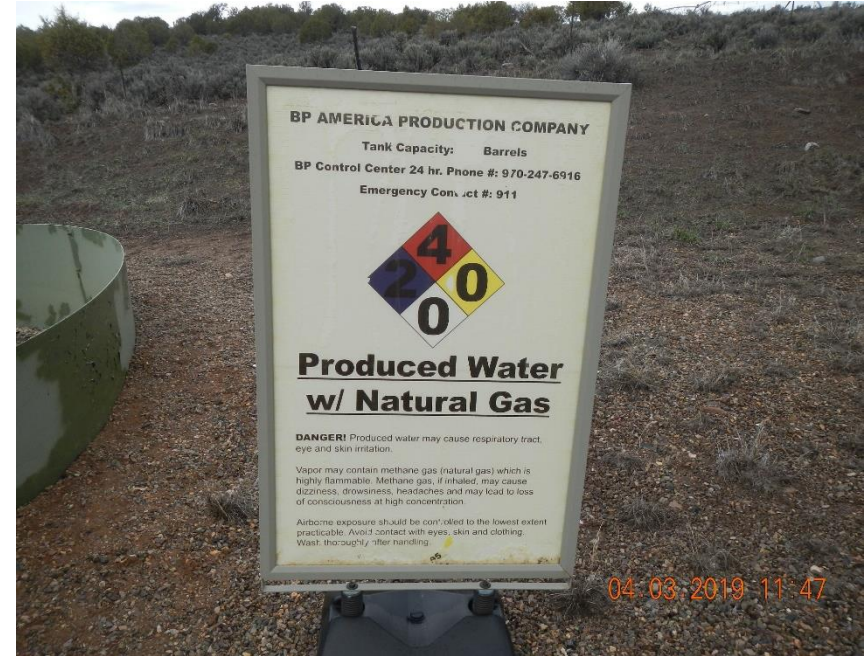
Capacity is not labeled on produced water sign.

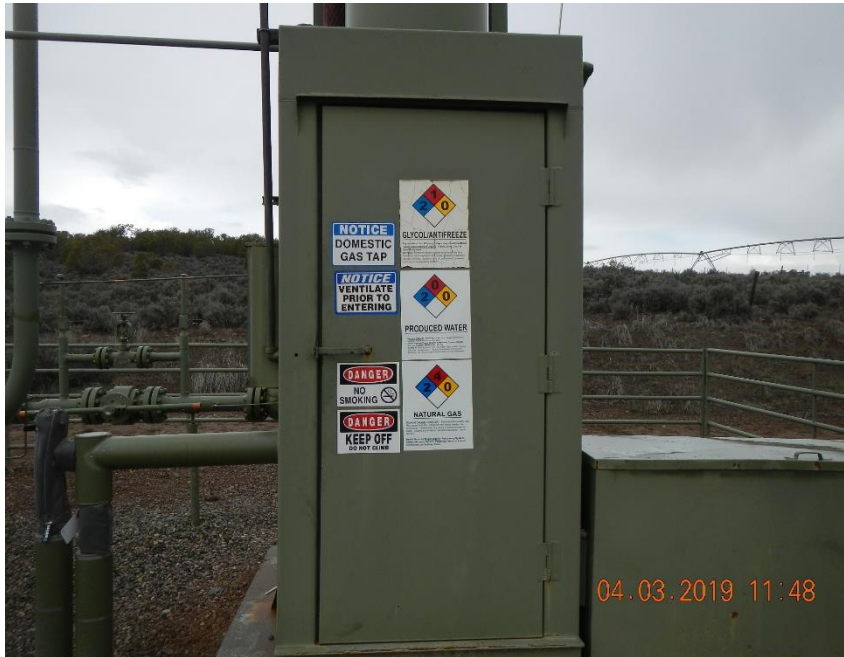
**Notice of domestic tap posted on vertical heated separator.**

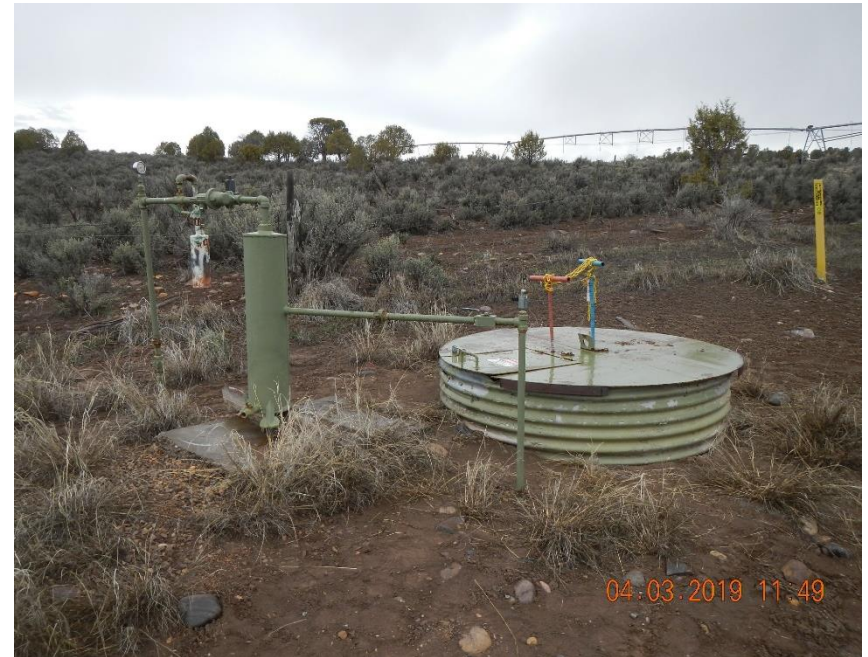
**Domestic tap and valve can on western edge of location.**

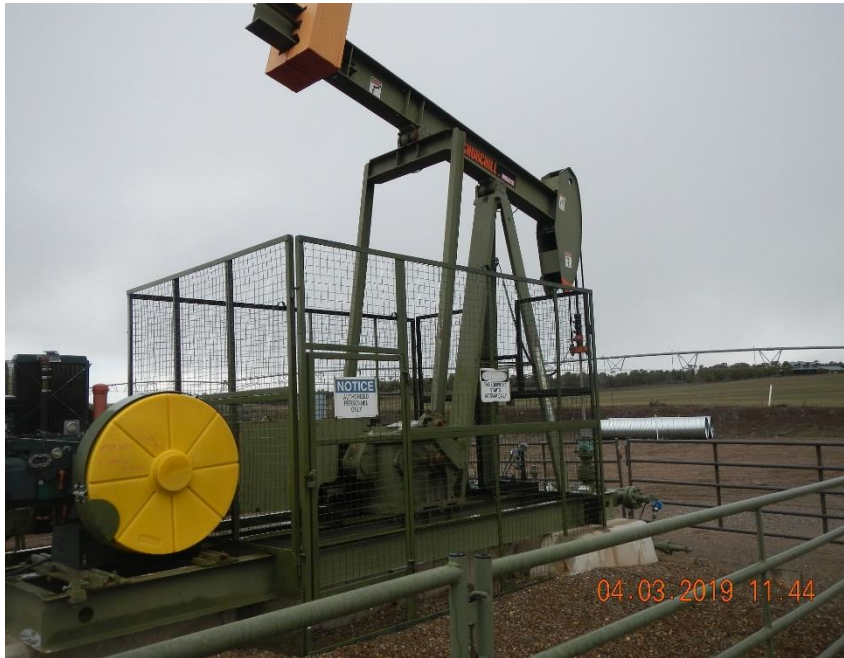
**Leroy McCaw B #1 pump jack.**

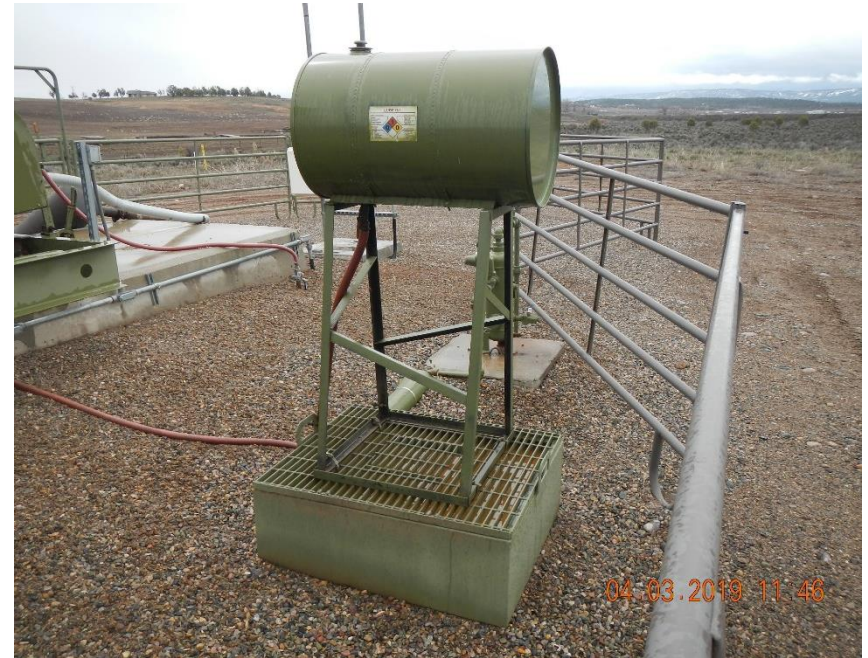
**Lube oil container on secondary containment.**
