**Inspection Photos**  
**Operator: Logos Operating**  
**Location/API #: 067-05781**  
**Date: 2-18-2019**

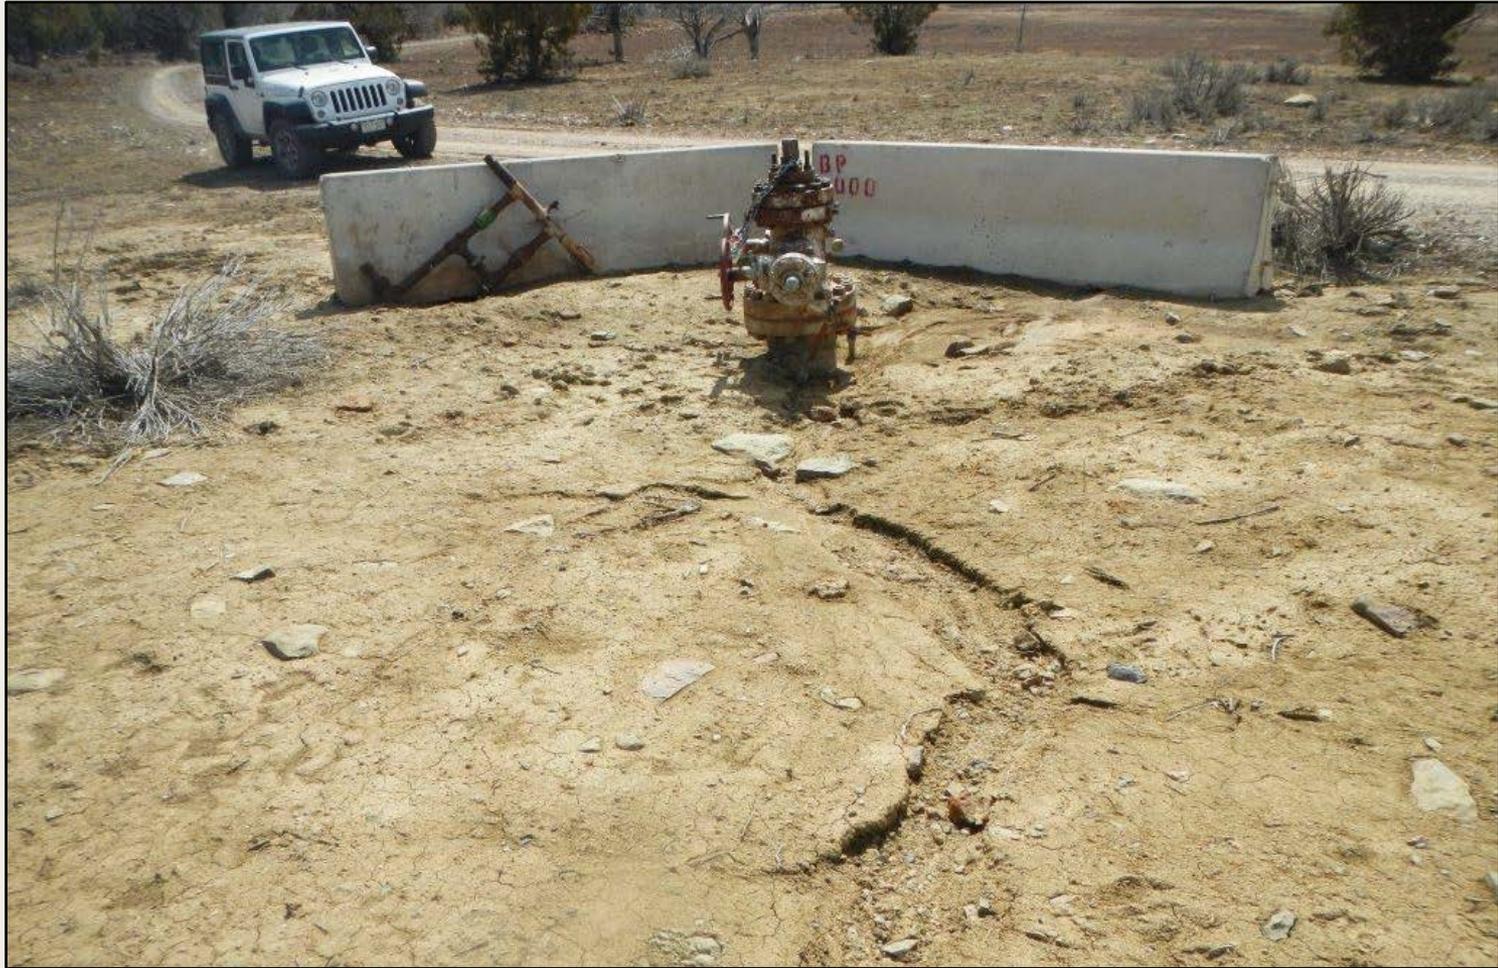
Photo 1. View of wellhead facing southward. Erosional channels is flowing around wellhead. Equipment placed next to jersey barrier does not appear to be functional and should be removed if not in use.

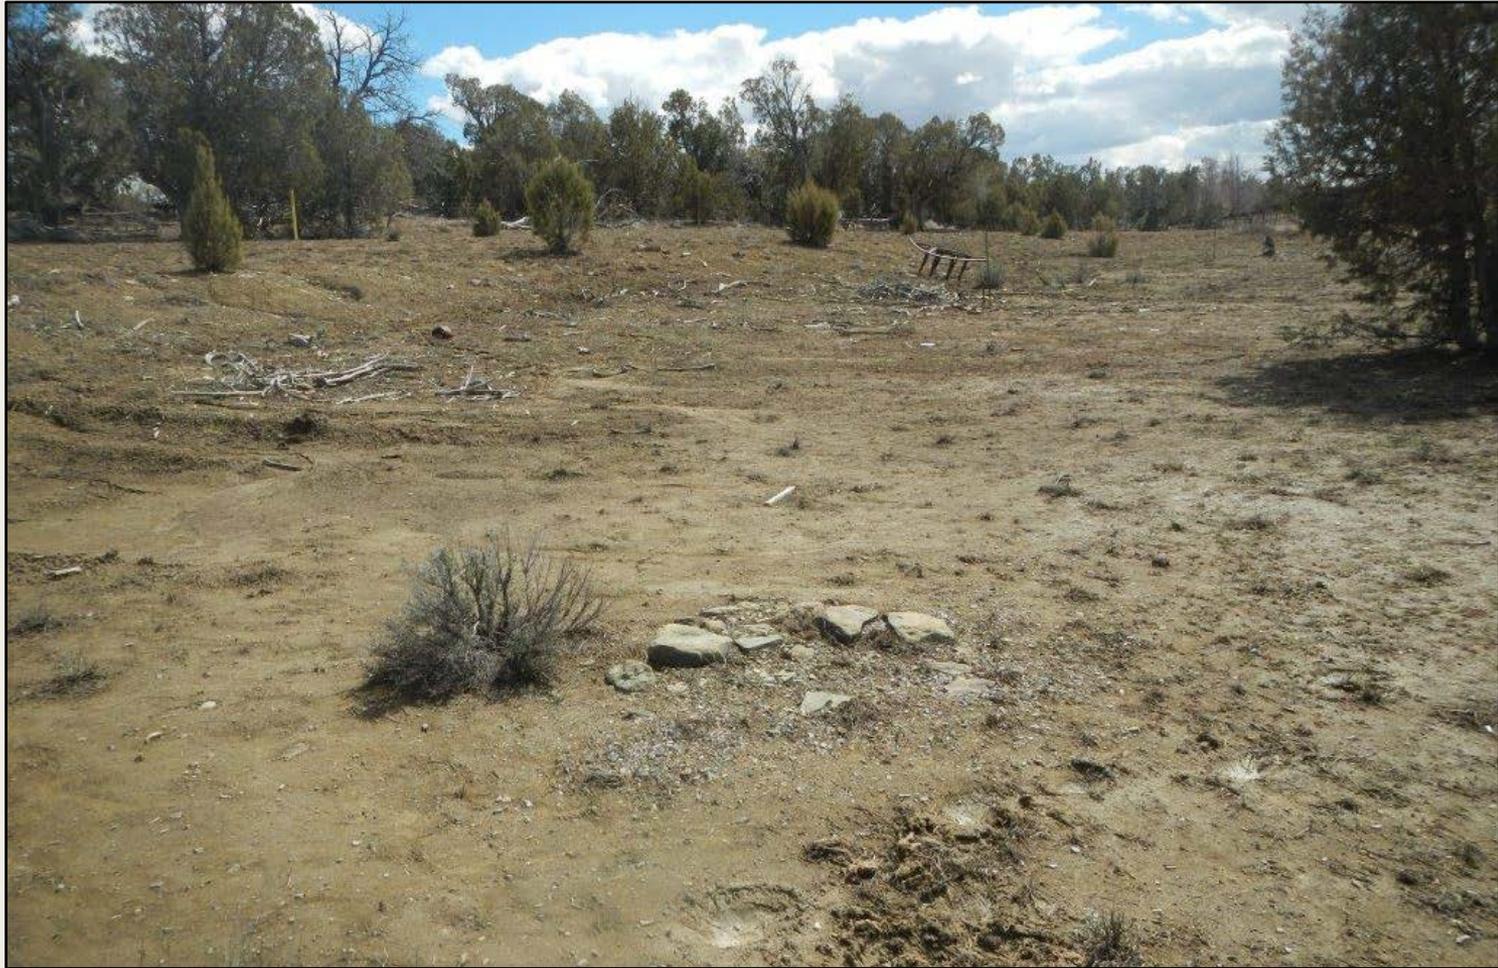
Photo 2. View of the eastern project area from the northern edge facing southward. Poor revegetation. Erosional run-on and sediment deposition observed, along with metal debris in background.

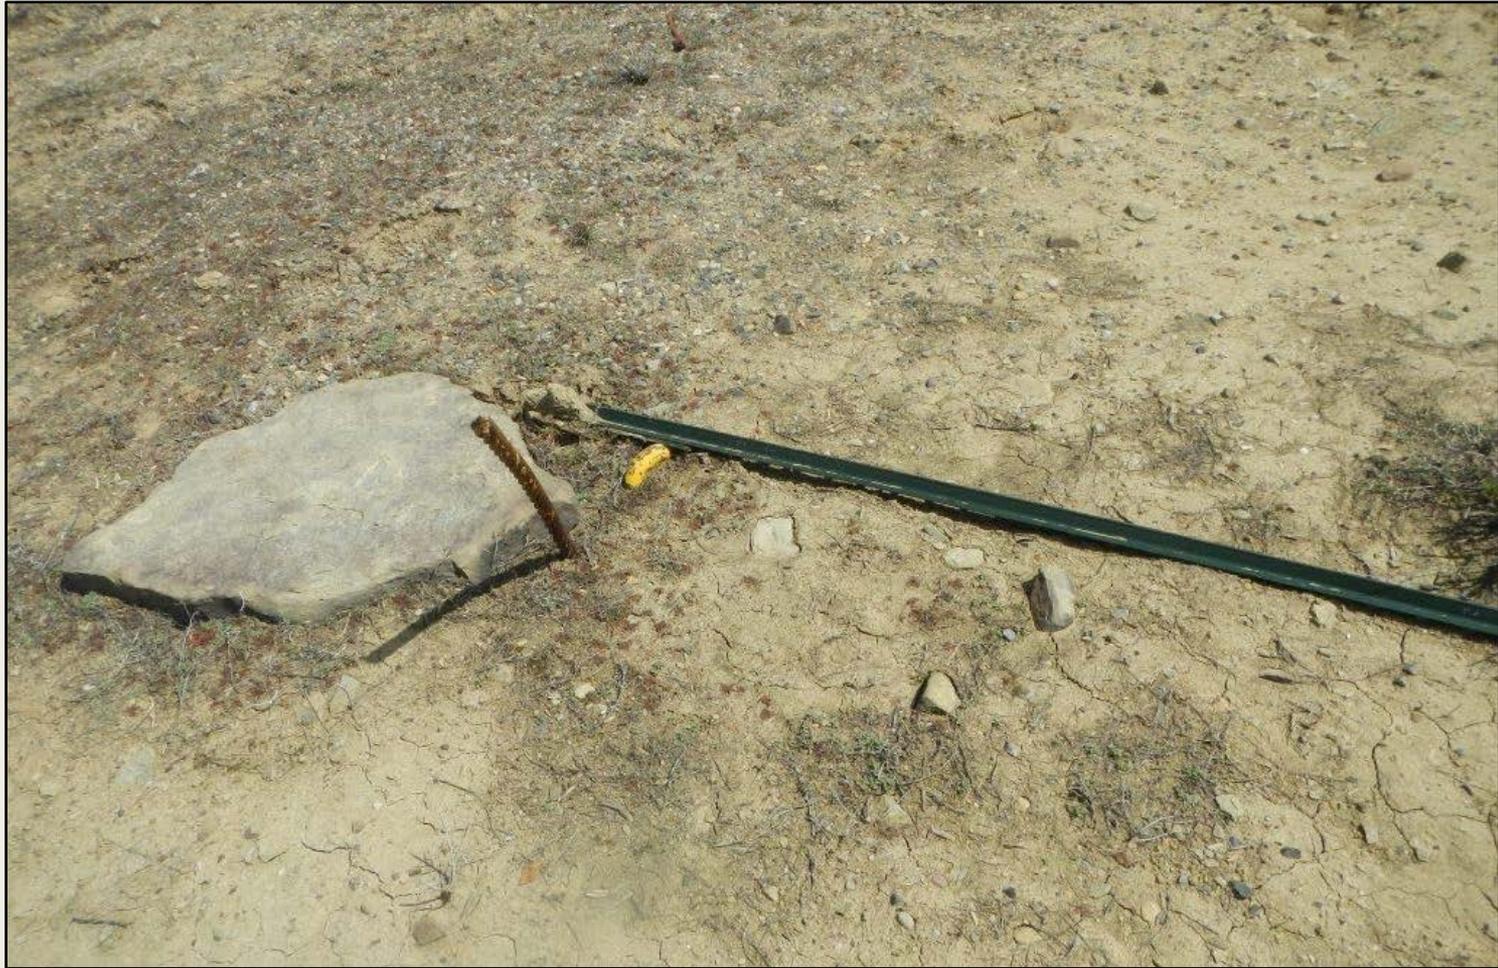
Photo 3. View of unmarked anchor marker within the project area.

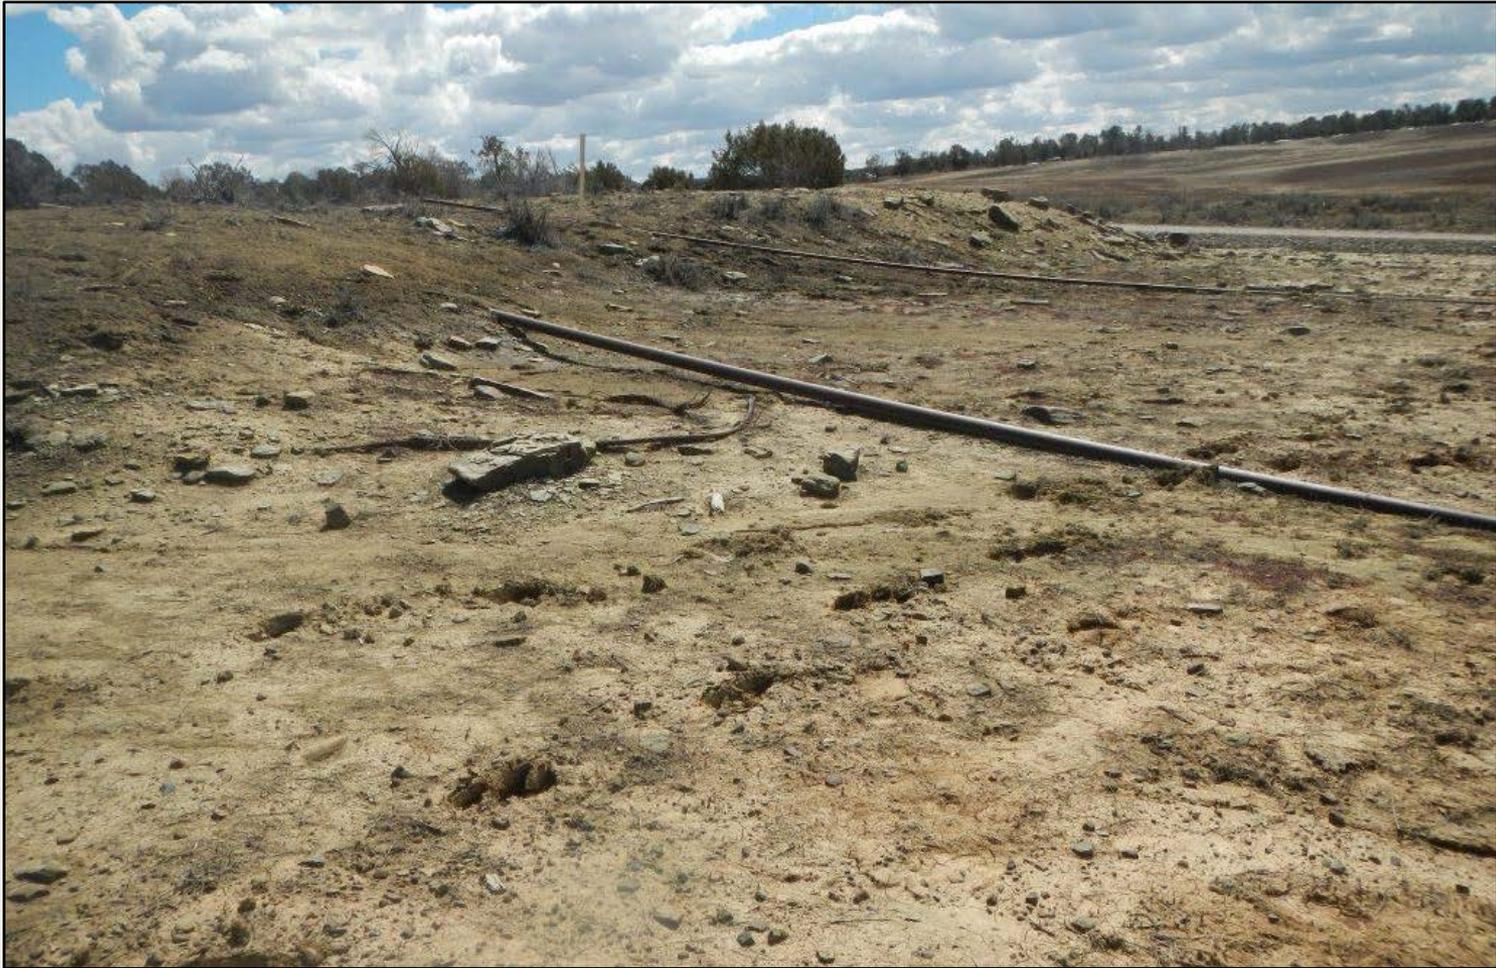
Photo 4. View of the western project area from the northwestern edge facing southward. Little desirable vegetation observed. Significant rilling from well pad fill slopes is occurring. Surface flow lines are not connected and decaying. These need to be removed.

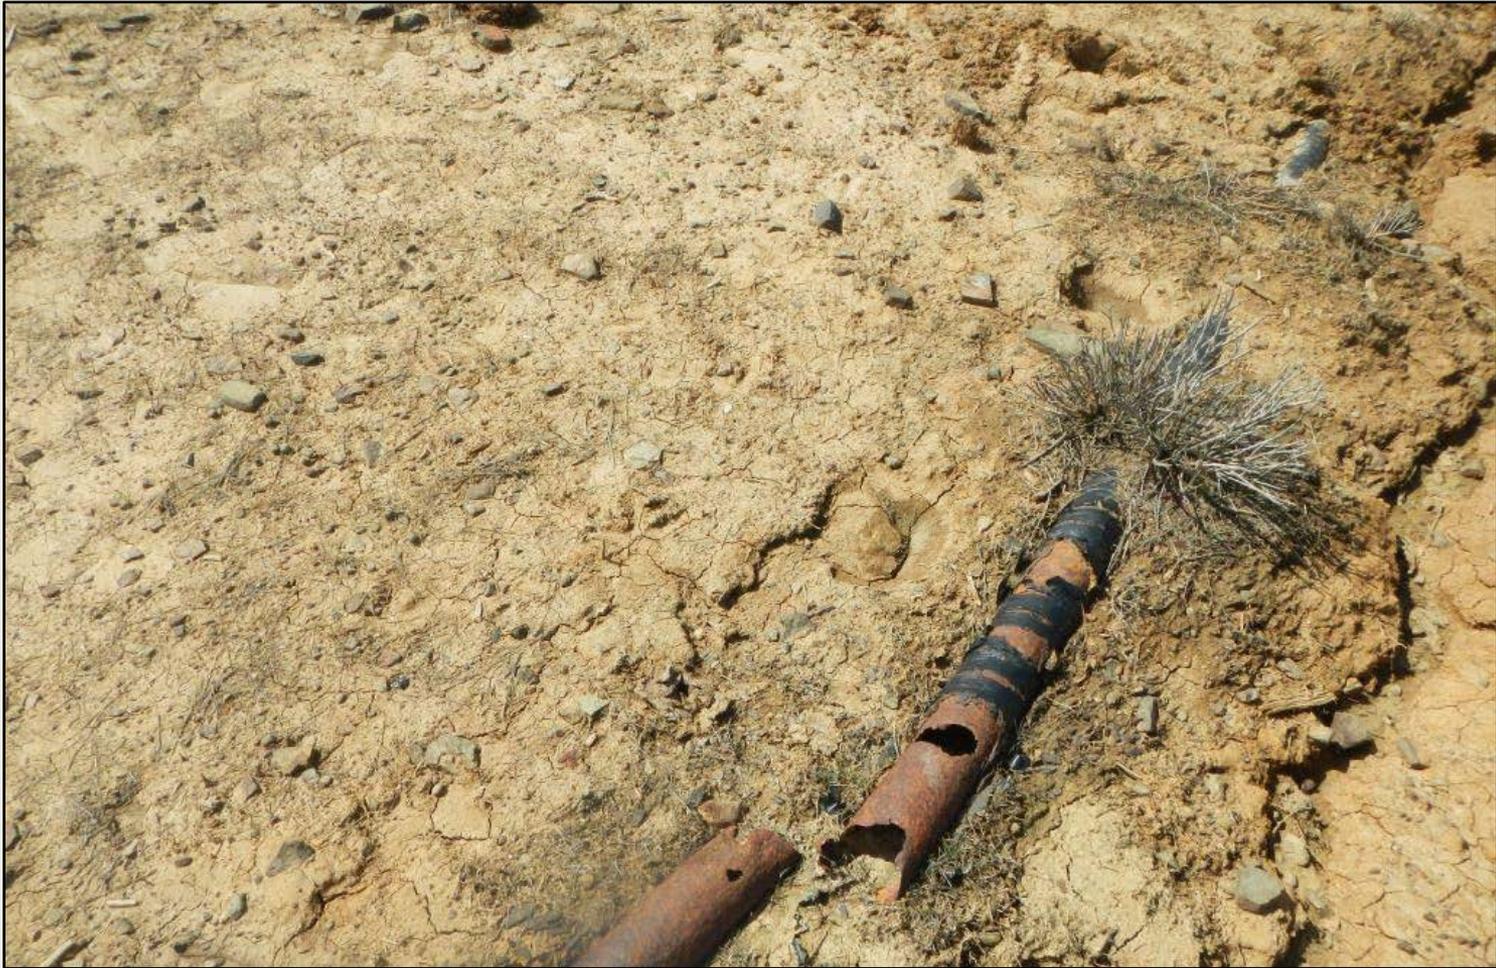
Photo 5. View of Corroded line that is no longer functioning.

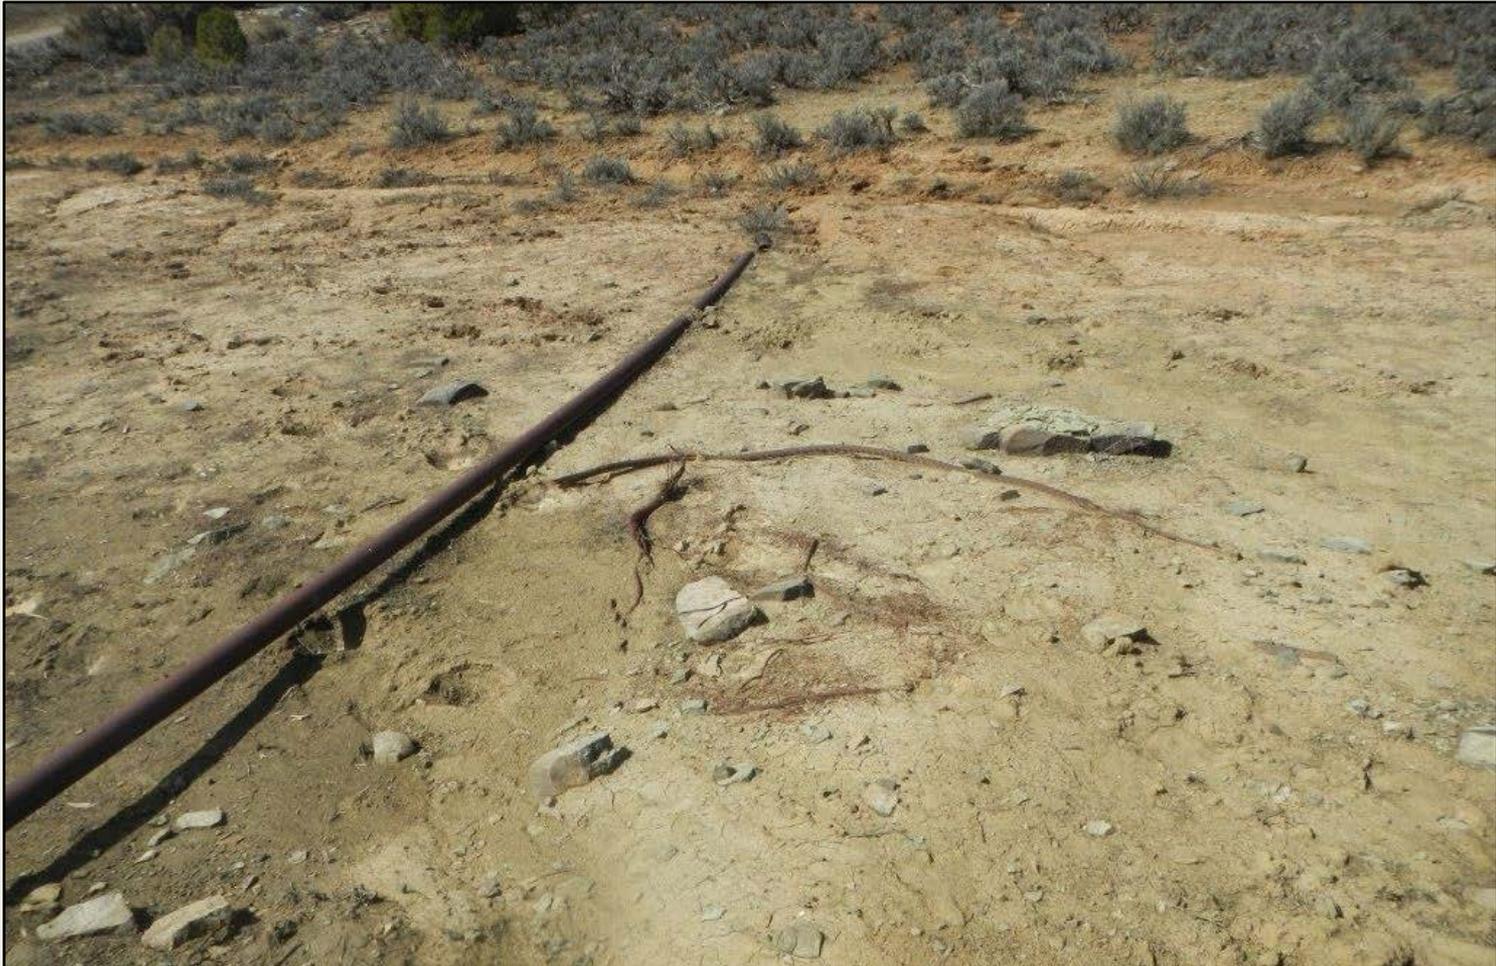
Photo 6. View of cable debris and sediment deposition within the western project area.

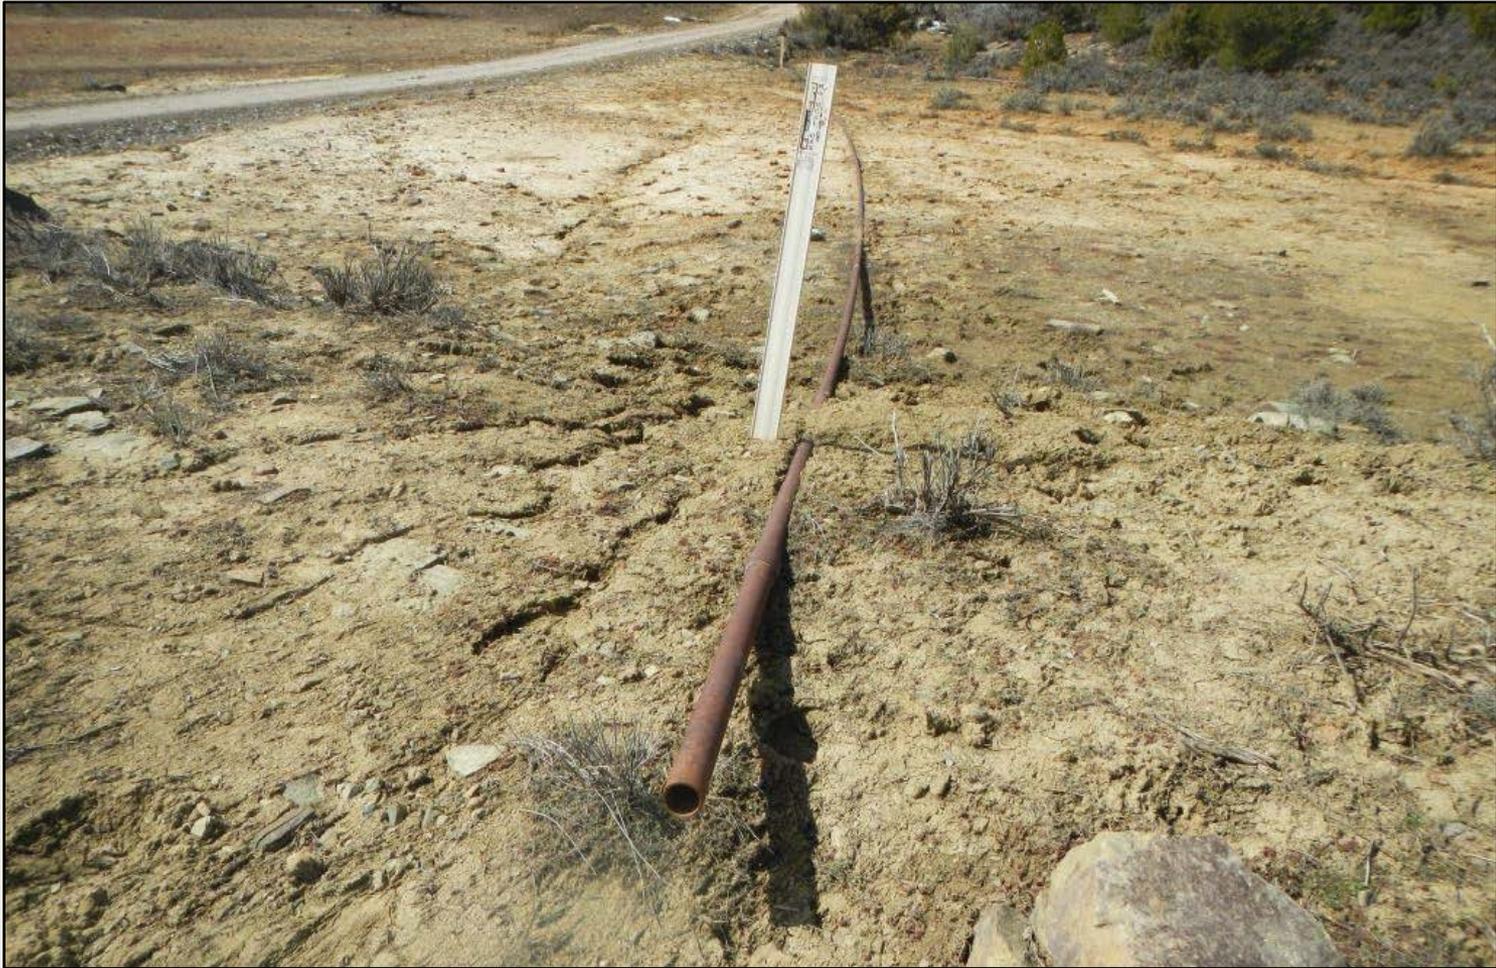
Photo 7. View of disconnected line that needs to be removed.

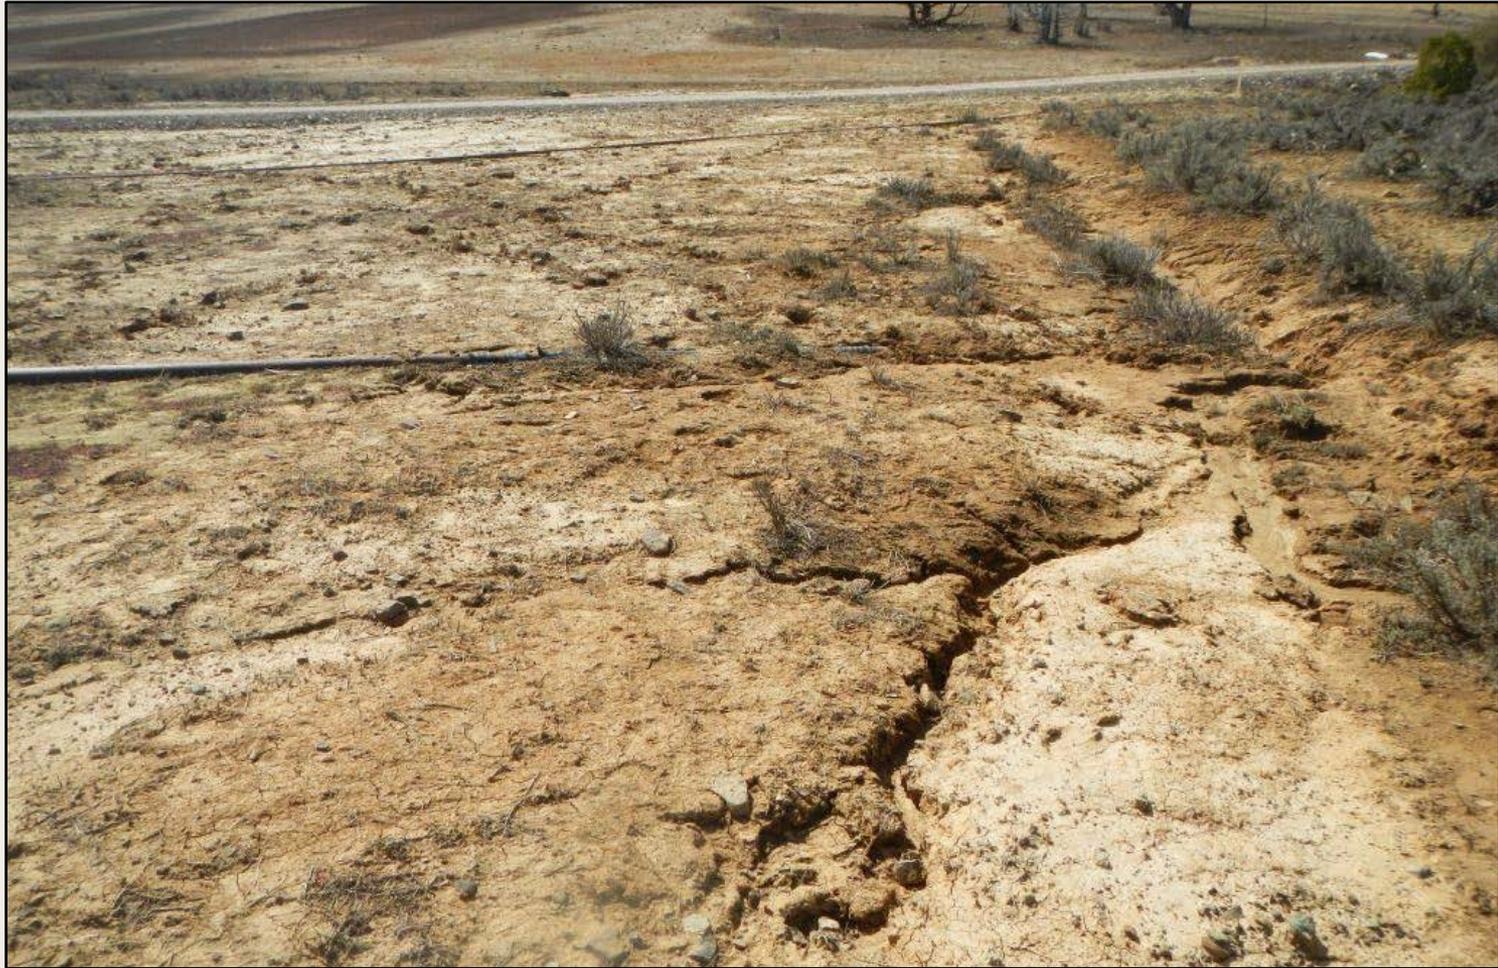
Photo 8. View of erosional along the western boundary of the project area.

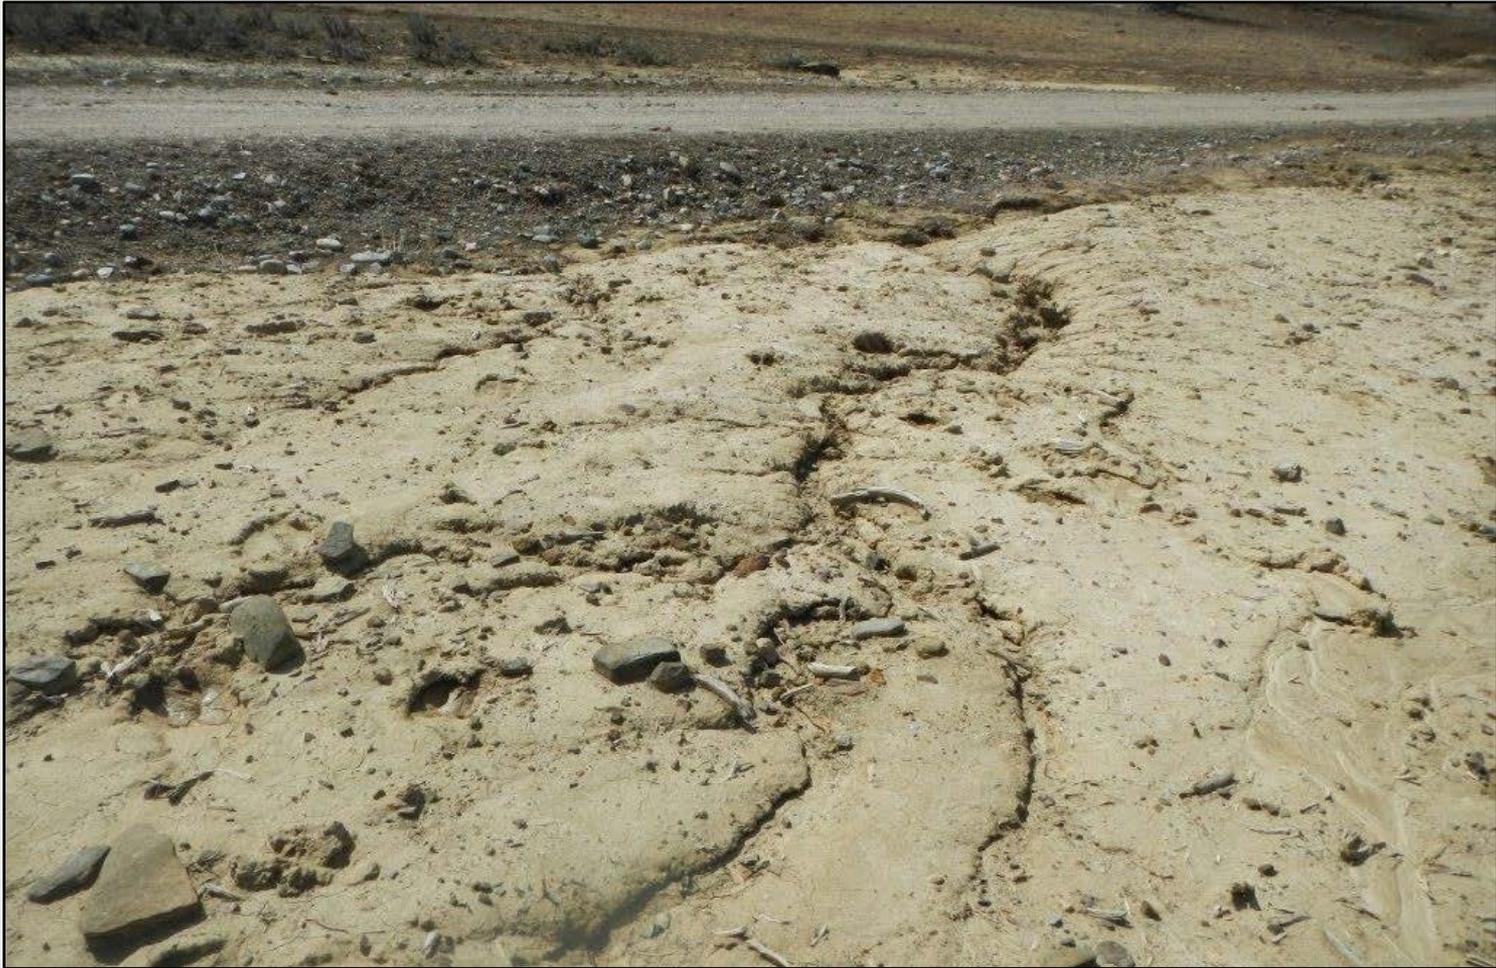
Photo 9. View of erosional channels forming within the southwestern project area.

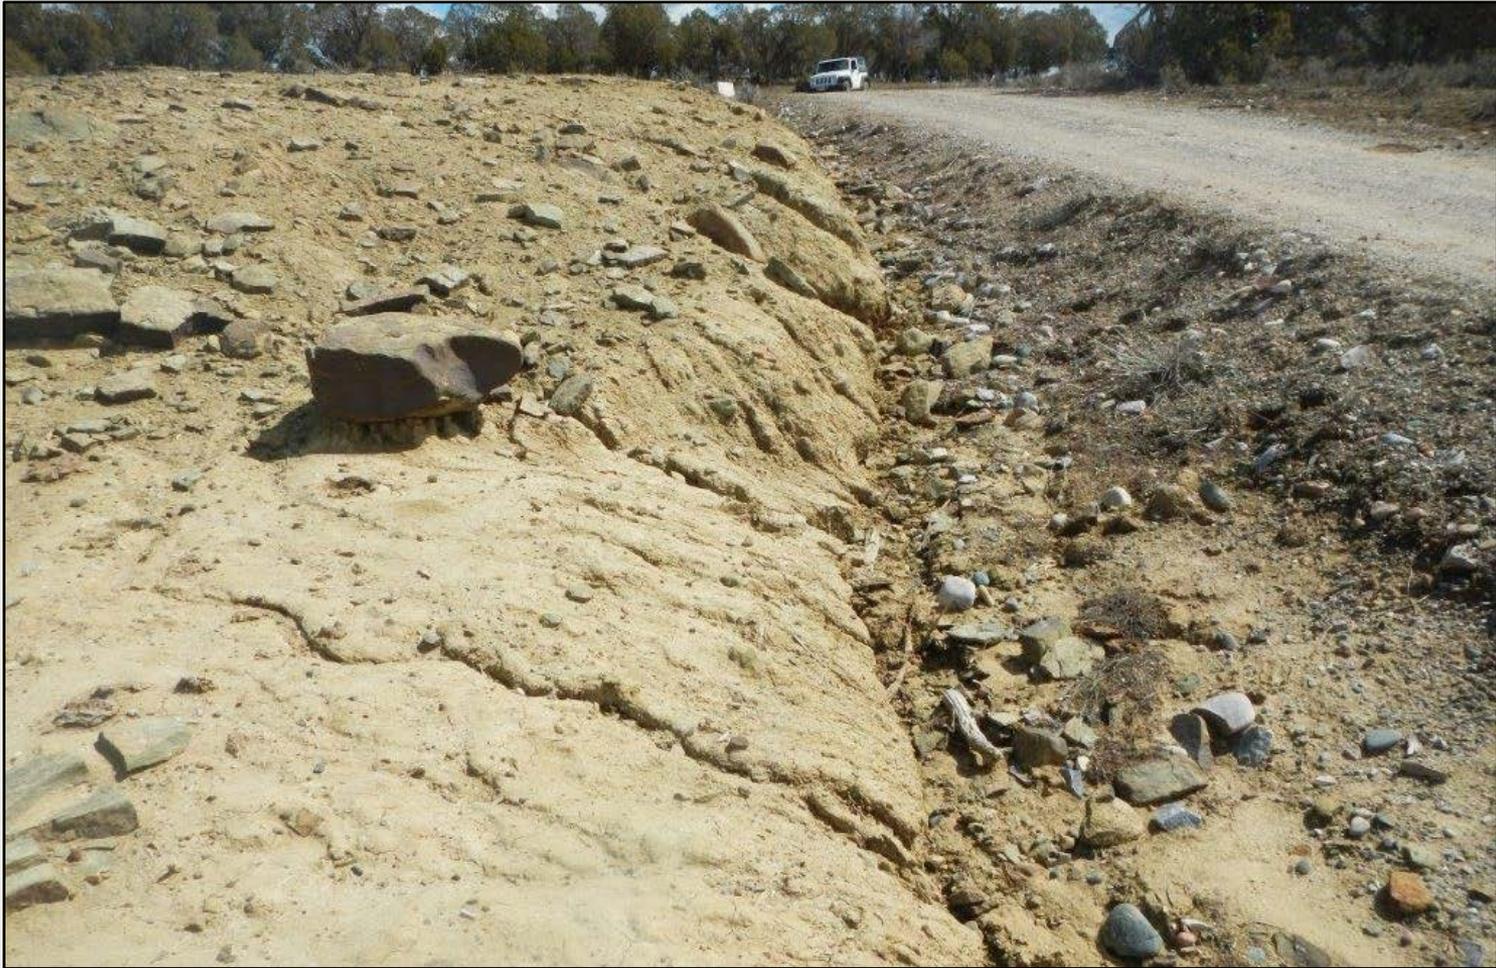
Photo 10. View of erosional channel approximately 3-4 feet wide and 3 feet deep, as well as erosional channels flowing into the channel, along the southern project area and access road.
