**FW: TEP Pit Facility ID 414560; Variance Sundry Doc. # 401954590**

# Terra Energy Partners: 2019 Netting Maintenance

Cover Photo: Facility 414560 (Clough Production-44-16-694)

April 4, 2019

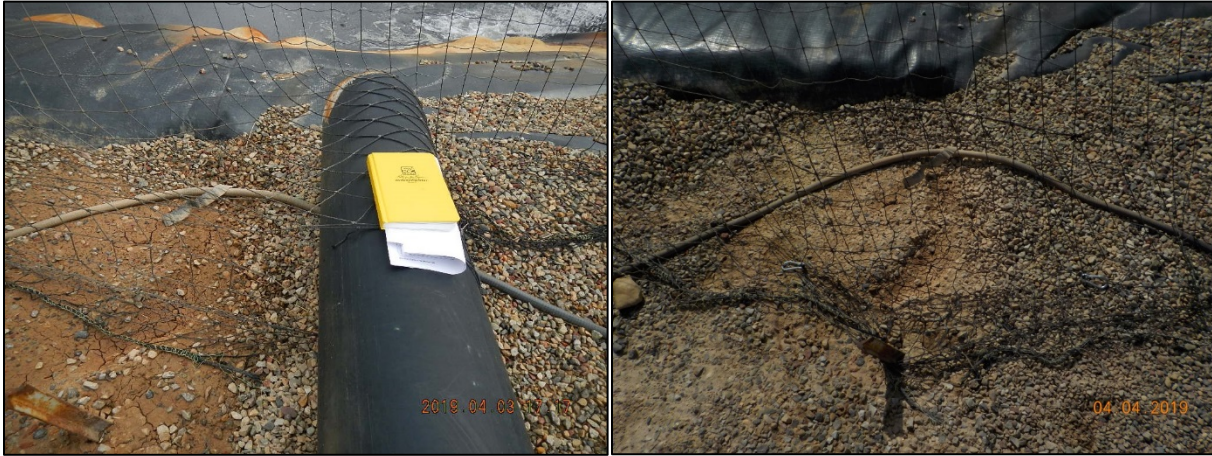
Clough Production Pond- Good Standing  
Figure 1

- Figure 1/ Figure 2
  - Removed poly line entering the structure and created an access point (secured flap) that could be utilized in the future to accommodate a poly line re-entry.

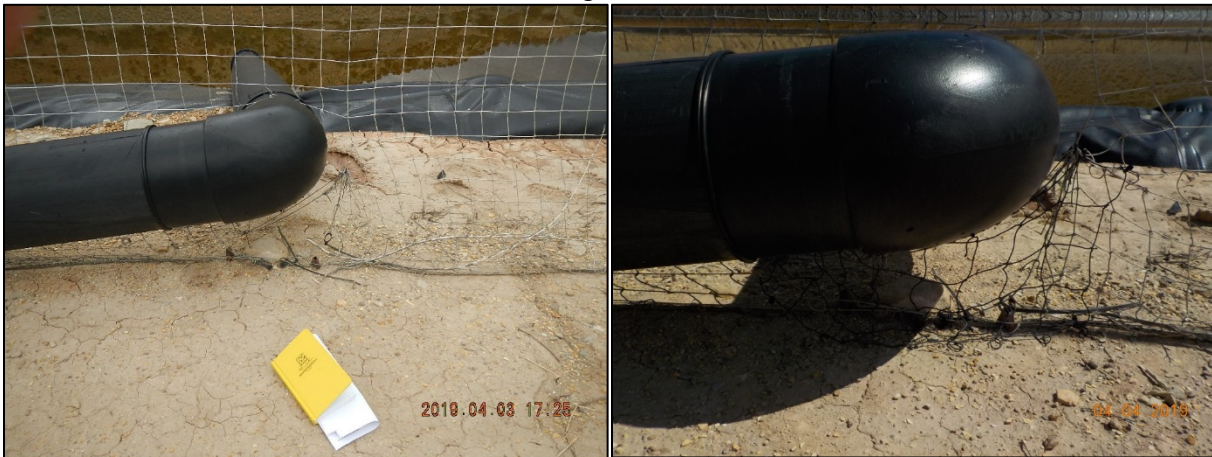
- Figure 3
  - Added extension underneath the poly line to eliminate any vacancies in the side panel to prevent wildlife access.

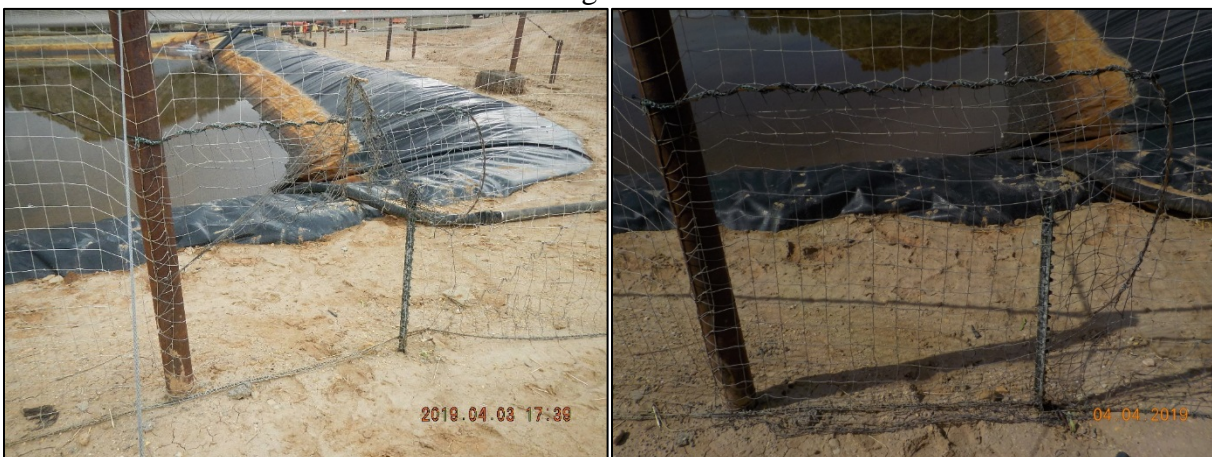
- Figure 4
  - Removed the debris that was causing the side panel to be elevated and anchored the netting to the ground.

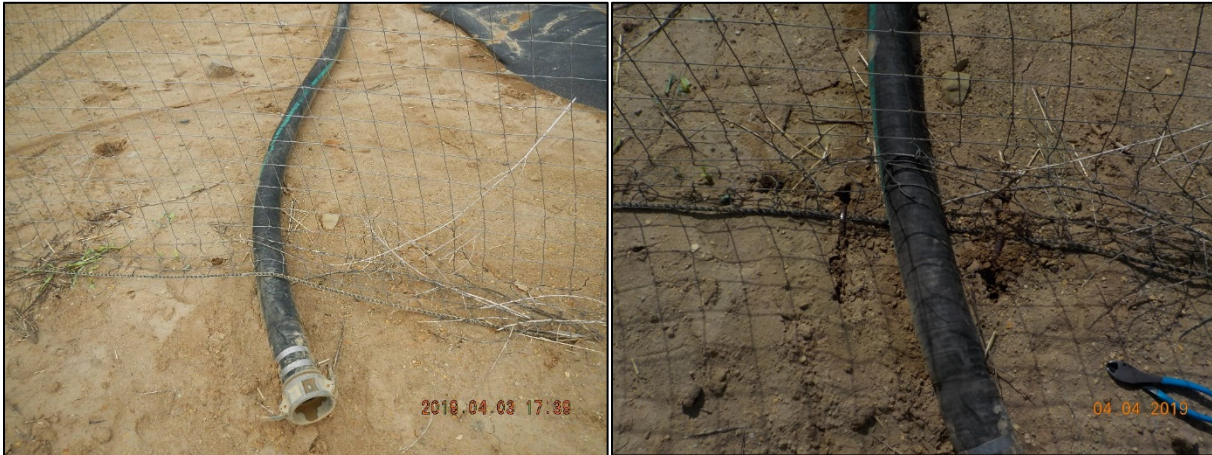
- Figure 5
  - Altered the side panel to accommodate a hose entering the pit and anchored the netting to the ground.
