# Inspection Photos

Operator: H & M PETROLEUM CORPORATION -  
10032

Location ID: 458288

Inspection Doc. Number: 682504700  
Logan County, CO

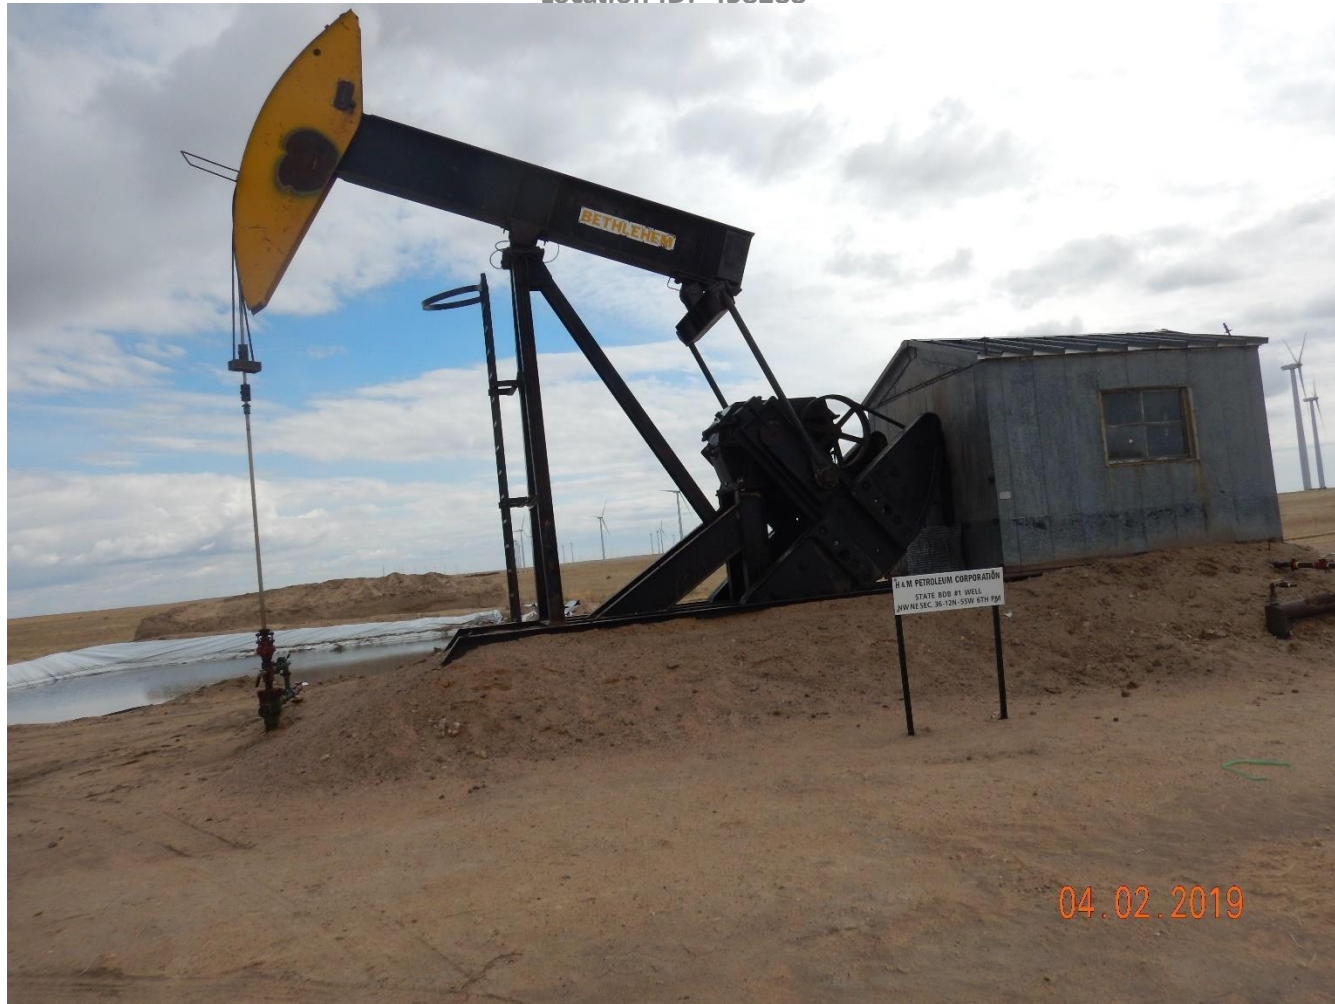
**Photo 1:** Photos taken from the well. Photo shows operator has installed signage at well head in accordance with 210.b(1) (emergency contact @ battery).

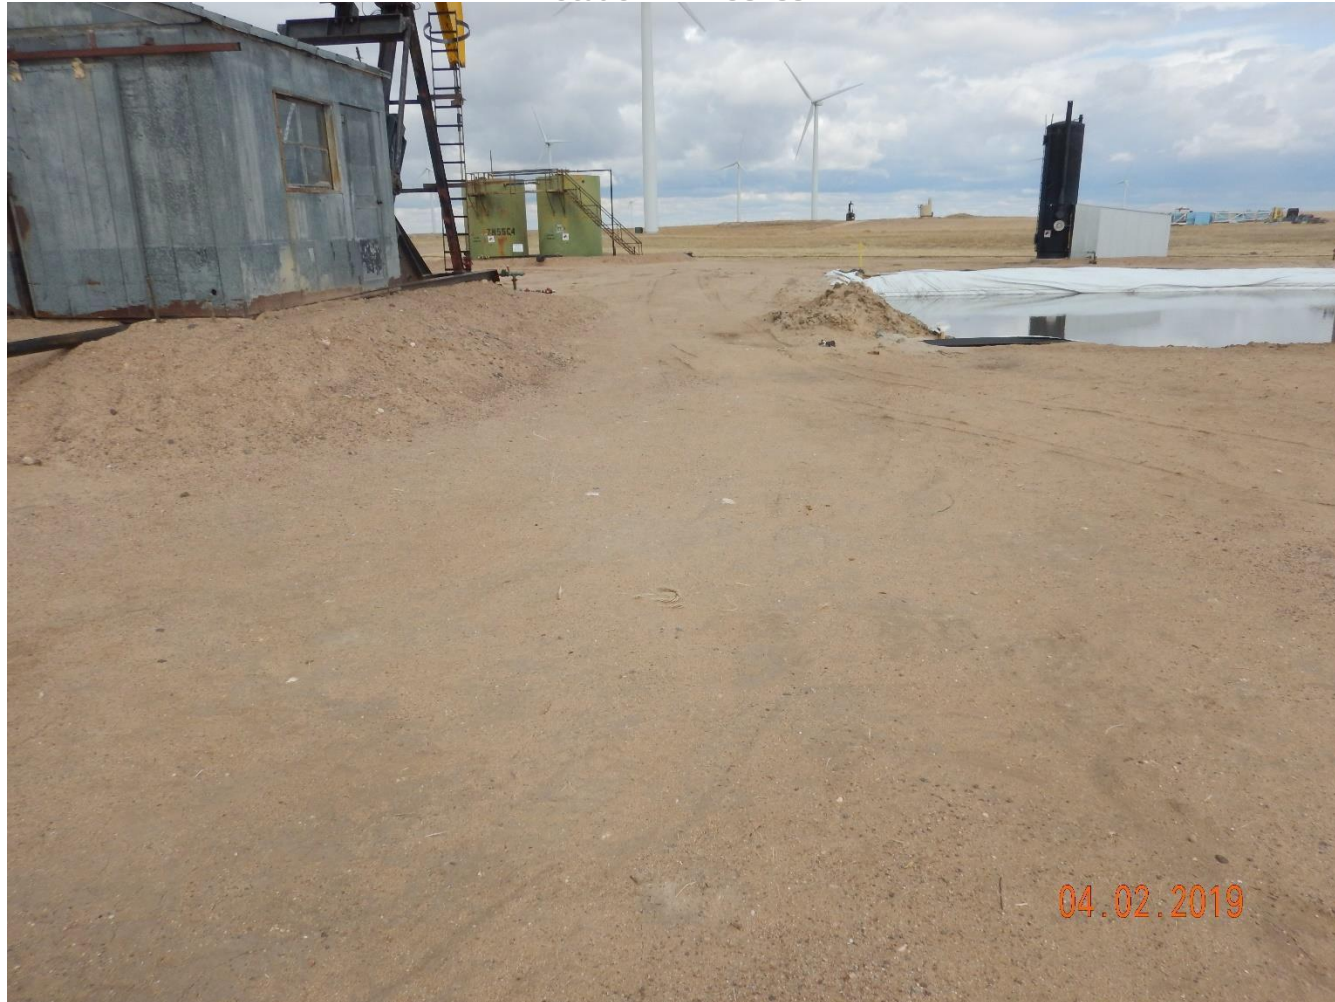
**Photo 2:** Photos taken from the east end of the well. Photo shows area where materials were improperly stored. Materials appear to have been removed from location.

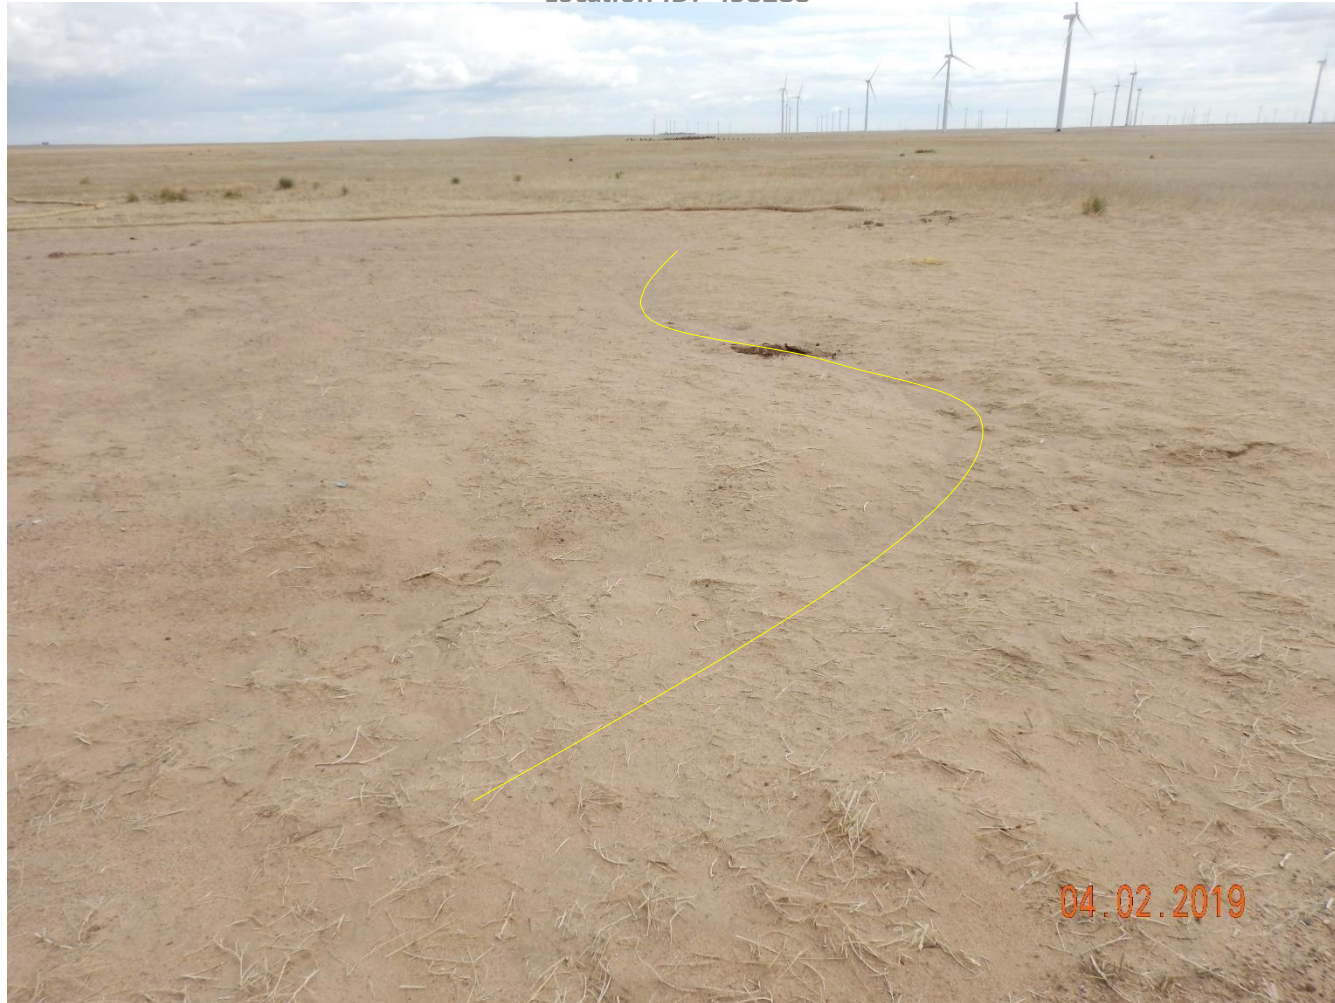
**Photo 3:** Photo taken from the south end of the location, facing east. Photo shows areas where aeolian soils were brought onto the location. Photo shows areas inspector observed a stormwater channel beginning to form.

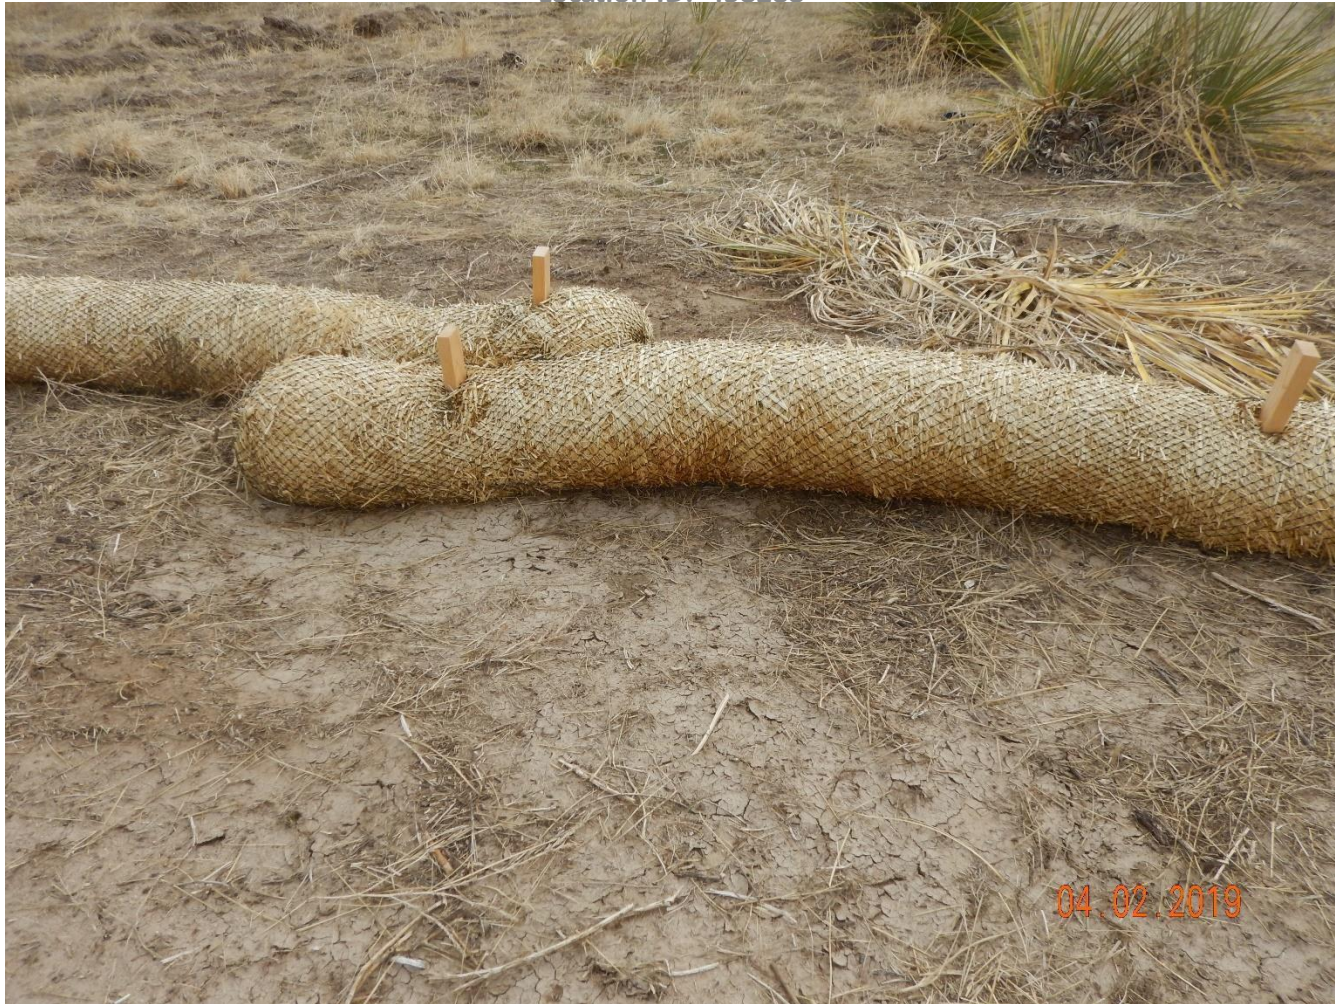
**Photo 4:** Photo taken from the east end of the location. Photo shows straw wattles have not been installed in accordance with good engineering practices.

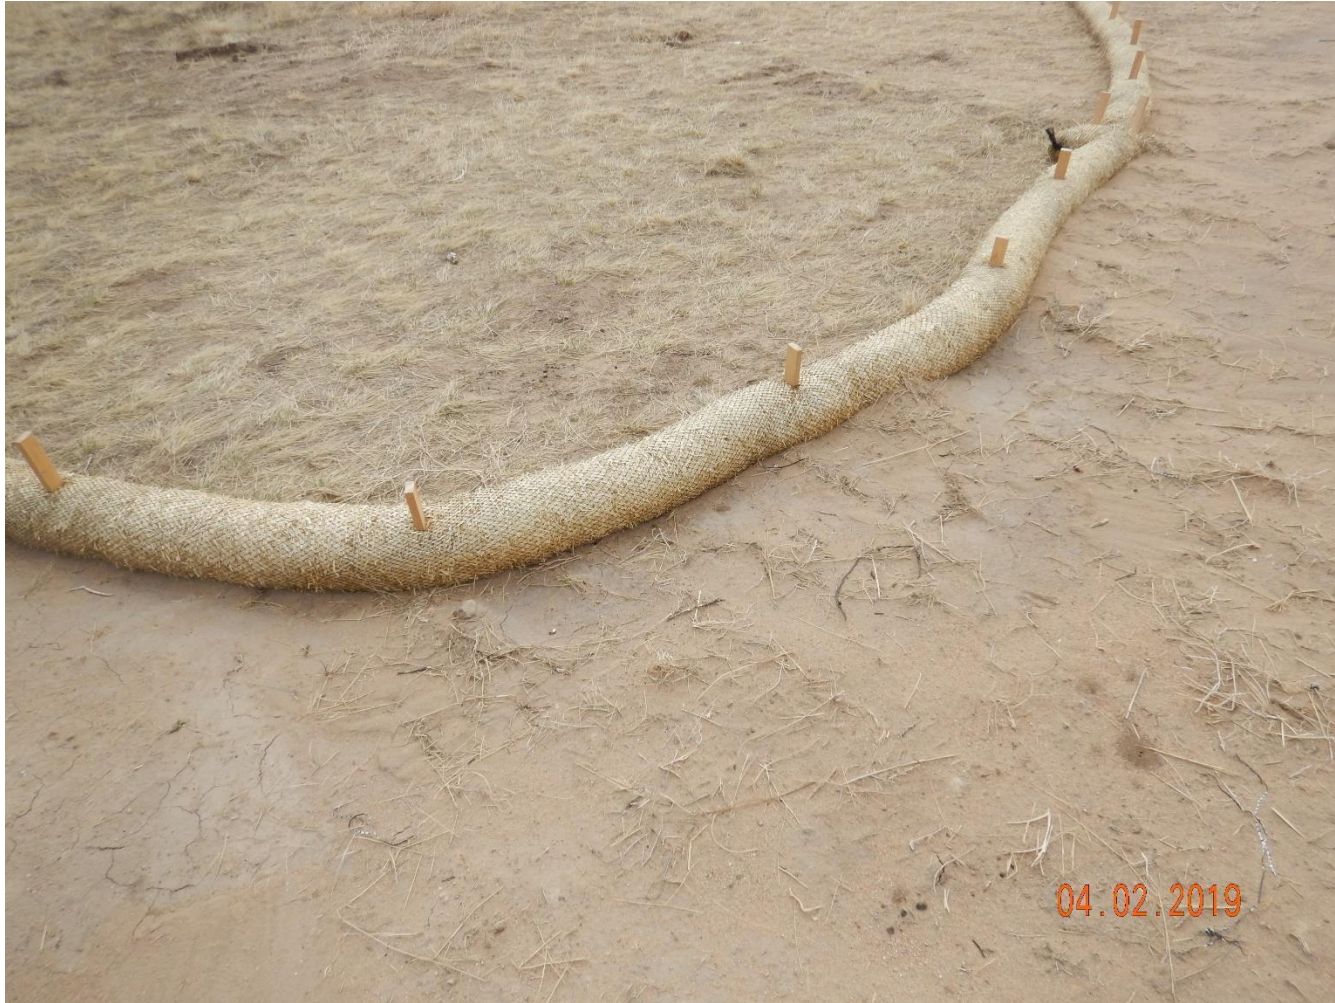
**Photo 5:** See comments under photo 4.

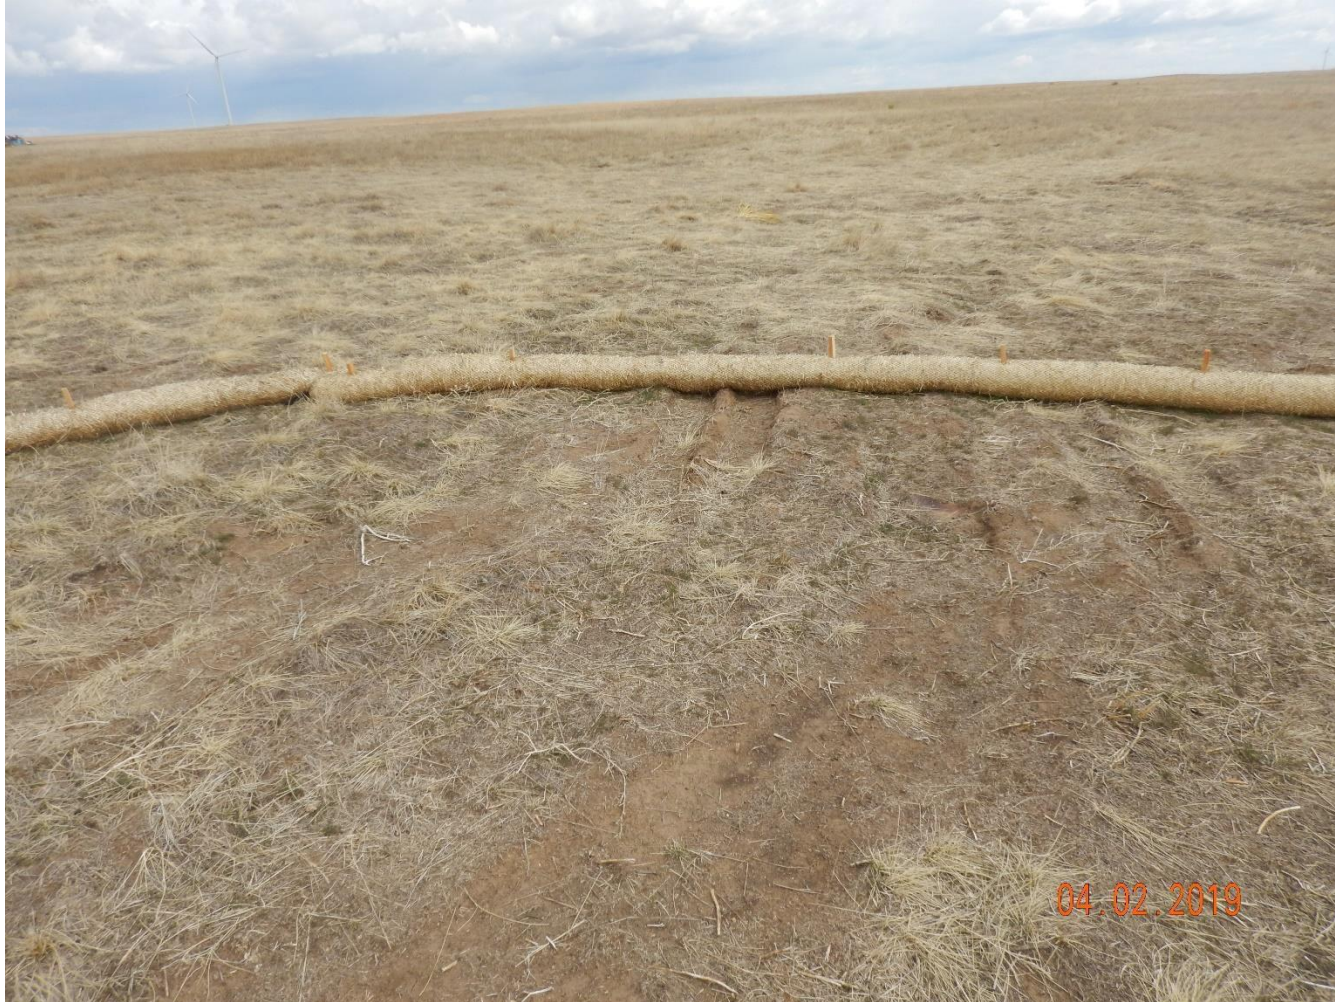
**Photo 6:** See comments under photo 4.

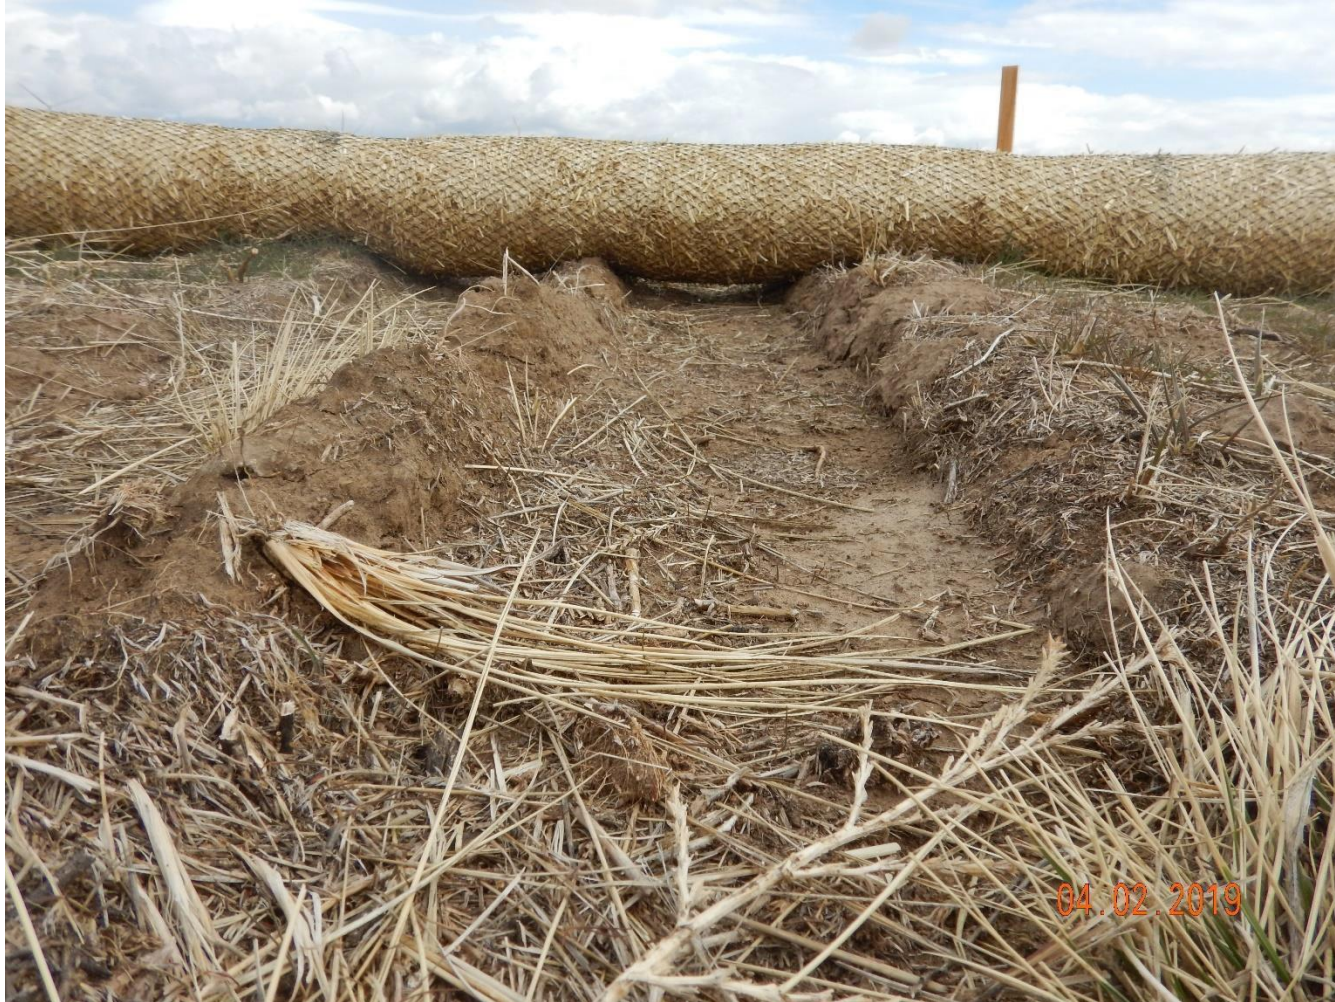
**Photo 7:** Continued from photo 6.

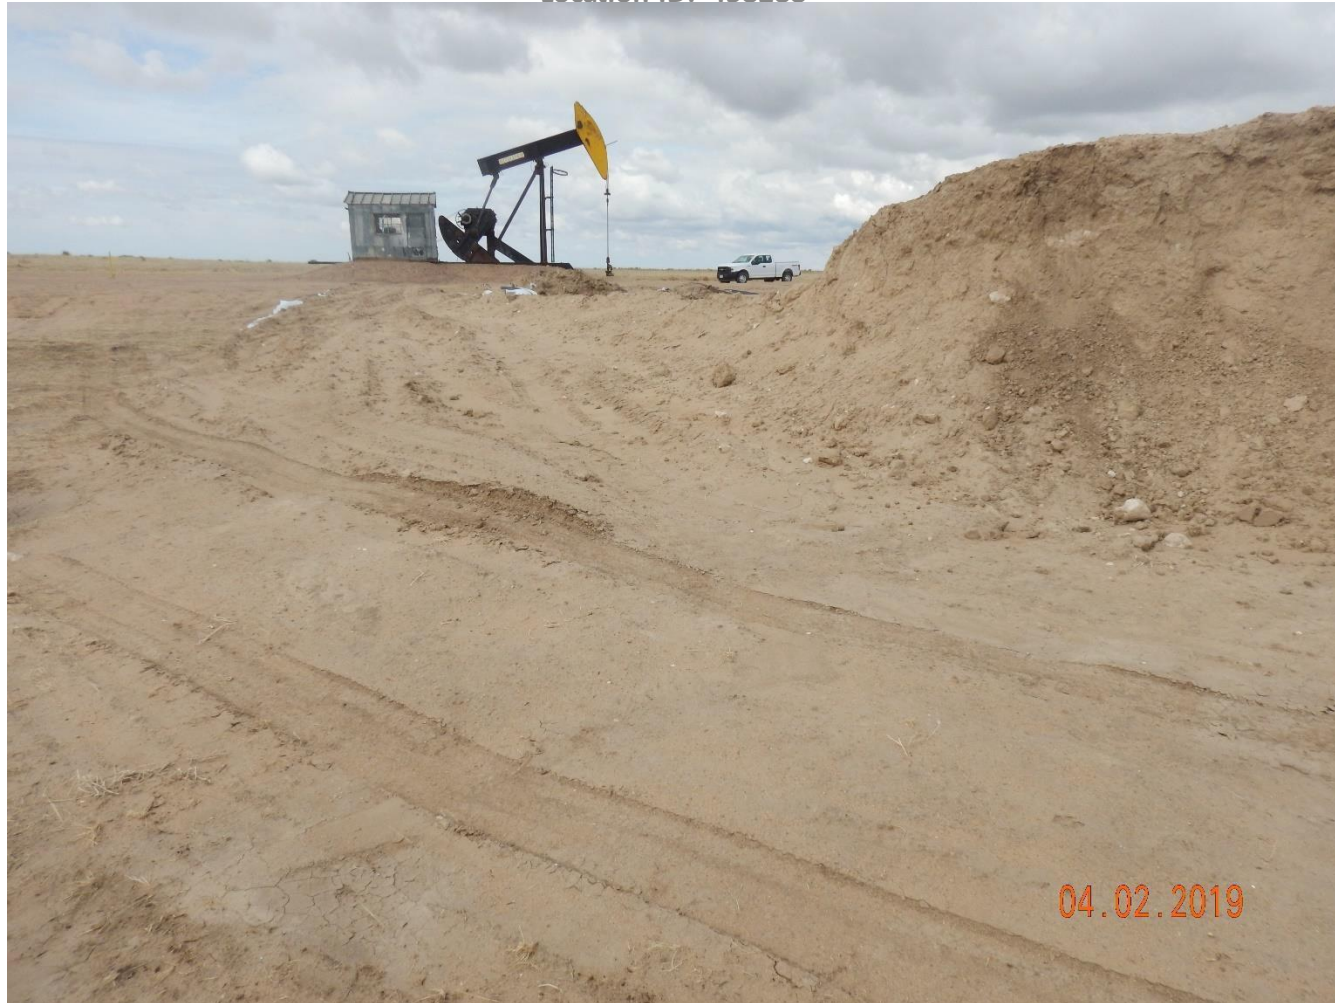
**Photo 8:** Photo taken from the east end of the location, facing west. Photos 8-10 provide overview from west, northwest to north, of the soil stockpile from pit. Photos show topsoil and the subsoil horizons were not separated and stored or marked/documentated in accordance with Rule 1002.b. Photos also show stockpile appears to remain loose, unstabilized material and stormwater erosion degradation is evident.

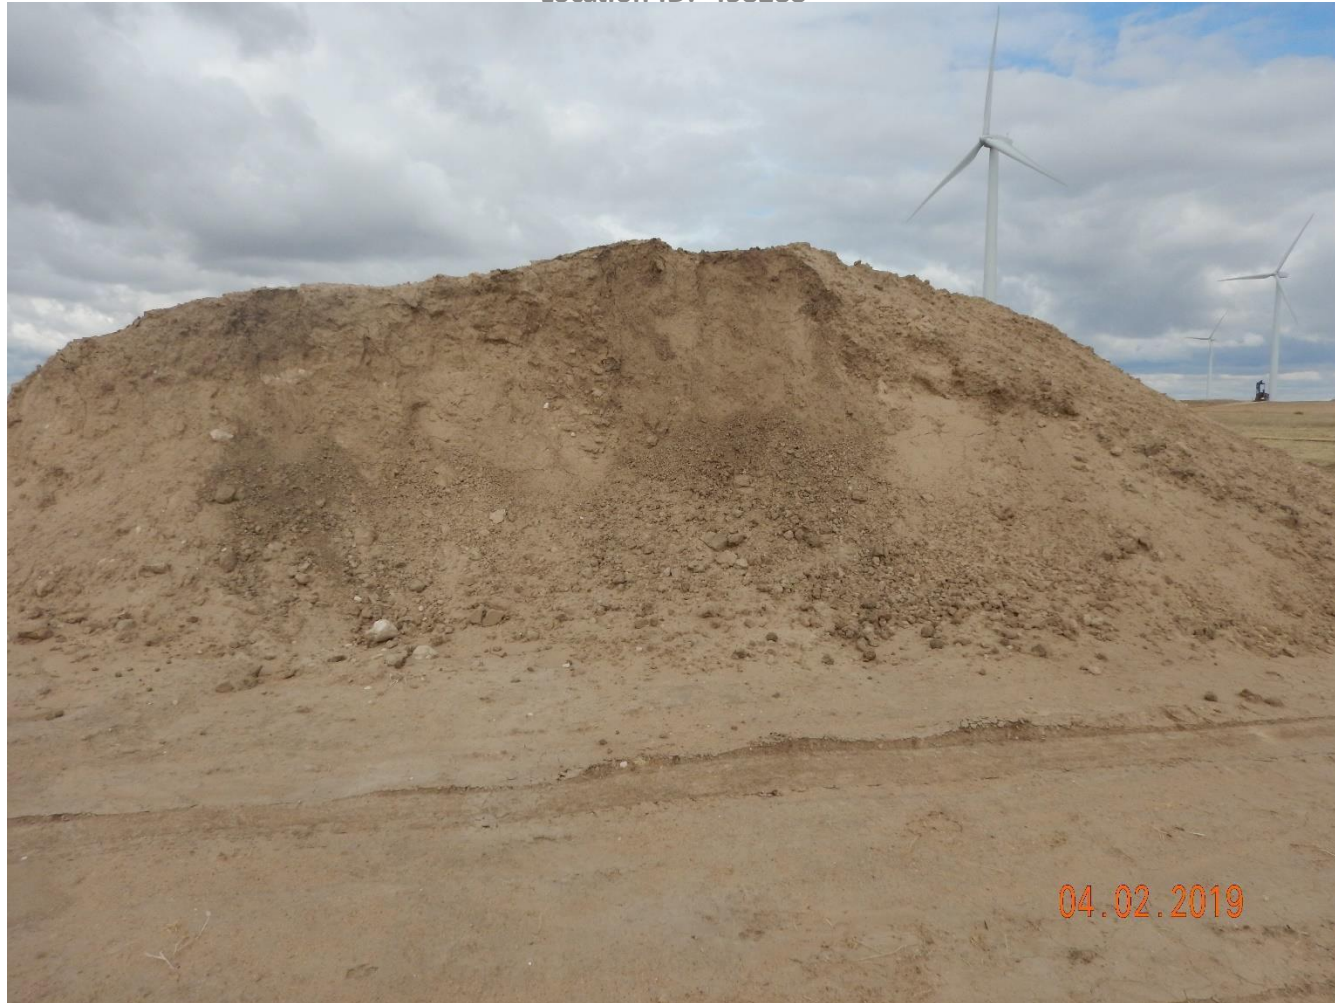
**Photo 9:** See comments under photo 8.

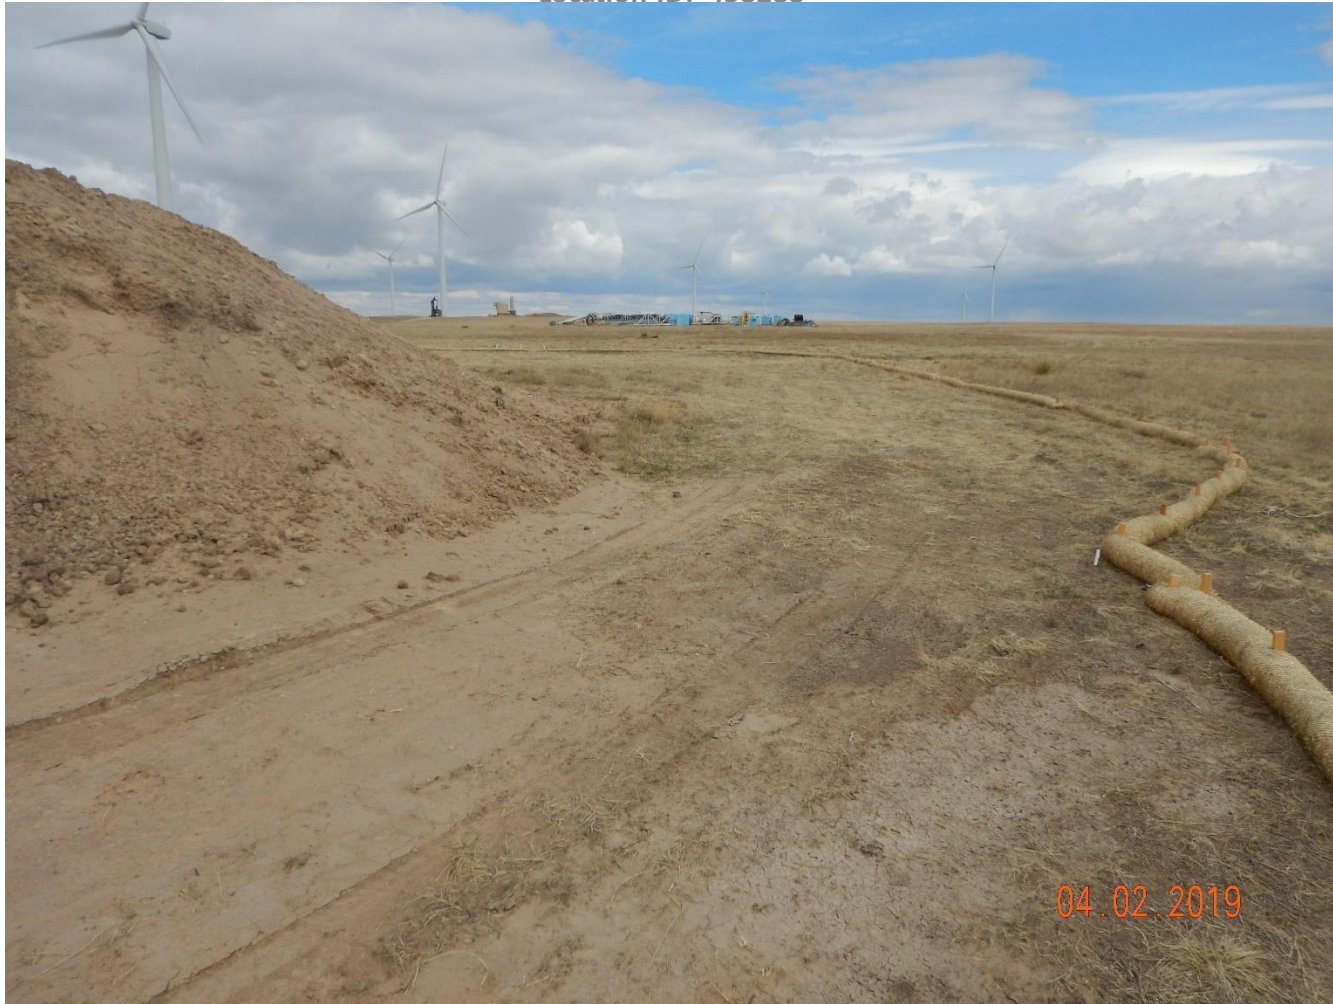
**Photo 10:** See comments under photo 8.

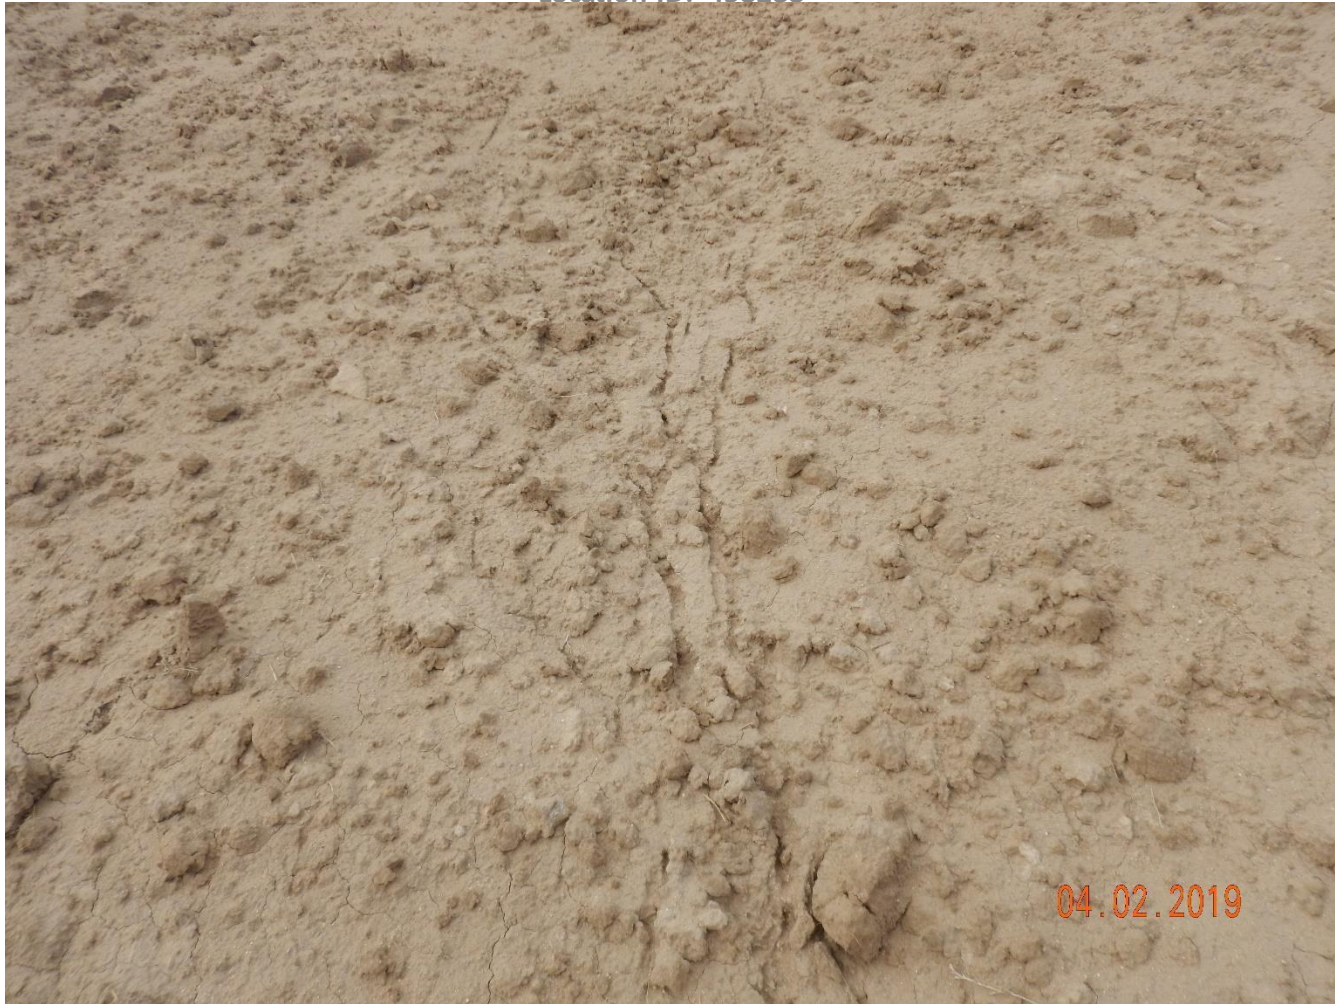
**Photo 11:** Photo taken from the soil stockpile. Photo shows erosion degradation evident on stockpile.

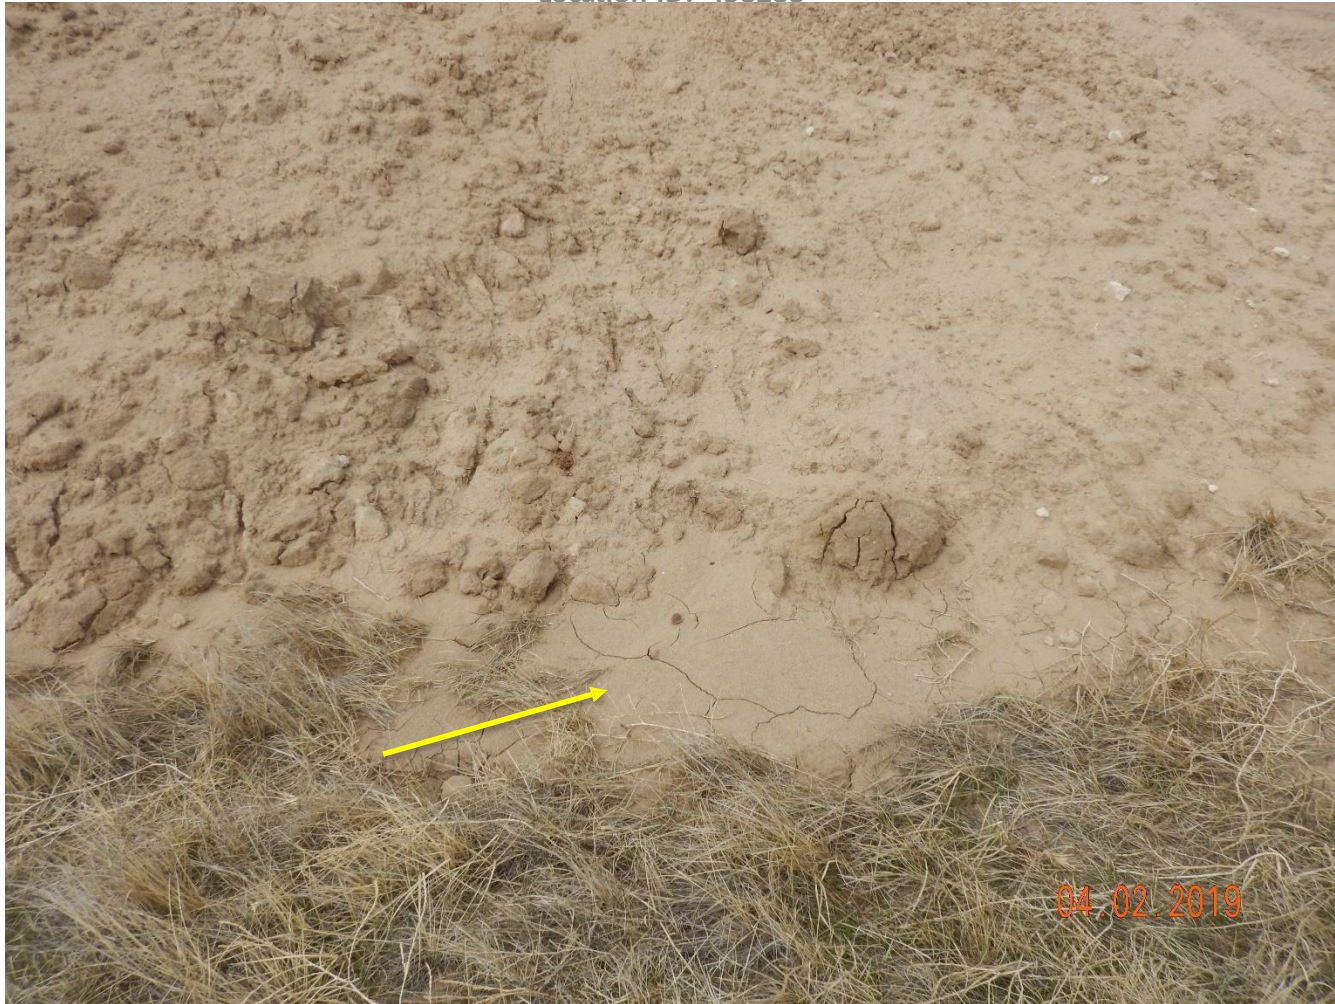
**Photo 12:** Photo taken from the soil stockpile. Photo show sediment deposition due to stormwater degradation and runoff from the soil stockpile.

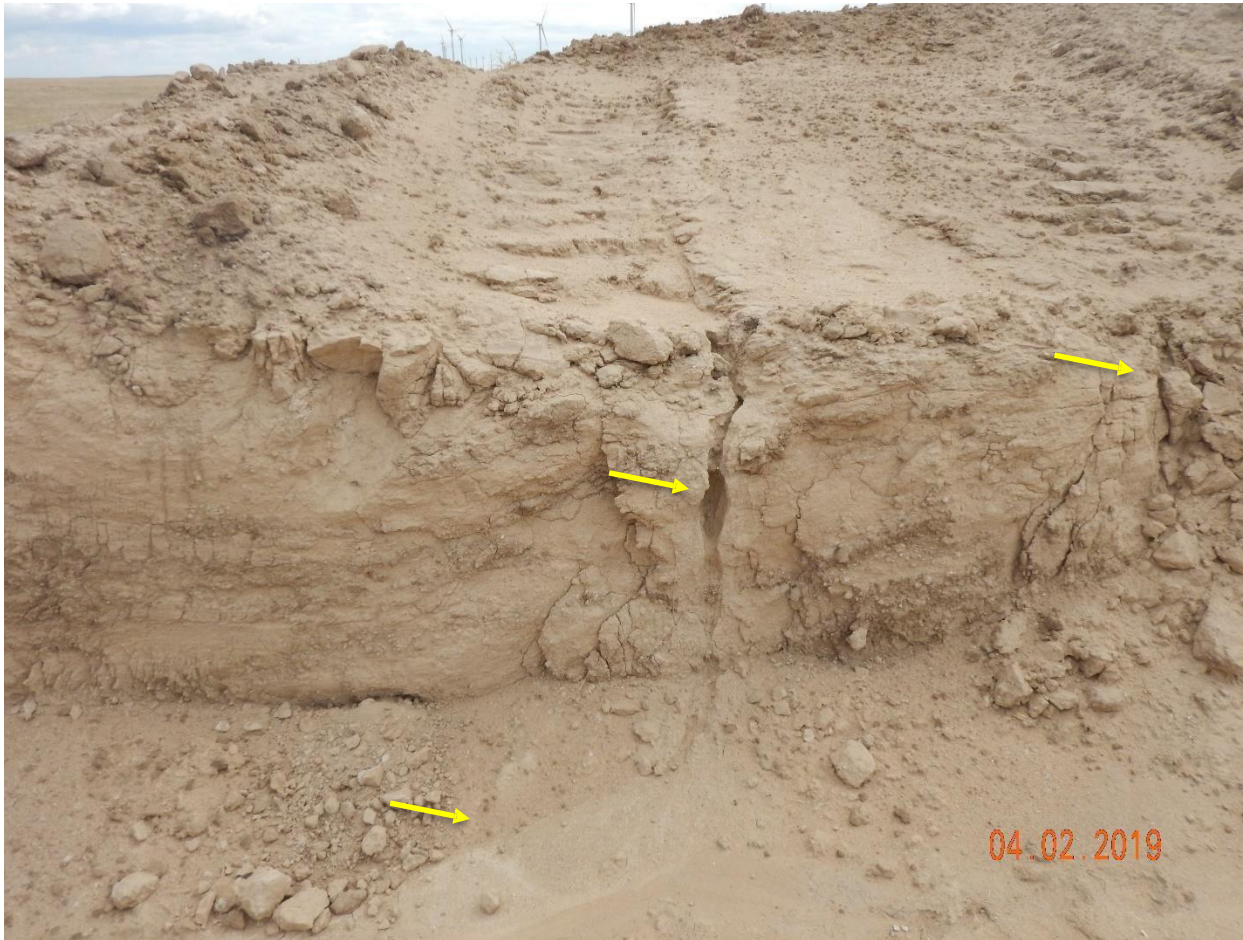
**Photo 13:** Photo taken from the soil stockpile. Photo erosion degradation due to stormwater

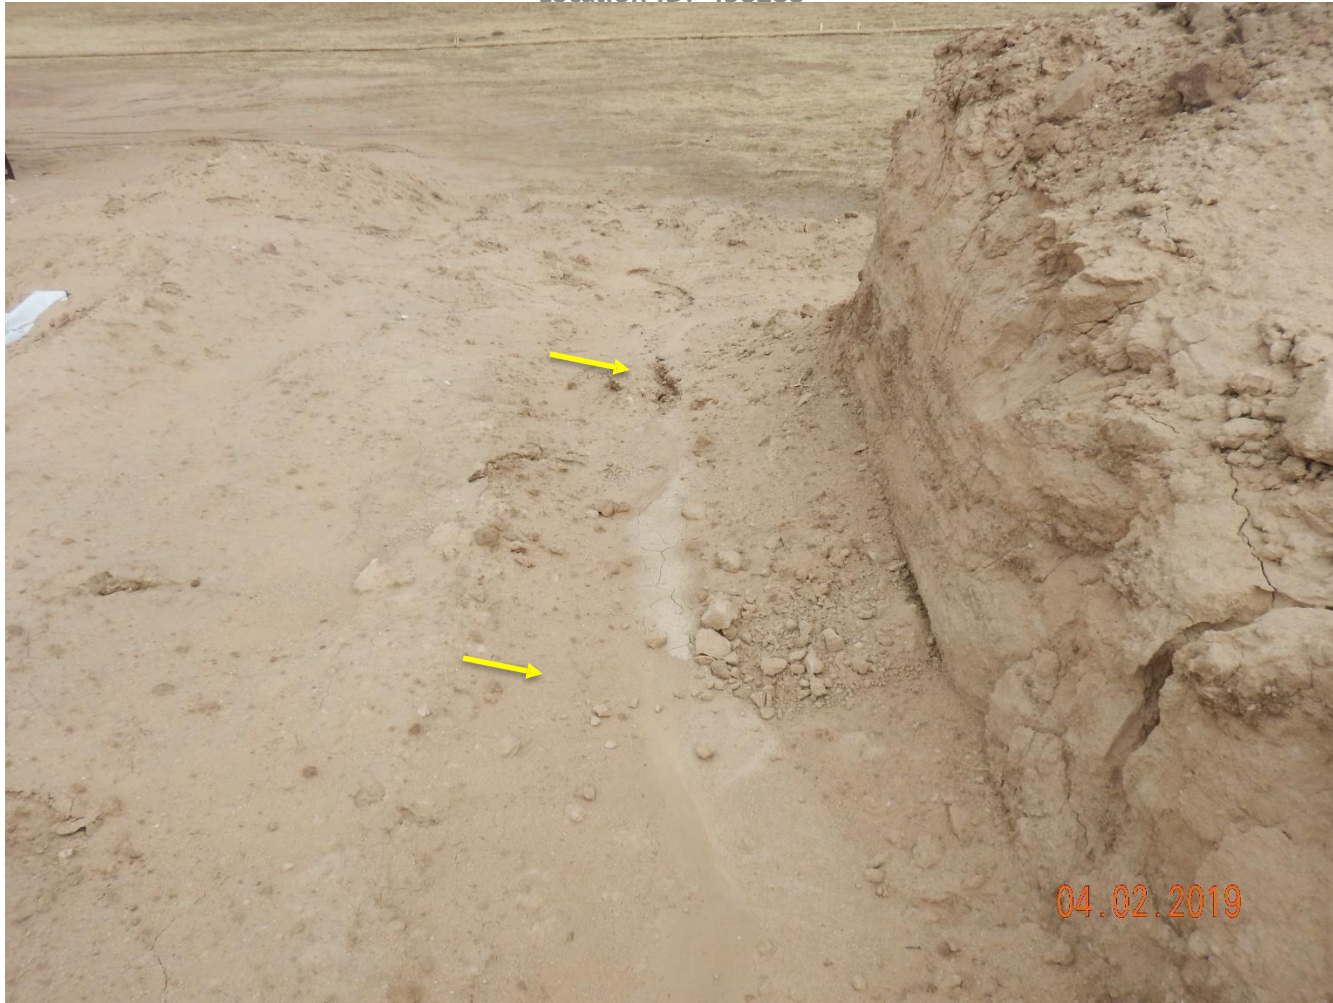
**Photo 14:** Continued from photo 13.

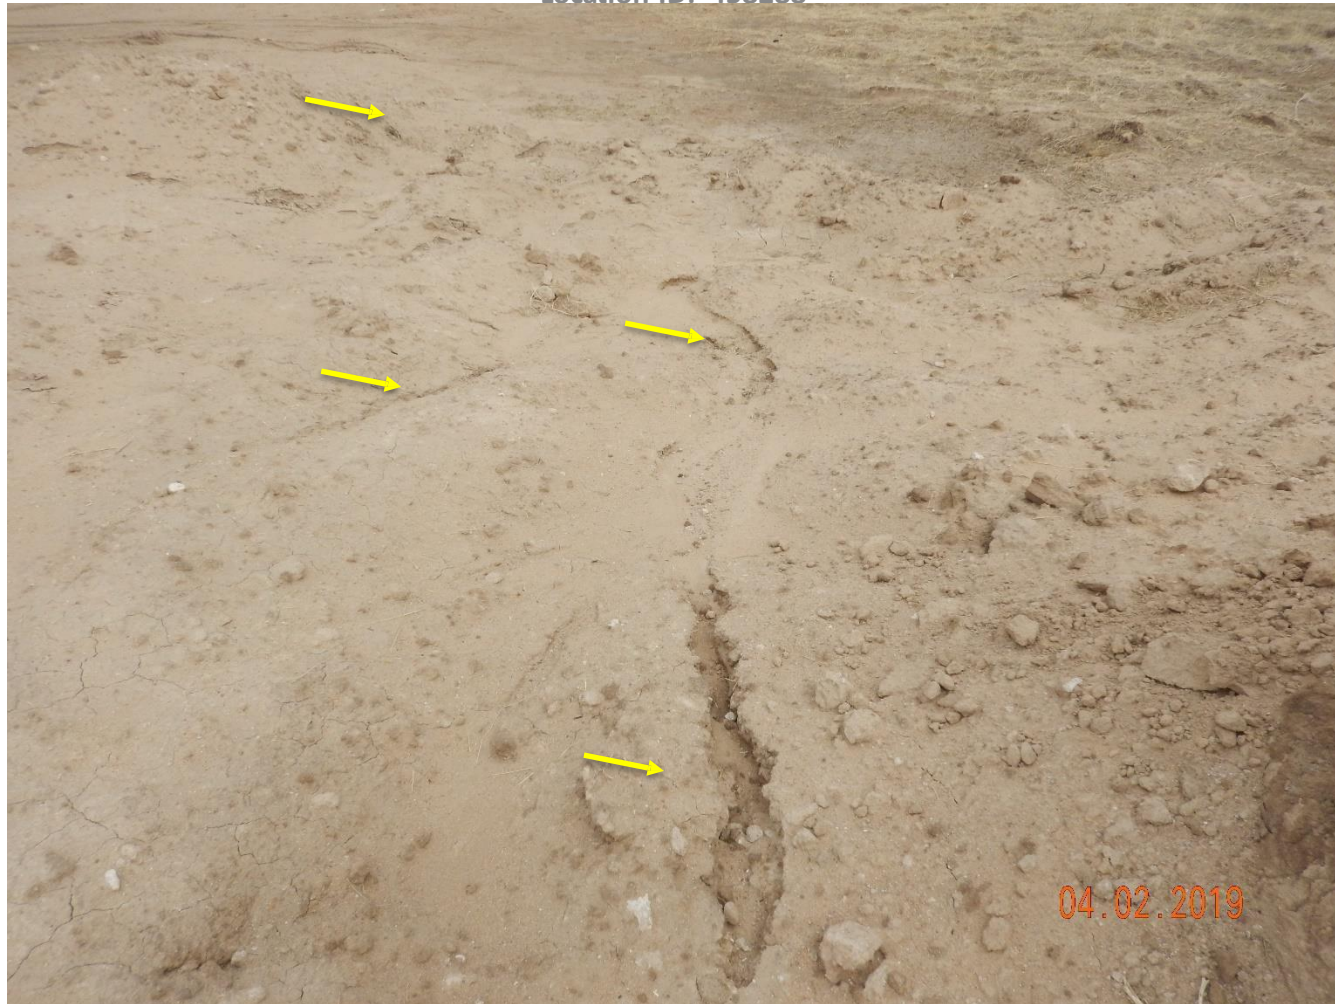
**Photo 15:** Continued from photo 13.

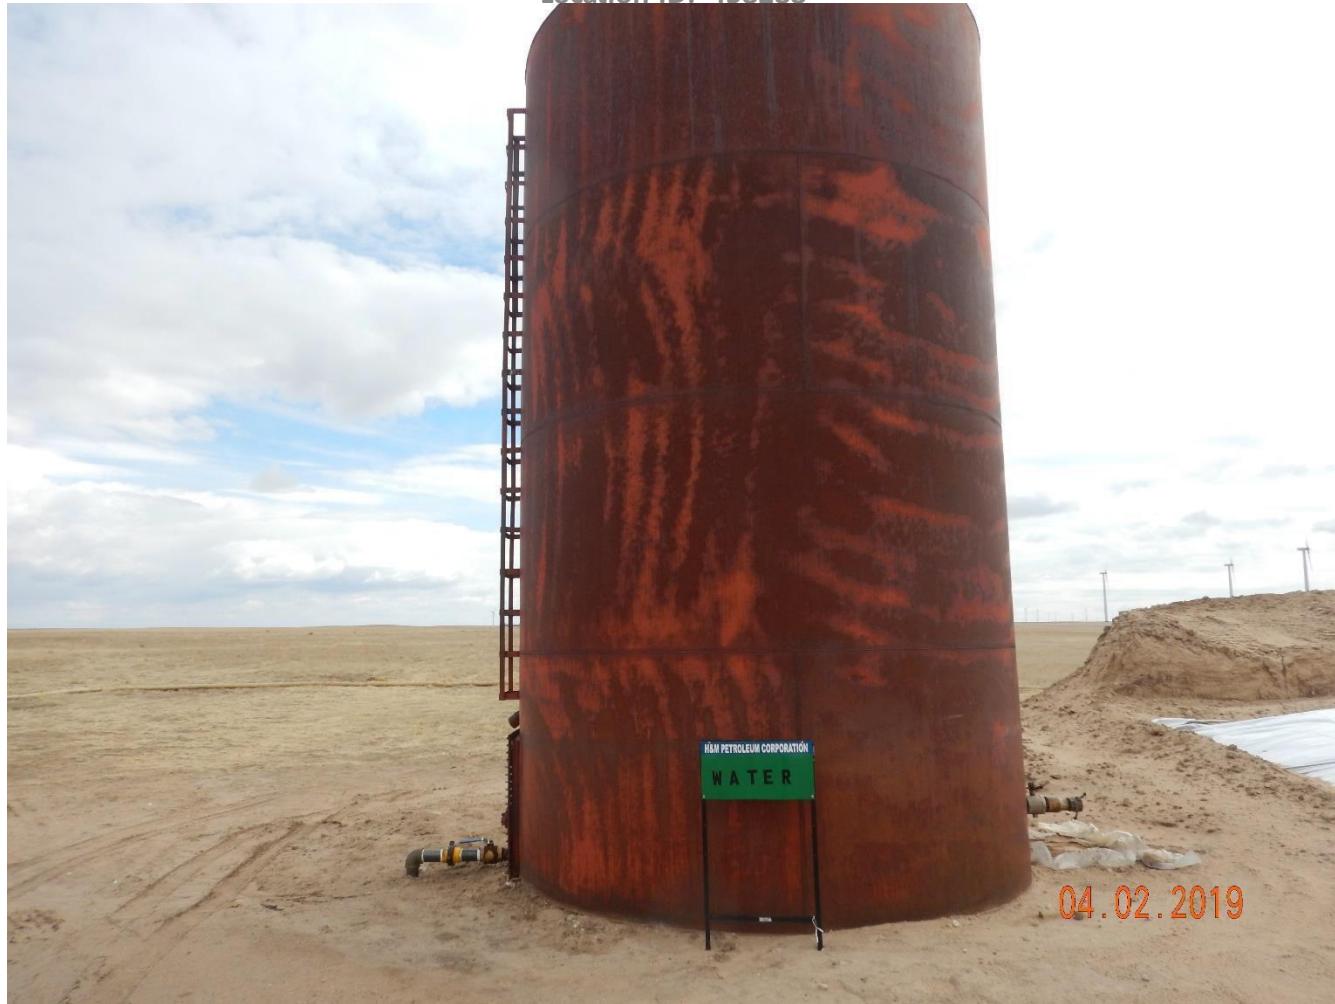
**Photo 16:** Photo taken from the produced water tank on the north end of the location. Photo shows insufficient signage (sign only says “water”) and labeling at tank in accordance with Rule 210.d. Photo also shows missing secondary containment at tank in accordance with 906.d(1).

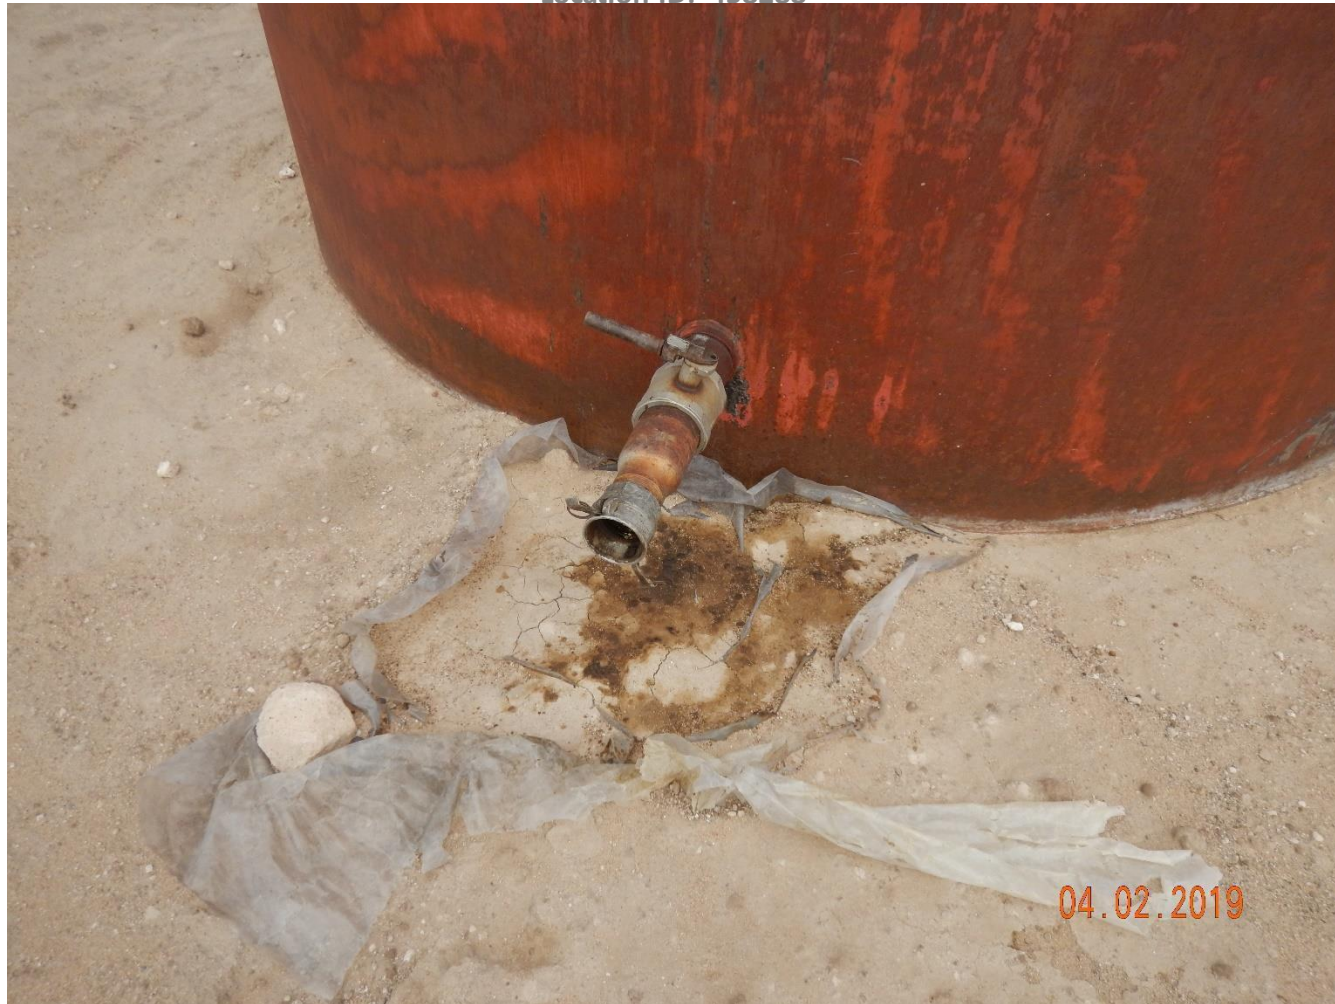
**Photo 17:** Photo taken from the south end of the produced water tank. Photo shows contaminated soils due to possible discharge from the tank.
