# Inspection Photos

Operator: H & M PETROLEUM CORPORATION -  
10032

Location ID: 458288

Inspection Doc. Number: 682504700  
Logan County, CO

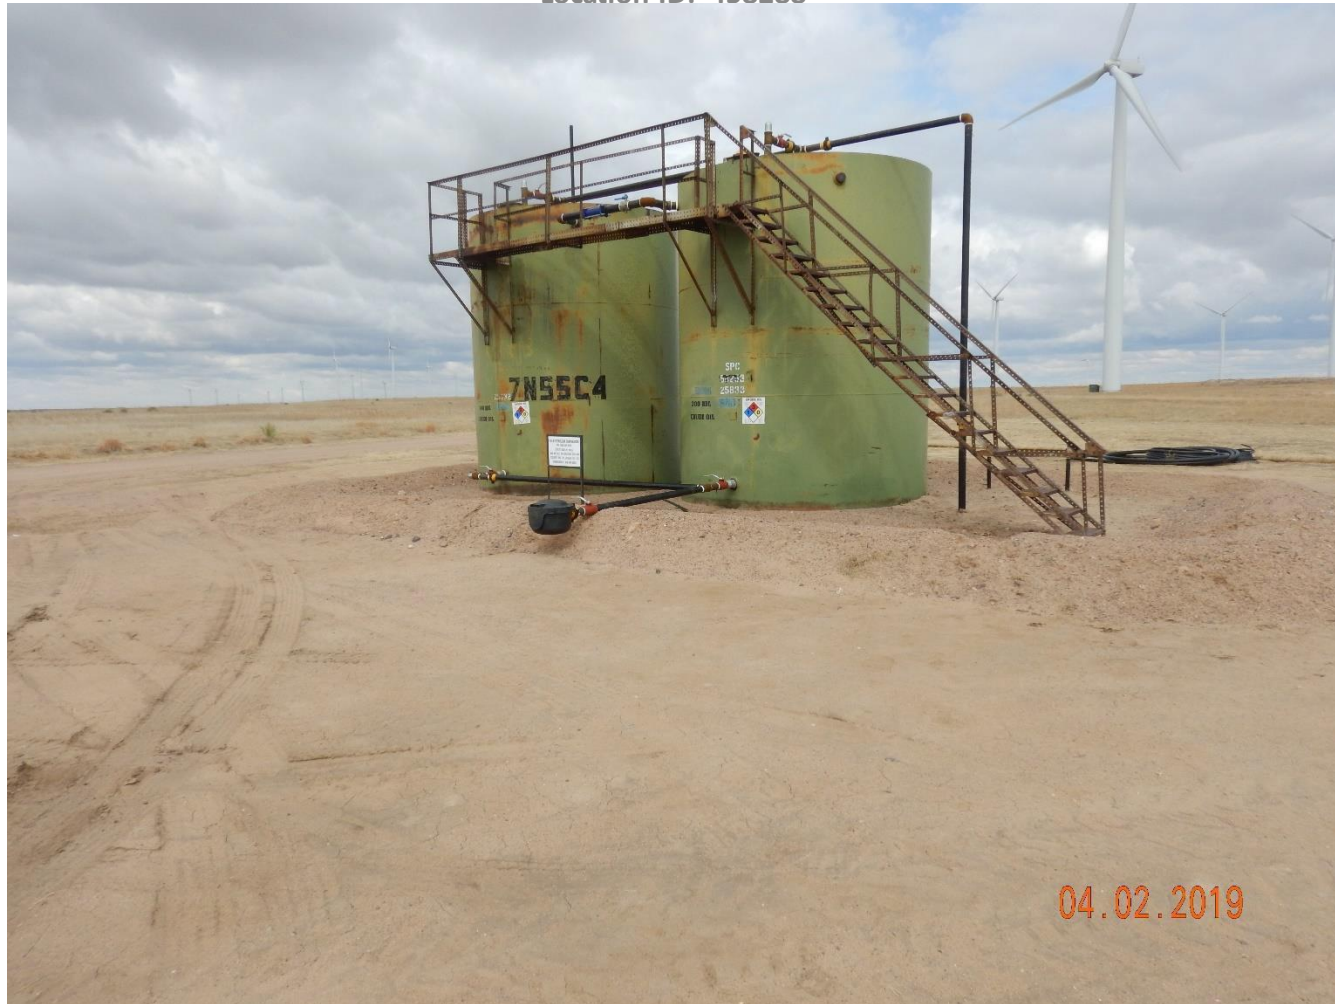
**Photo 18:** Photo taken from the north end of the location, facing northwest. Photo shows berm at battery appears to be unchanged. Operator does not appear to have installed secondary containment to comply with 906.d(1)

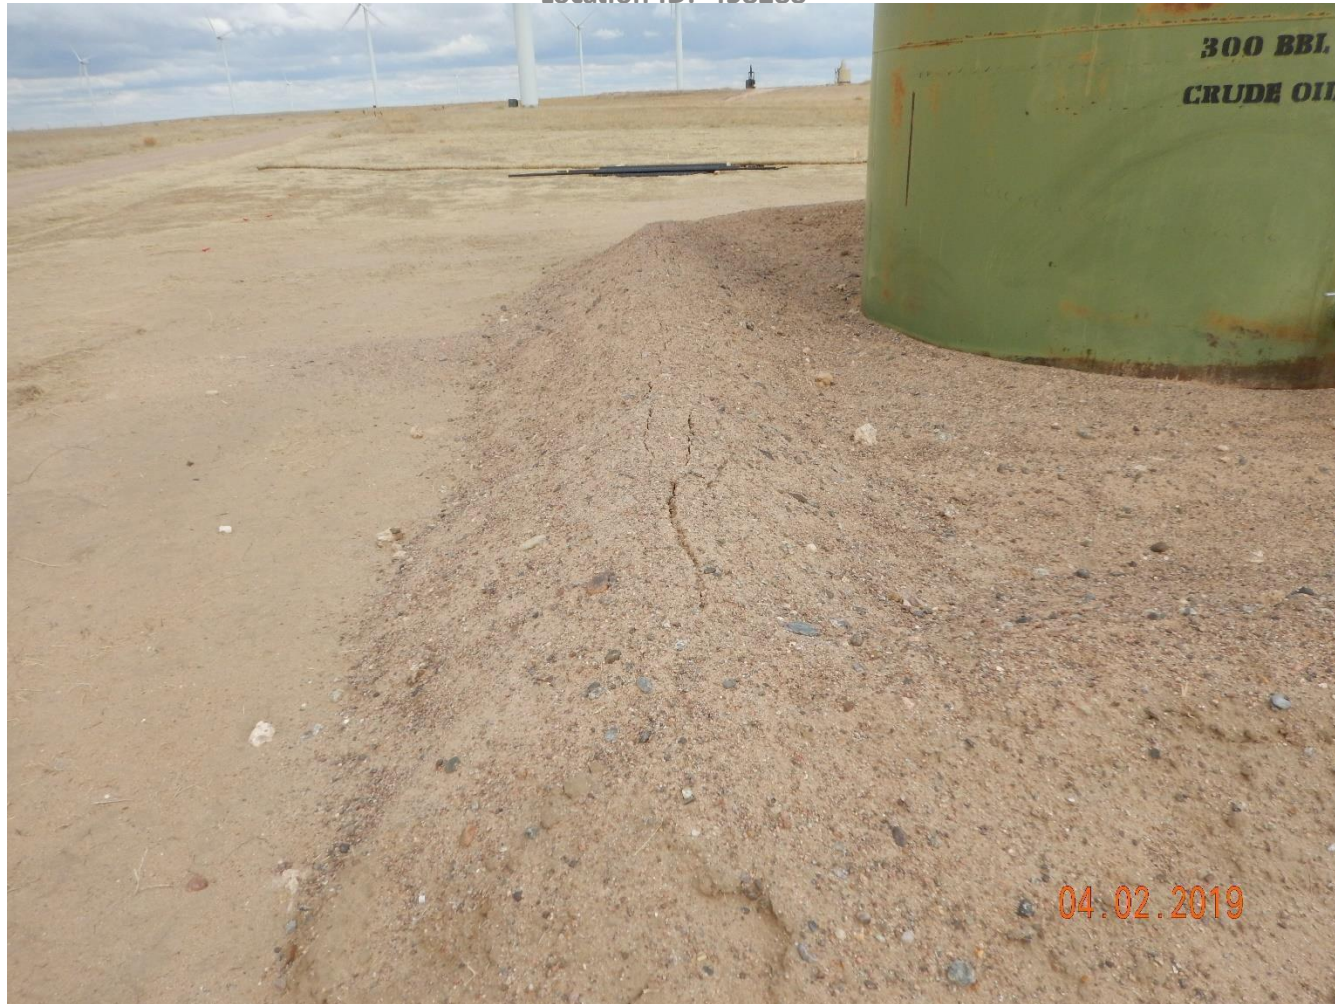
**Photo 19:** See comments under photo 18.

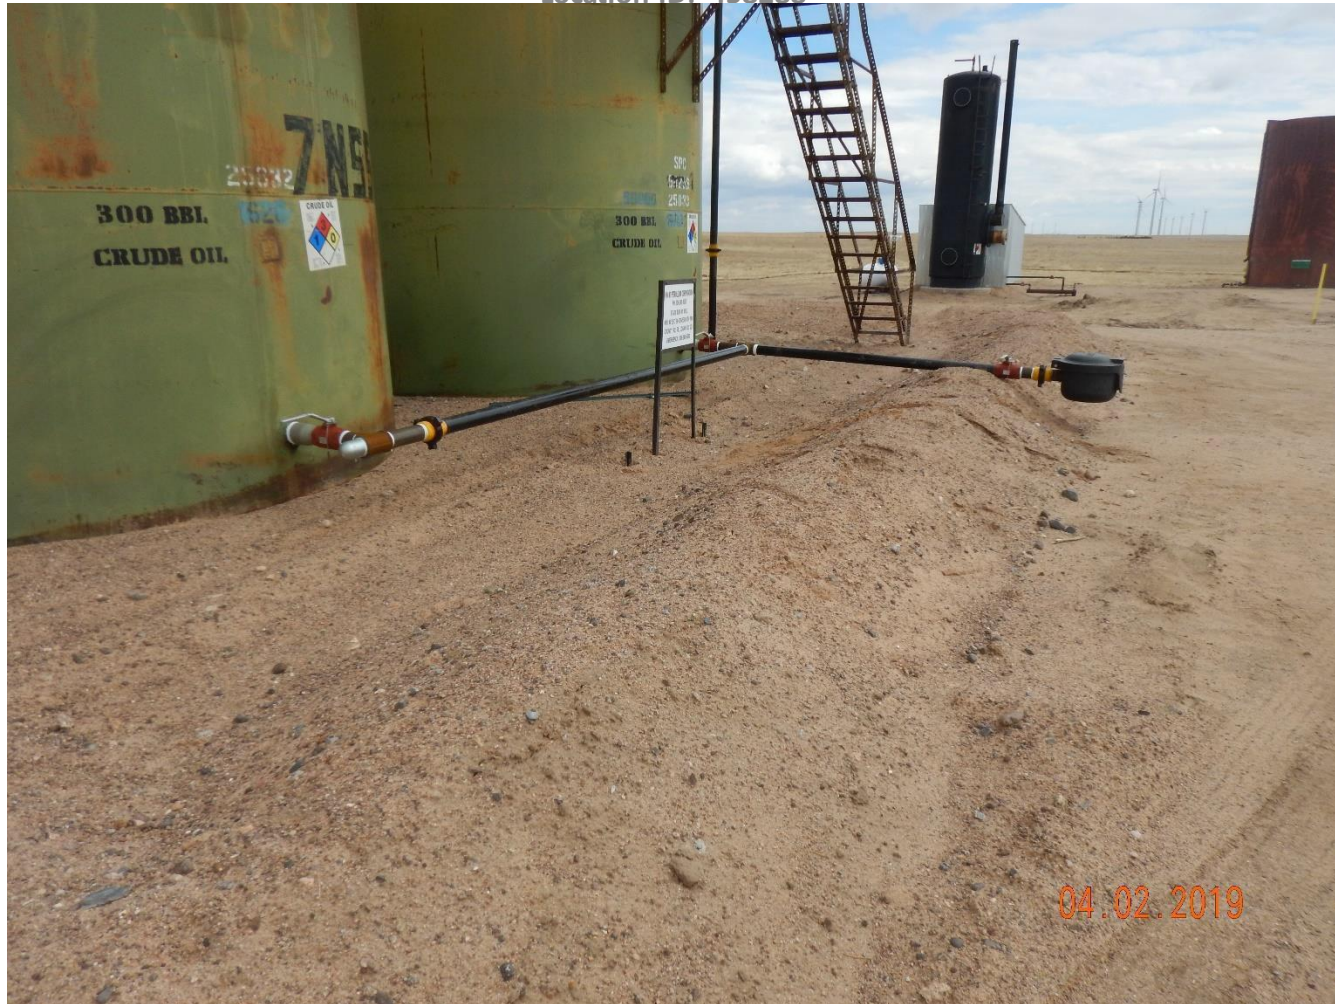
**Photo 20:** See comments under photo 18.

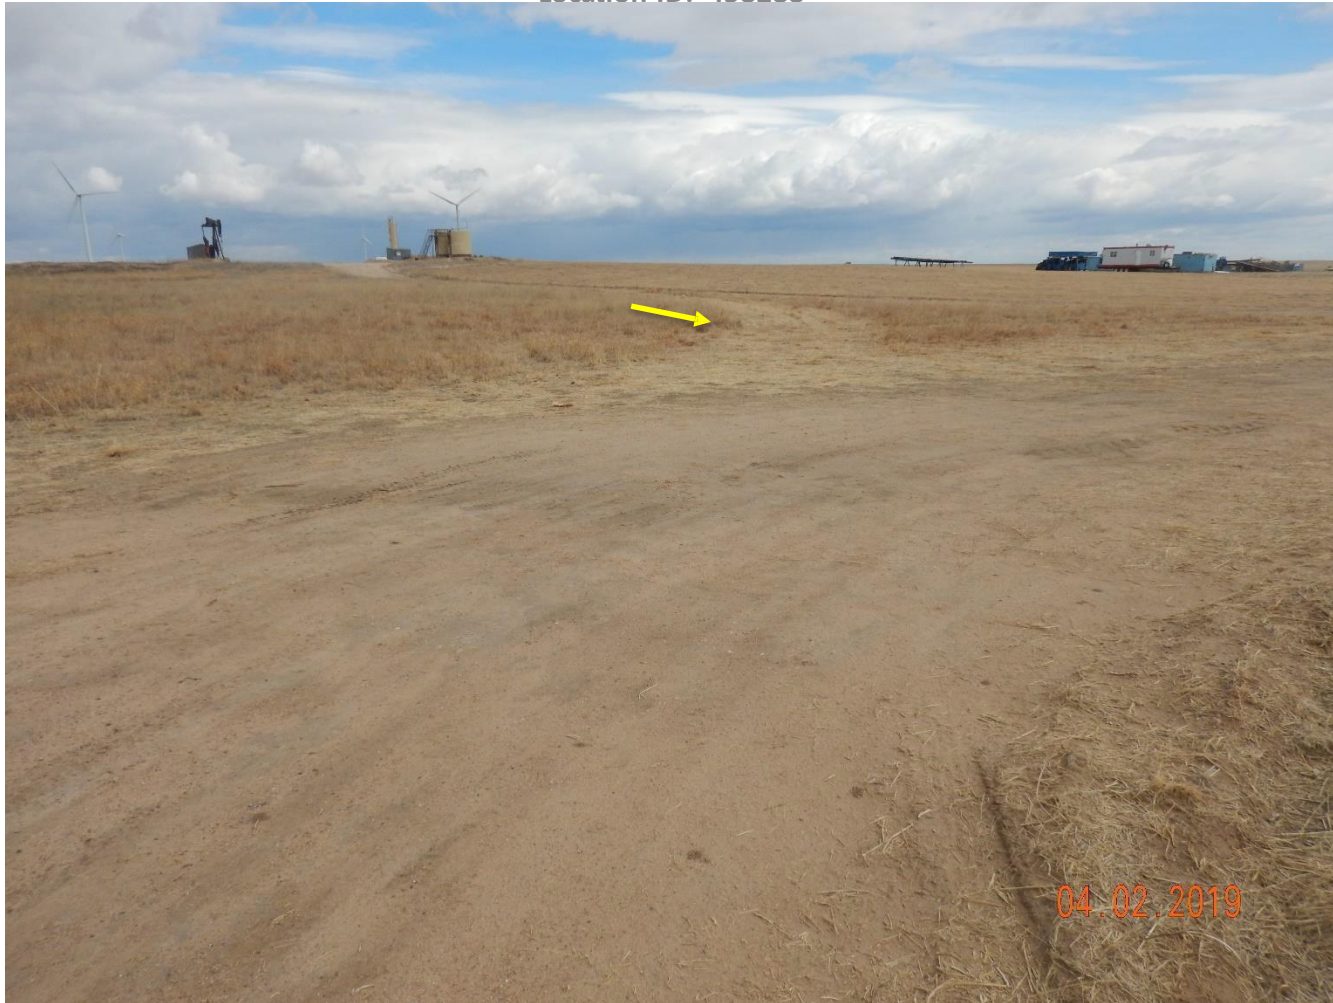
**Photo 21:** Photo taken from north of the location, at the area where the access road turns from north to east. Photo shows operator also appears to have created an additional section of access road traveling to the Highball 1 location, rather than restricting travel to the existing access road. This is unnecessary additional disturbance and does not comply with 1002.e

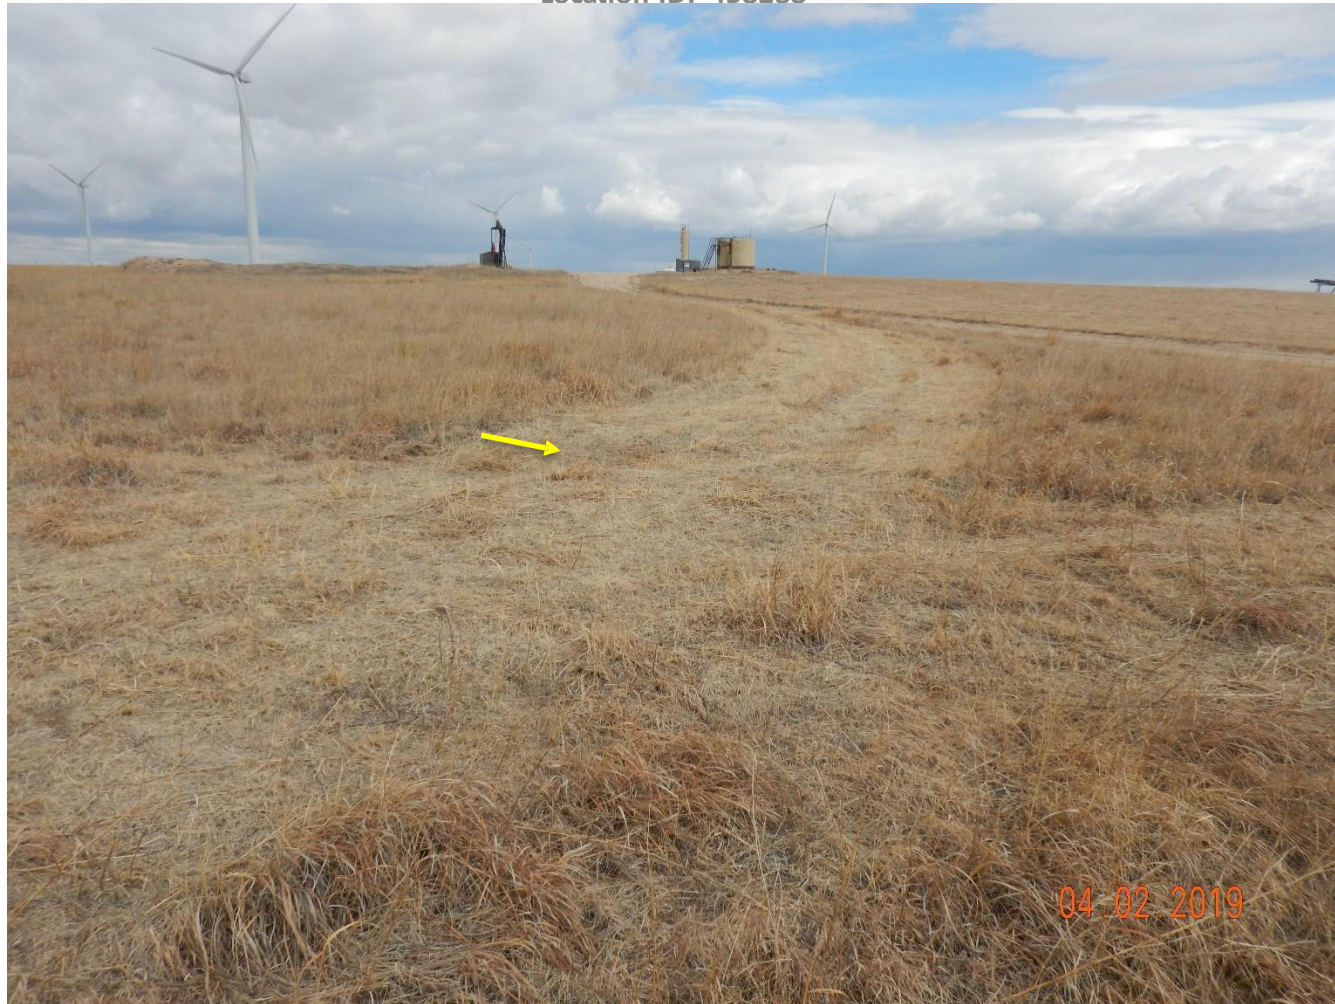
**Photo 22:** Continued from photo 21.

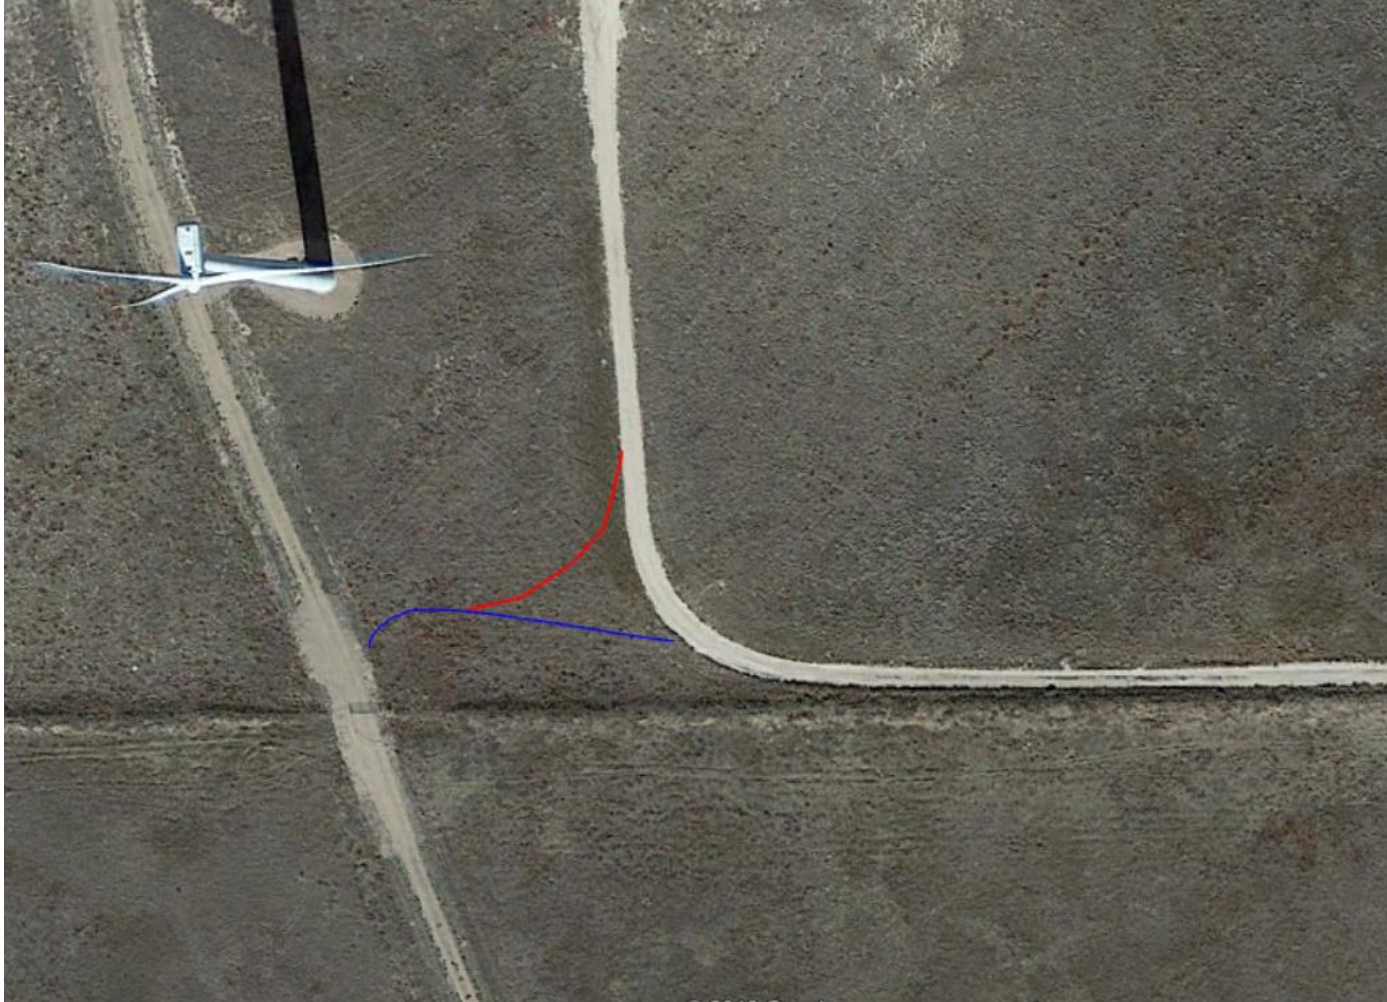
**Photo 22.b:** Google earth Aerial imagery. Red line represents approximate area of where operator created an additional section of access road traveling to the Highball 1 location, rather than restricting travel to the existing access road

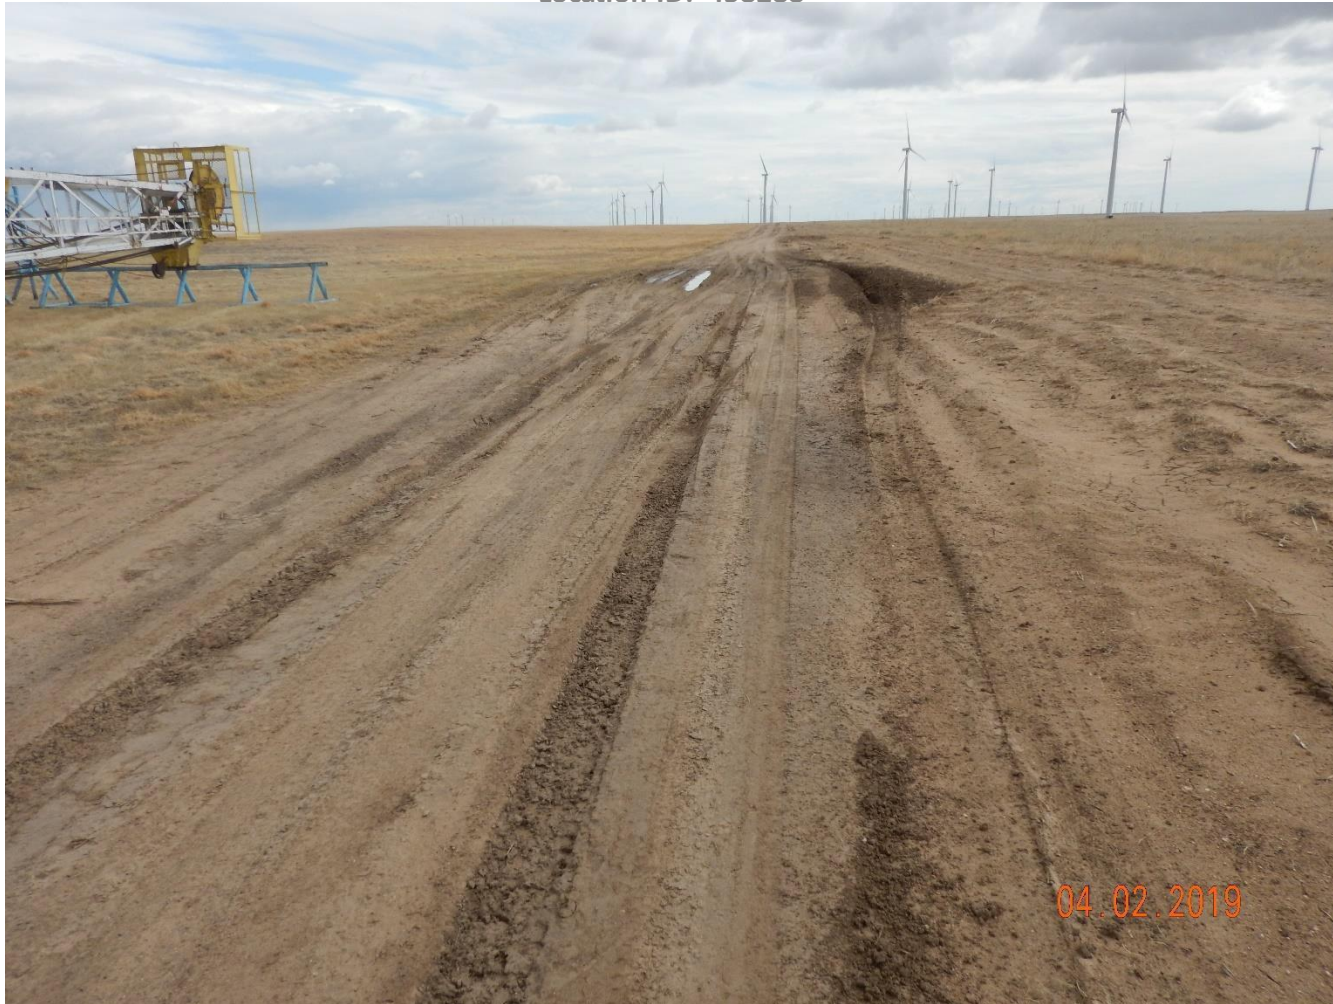
**Photo 23:** Photo taken from the from the east/west section of access road. Photo shows rutting degradation occurring along access road. BMPs should be installed and maintenance conducted to mitigate degradation to access road, and areas beyond the access road.

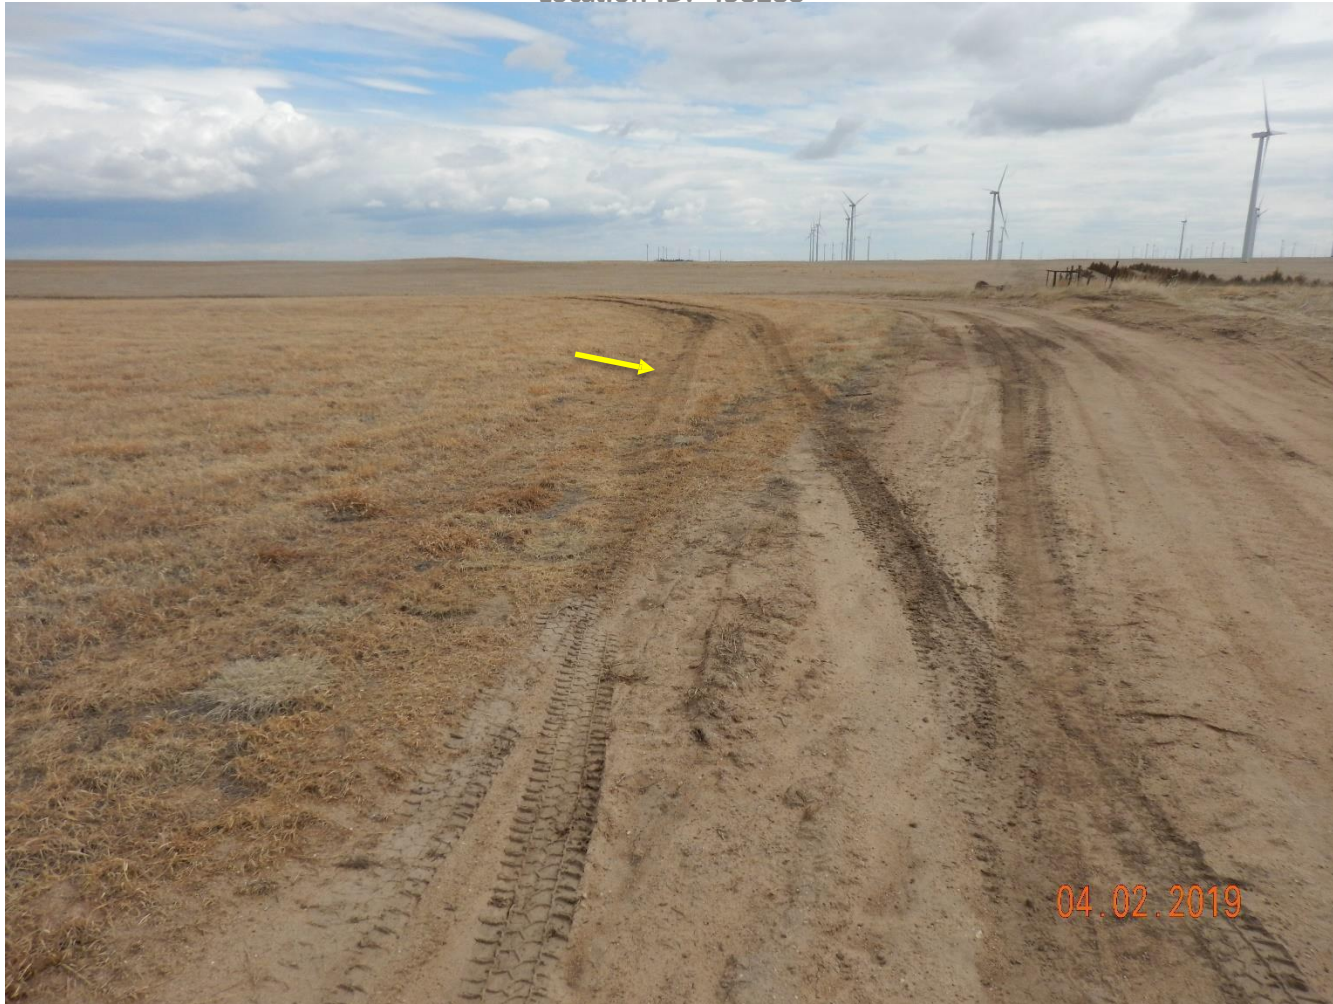
**Photo 25:** Photo taken northeast of the location, where the access road turns east/west to north/south. Photo shows operator appears to have travelled beyond the designated access road onto adjacent lands creating additional disturbance. This does not comply with 1002.e and will require reclamation.

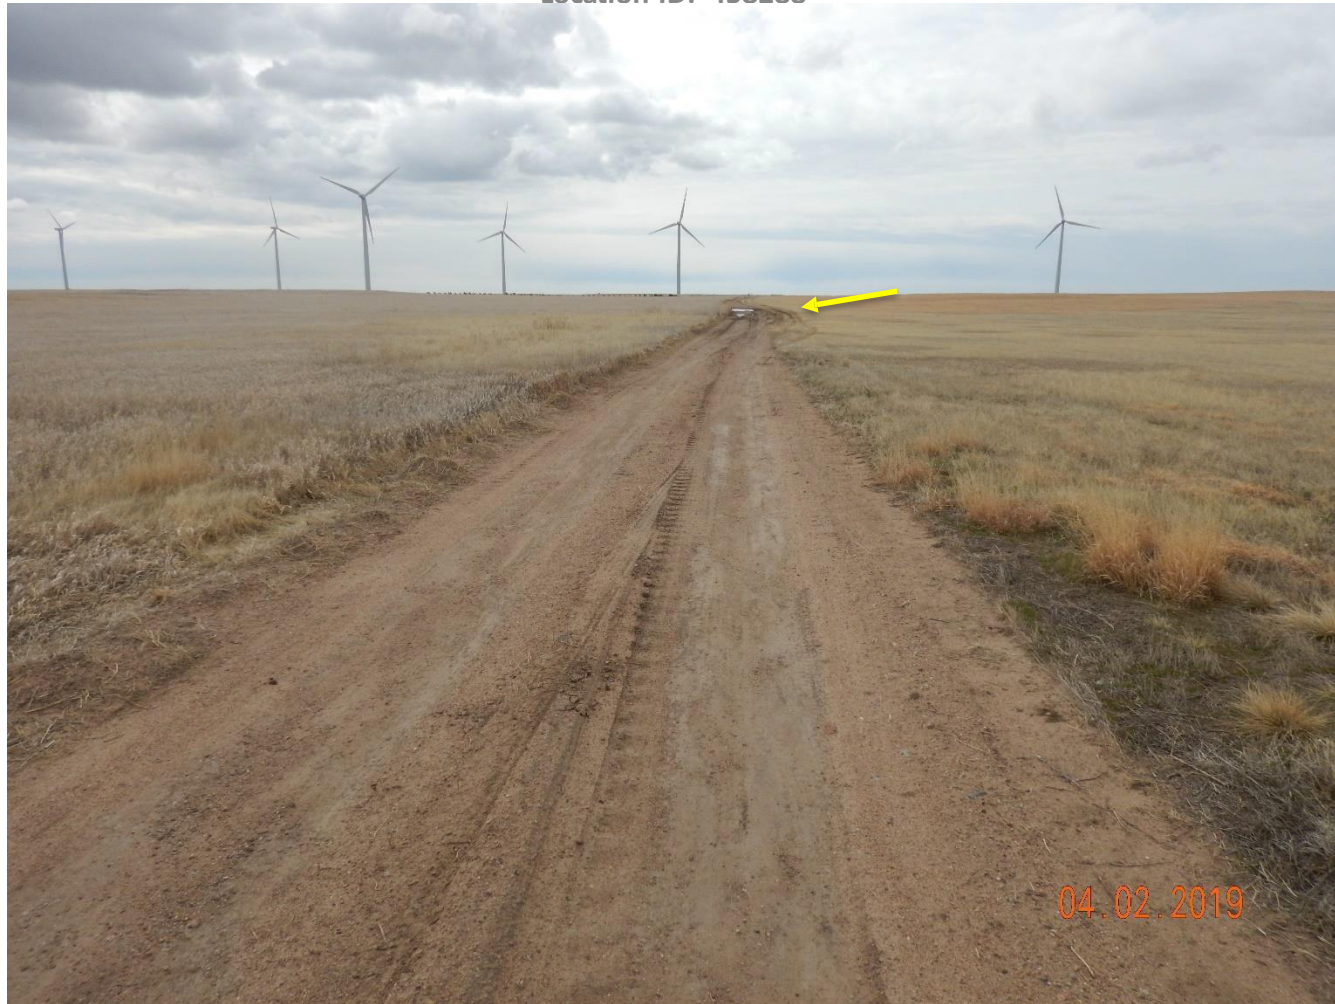
**Photo 26:** Photo taken from the north/south section of access road, facing south. See comments under photo 25.

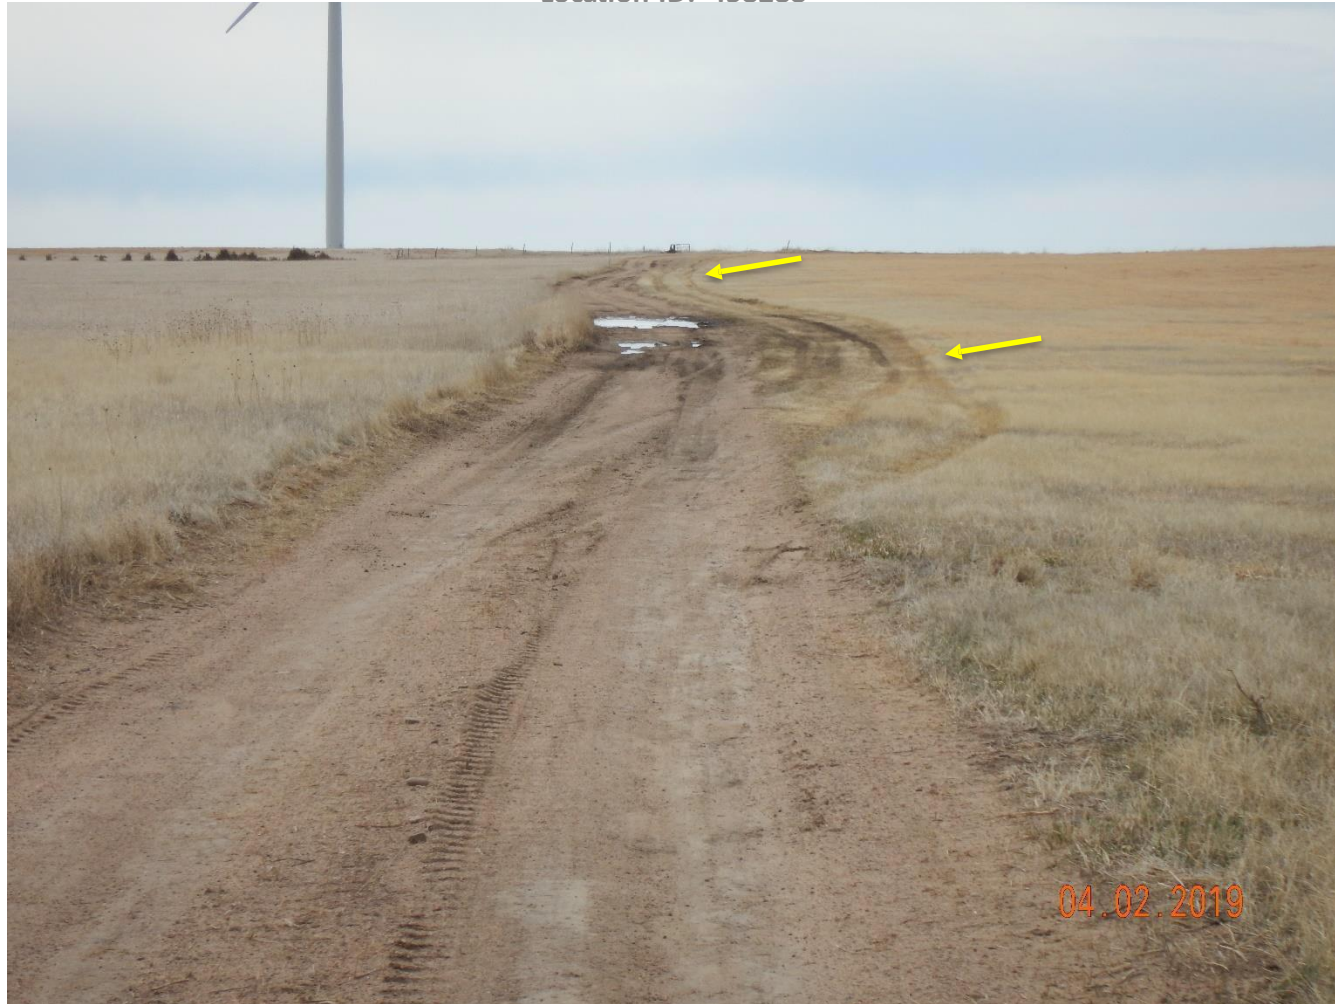
**Photo 27:** Photo taken from the north/south section of access road, facing south. See comments under photo 25.

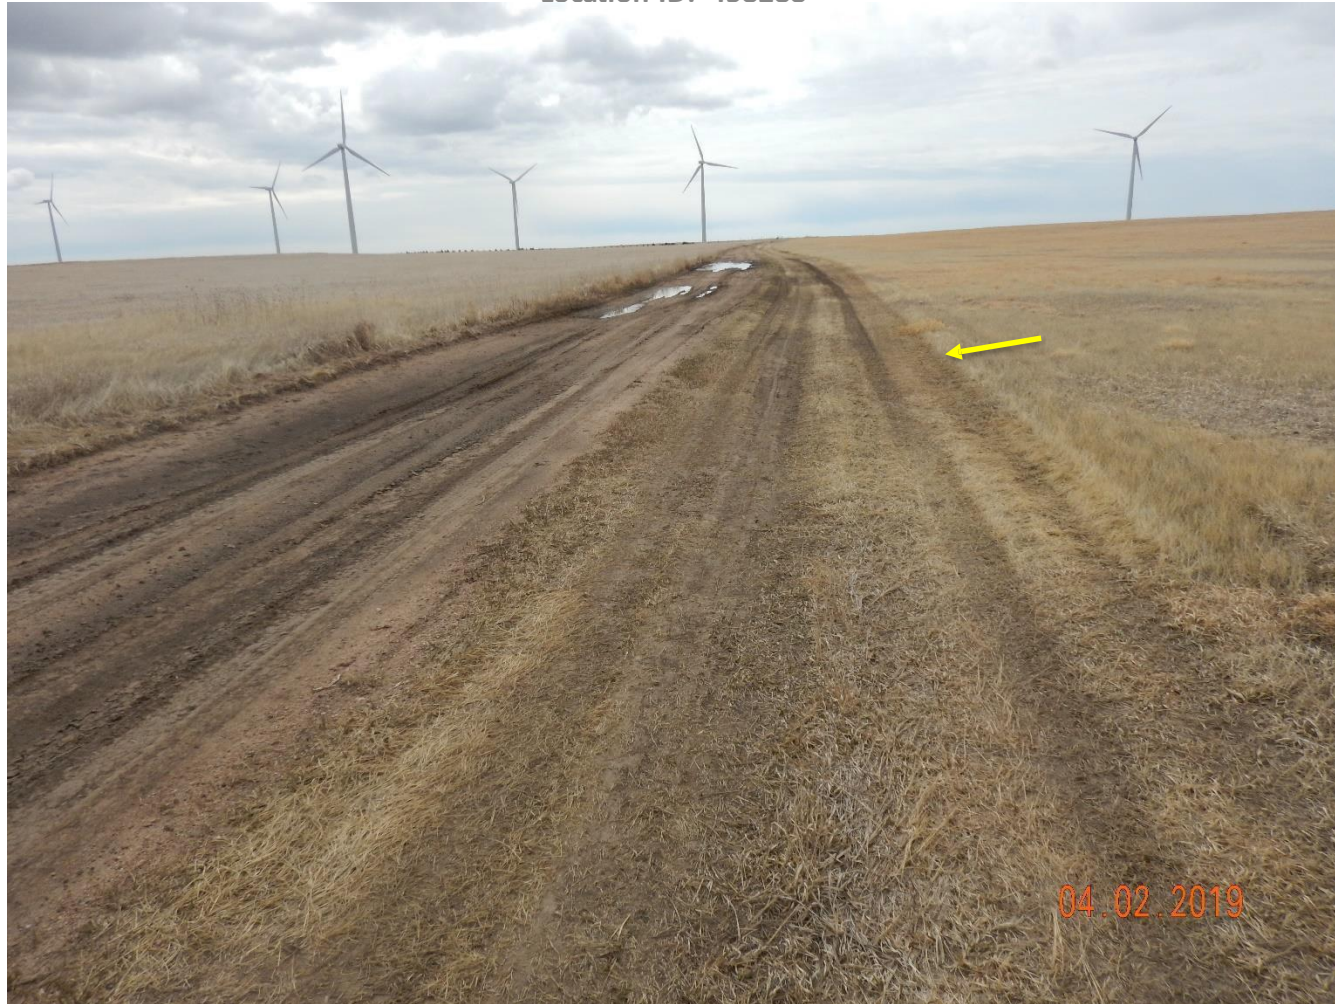
**Photo 28:** Photo taken from the north/south section of access road, facing south. See comments under photo 25.

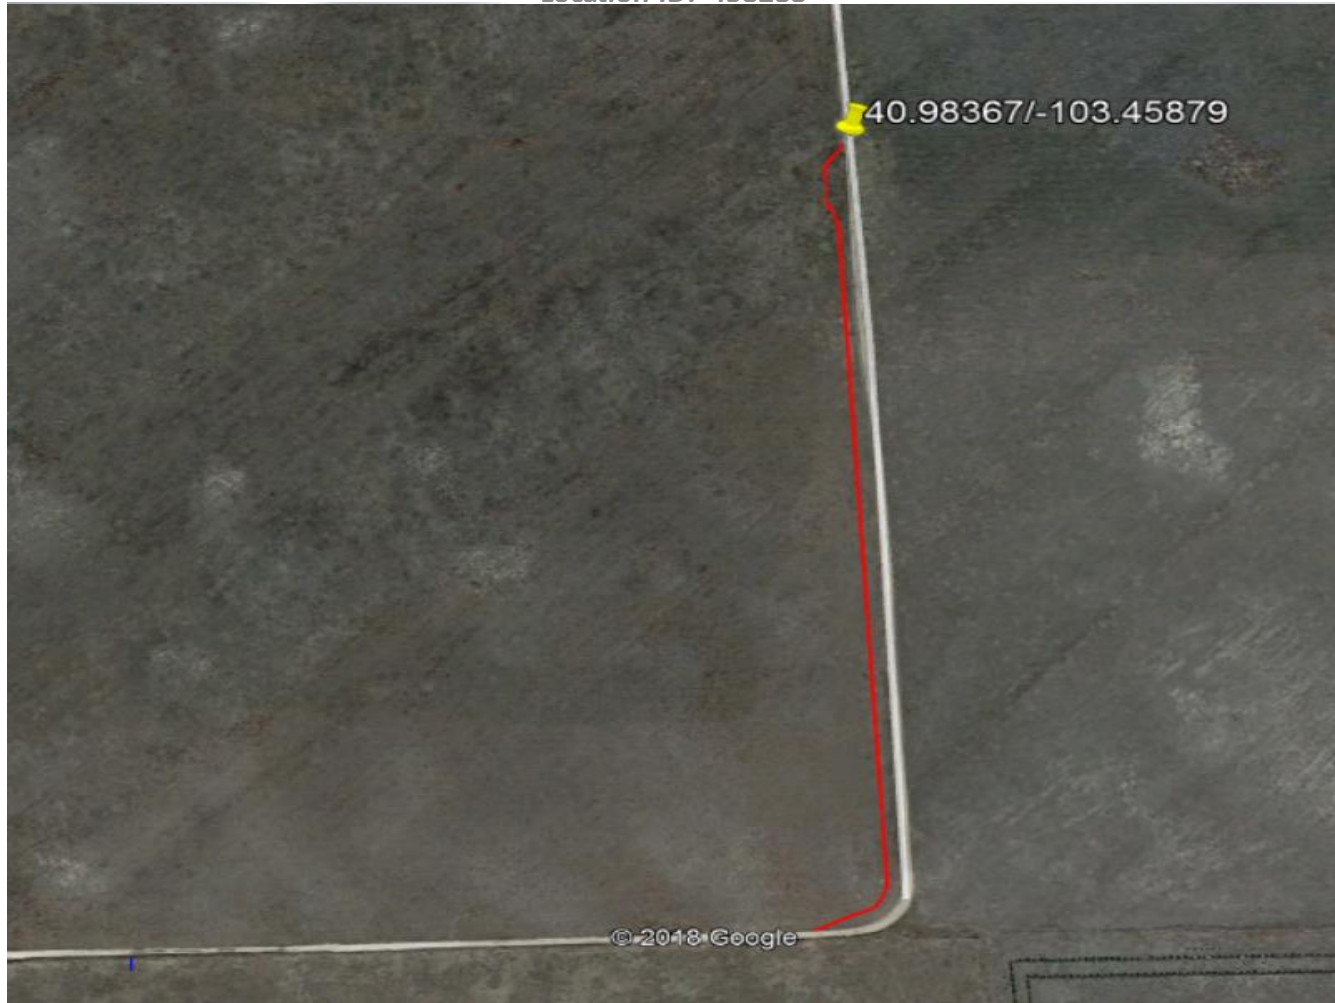
**Photo 28.b:** Google earth aerial image. Red line represents approximate area of where operator travelled off access road and created the additional 0.33 mile disturbances observed in photos 25-28.

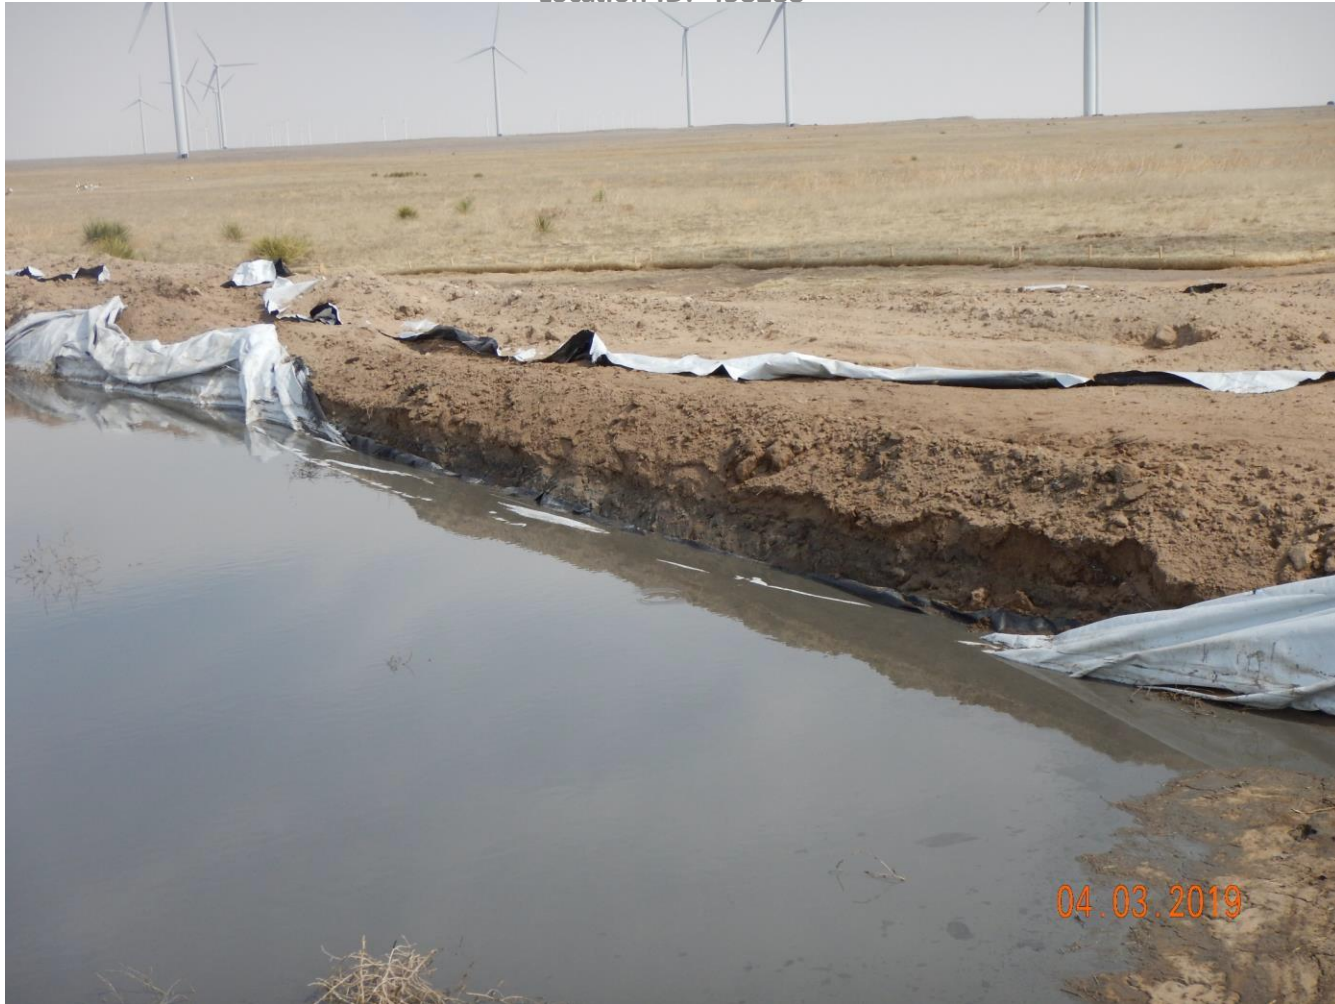
**Photo 29:** Photo taken from the drill pit, facing east. Photo shows section of the drill pit where the liner is no longer in proper functioning condition.

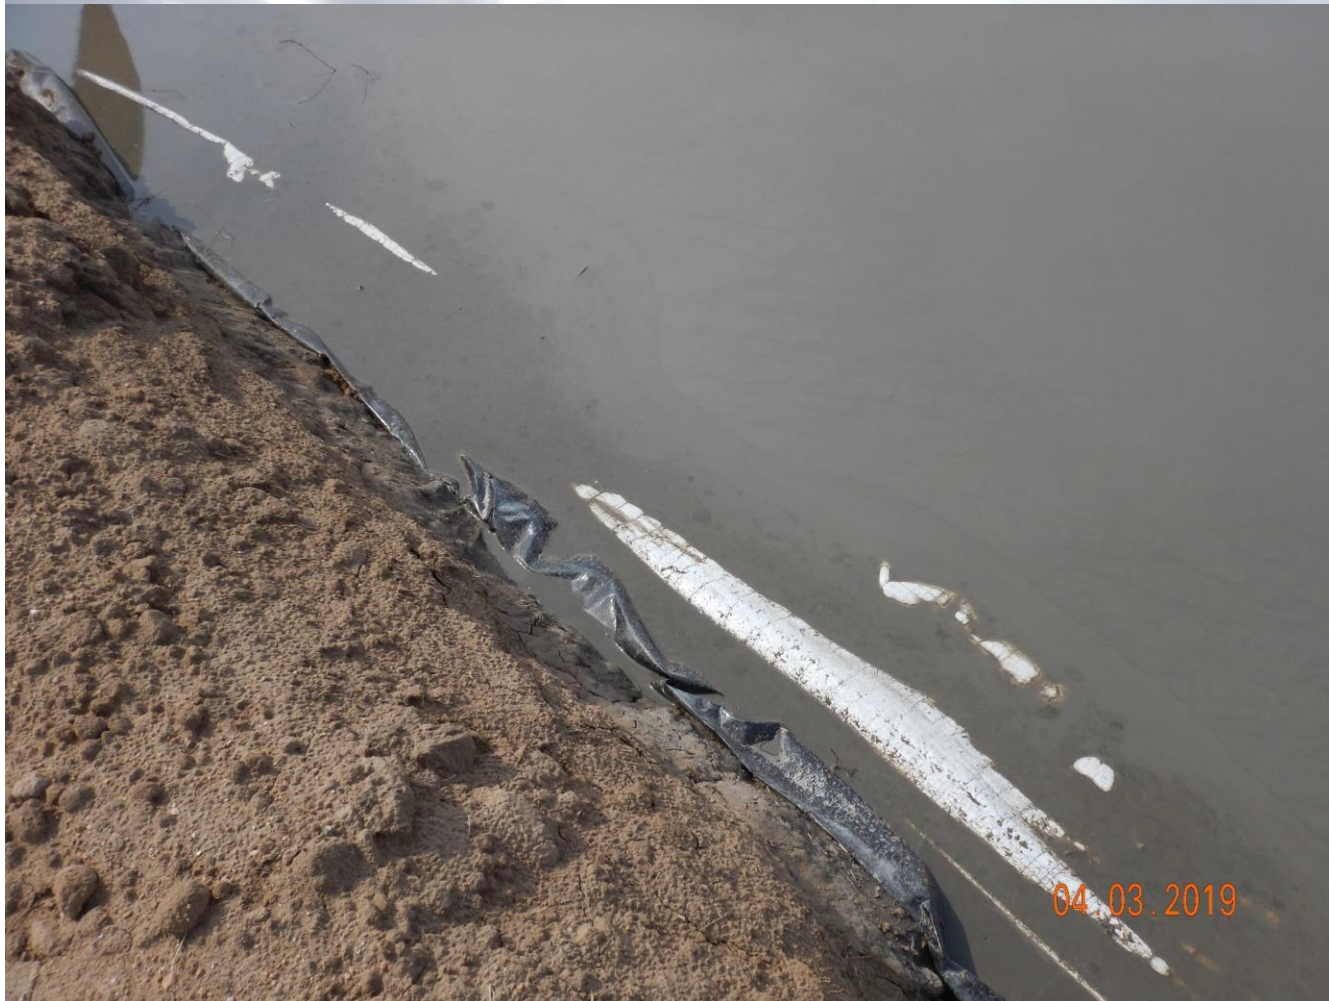
**Photo 30:** Photo taken from the drill pit. Photo shows section of the drill pit where the liner is no longer in proper functioning condition.

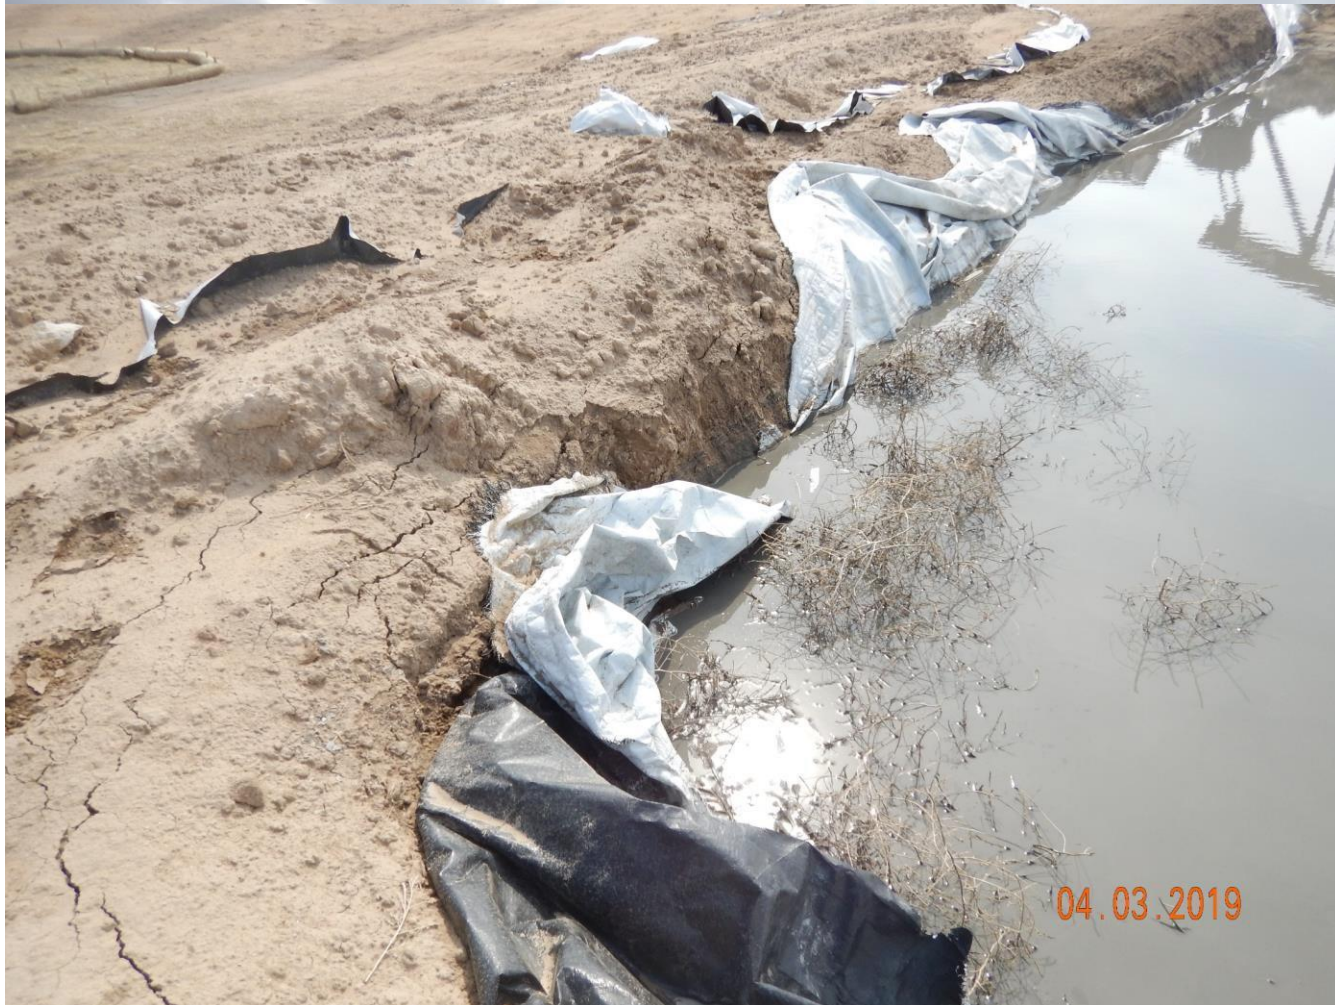
**Photo 31:** Photo taken from the drill pit. Photo shows section of the drill pit where the liner is no longer in proper functioning condition.

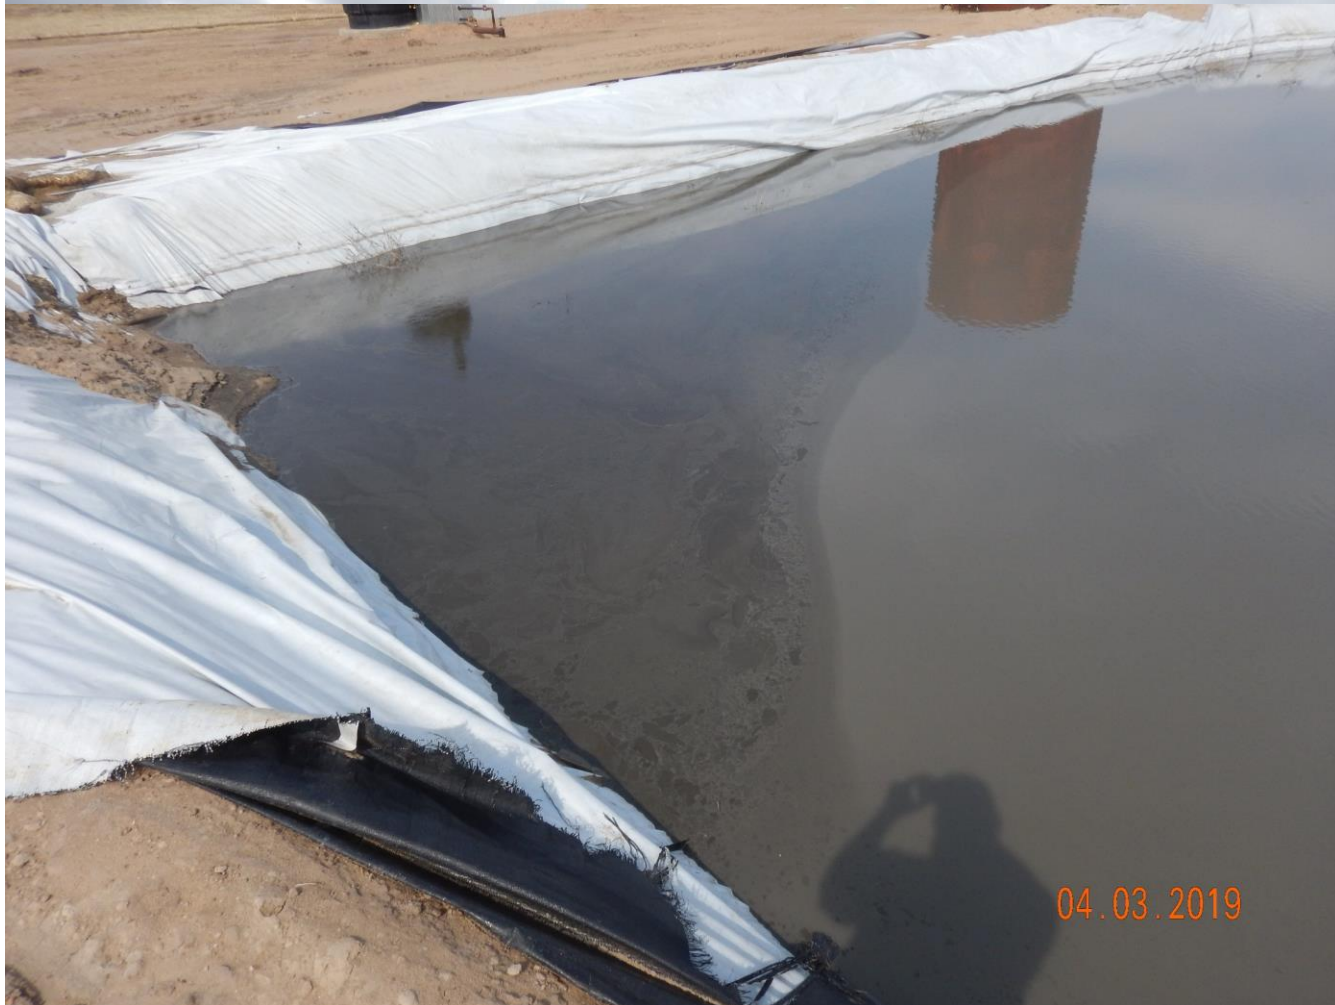
**Photo 32:** Photo taken from the drill pit. Photo shows chemicals/fluids within the pit.
