Inspection Photos

Loc#335553

Inspection Number: 692400826

Inspection Photos: Ursa Valley Farms I Pad Loc#335553

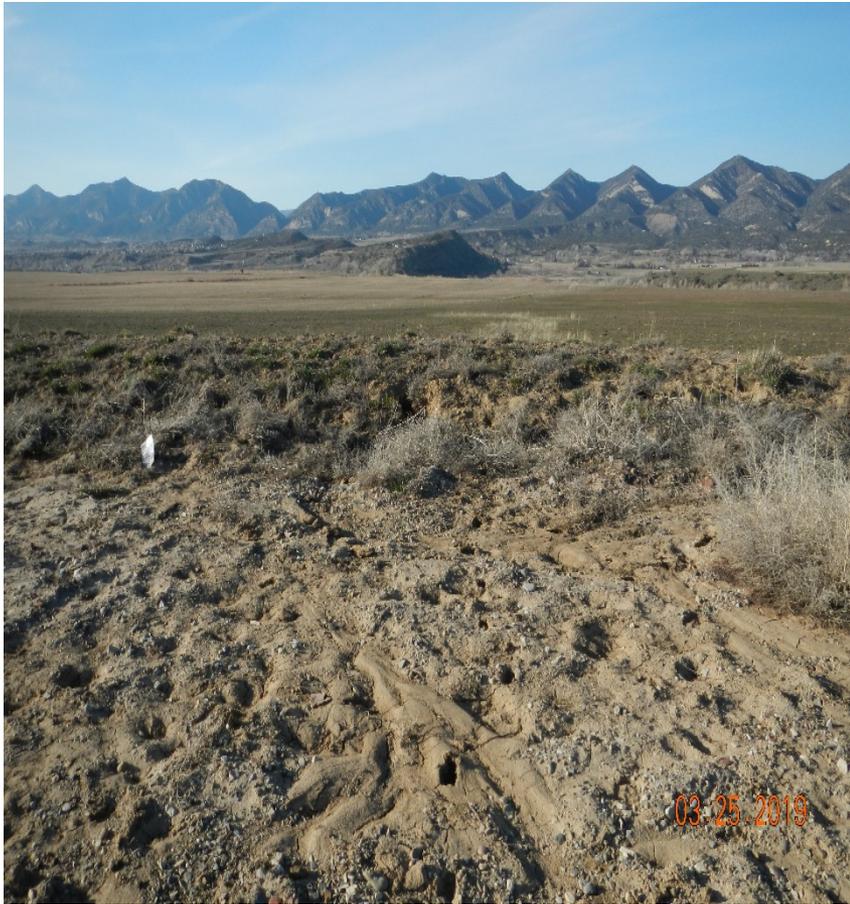
Photo#1:
NW corner of Pad where Stormwater has collected & blown out channels through Fill slope.

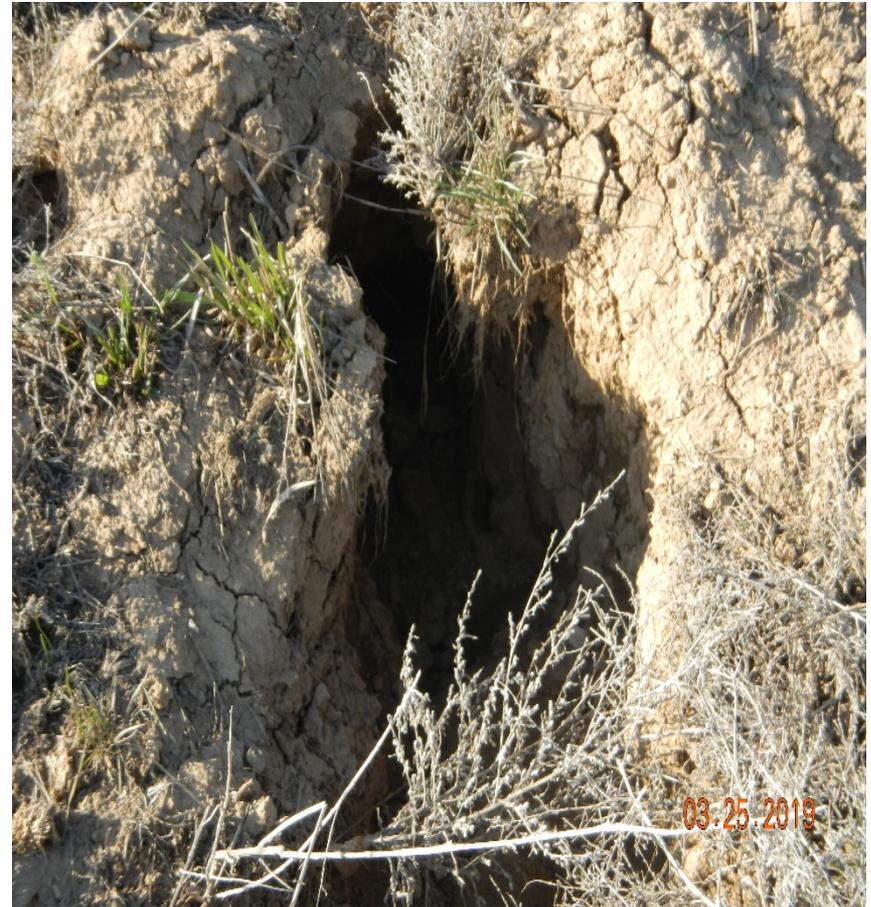
Photo#2:
NW corner of Pad where Stormwater has collected & blown out channels through Fill slope.

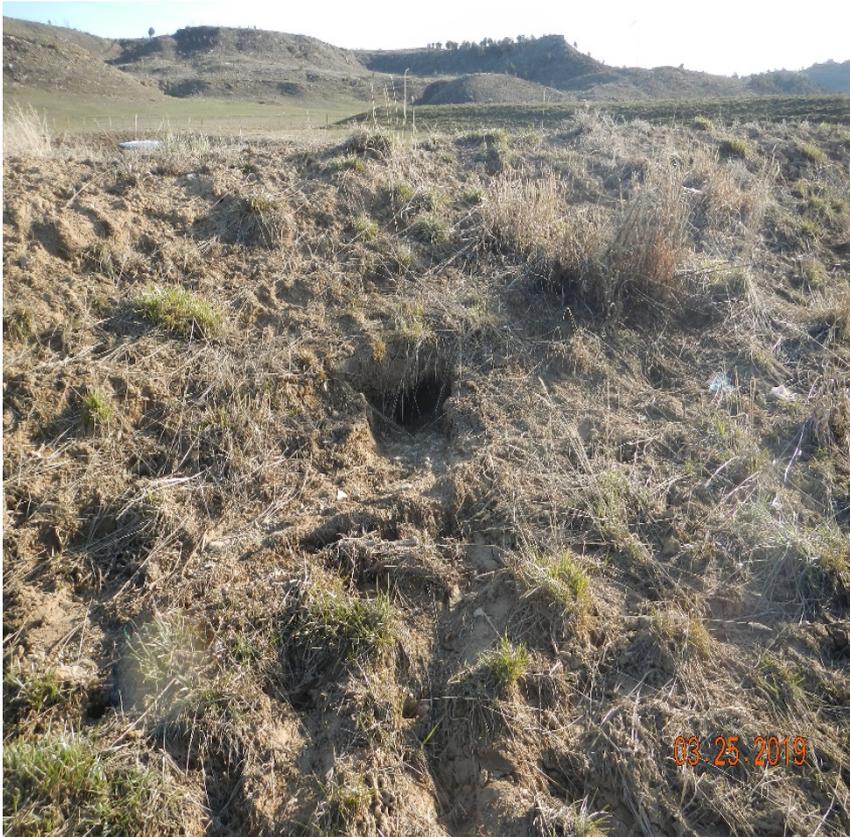
Photo#3:
Point where stormwater discharges on outside of
NW Fill slope.

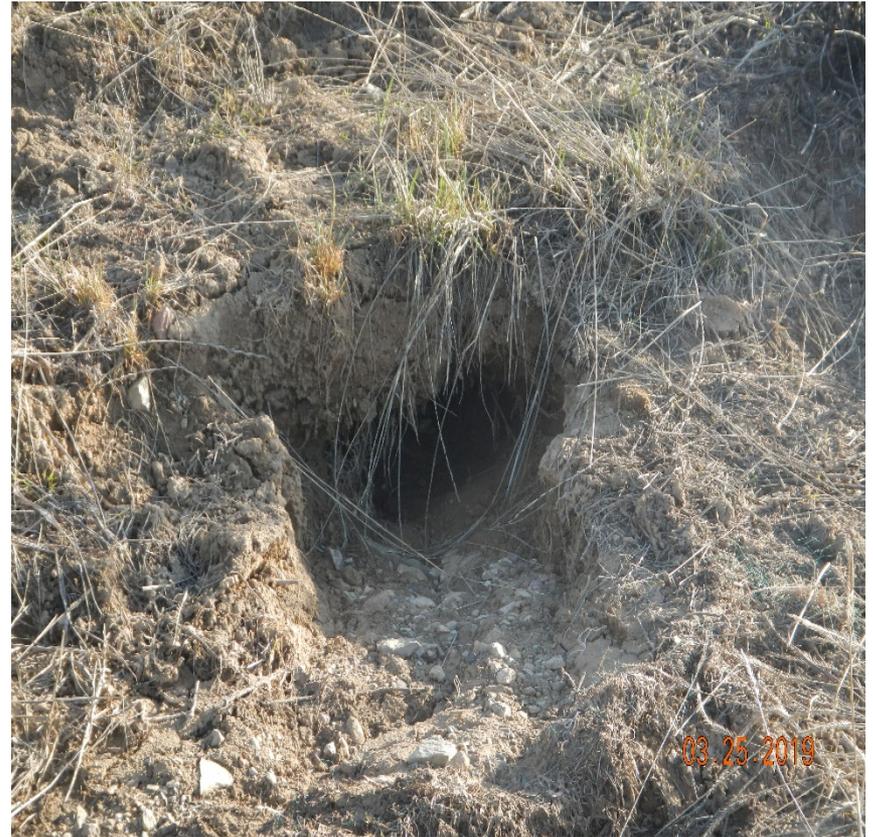
Photo#4:
Point where stormwater discharges on outside of
NW Fill slope.

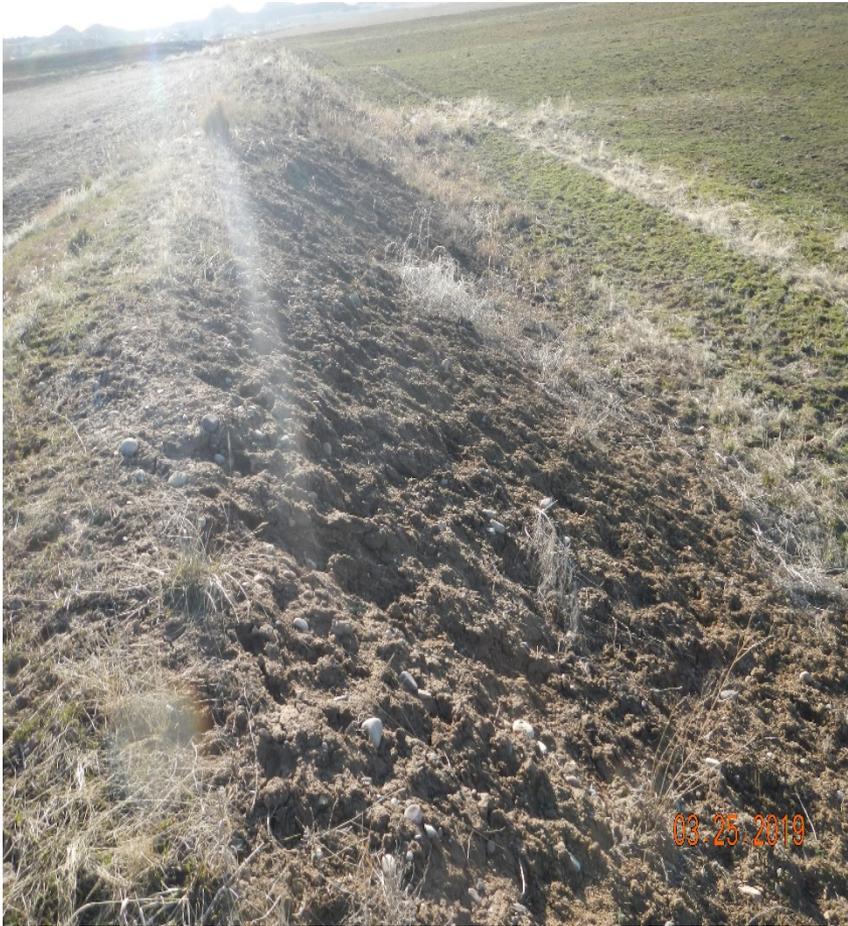
Photo#5:
View over fill slope to West. Areas of fill slopes are in need of stabilization.

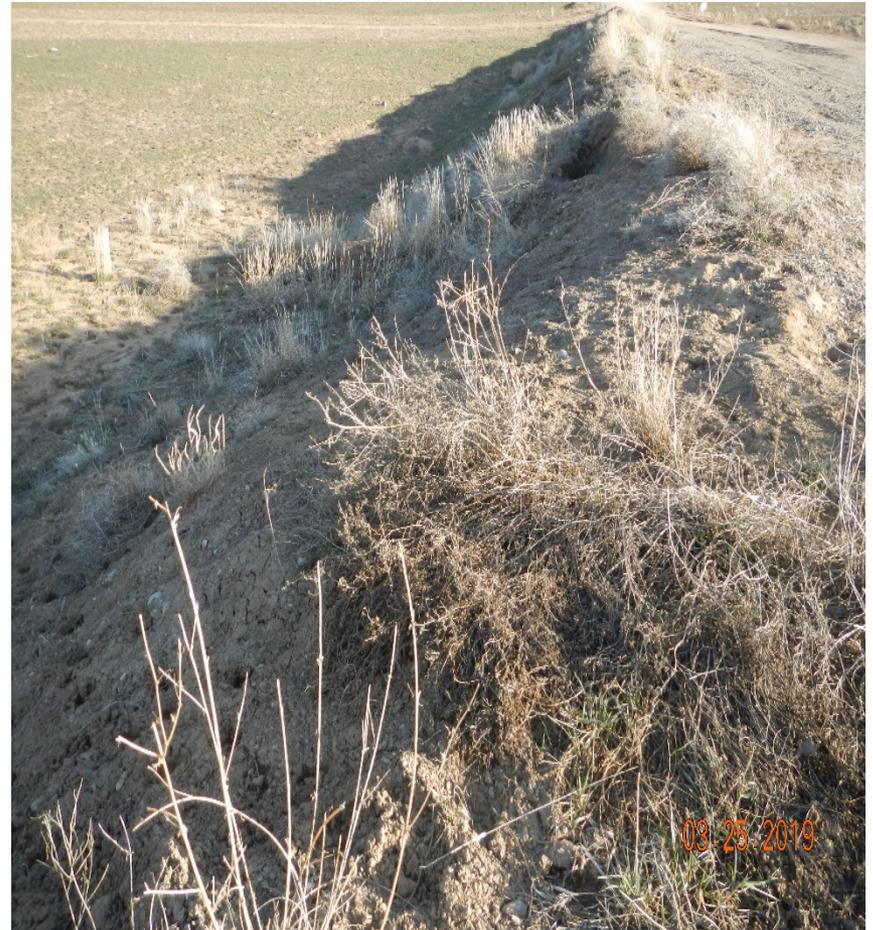
Photo#6:
View over fill slope to East. Areas of fill slopes are in need of stabilization.

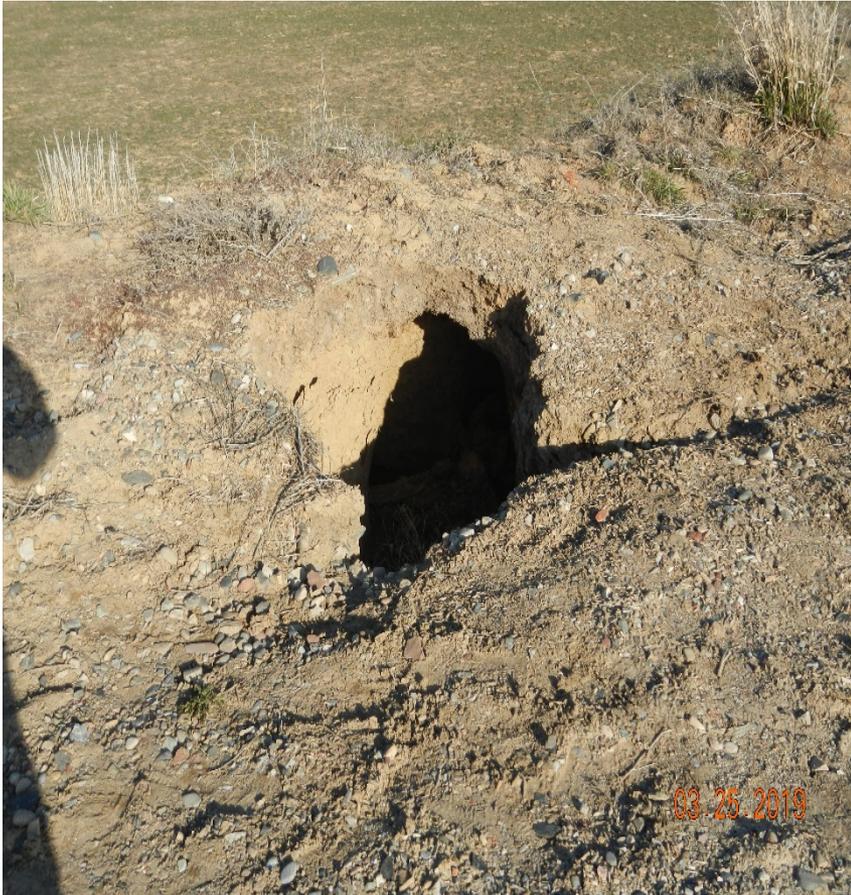
Photo#7:
East side of Pad where Stormwater has collected & blown out channels through Fill slope.

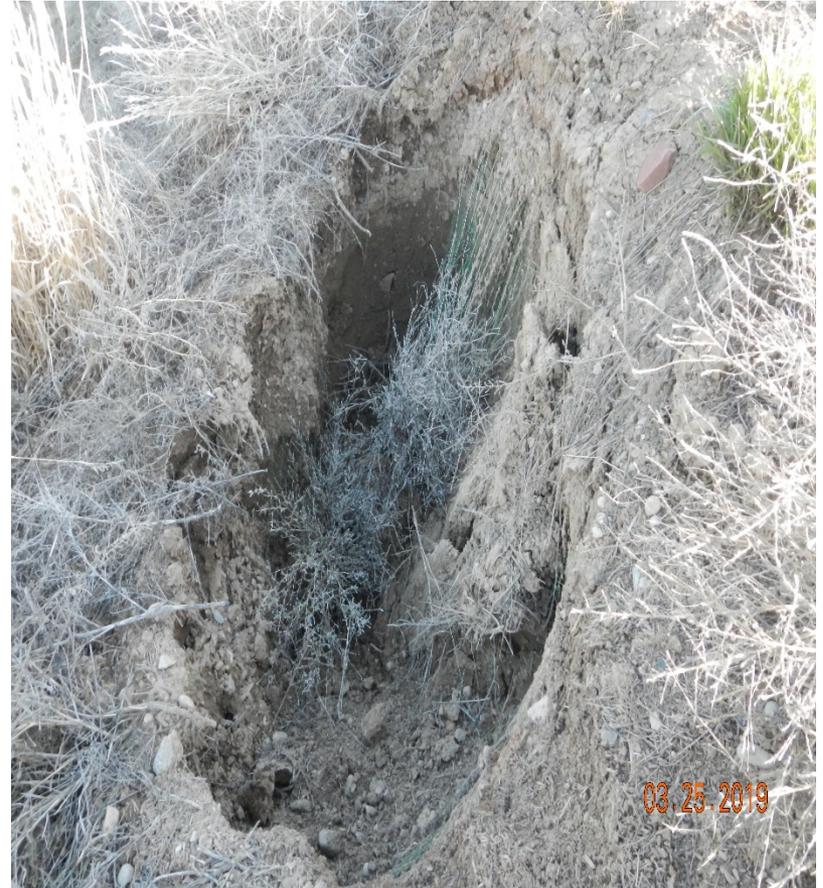
Photo#8:
Point where stormwater discharges on outside of East Fill slope.

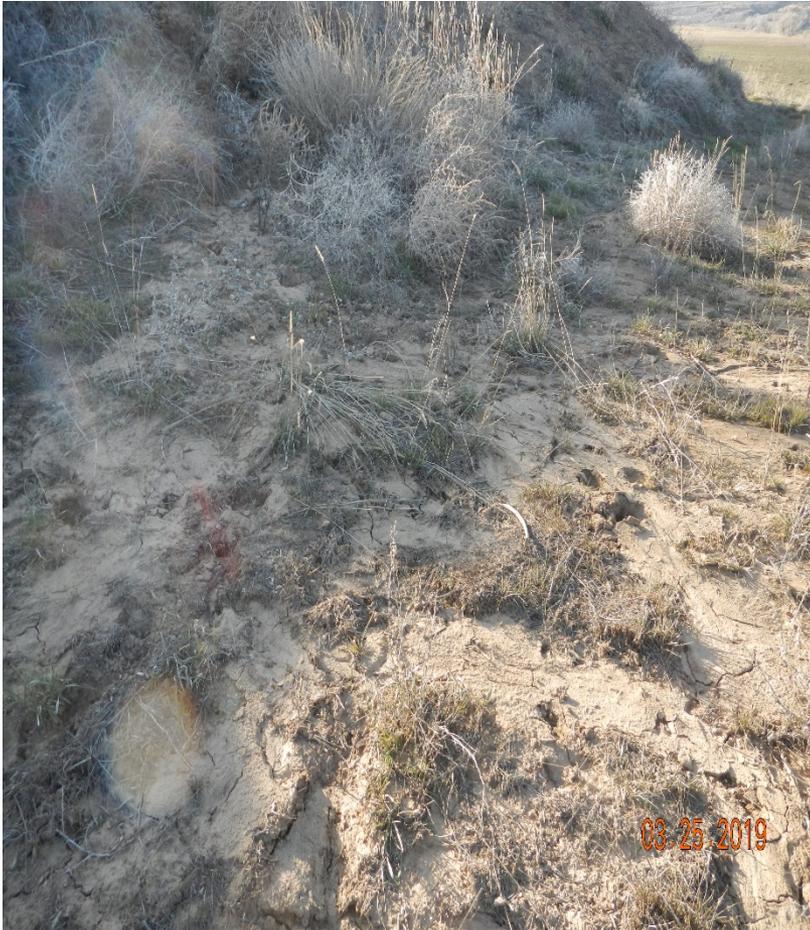
Photo#9:
Base of East fill slope showing Sediment migration.

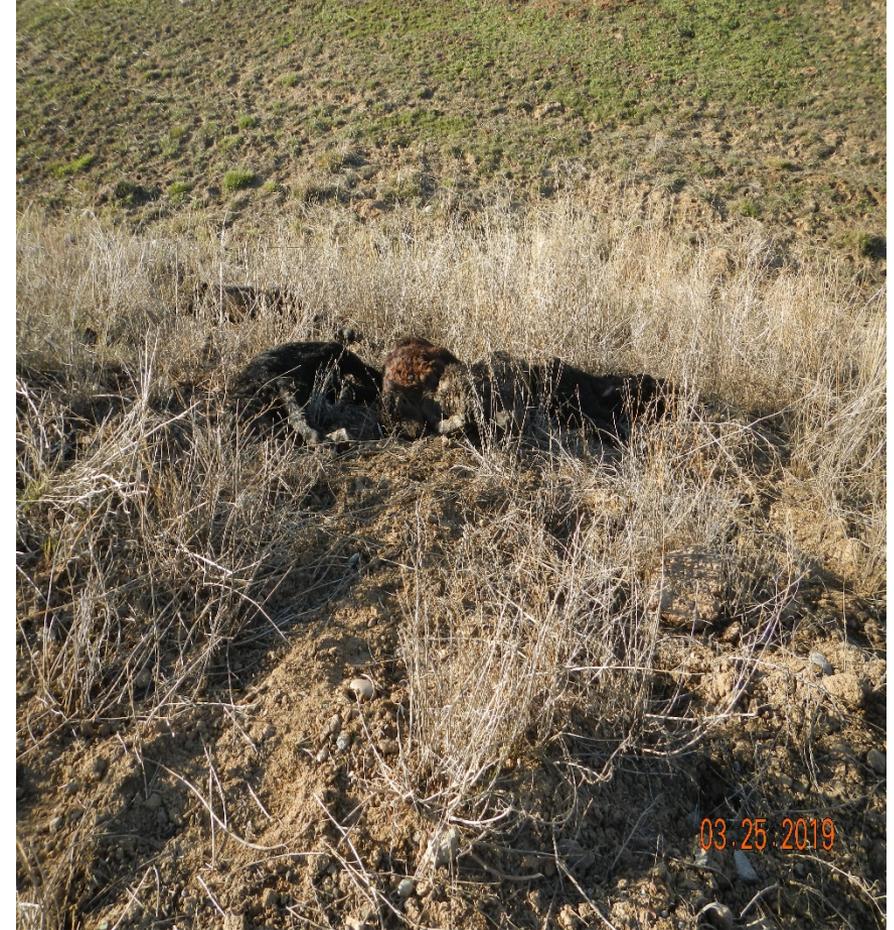
Photo#10:
Calf carcasses have been dumped on Northeast
area of Fill slope.
