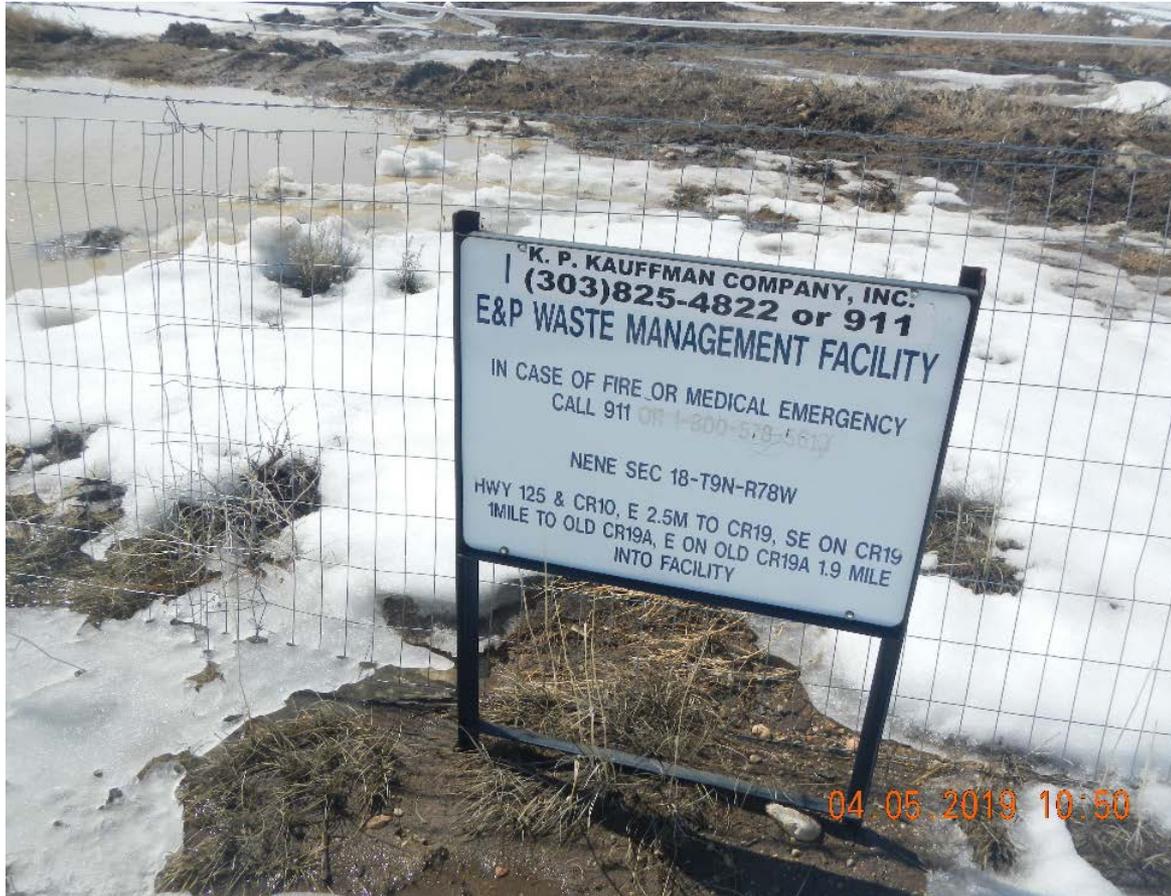
Photo 1 –Posted Sign on at land farm.

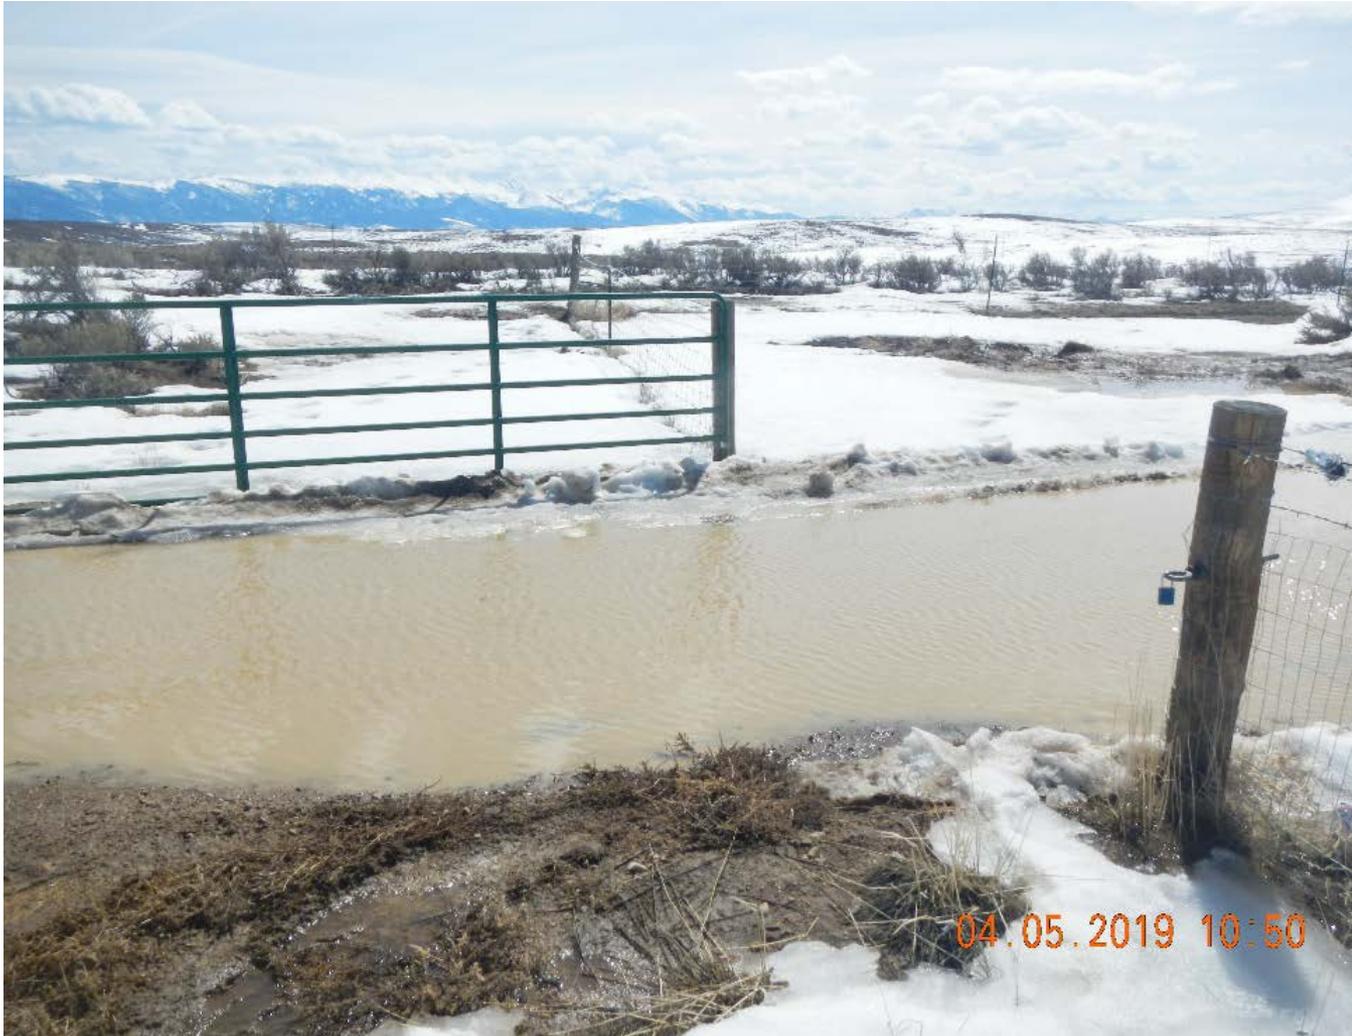
Photo 2 –Gate was open at time of inspection. Snow melt at entry, this snow melt appears to be outside of the secondary containment of the treatment area.

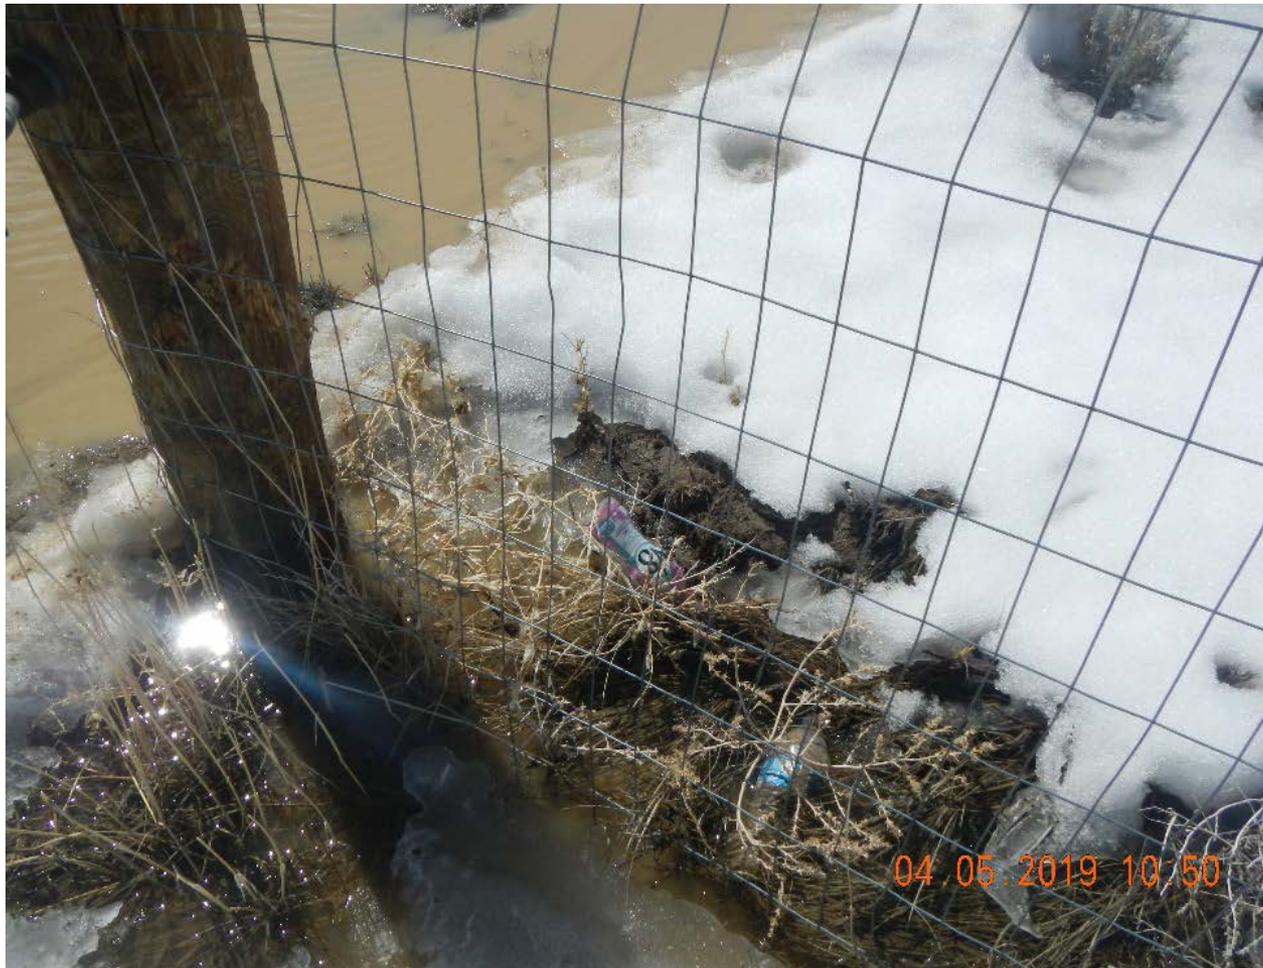
Photo 3 –trash at gate.

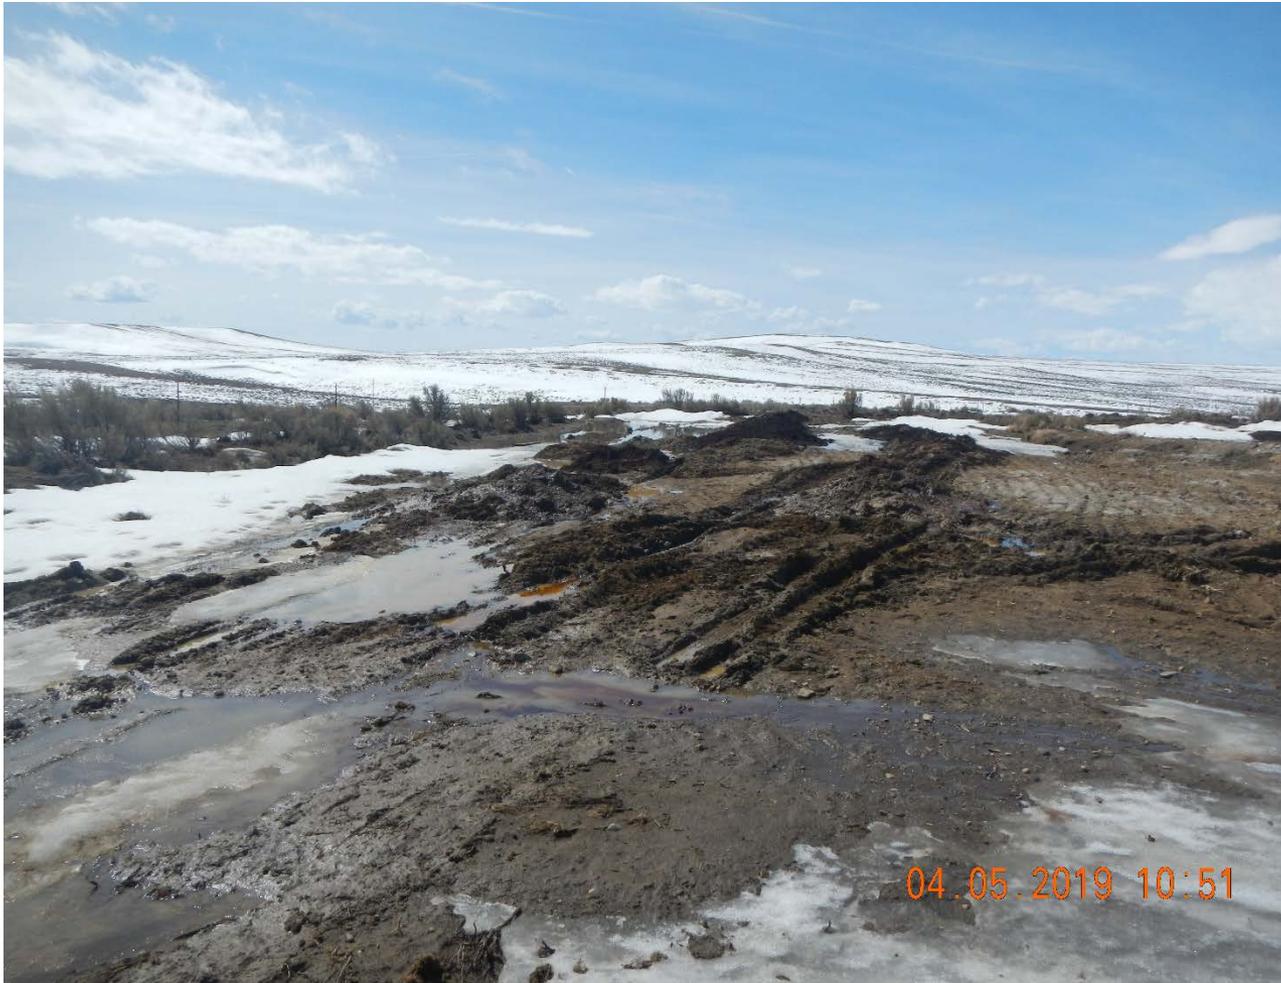
Photo 4 –Eastern cell. Some liquid hydrocarbon present in snowmelt

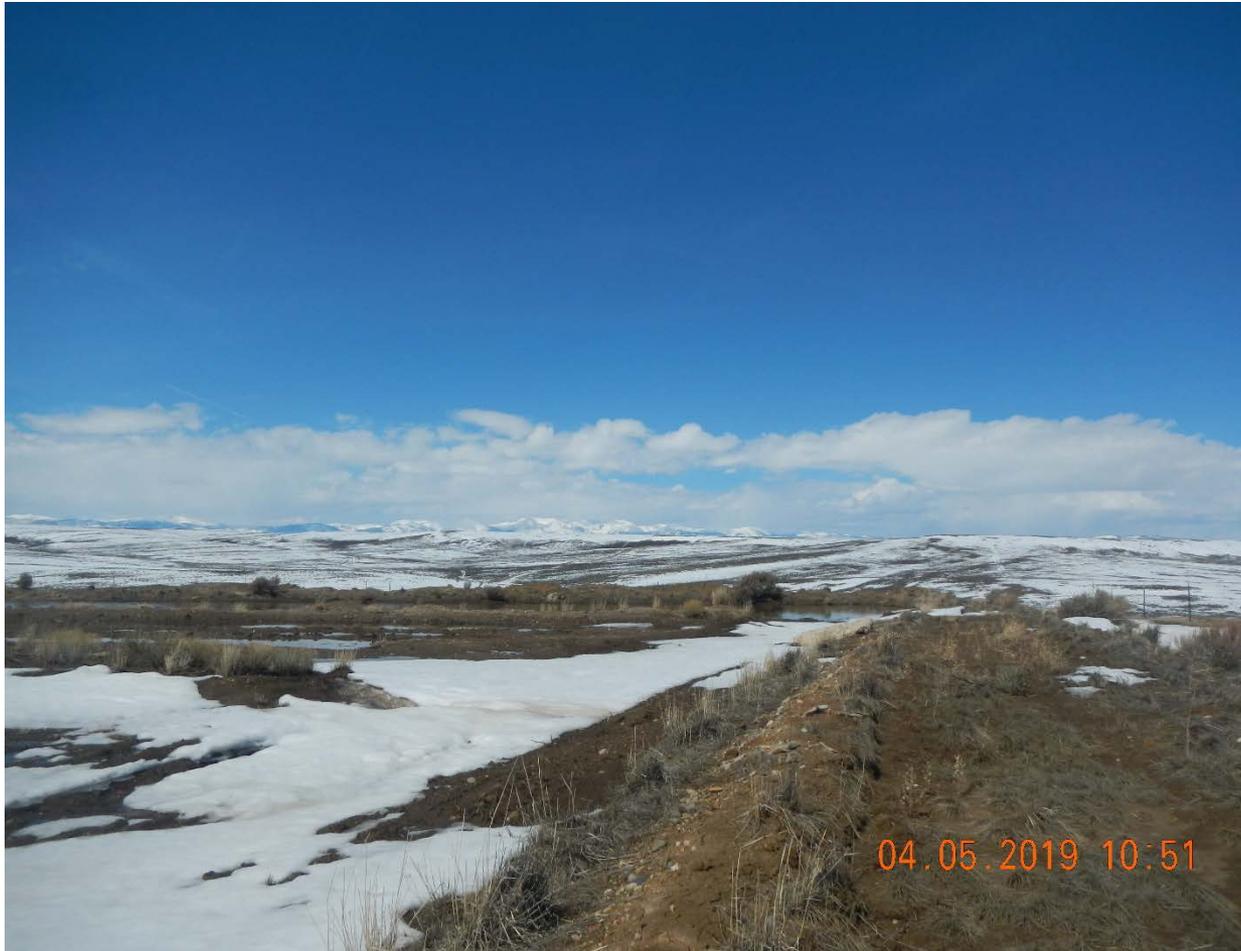
Photo 6 –Land treatment area. Looking west

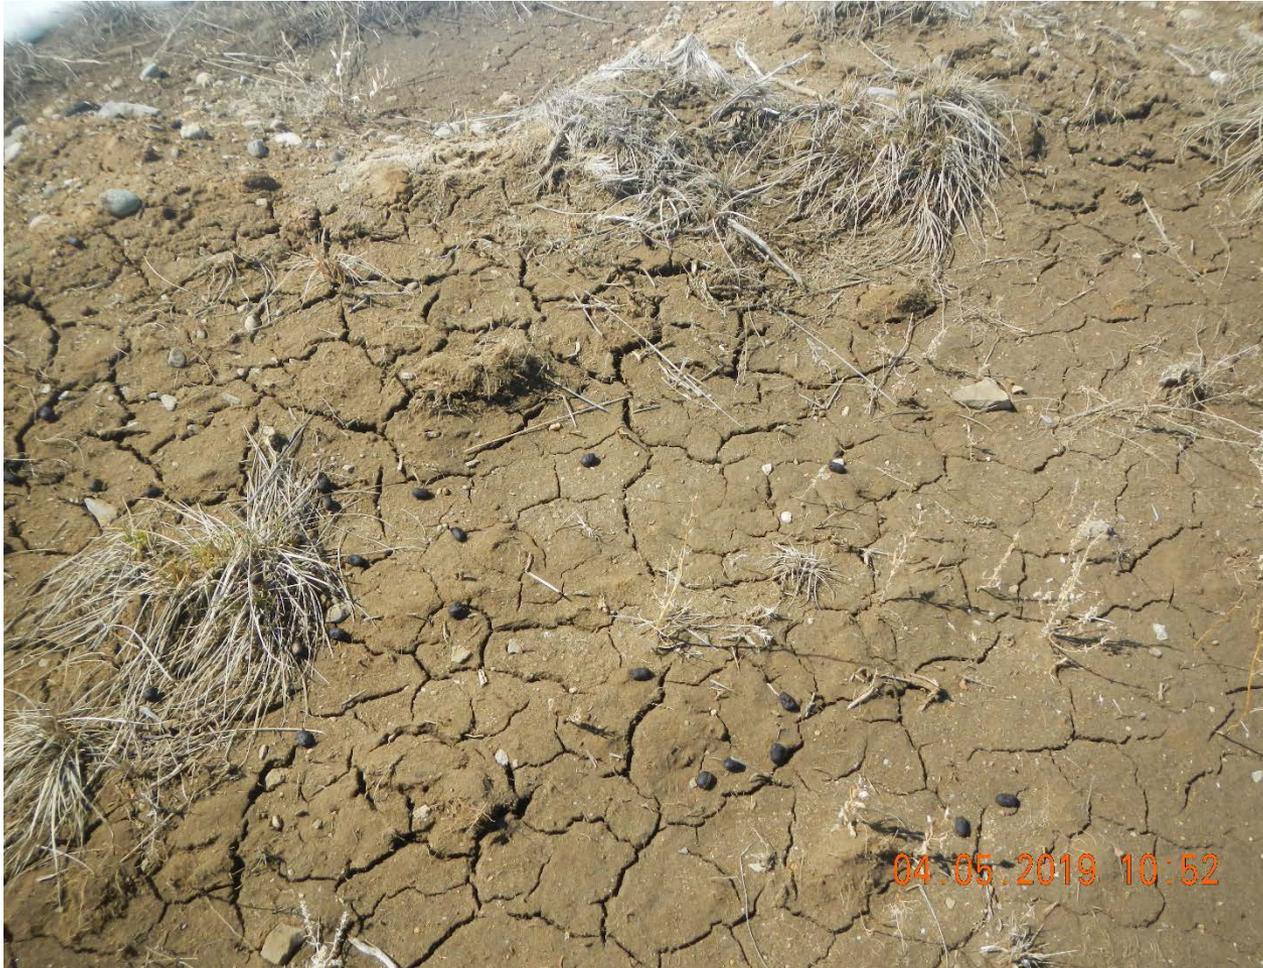
Photo 7 –wildlife scat.

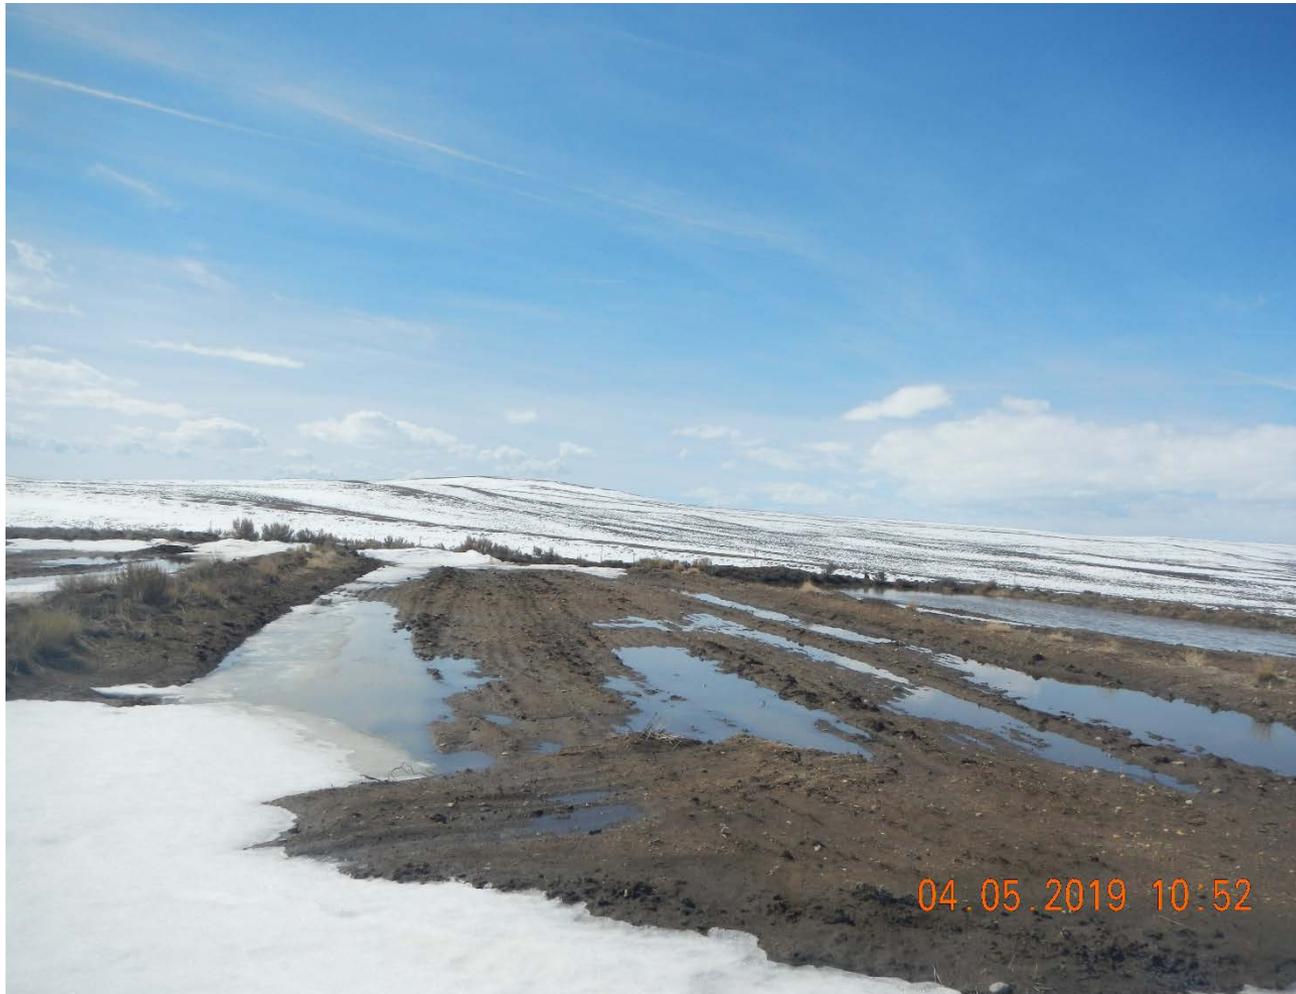
Photo 8 –Land treatment area. Pooling stormwater.

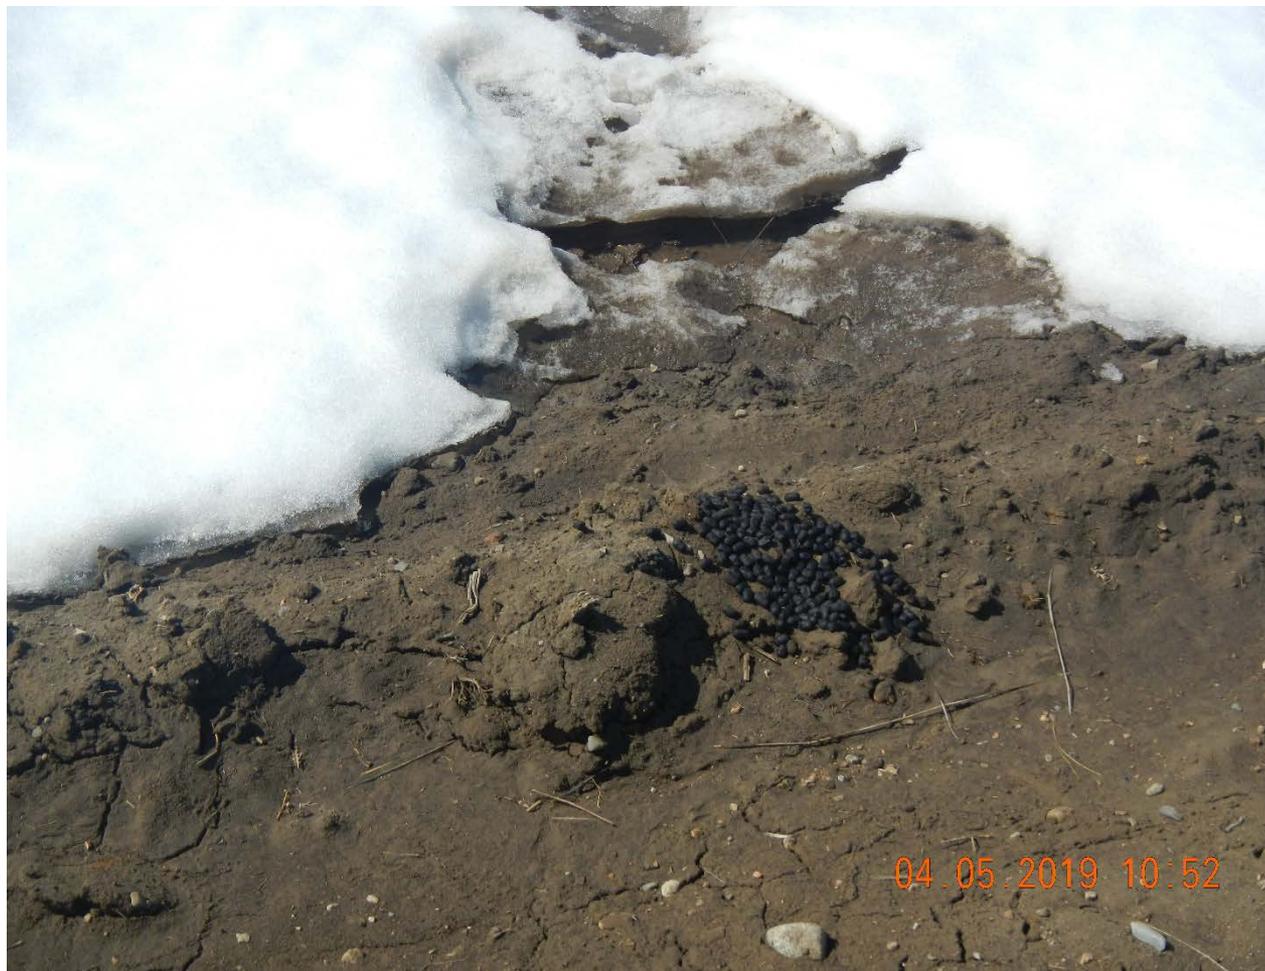
Photo 9 –wildlife scat.

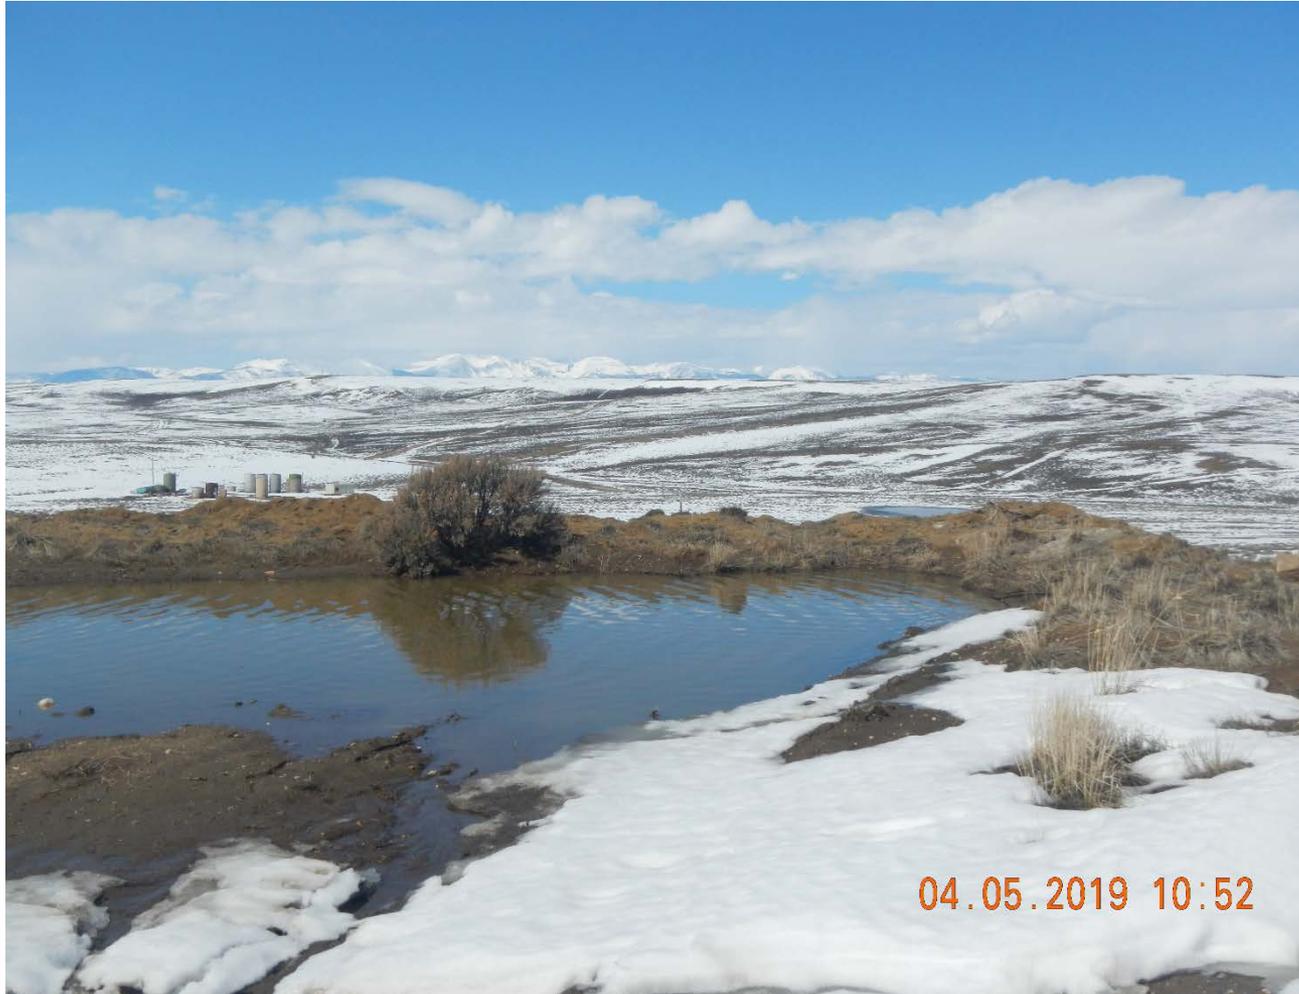
Photo 10 –Looking west at western most cell of land treatment area. It appears that the facility drains to the west, note pooling.

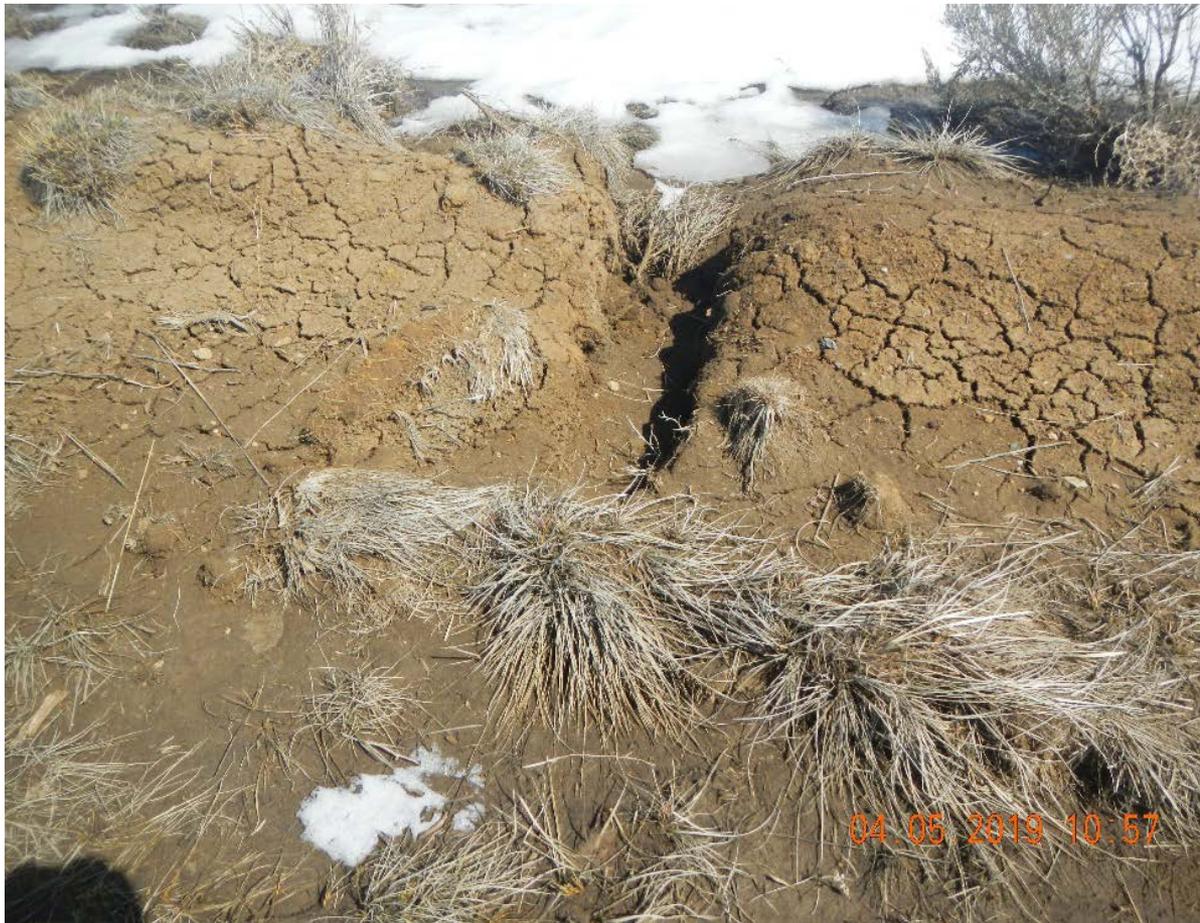
Photo 15 –North side of secondary containment area. Corrective Action: assure that secondary containment is being maintained.

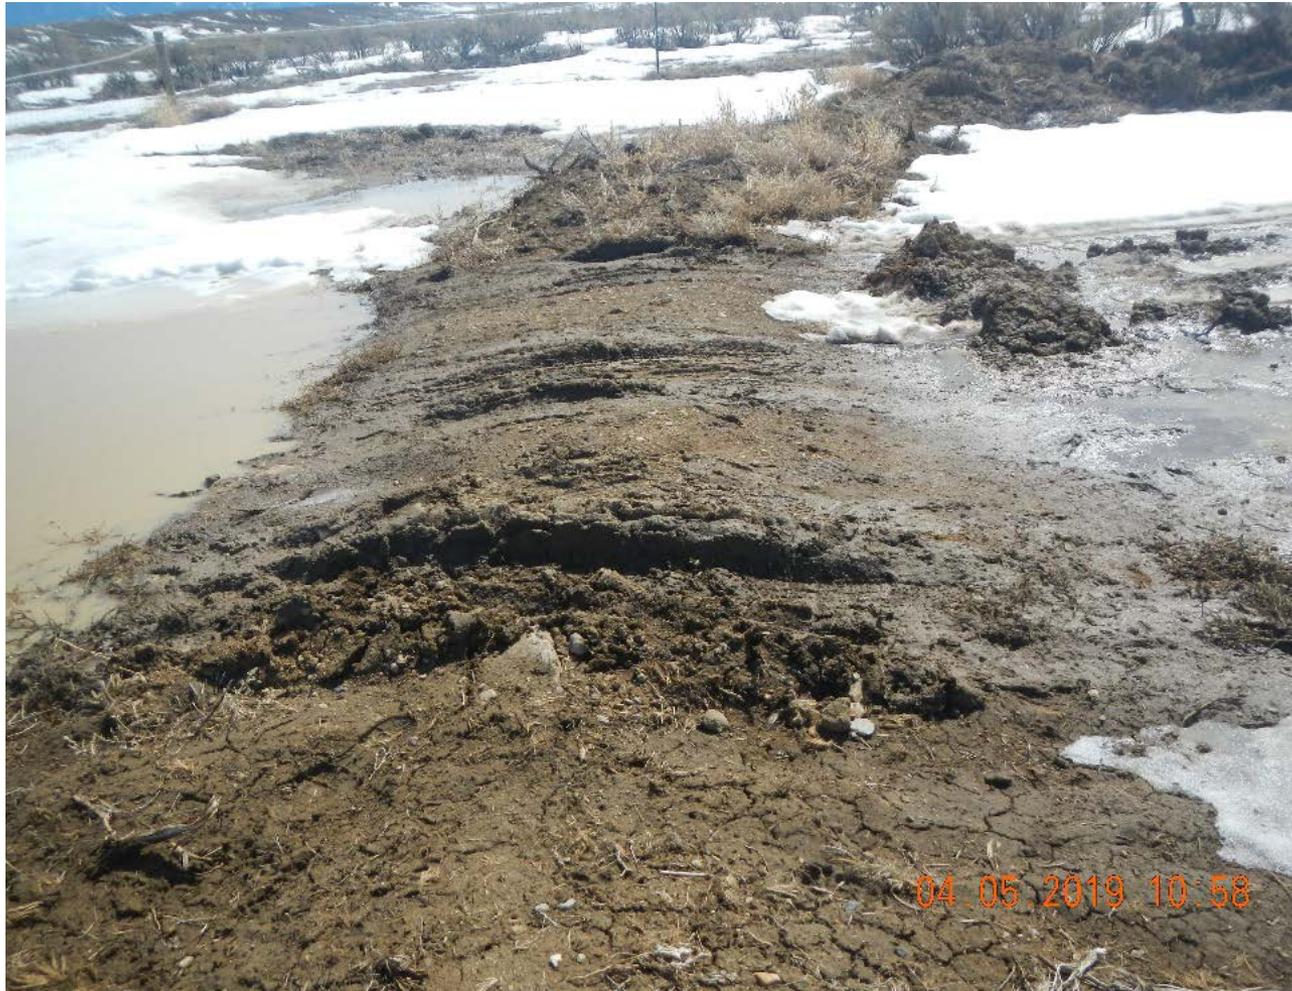
Photo 16 Drive over secondary containment at access to land treatment location.

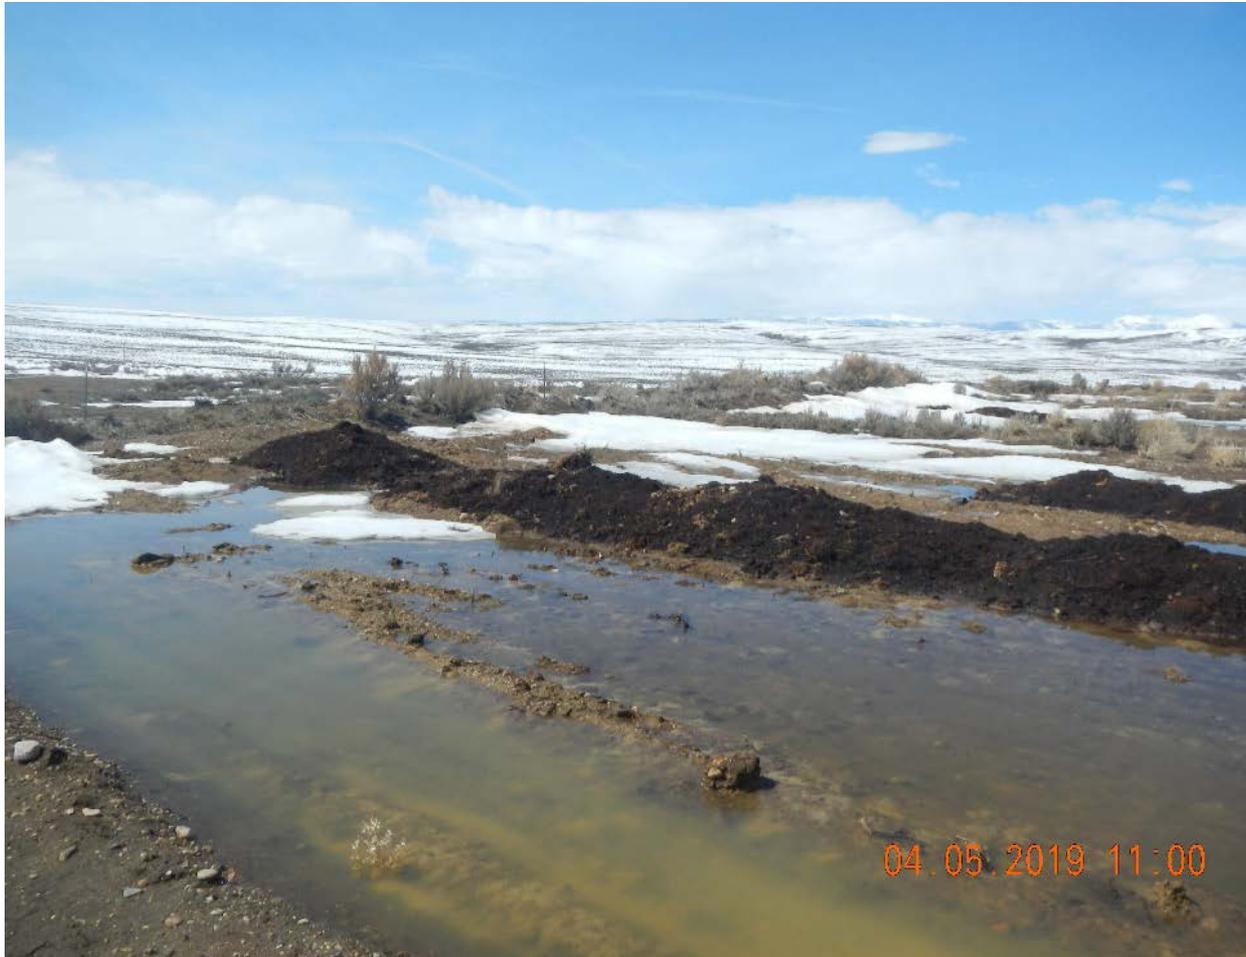
Photo 17 –Pooled water inside land treatment area. Some water had liquid hydrocarbon.
