**GM 44-1**  
**Api. # 05-045-07448**  
**Inspection # 689702998**

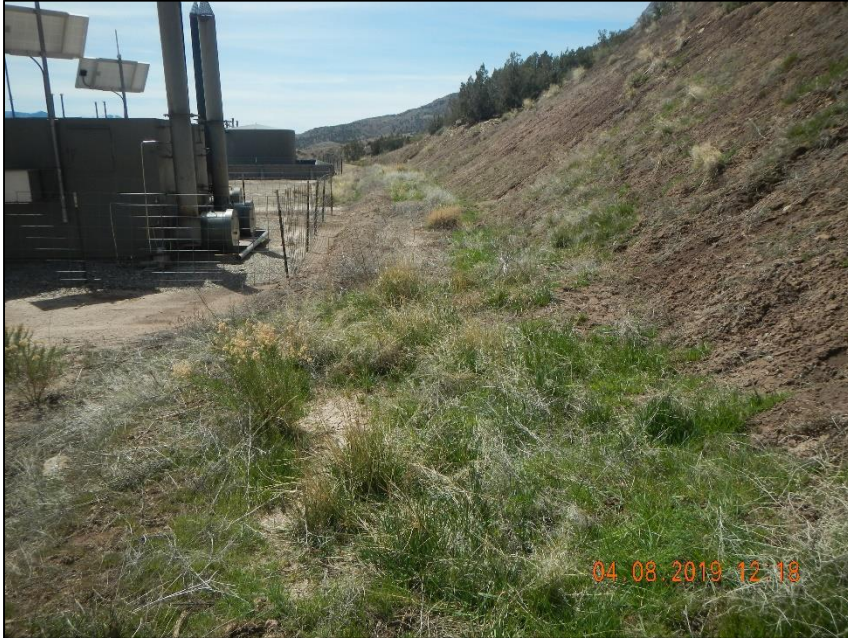
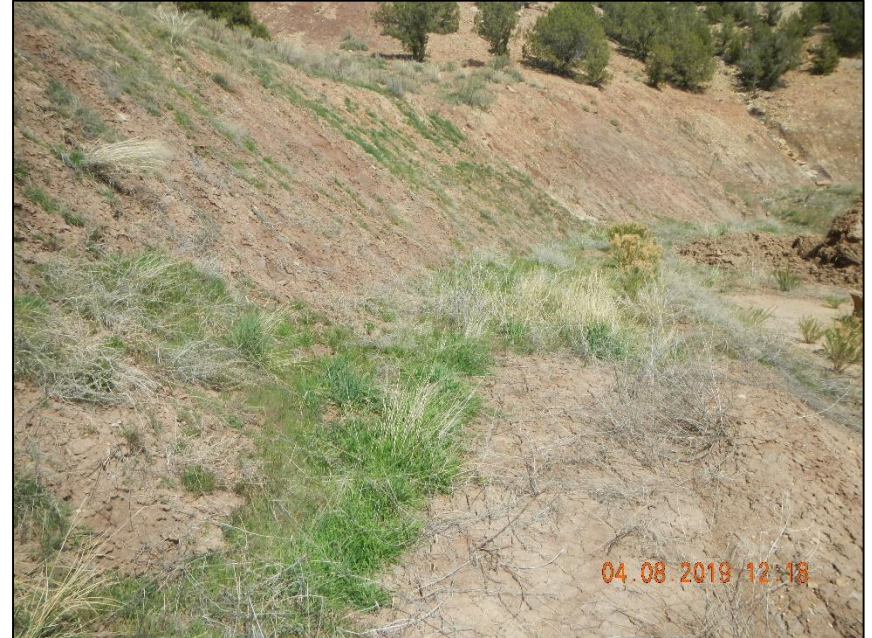
**Sediment build up in ditch around cut slope.**

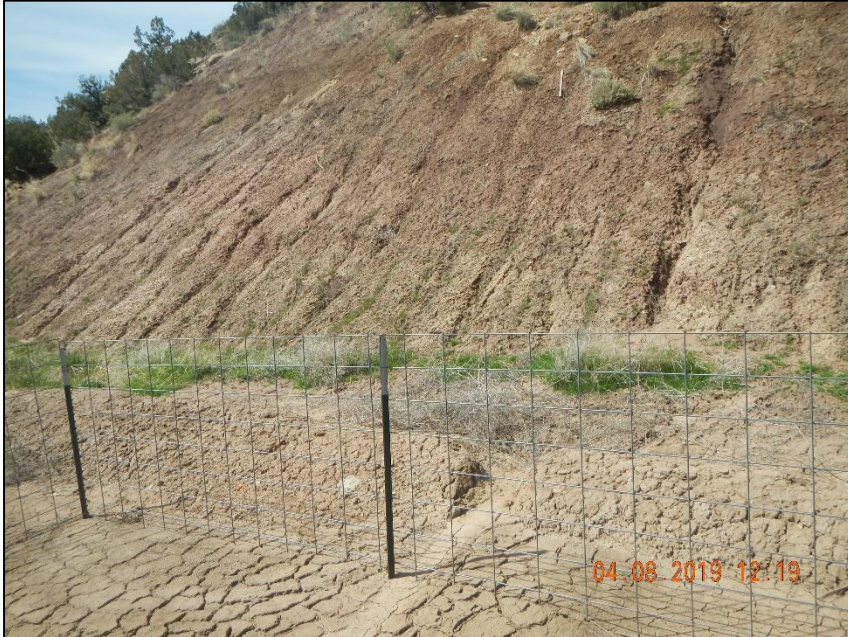
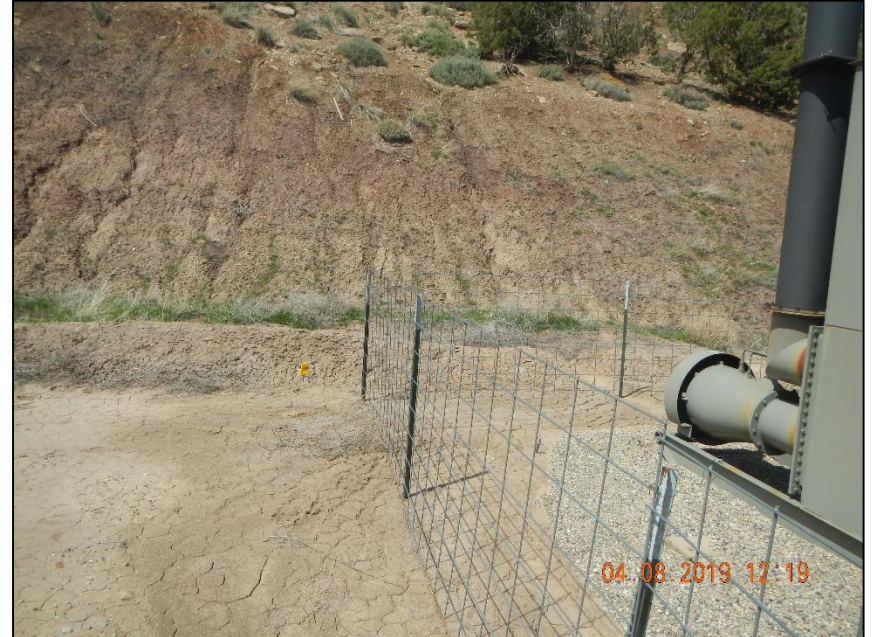
**Berm washed out behind separators.**

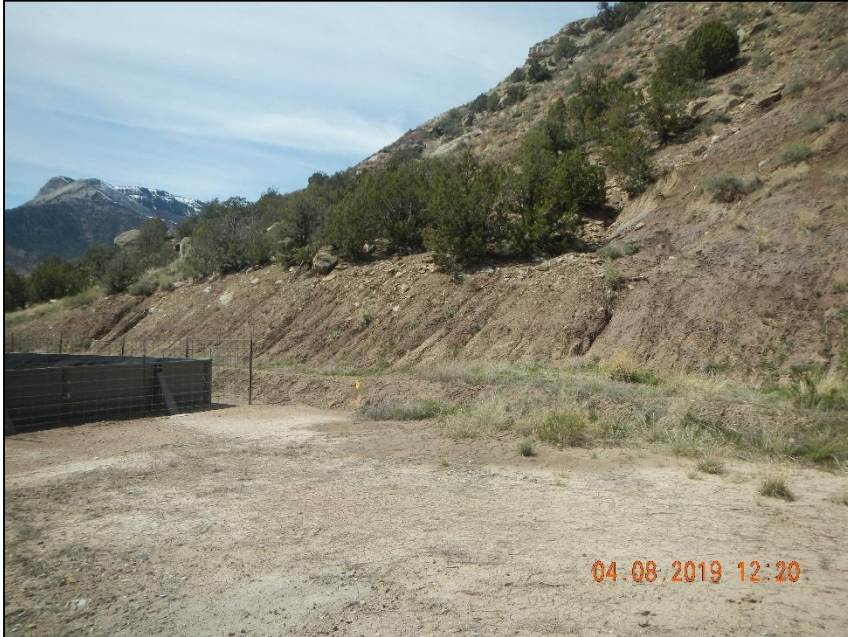
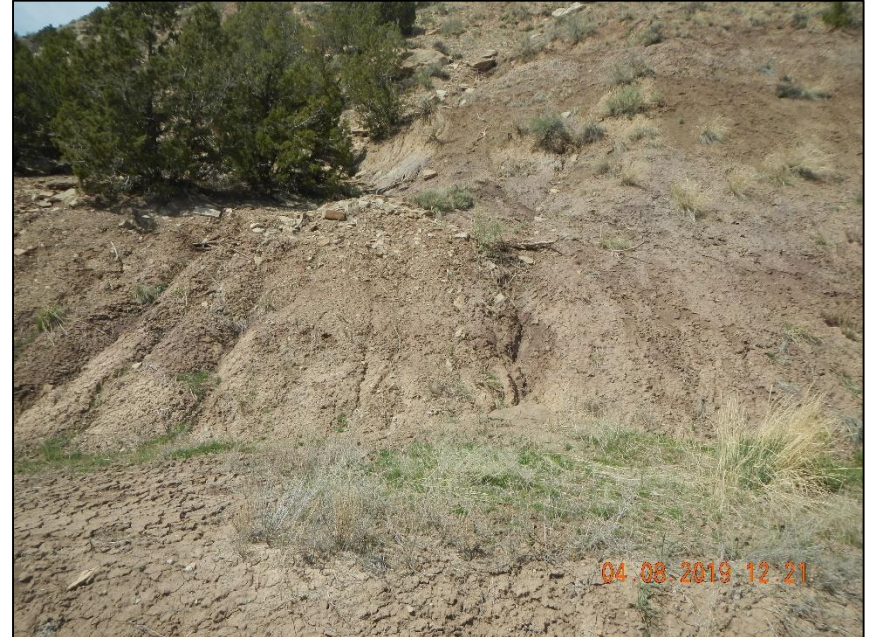
**Sediment over flow by the tank battery.**

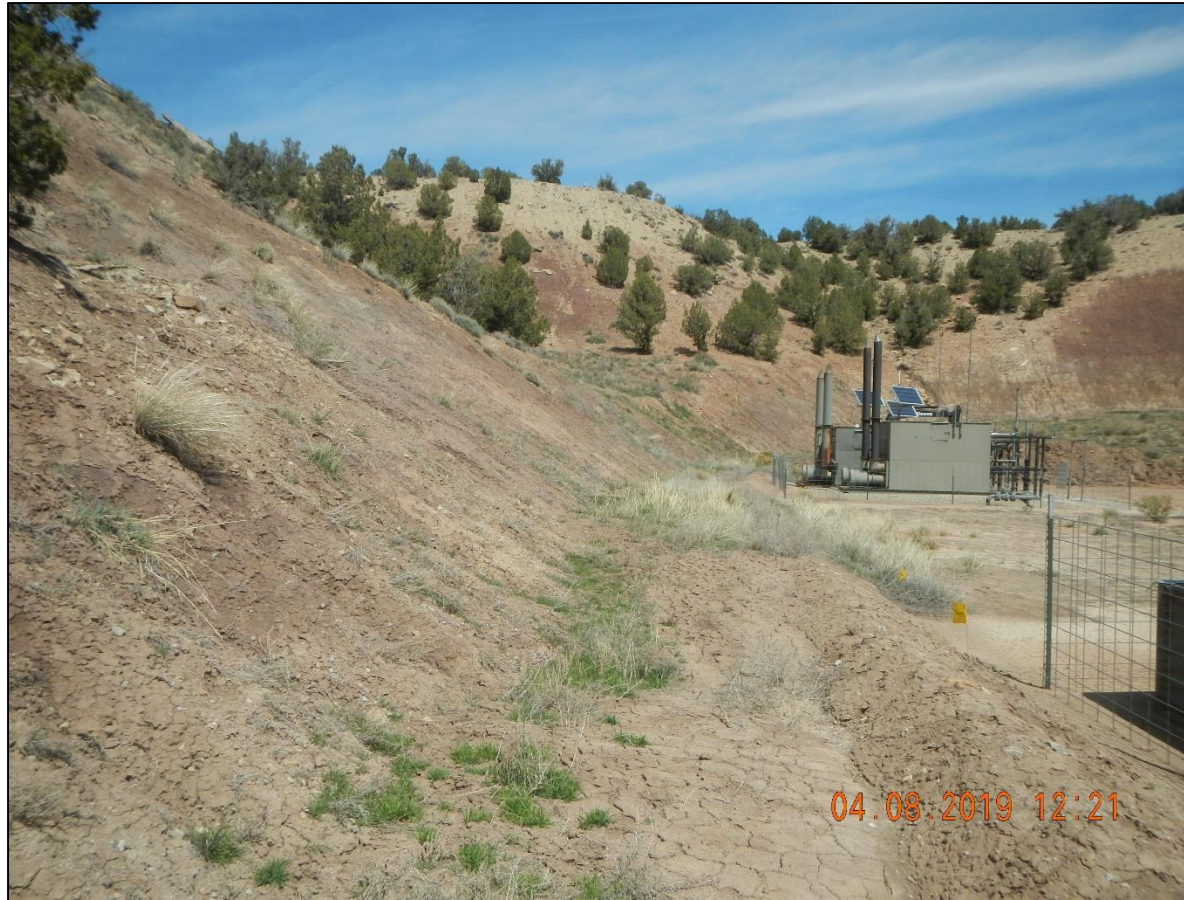
**Sediment build up in ditch around cut slope.**

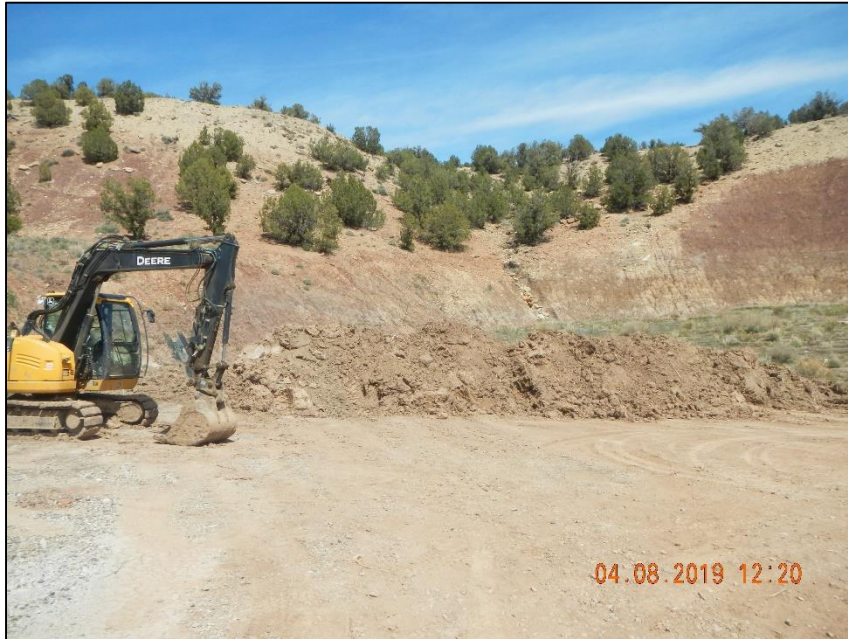
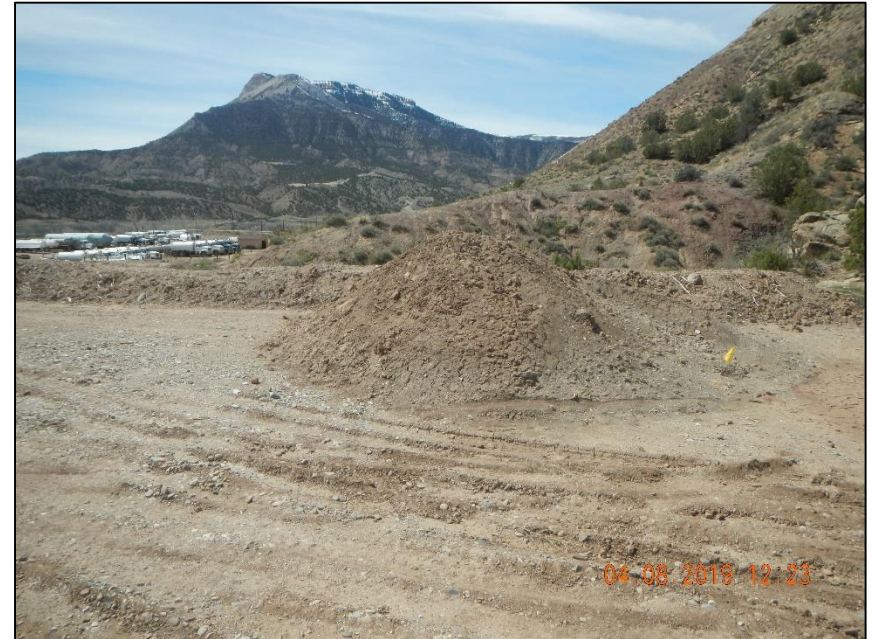
**Dirt stock piles.**

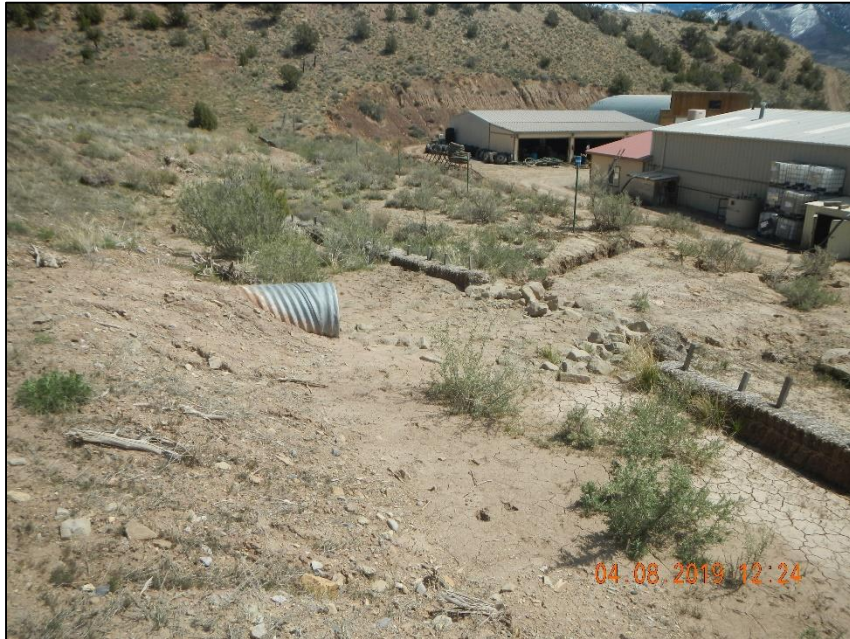
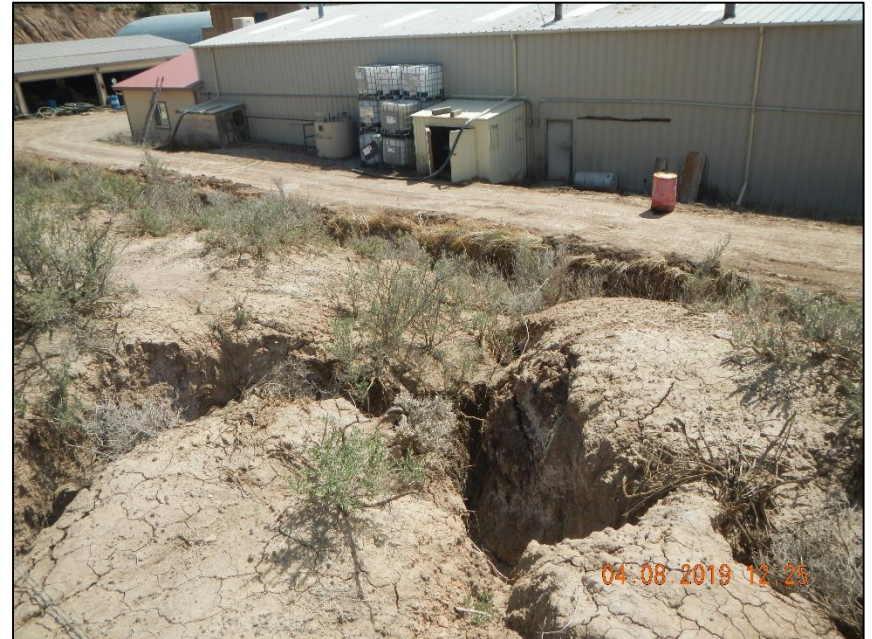
**Erosion from culvert outlet flow.**

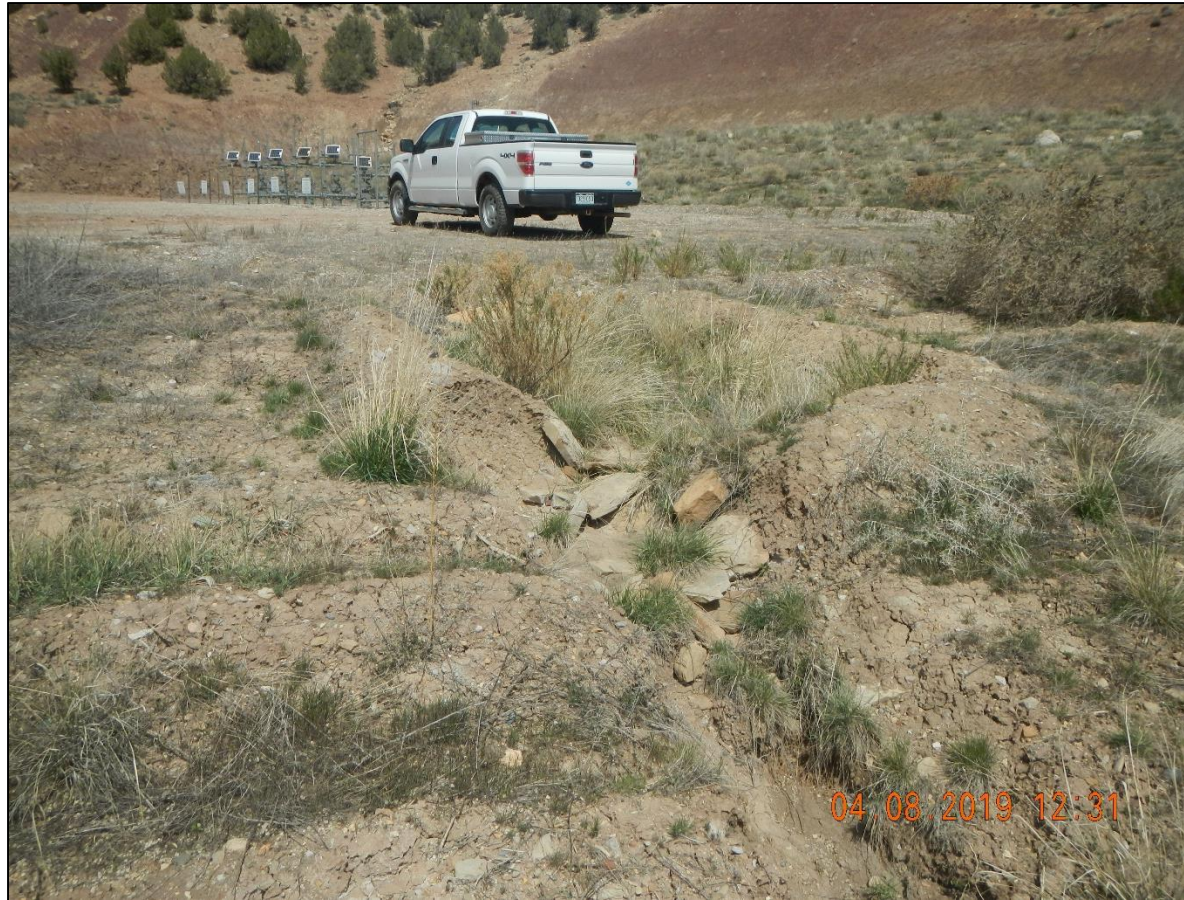
**Checkdam is washed out and needs maintained.**
