Inspection Photos
Location Name: GE #30-3
Location ID: 309291

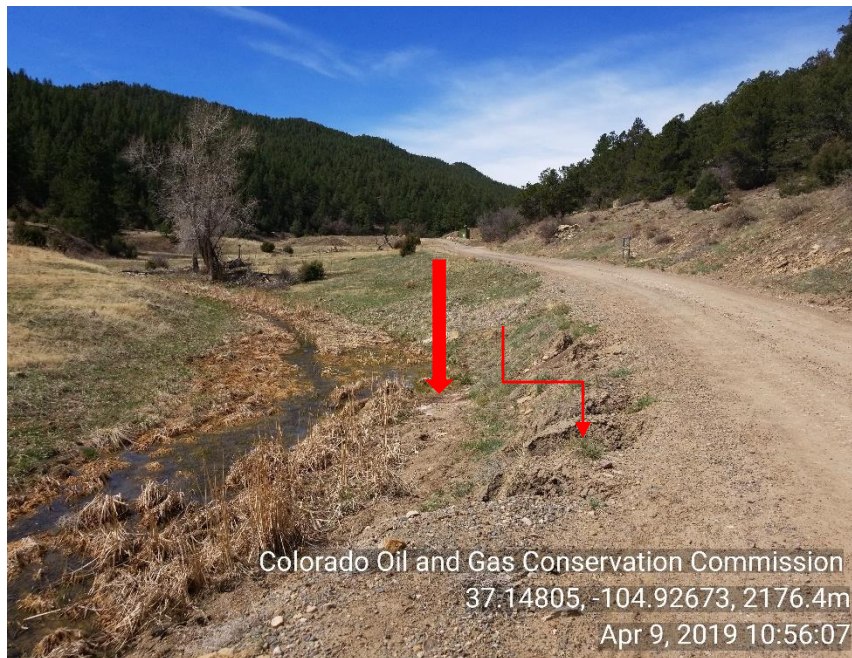
Photo 1 Storm water: Reels on road to location allowing sediment into water way

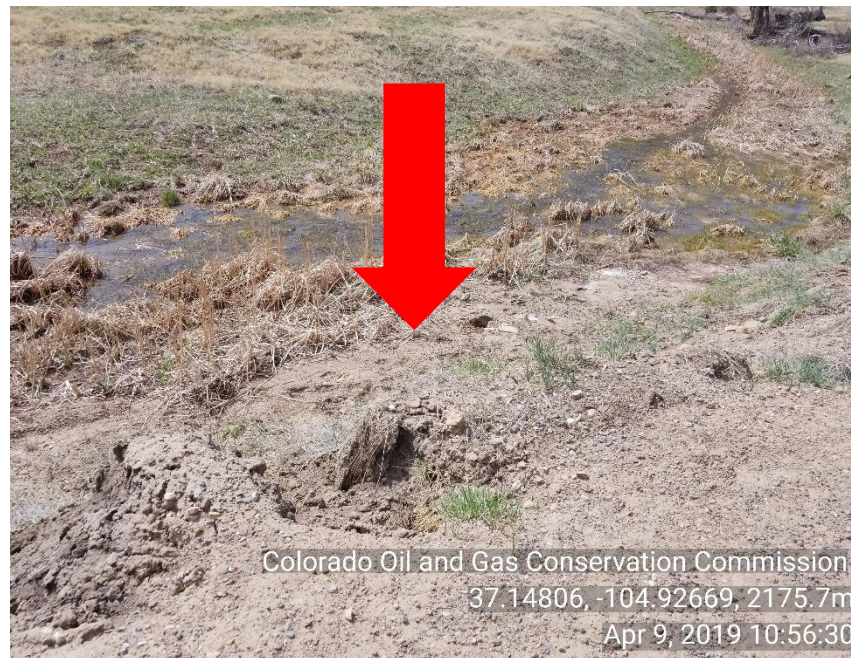
Photo 2 sediment in water way from road in Photo 1

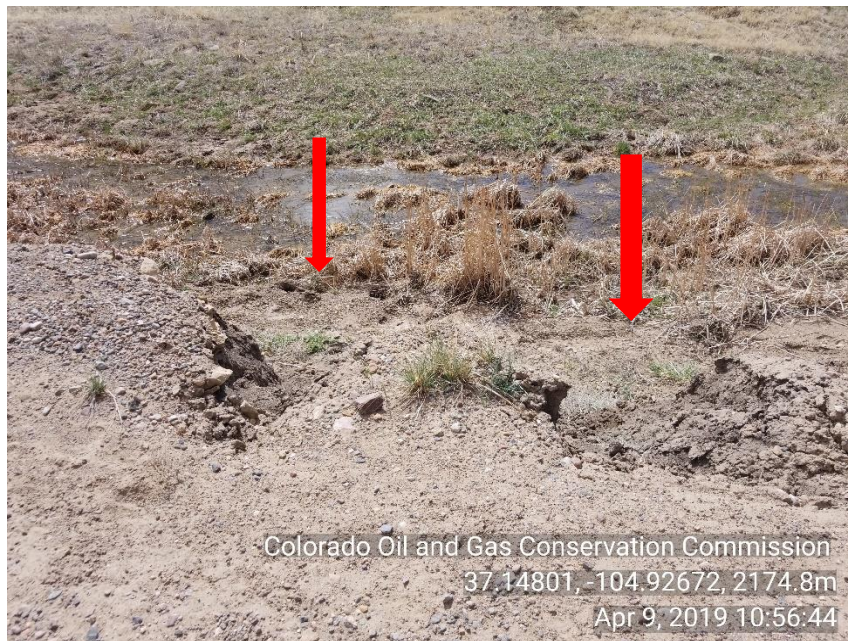
Photo 3 Storm water: Reels on road to location allowing sediment into water way

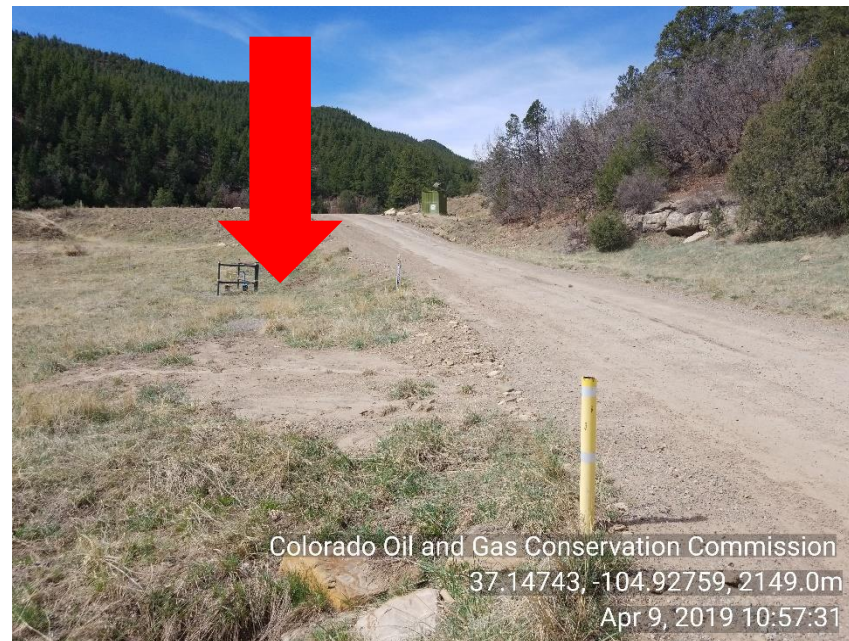
Photo 4 sediment from road being carried of road way into water way.

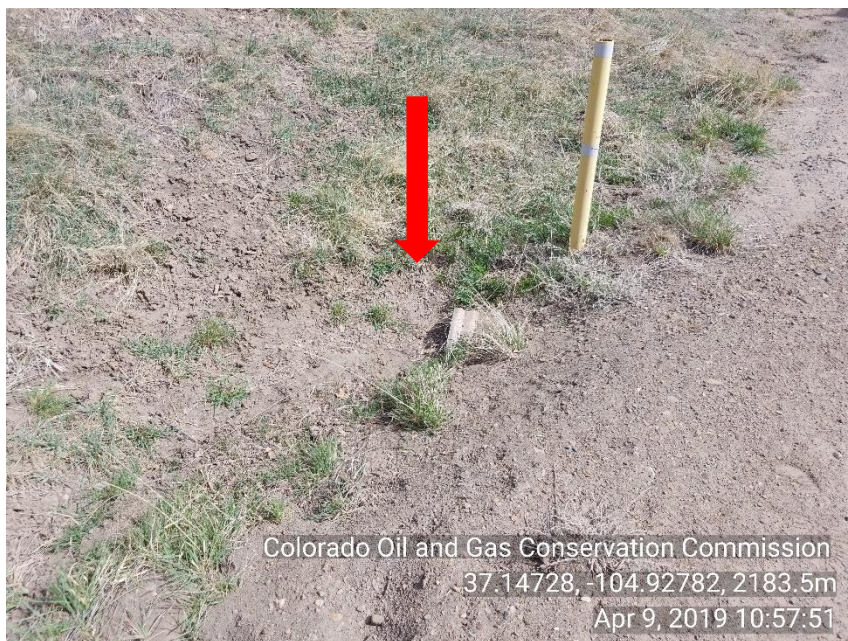
Photo 5 Culvert at entrance to location plugged allowing storm water and sediment to flow across access road in to water way.

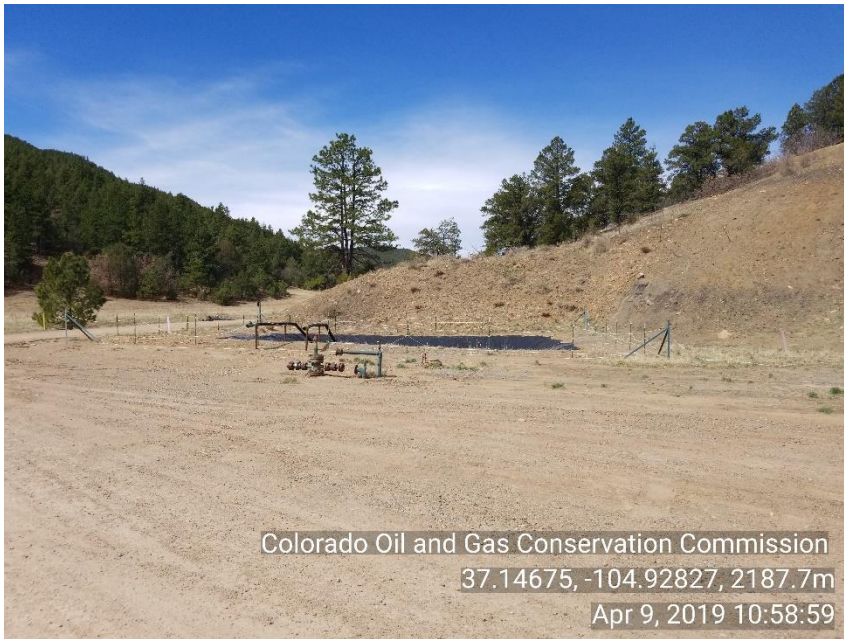
Photo 7 WH. **Well is TA**

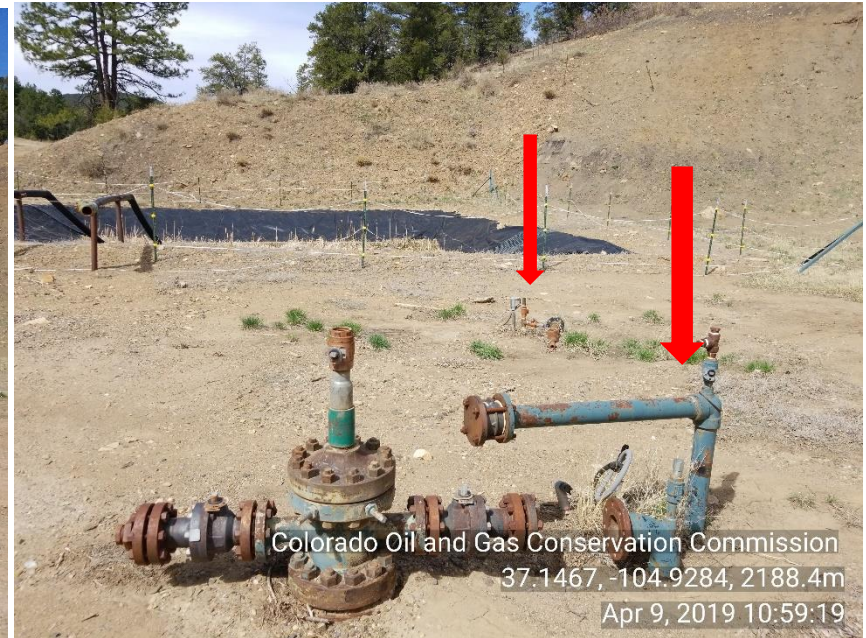
Photo 8 Unused equipment: unused unmarked not LOTO 2" piping and 1" electric lines

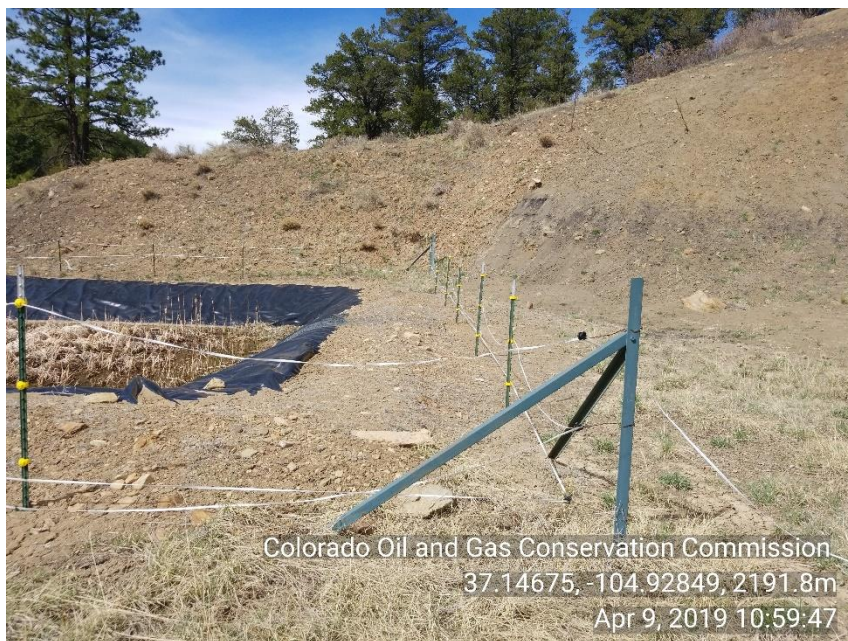
Photo 9 Fence around pit in disrepair

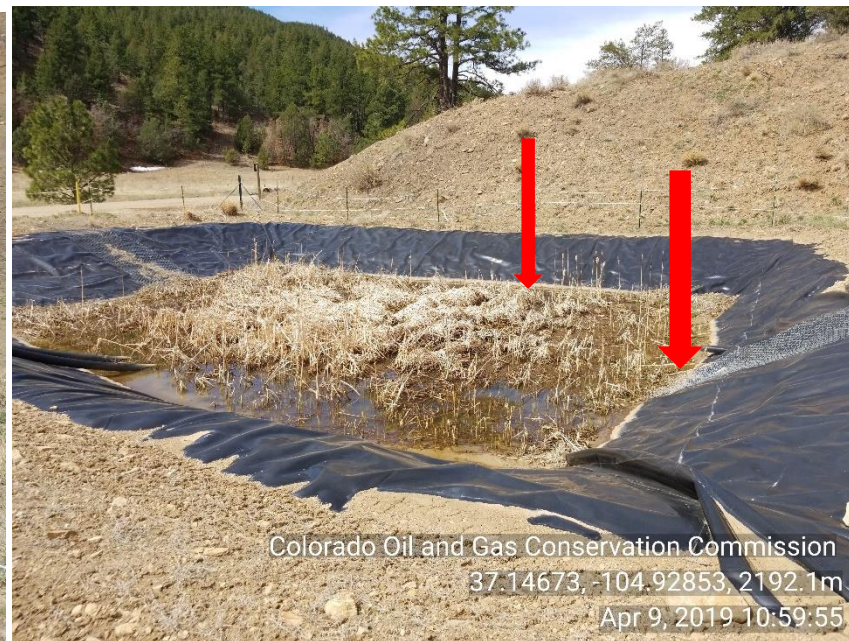
Photo 10 storm water: pit appears to have sediment and growth in liner.

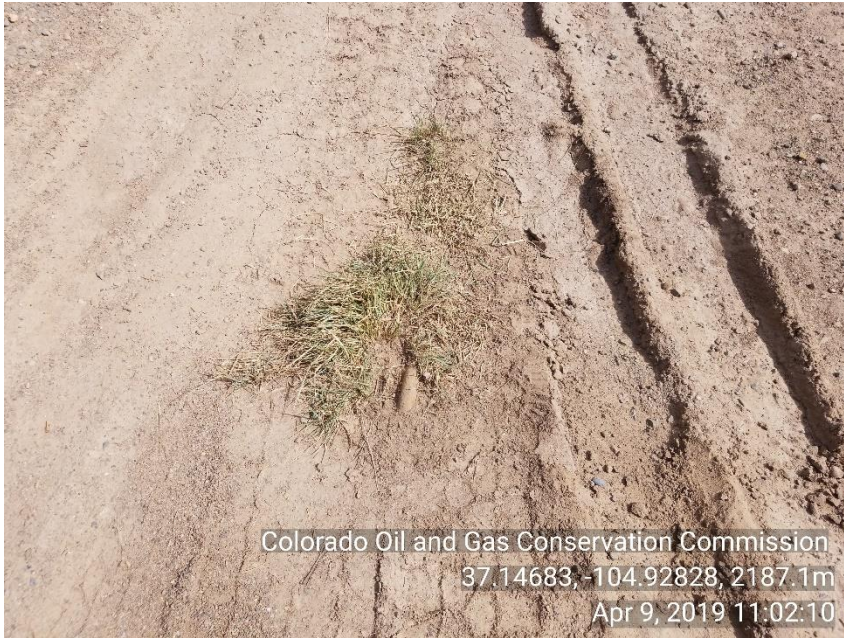
Photo 11 Unmarked Guy line anchor
