Inspection Photos
Location Name: New Elk 24-16
Location ID: 309390

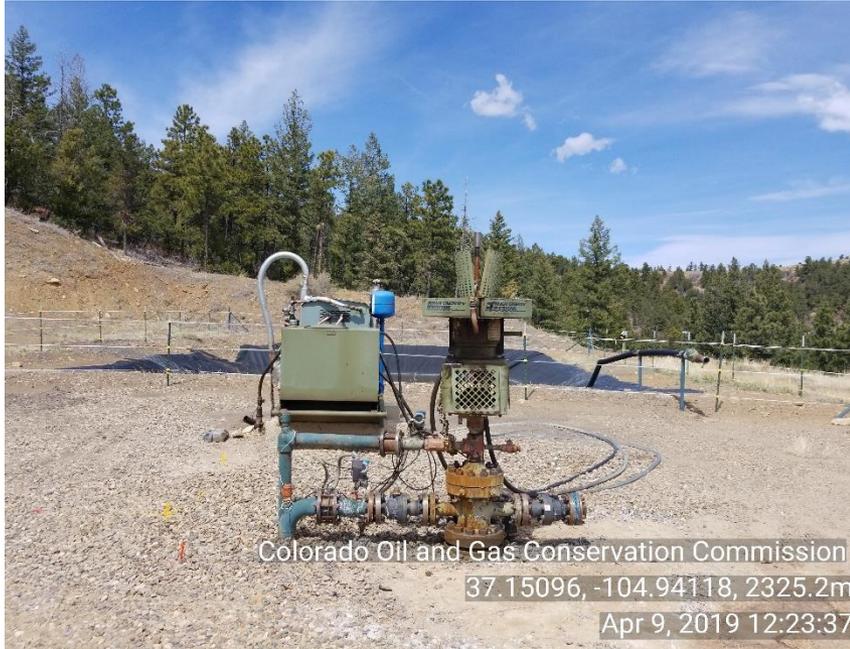
Photo 1 WH

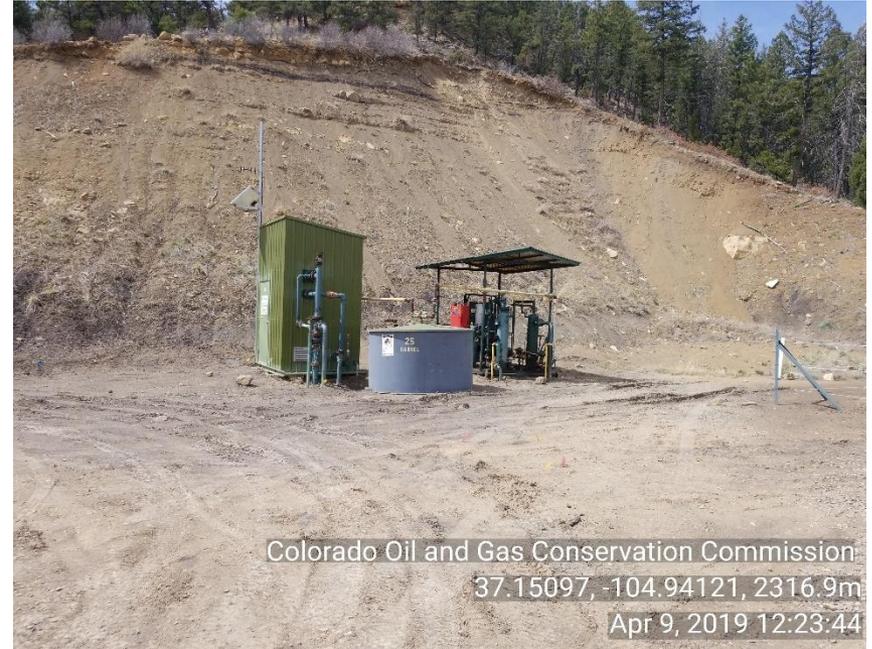
Photo 2 loc pic

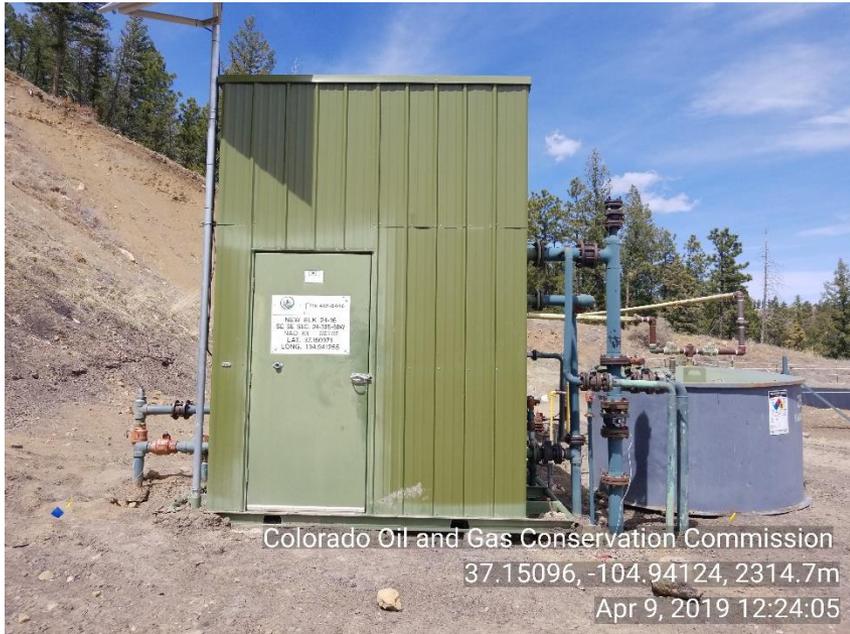
Photo 3 meter/sep building

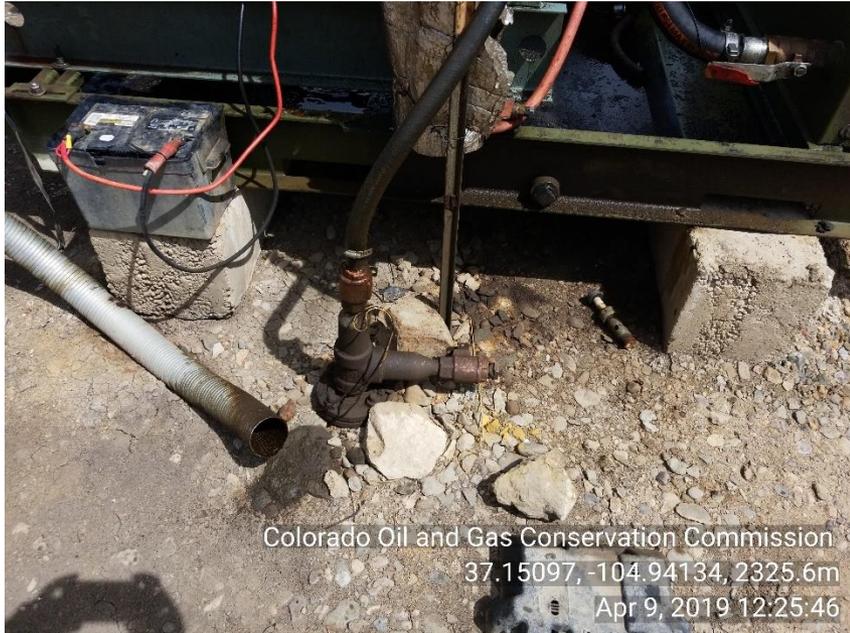
Photo 5 Stained soil around HYD skid

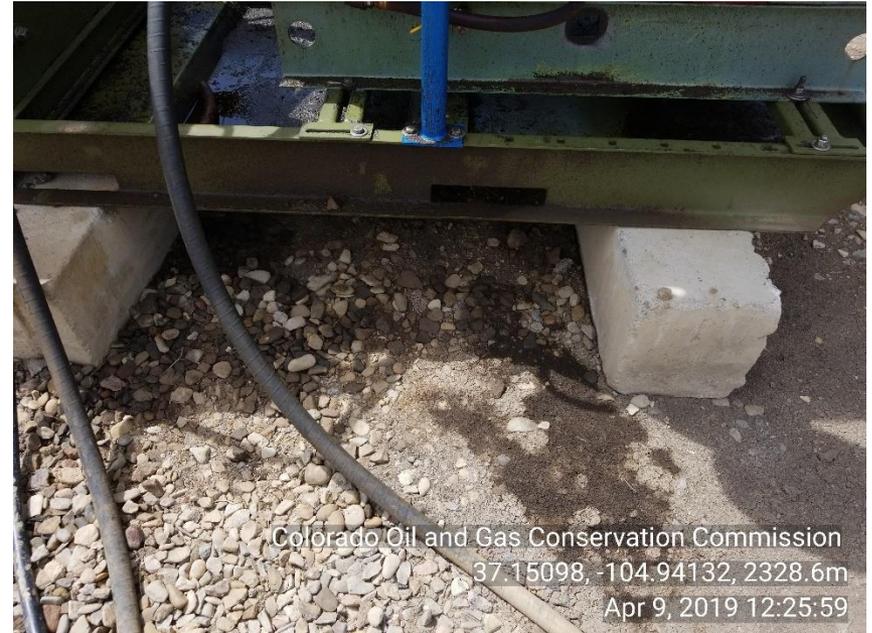
Photo 6 Stained soil around HYD skid

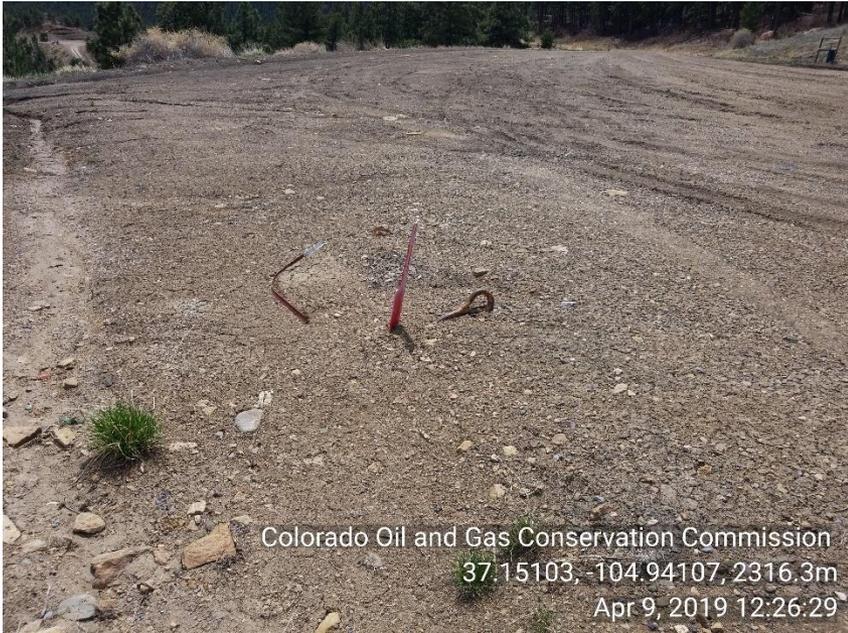
Photo 7 Guy line anchor not properly marked

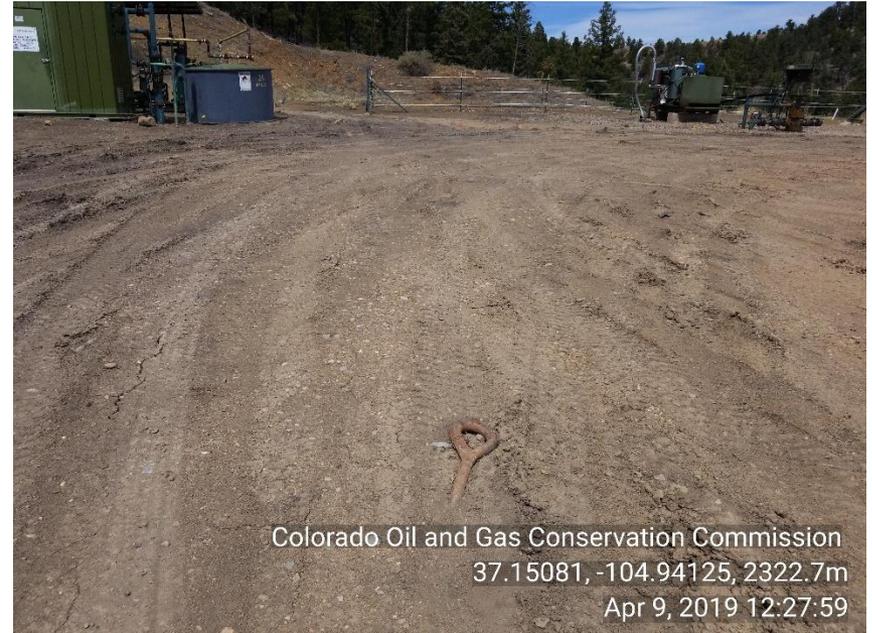
Photo 8 Guy line anchor marker missing
