**Inspection Photos**  
**Location Name: New Elk #26-12**  
**Location ID: 308662**

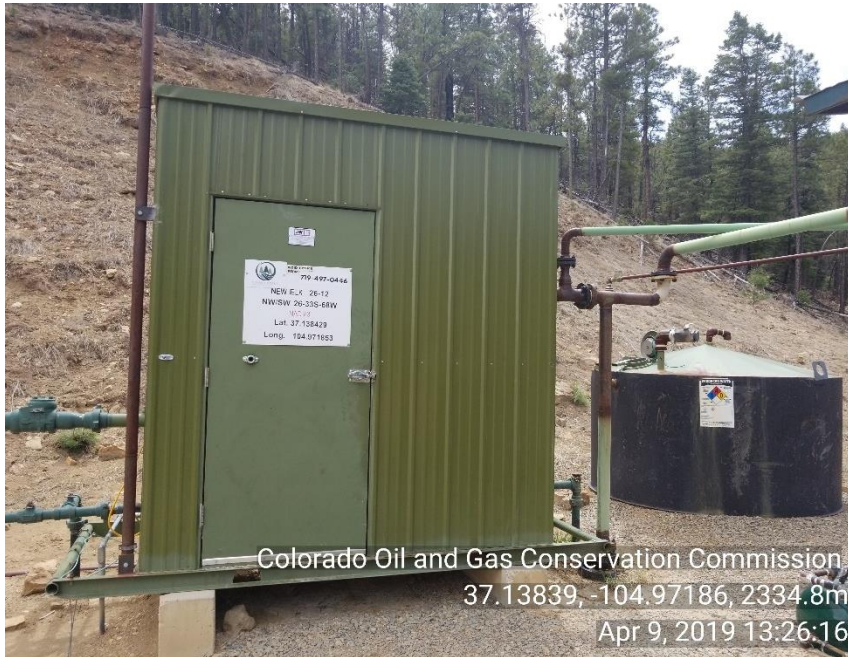
**Photo 1 Sep/meter run house**

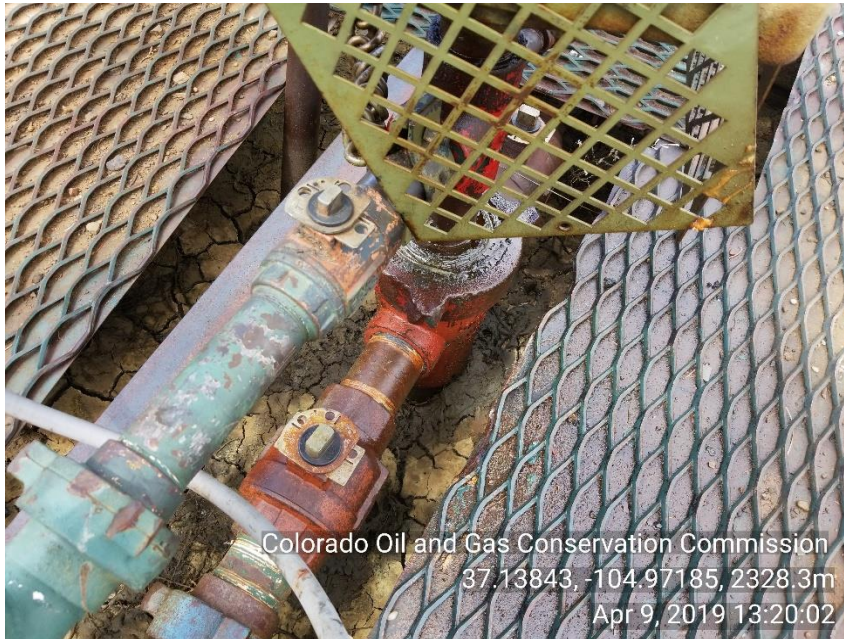
**Photo 3 Stained soil inside cellar of WH**

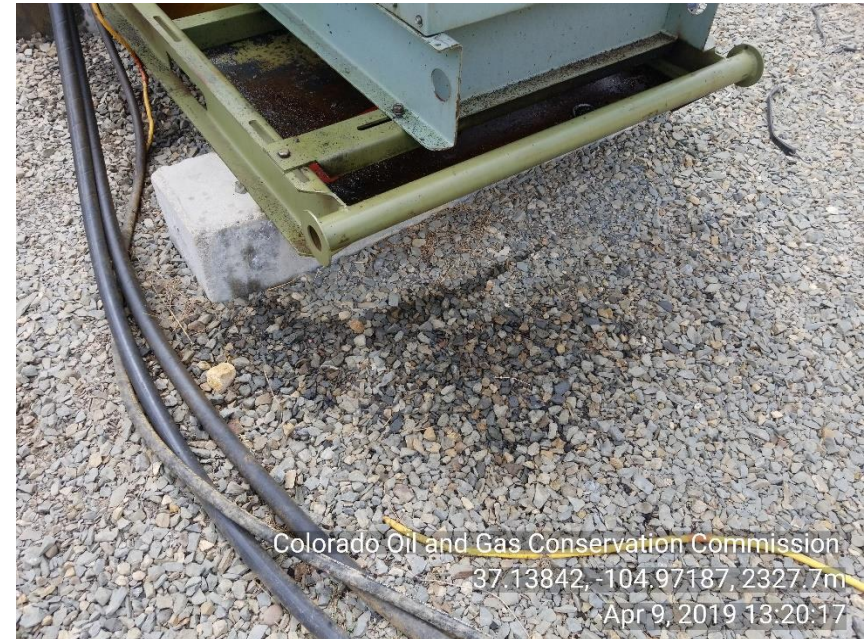
**Photo 4 Stained soil around HYD skid**

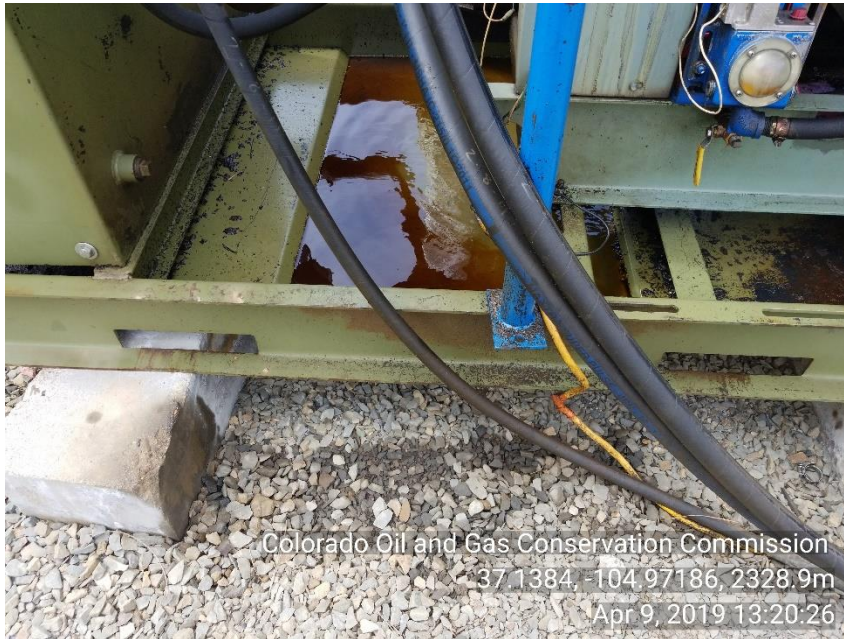
**Photo 5 stained soil around HYD skid**

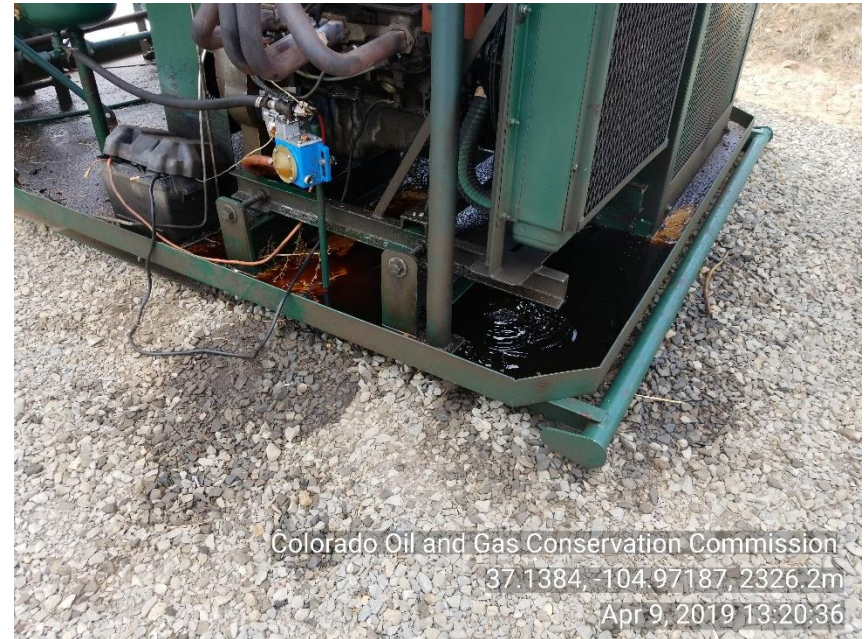
**Photo 6 Stained soil around liquid ring skid**

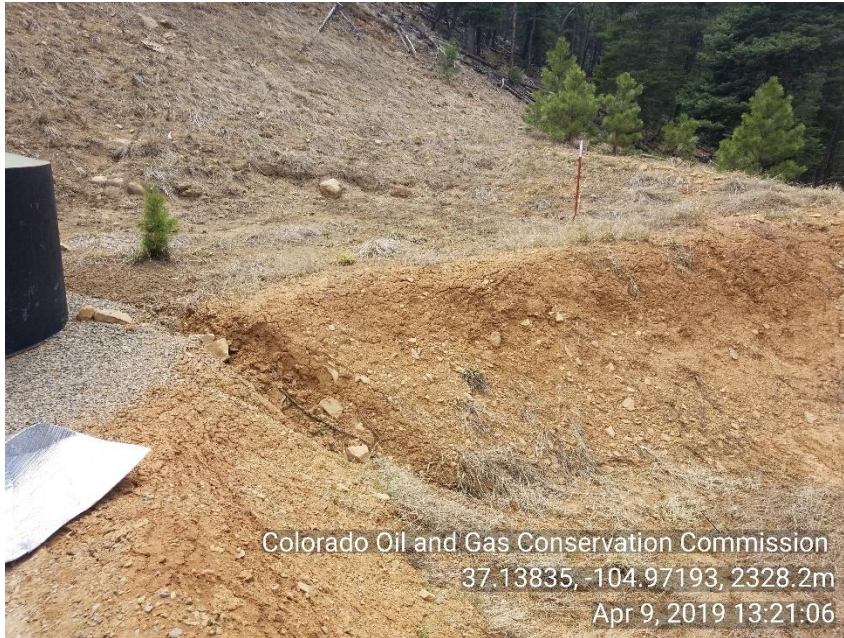
**Photo 7 storm water erosion from back of location making large reel into produced water pit**

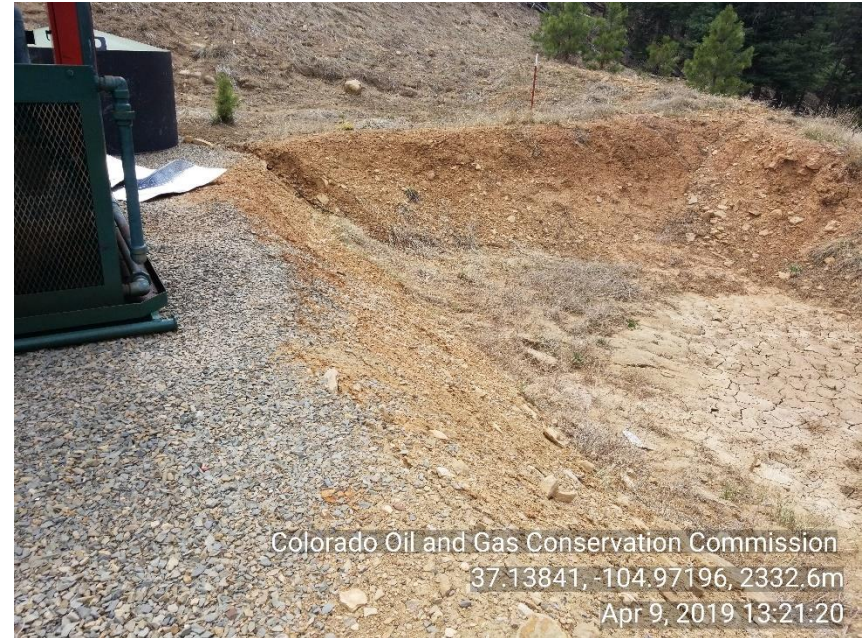
**Photo 8 Storm water no berm around back side of production pit**

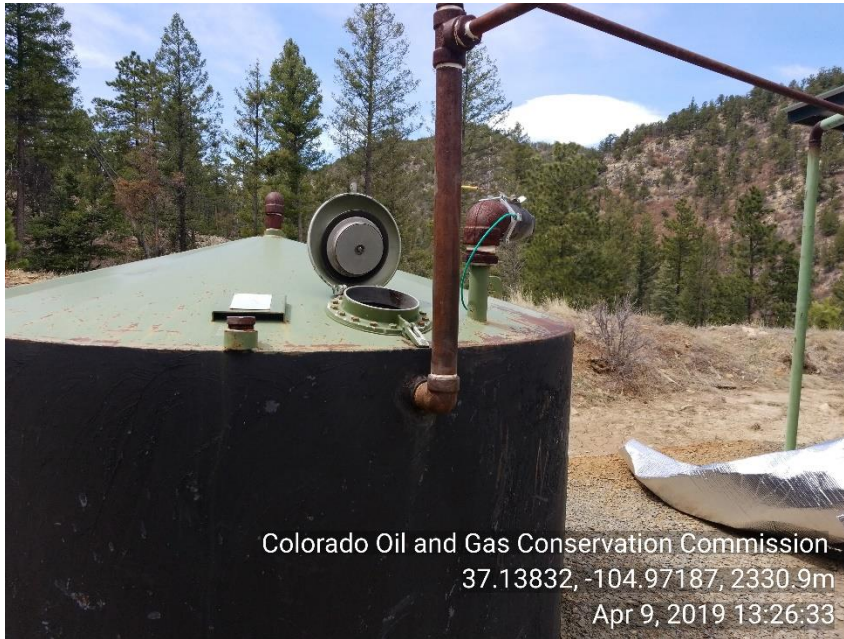
**Photo 11 Thief hatch open**

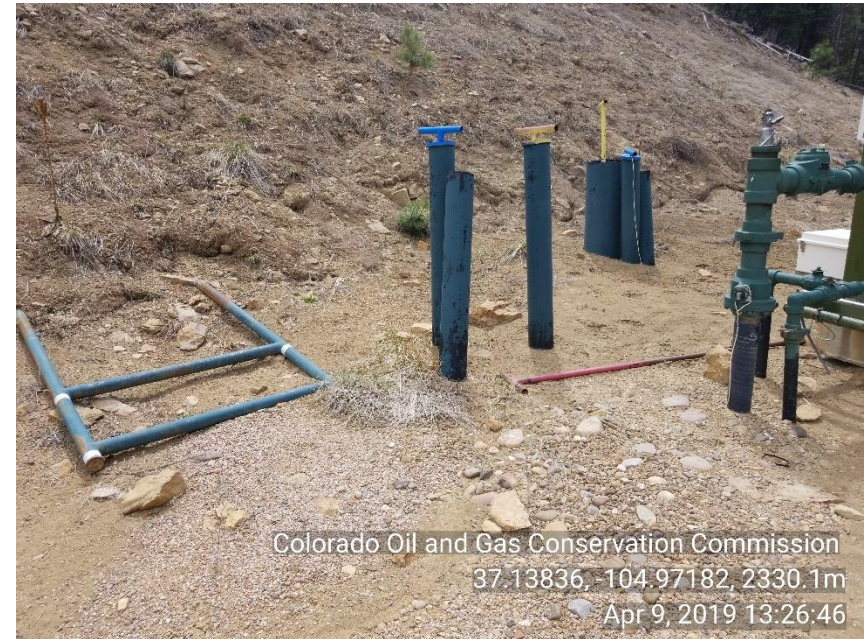
**Photo 12 Unused equipment: guard and red tee handle**
