Inspection Photos

Operator: DENVER EAST MACHINERY COMPANY
- 24040

Location ID: 390528

Inspection Doc. Number: 682504713
Logan County, CO

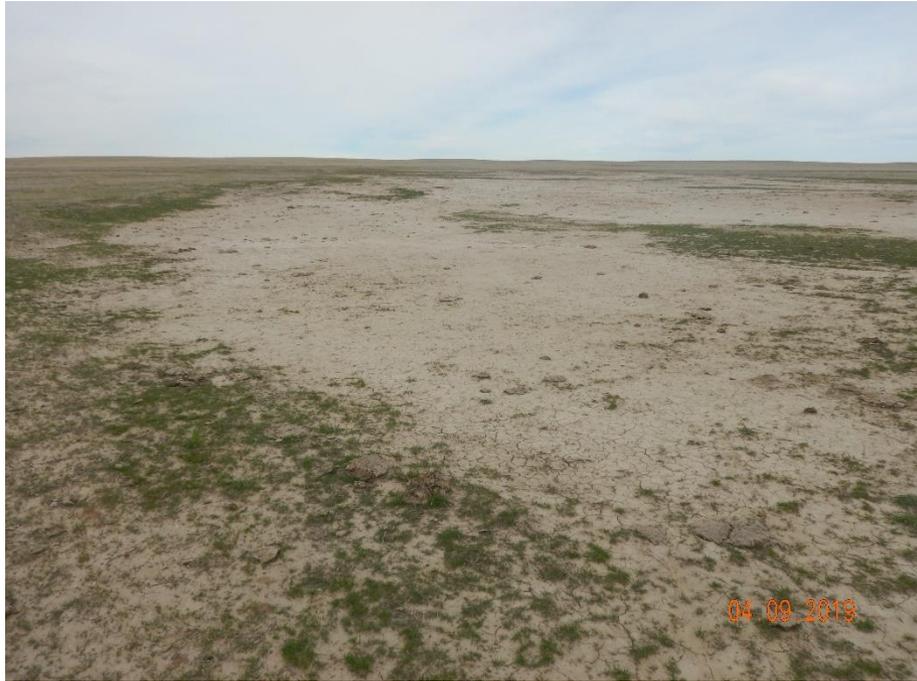
Photo 1: Photo taken from the southeast corner of the location, facing west. Previous inspections documented that reclamation does not appear to be progressing and required operator to perform additional reclamation activities by 3/31/2018. Photo shows no additional reclamation or remediation activities appear to have been conducted. The location/disturbance remains predominantly bare and exposed soil, or undesirable weedy plant species.

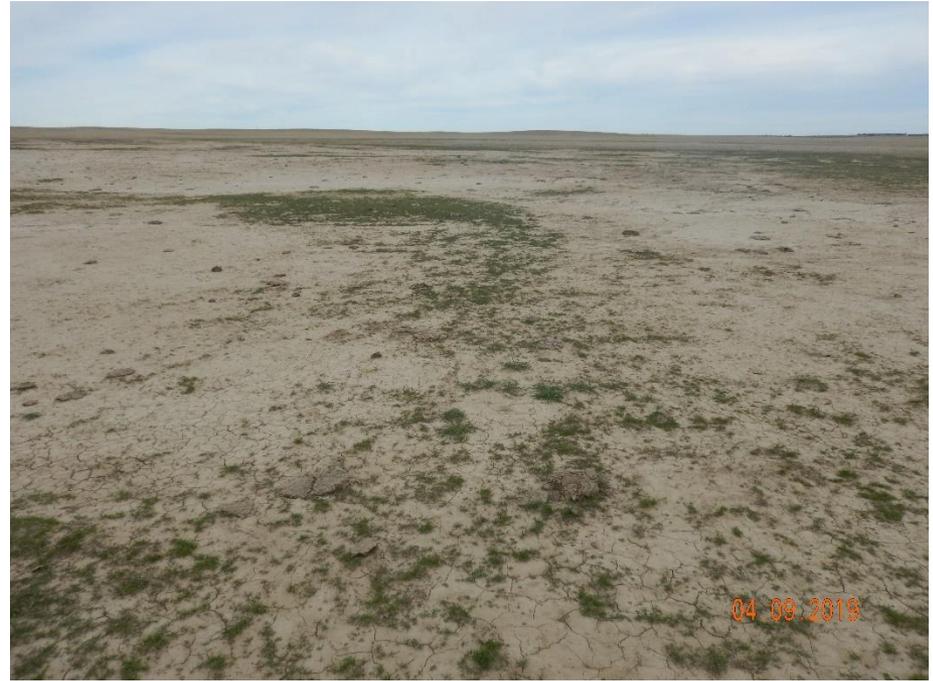
Photo 2: Photo taken from the southeast corner of the location, facing northwest. See comments under photo 1.

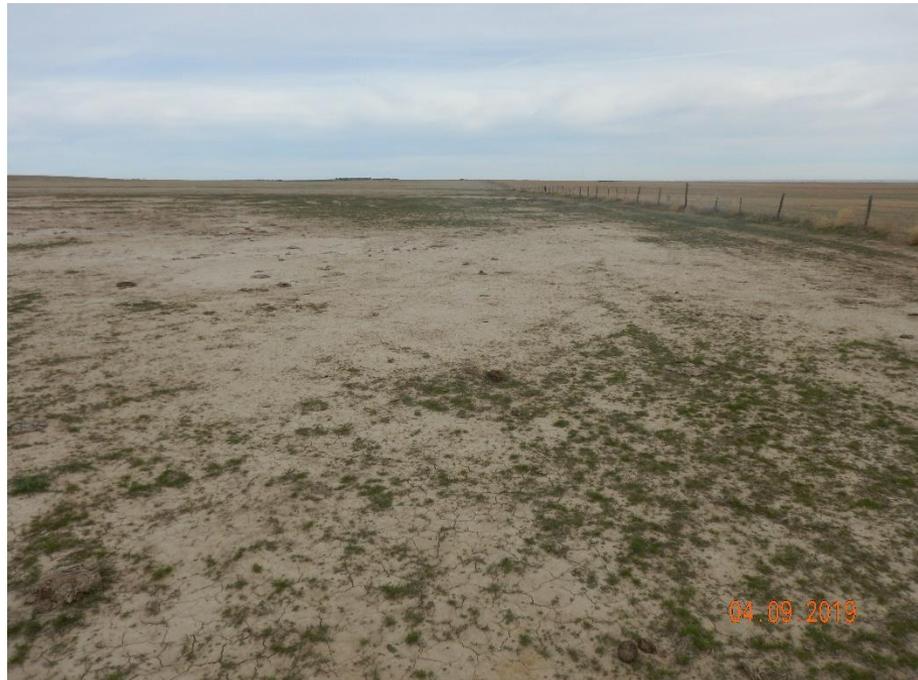
Photo 3: Photo taken from the southeast corner of the location, facing north. See comments under photo 1.

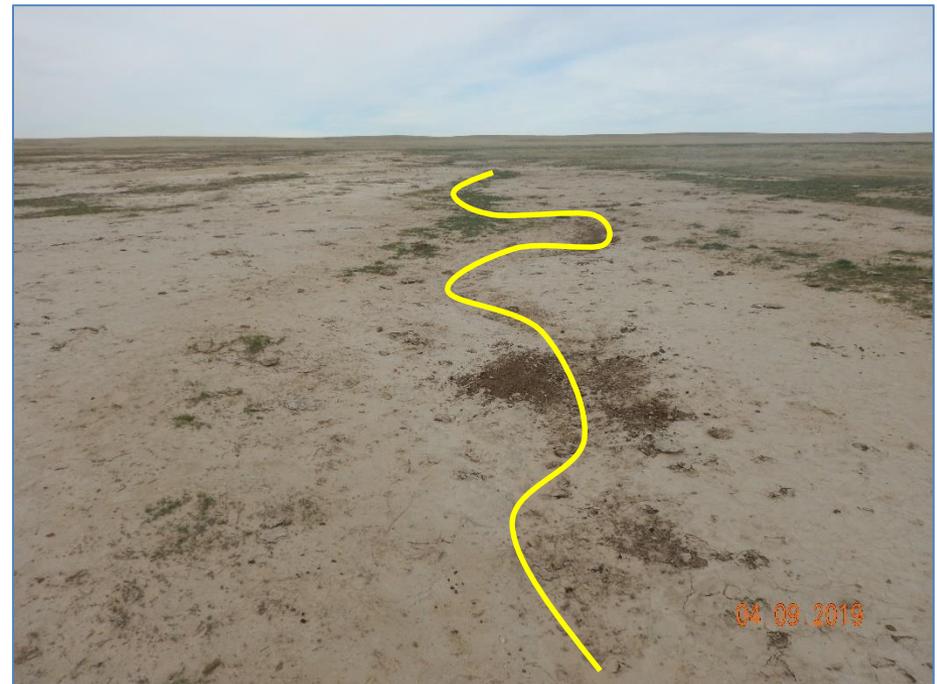
Photo 4: Photo taken from the disturbance area, facing west. Photo shows stormwater erosion degradation on location.

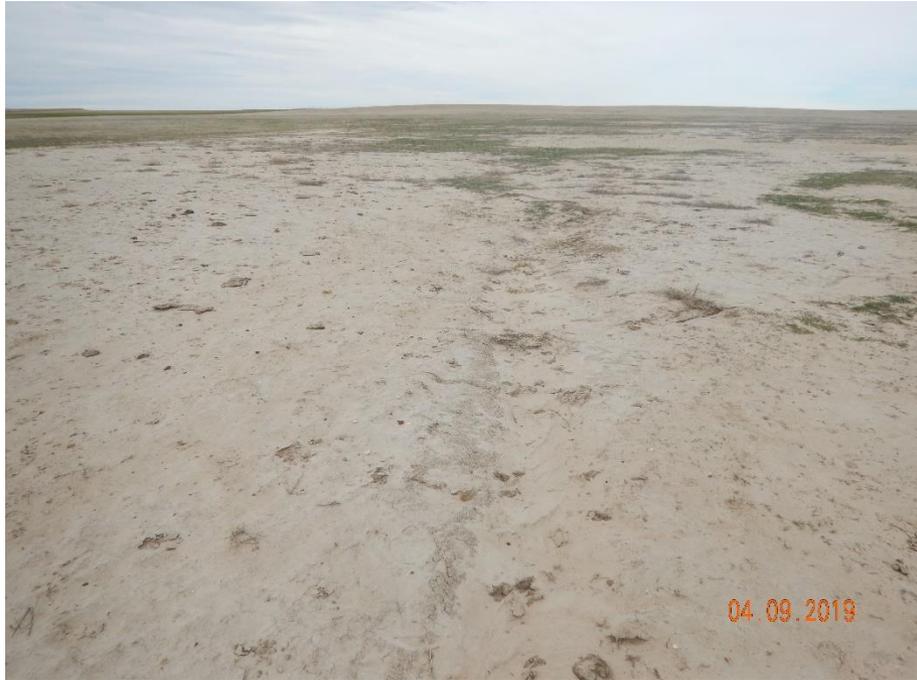
Photo 5: See comments under photo 1.

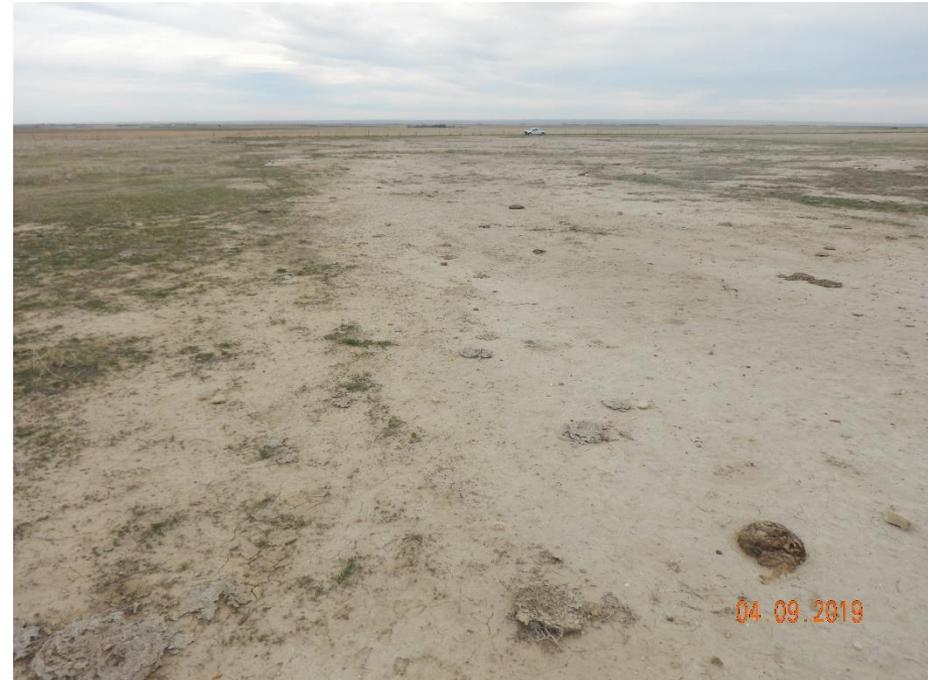
Photo 6: See comments under photo 1.

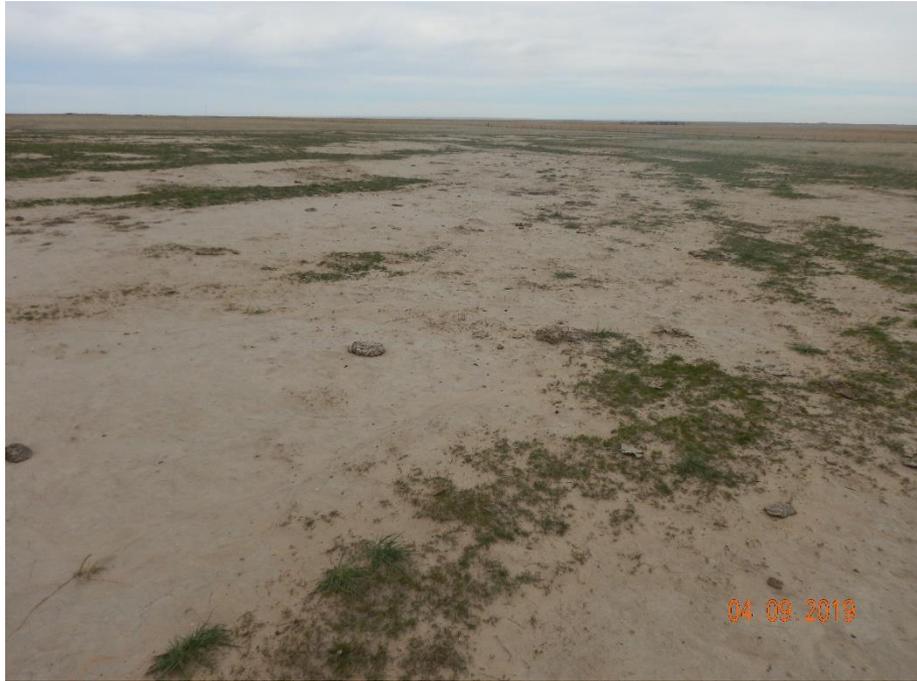
Photo 7: Photo taken from the northwest area of the location, facing north. See comments under photo 1.

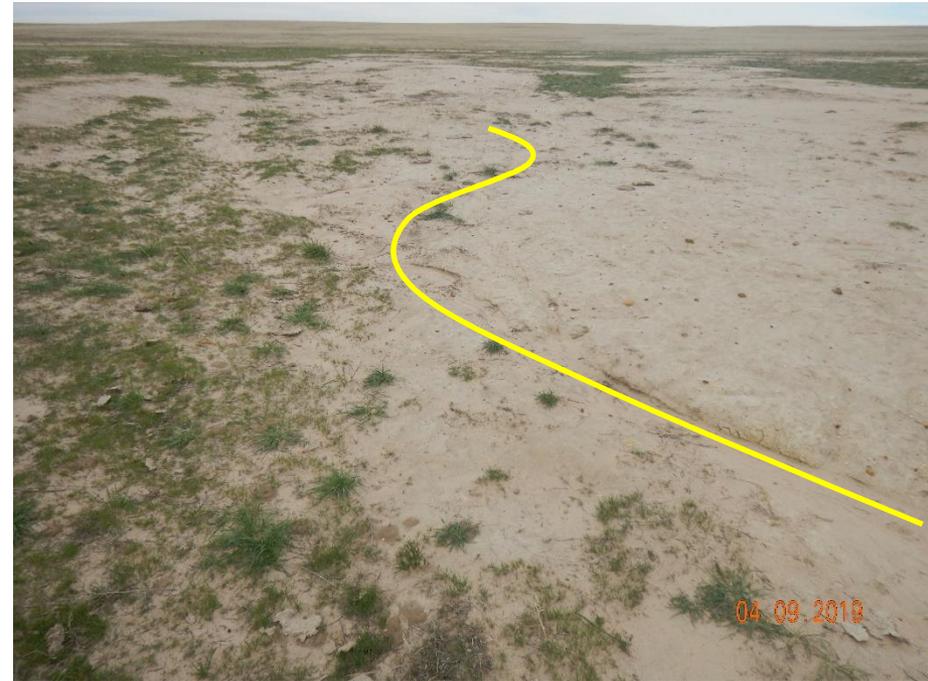
Photo 8: Photo taken from the northwest area of the location, facing west. Photo shows erosion degradation on location.

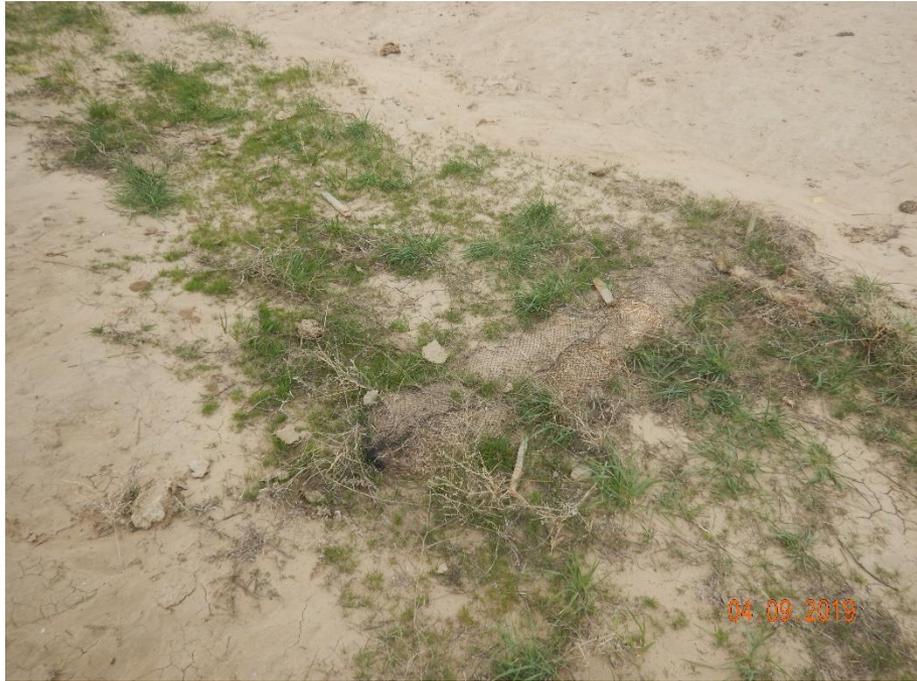
Photo 9: Photo taken from the northwest end of the location. Photo shows wattles are not longer in proper functioning condition.

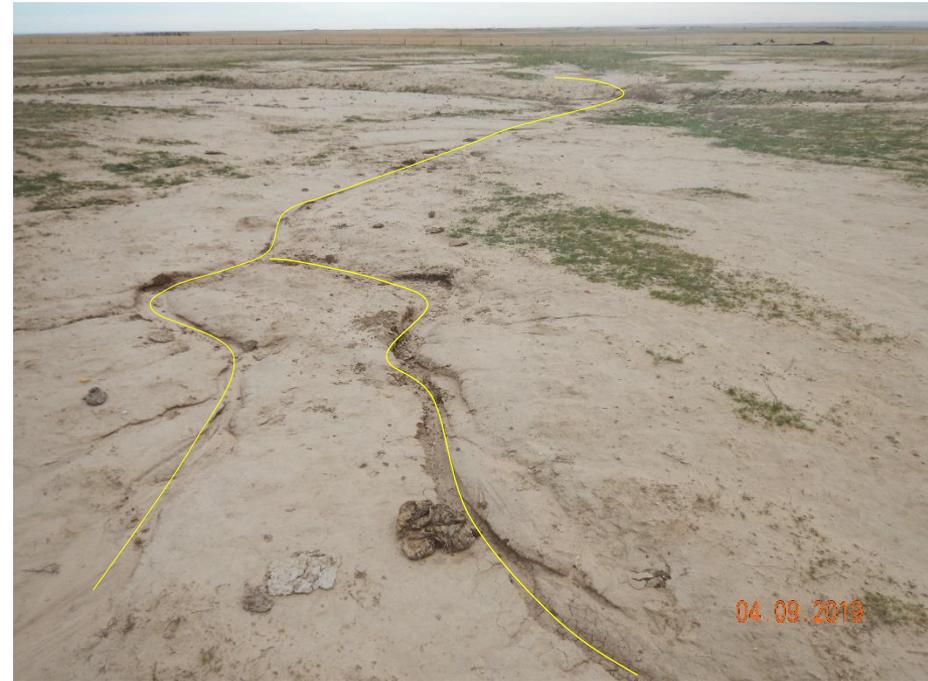
Photo 10: Photo taken from the northwest area of the location, facing east. Photo shows erosion degradation on location.

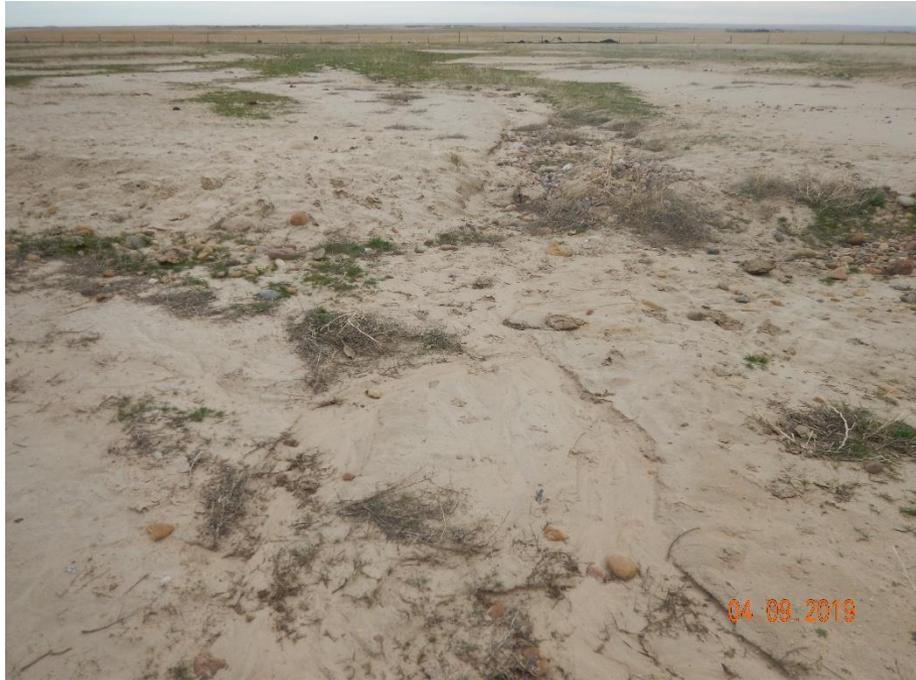
Photo 11: Photo taken from the north end of the location. Photo shows stormwater berm has been blown out and no longer in proper functioning condition. Photo also shows erosion degradation on location.

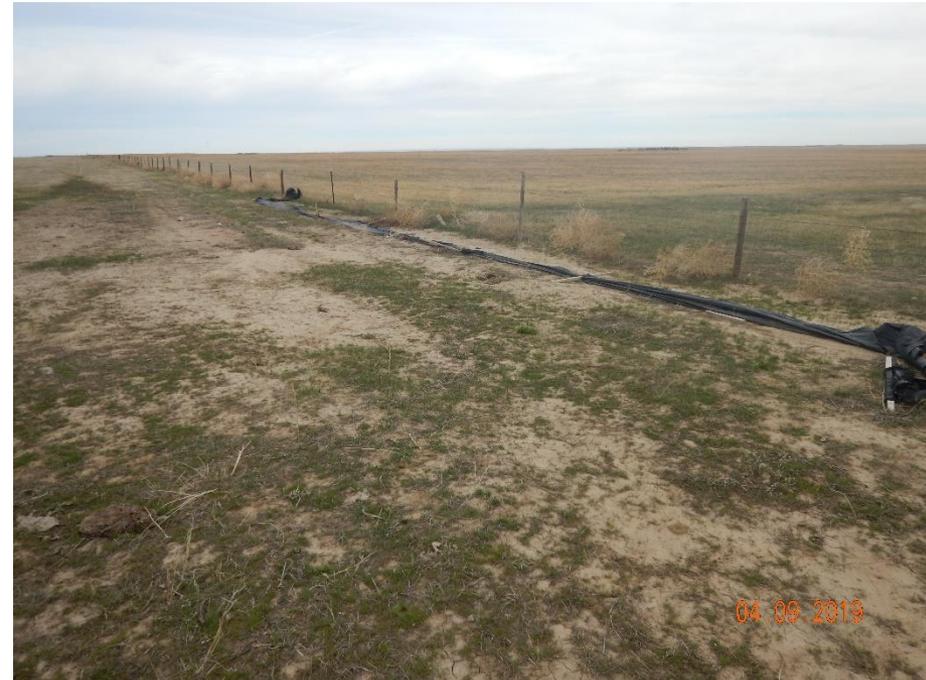
Photo 12: Photo taken from the northeast end of the location, facing northeast. Photo shows silt fence is no longer in proper functioning condition.

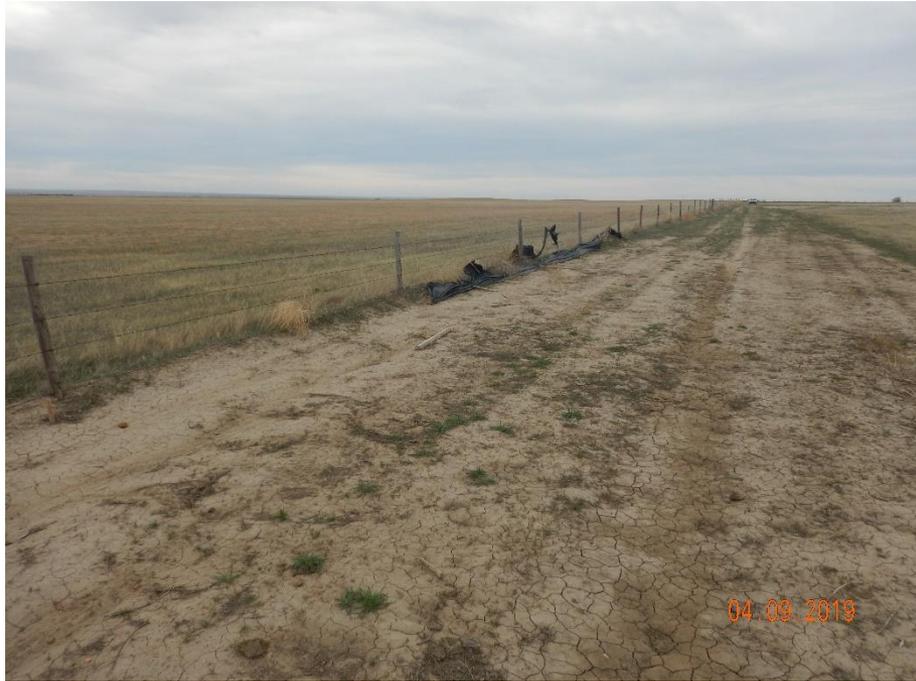
Photo 13: Photo taken from the northeast end of the location, facing southeast. Photo shows silt fence is no longer in proper functioning condition.

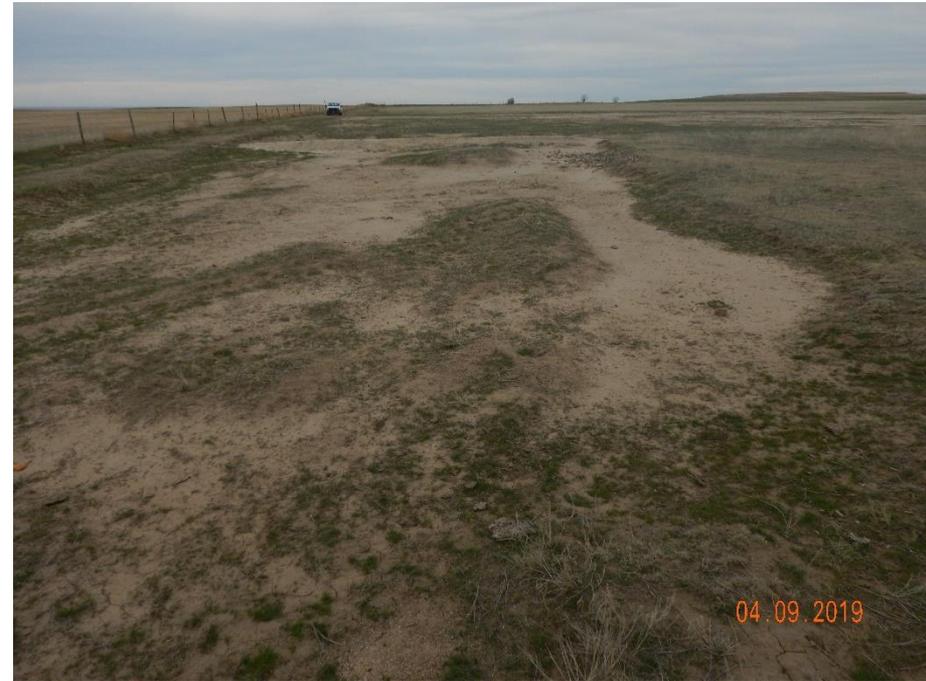
Photo 14: Photo taken from the west end of the location. Photo shows erosion degradation on the location.
