Inspection Photos

API: 05-055-06137

Operator: SILVER MOUNTAIN PRESERVE

Inspection Date: 4/4/2019

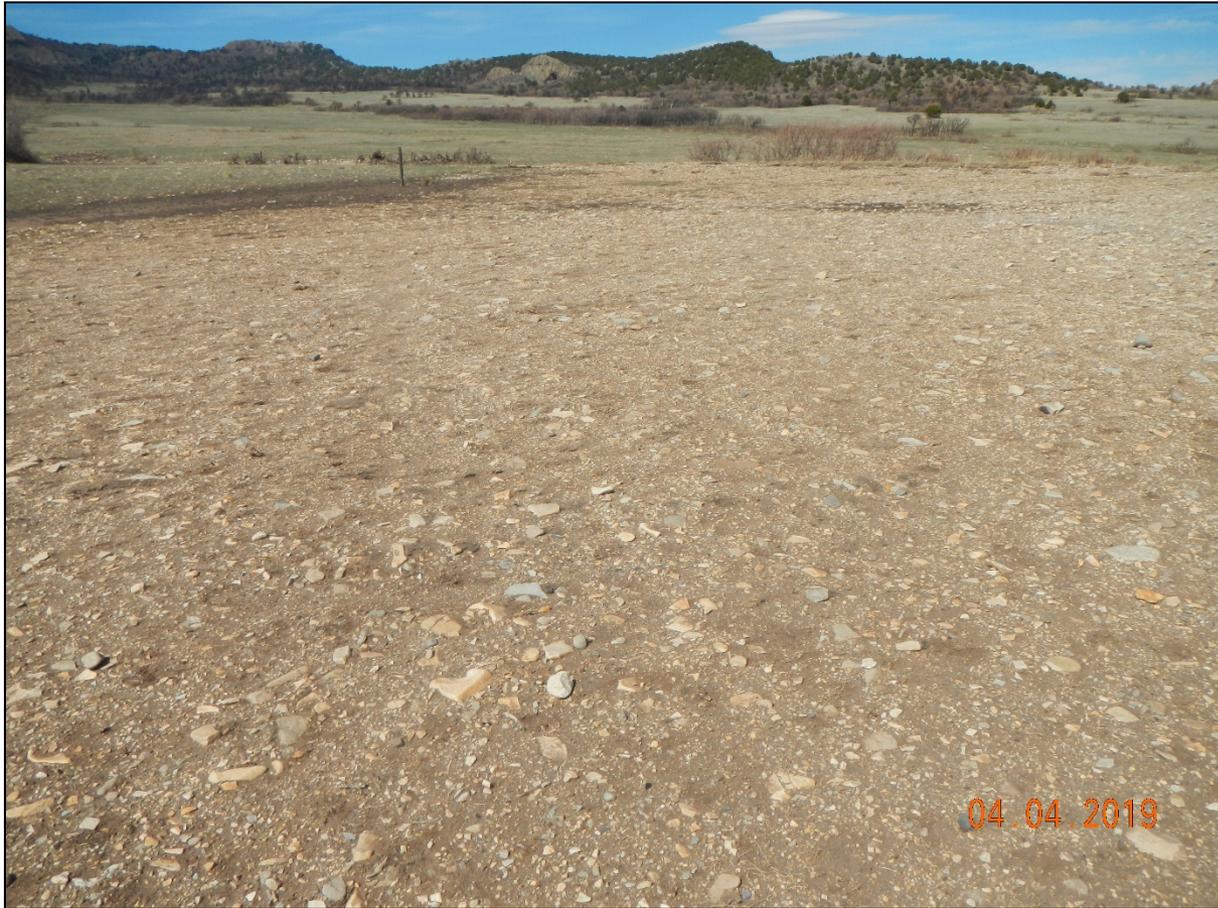
Photo 1. Facing north at the location. The location is bare of vegetation. It appears some vegetation has been burned off but vegetation has not re-established.

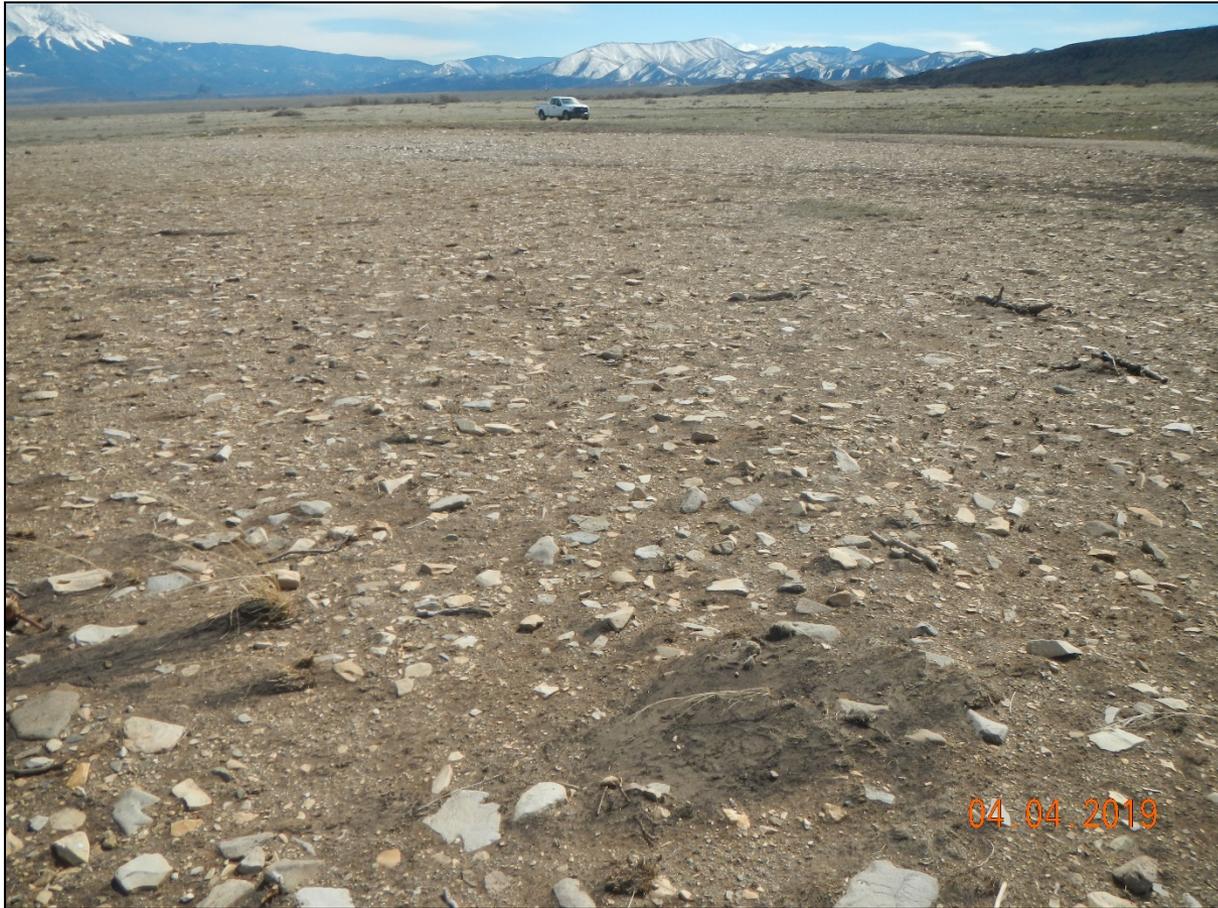
Photo 2. Facing south at the location. The location is bare of vegetation. It appears some vegetation has been burned off but vegetation has not re-established.

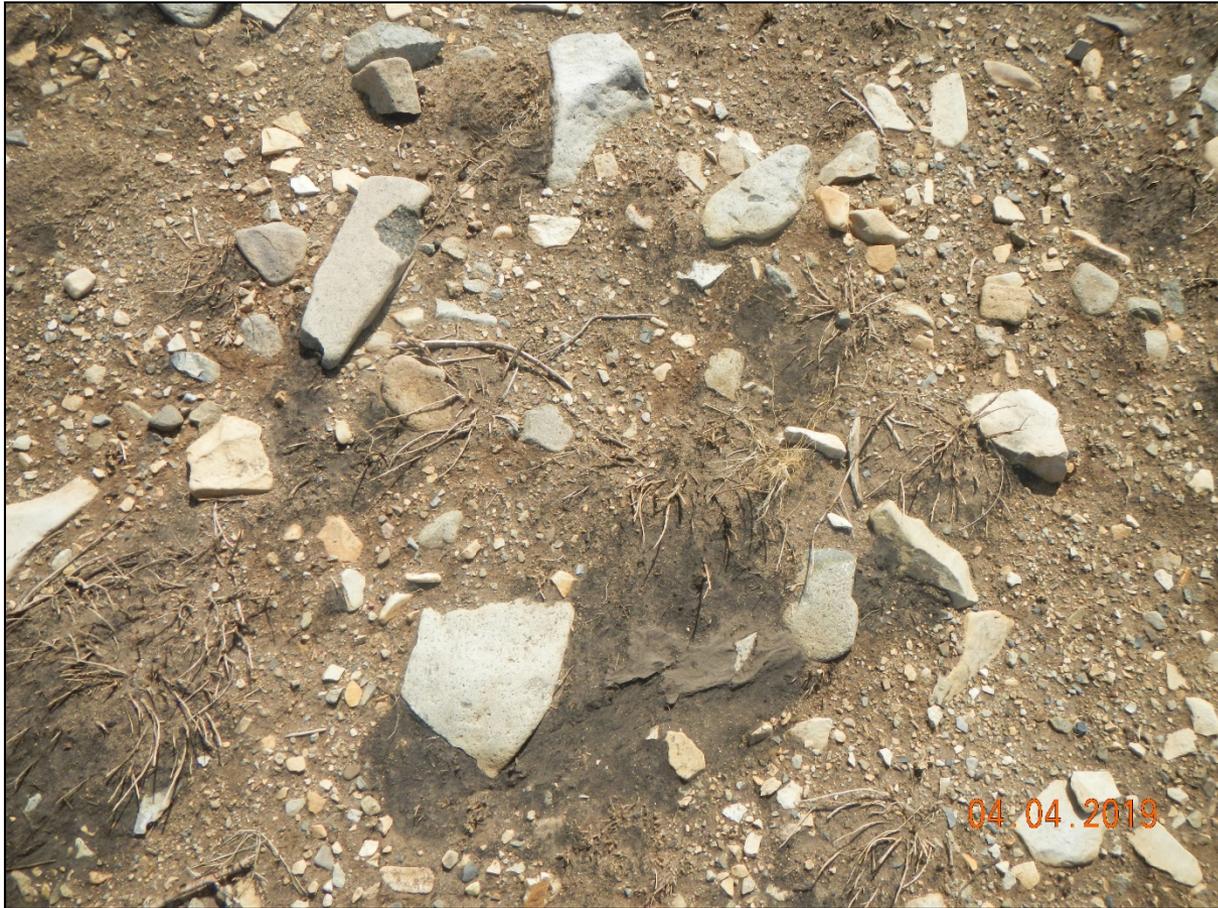
Photo 3. Close up view of the ground. There is some burnt stems present. Re-establishment of vegetation has not occurred like the surrounding pasture.

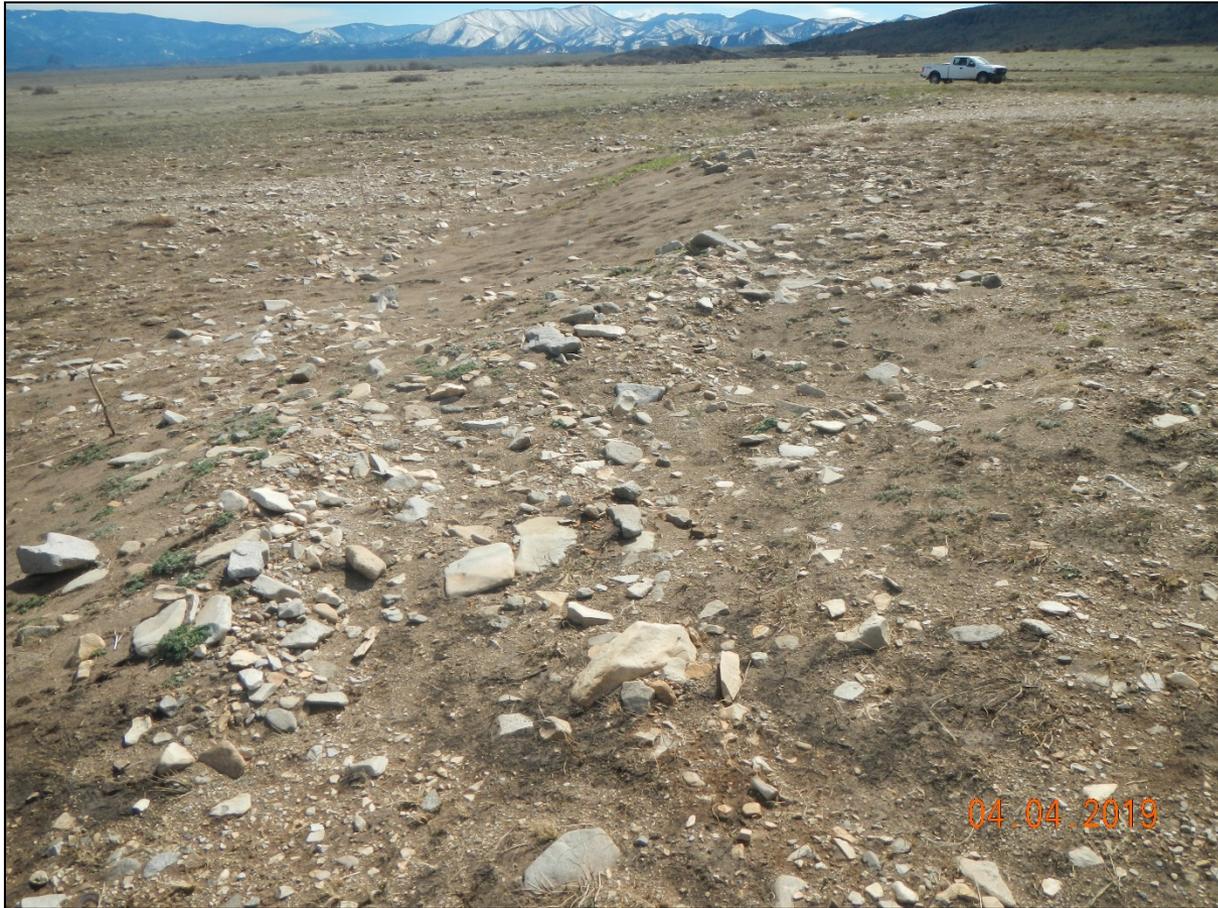
Photo 4. Facing south at the east side of the location. This area is the fill slope and is not leveled very well.

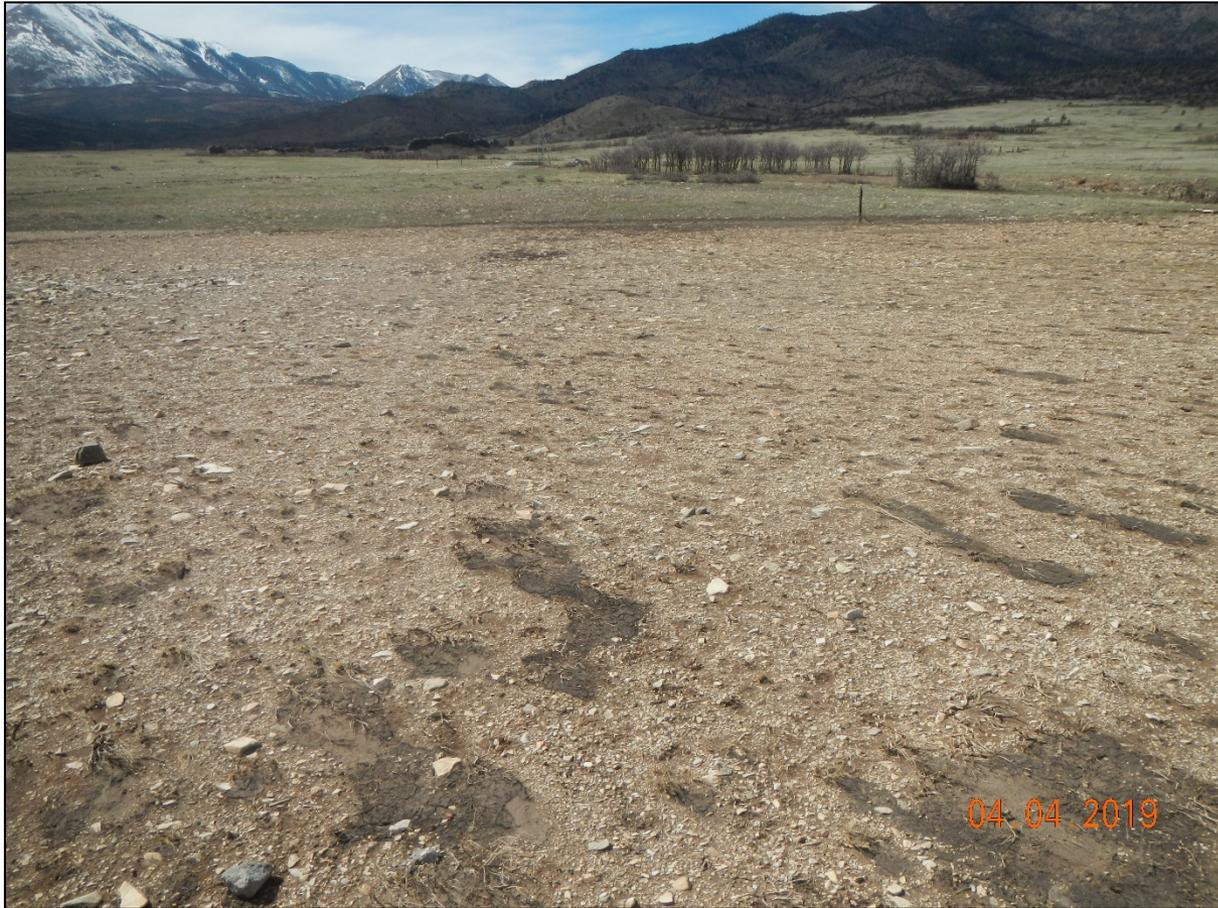
Photo 5. Facing west toward the location. The location is bare of vegetation.

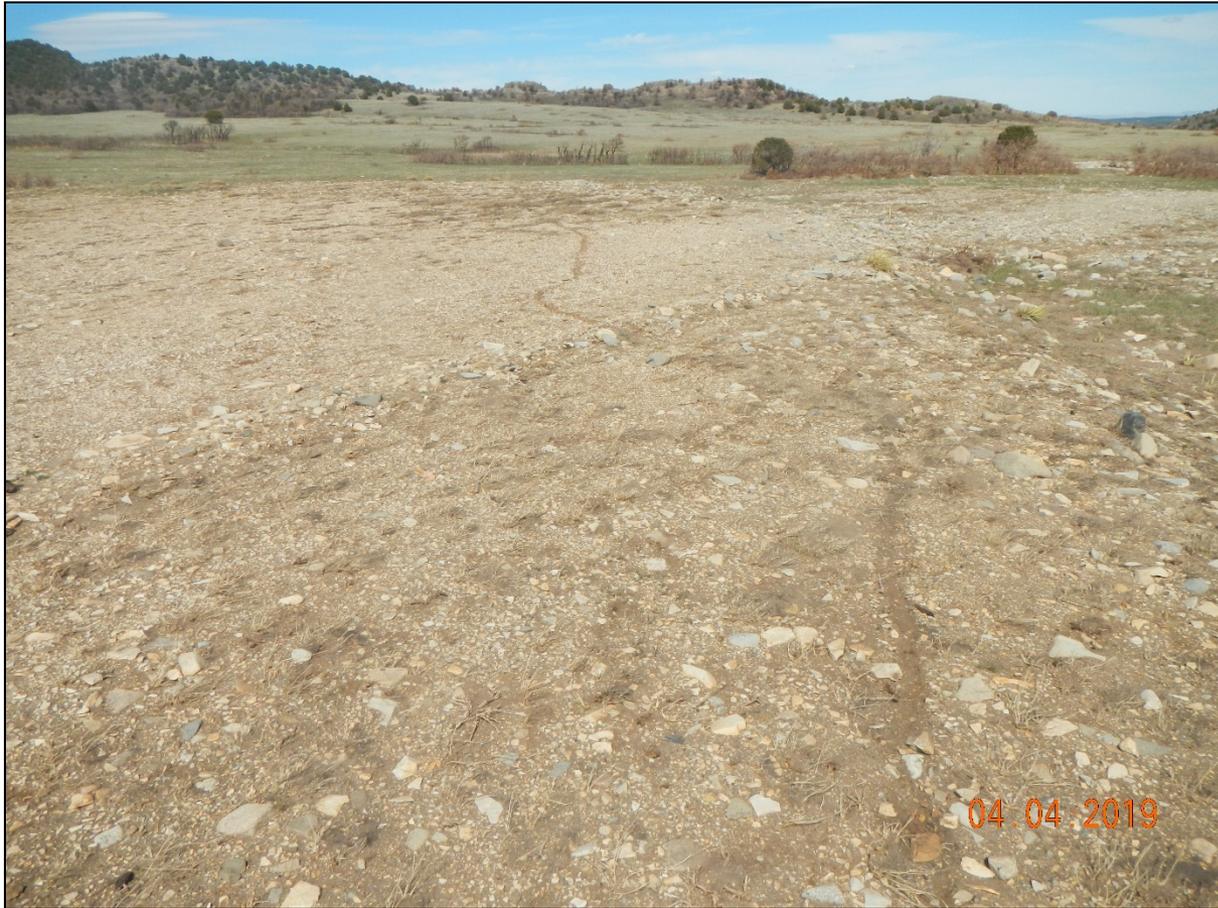
Photo 6. Facing north at the east side of the location. This area is the fill slope and is not leveled very well.

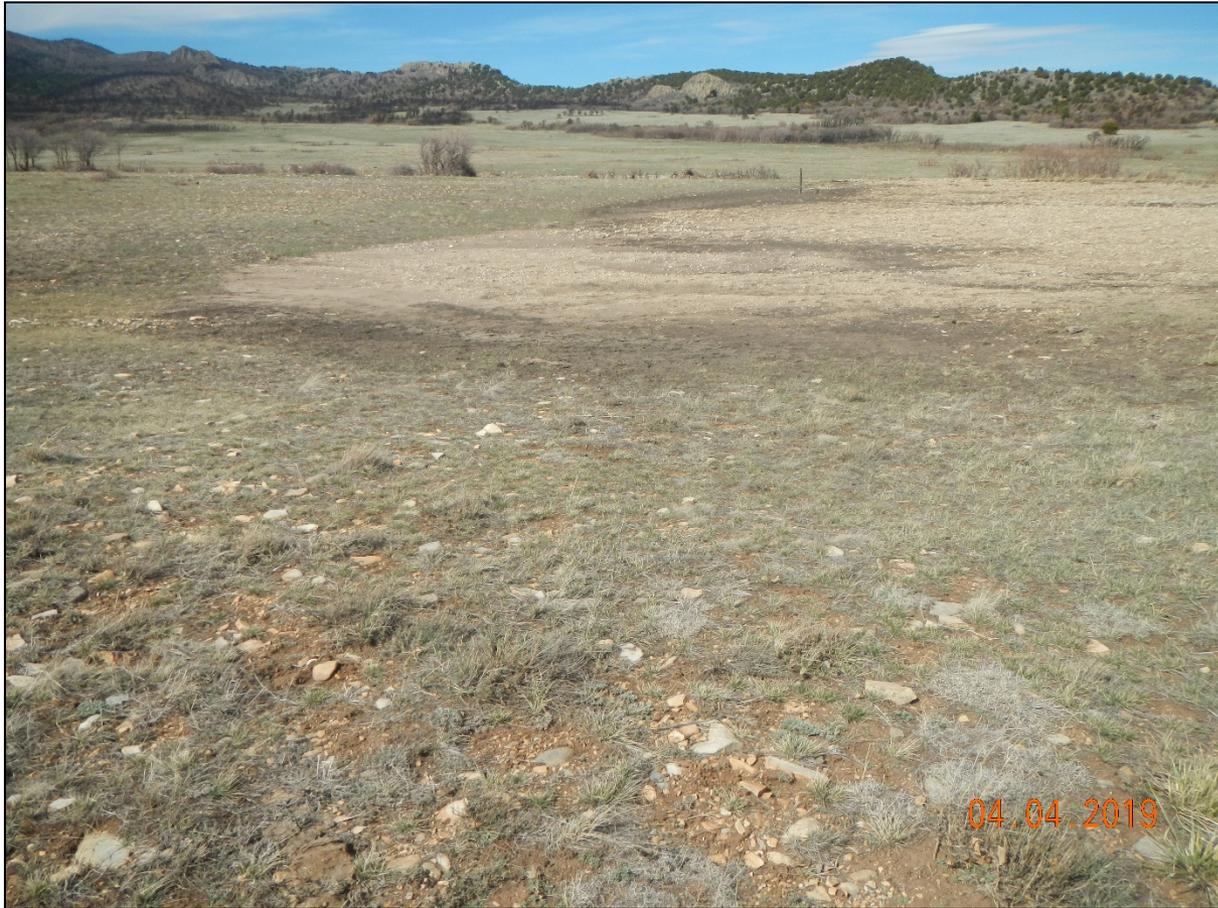
Photo 7. Facing north toward the west side of the location. Photo shows green vegetation establishment outside of the location.

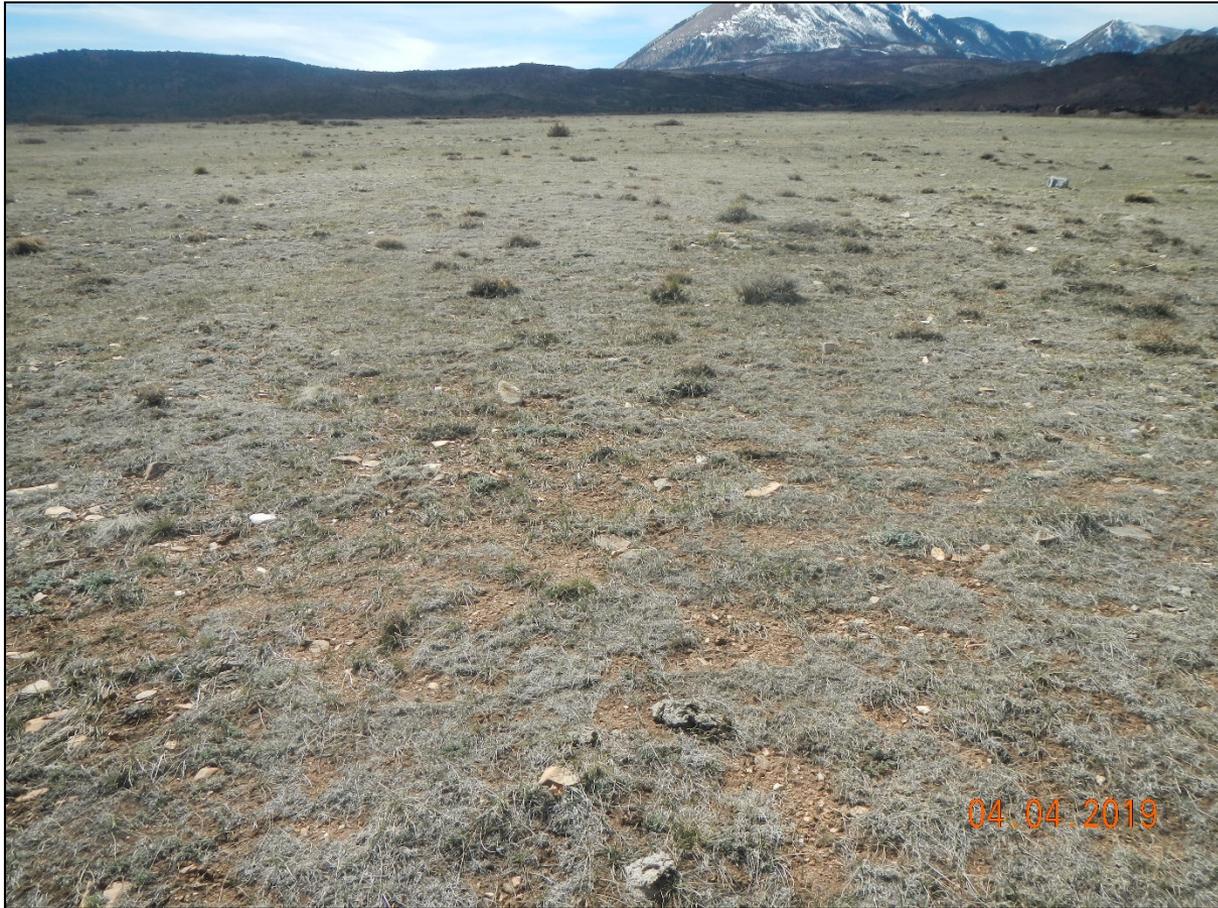
Photo 8. Facing west outside of the location at the adjacent field (reference area). Vegetation consist of Blue grama, Fringed sage, Western wheat, Prairie threeawn.
