Inspection Photos

API: 05-043-05088

Operator: JAVERNICK OIL

Inspection Date: 4/10/2019

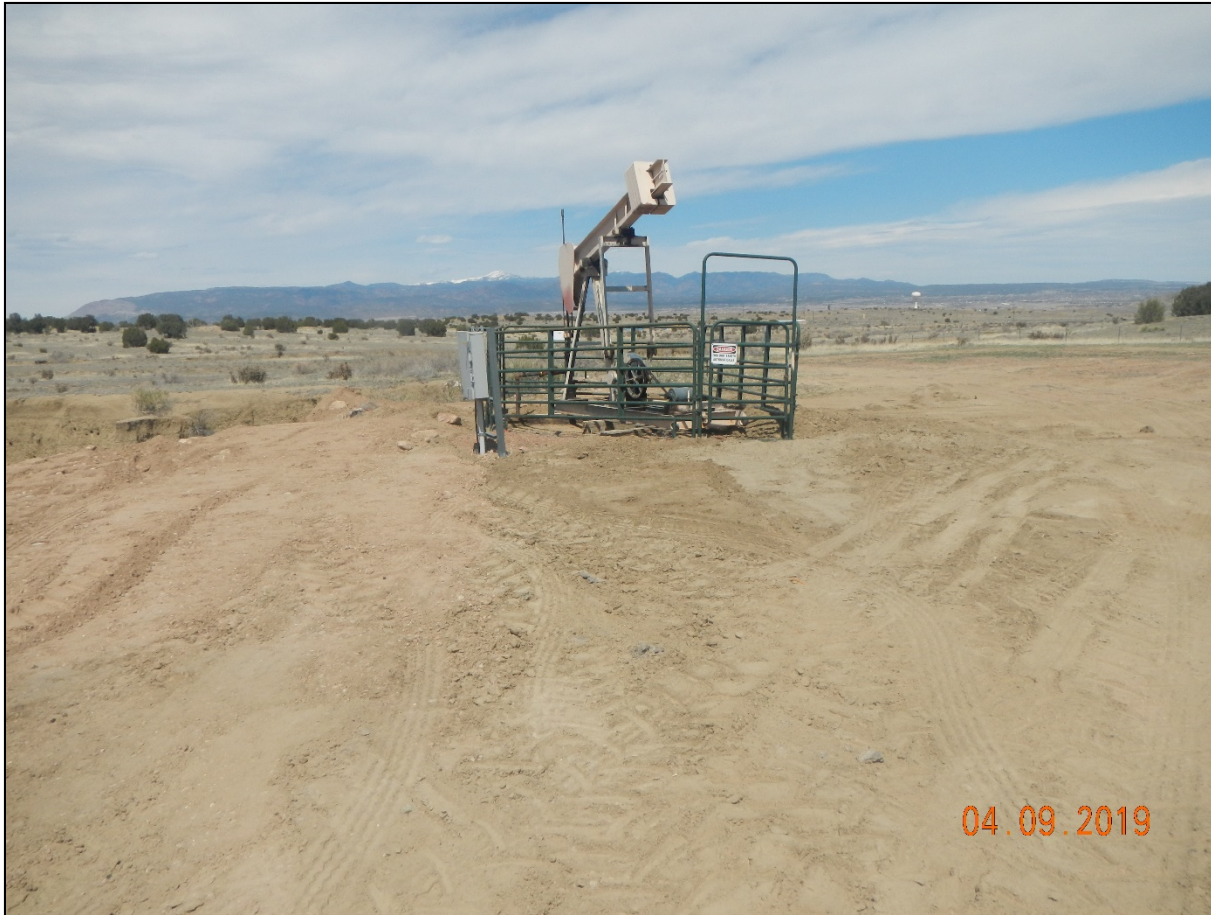
Photo 1. Facing north toward the wellhead.

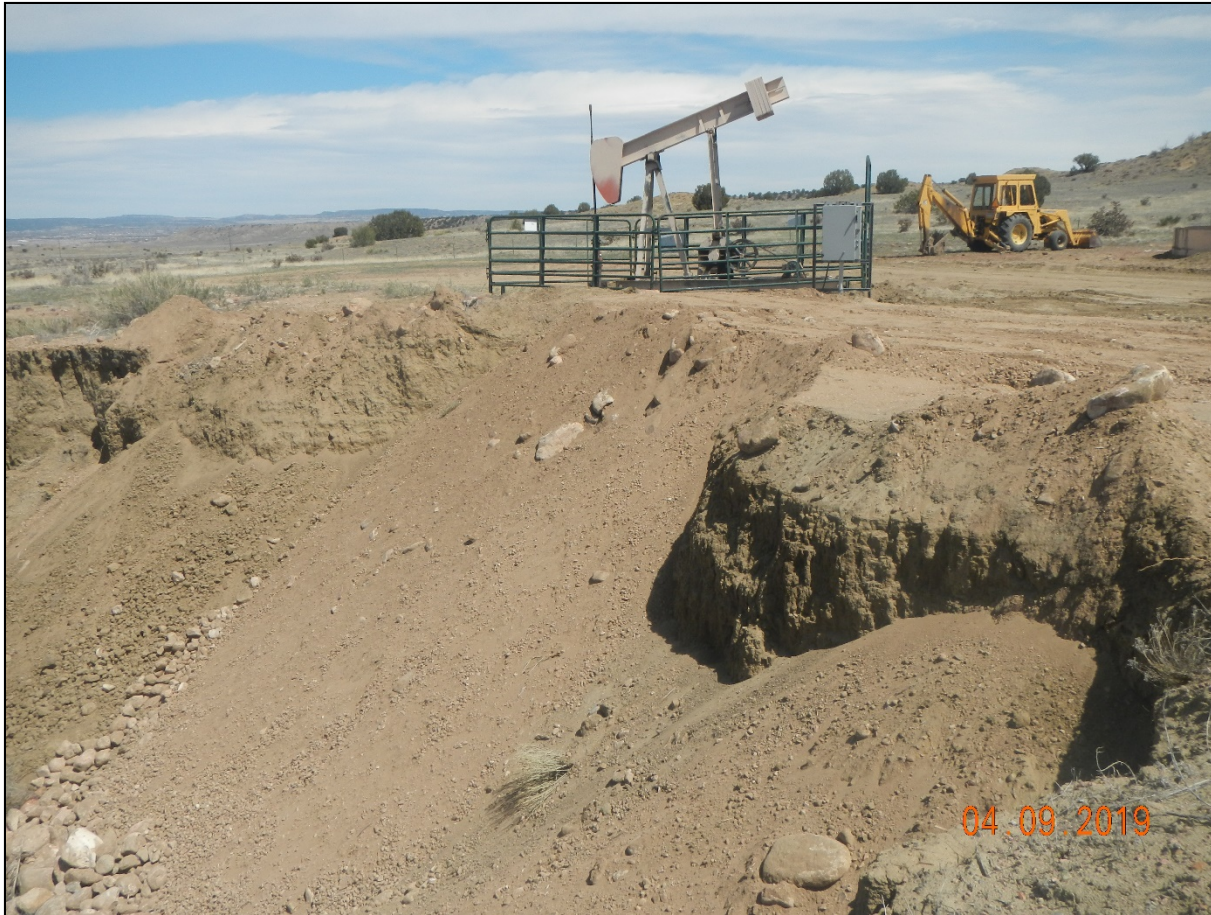
Photo 2. Soil has been brought into the erosional channel near the wellhead. It appears more material is need to slope and stabilize the embankment.

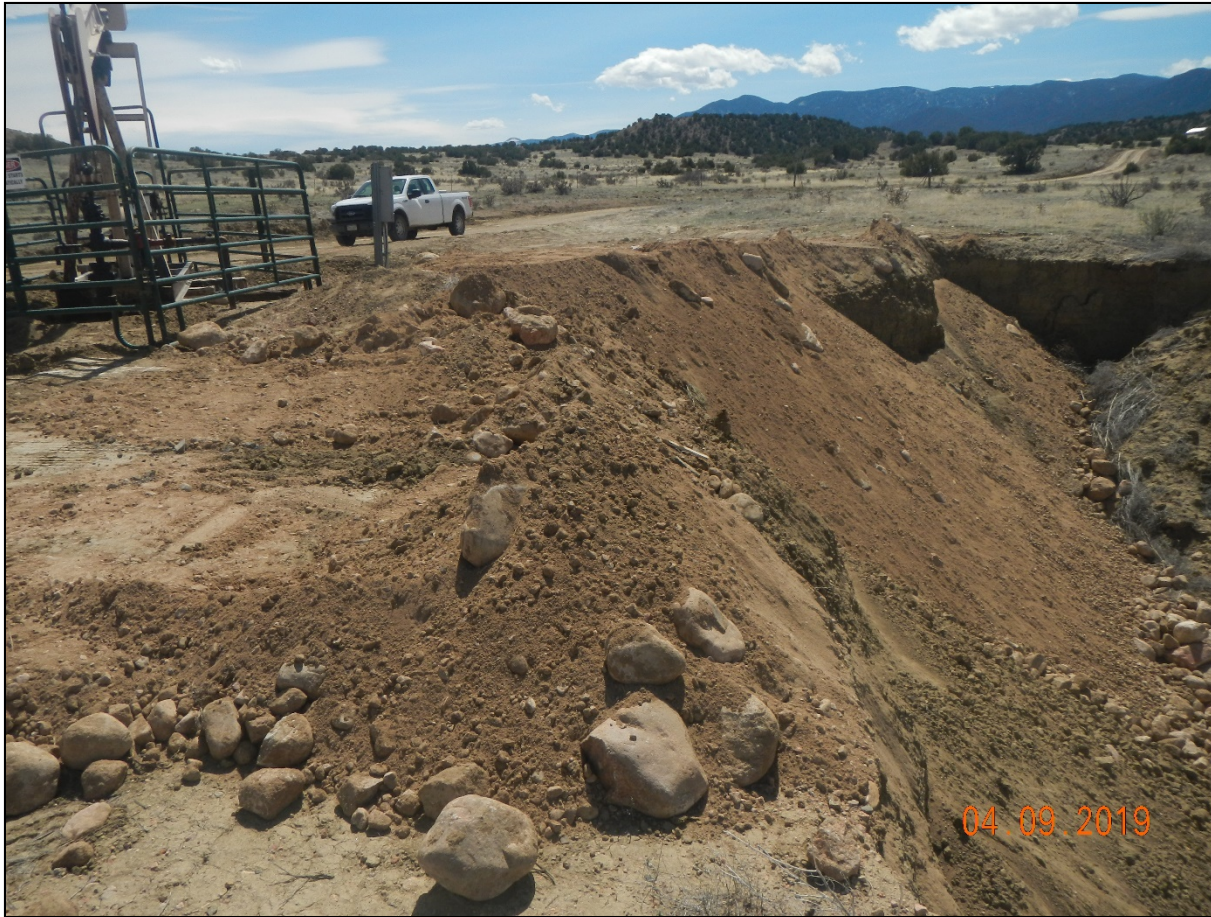
Photo 3. View of the western project area from the western edge facing southward. Wellhead is adjacent to an erosion channel. This area needs immediate stabilization to prevent any further erosion.

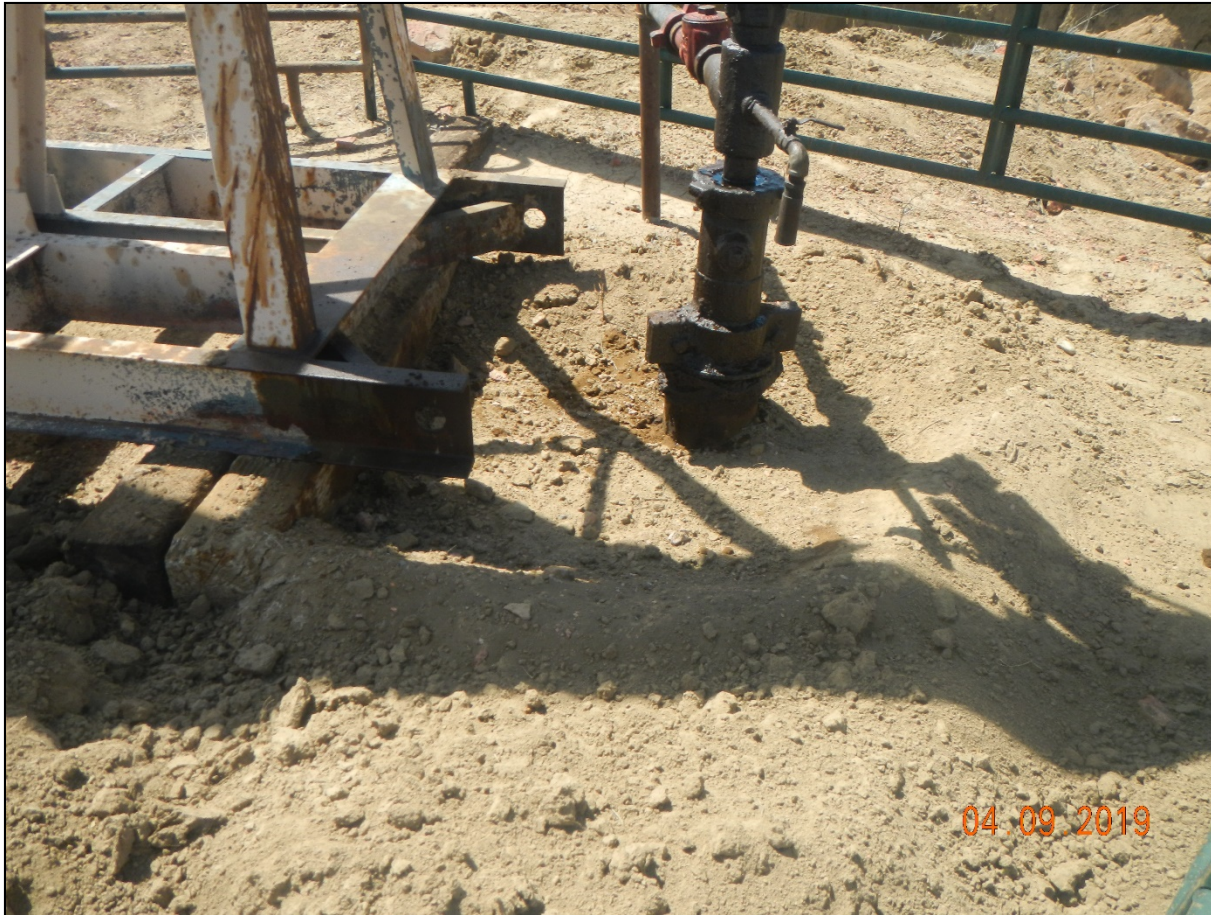
Photo 4. Oil stained soil still appears around the wellhead.

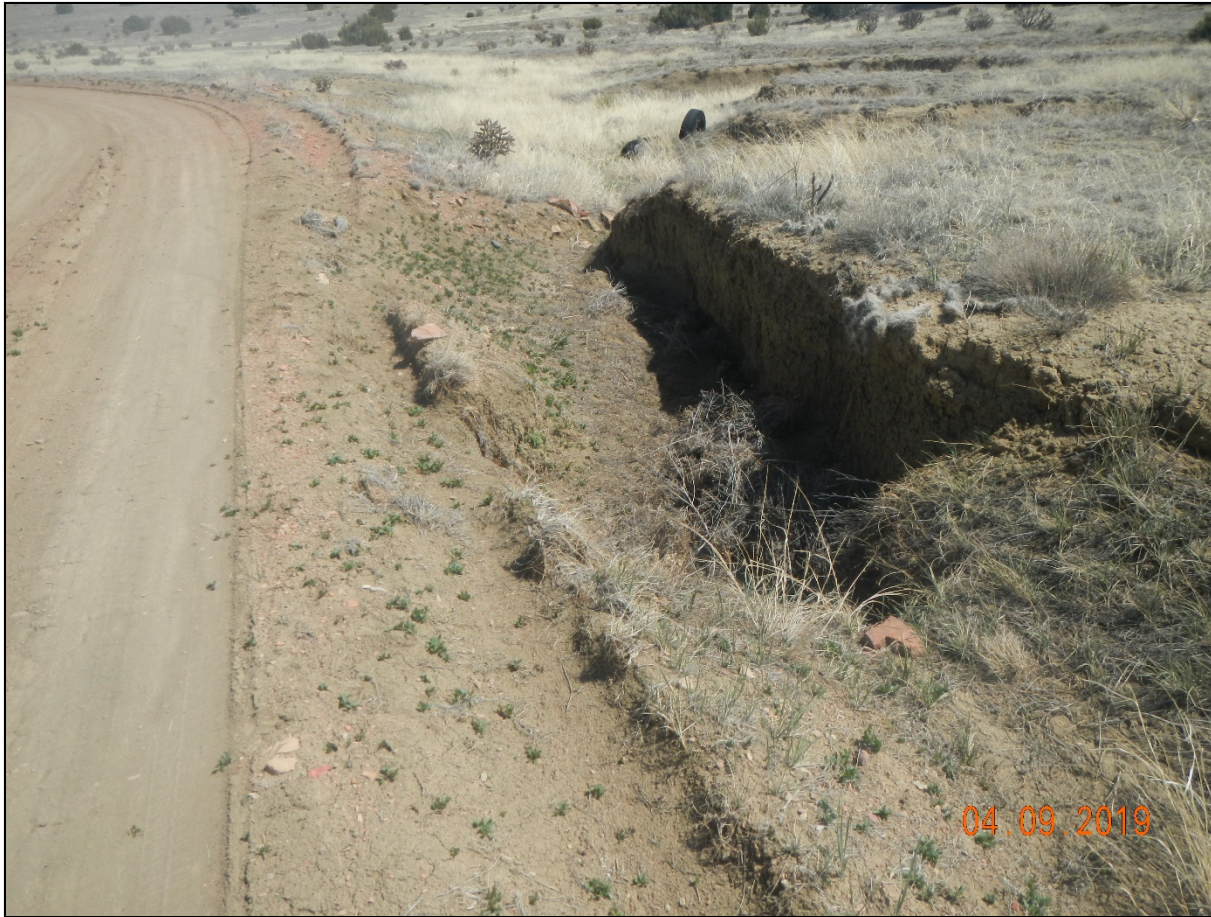
Photo 5. View of erosional headcut, approximately 3 feet wide and deep, along the access road (Lat/Long:38.33276,-105.11330. Stormwater controls have not been installed.
