Inspection Photos

Operator: BP America

API: 05-067-08834

Date: 12/21/2018

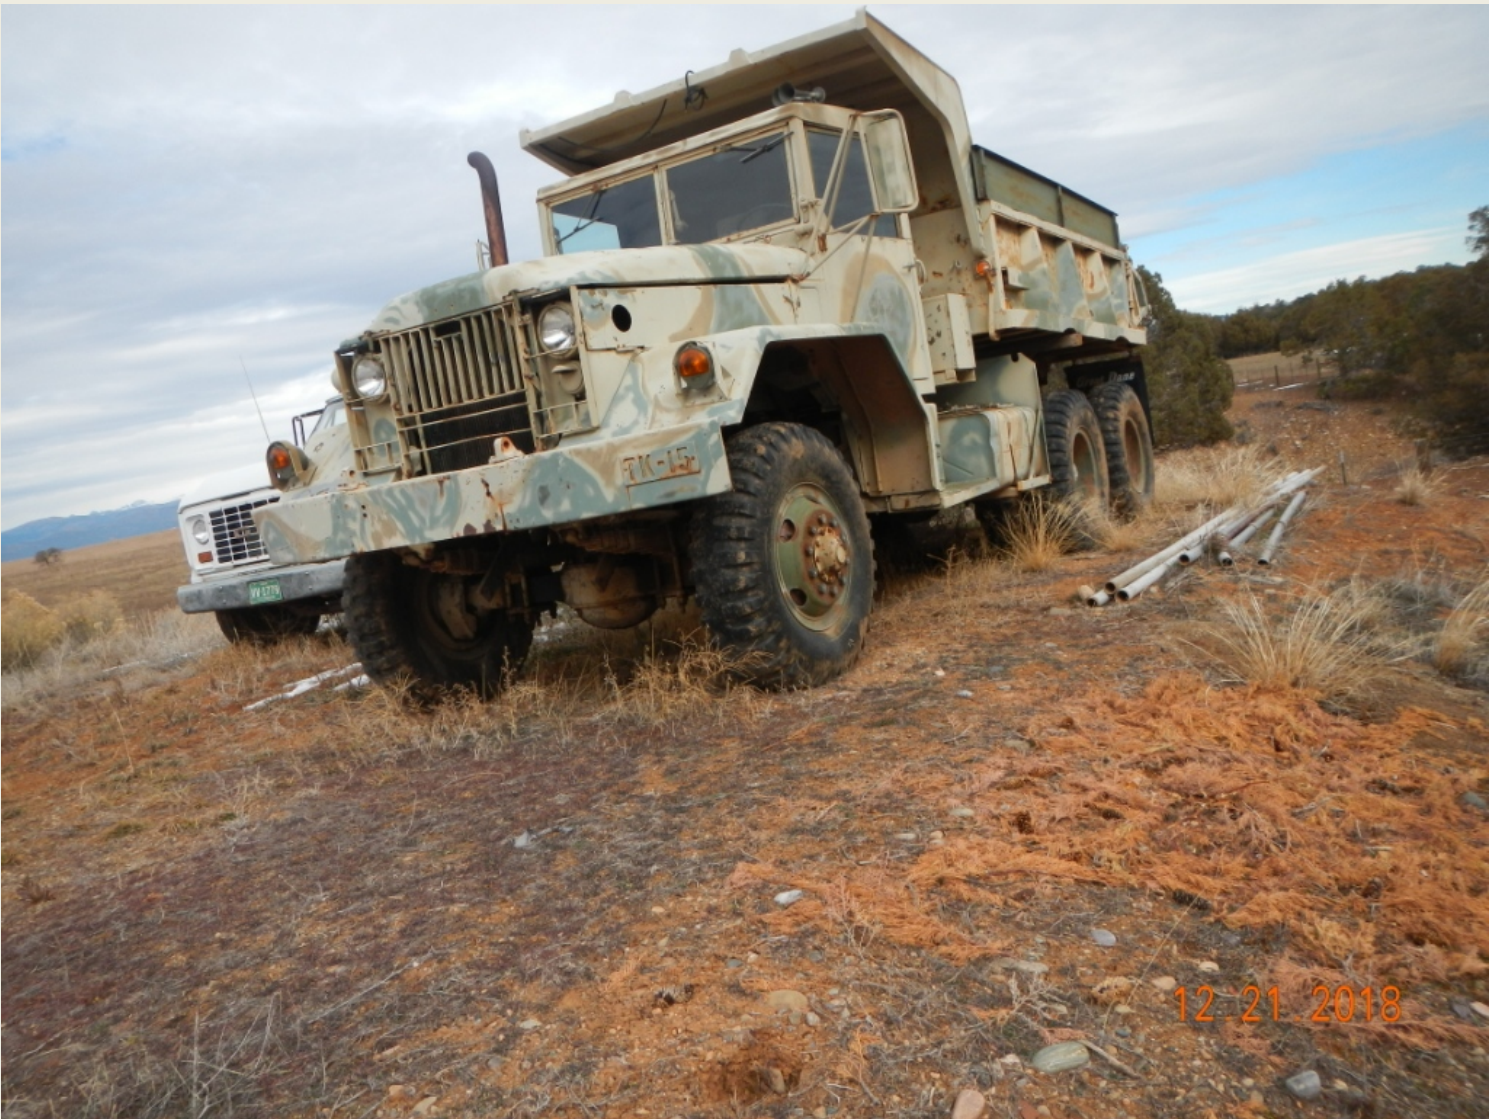
Photo 4. View of what appears to be surface owner equipment within the southeastern project area.

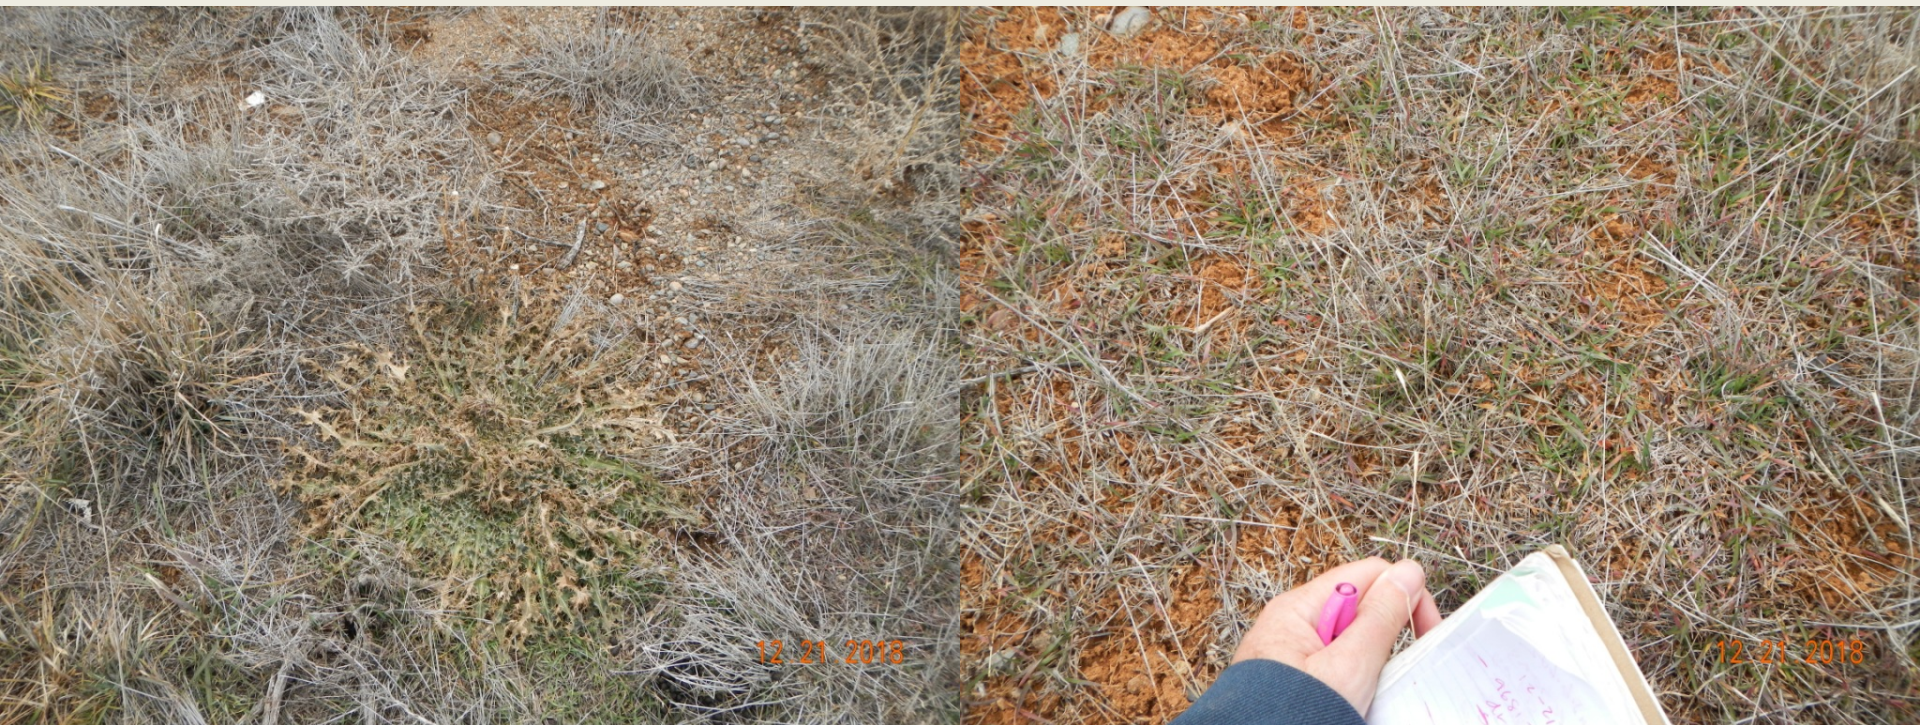
Photos 5/6. View of noxious weeds, musk thistle (*Carduus nutans*) and jointed goatgrass (*Acroptilon repens*) within the interim reclamation area.
