Inspection Photos

API: 05-043-06222

Operator: INCREMENTAL OIL & GAS

Inspection Date: 4/10/2019

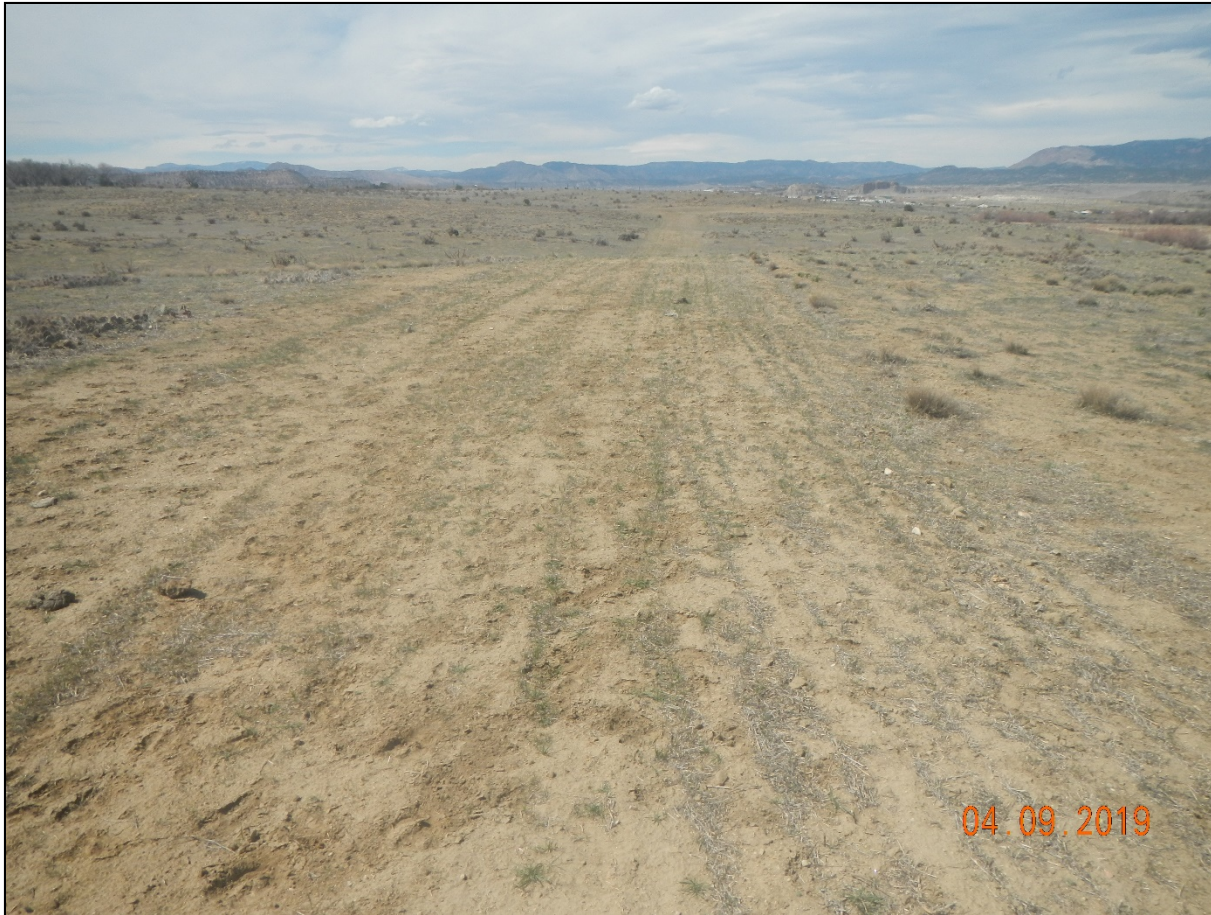
Photo 1. Facing northwest along the reclaimed access road.

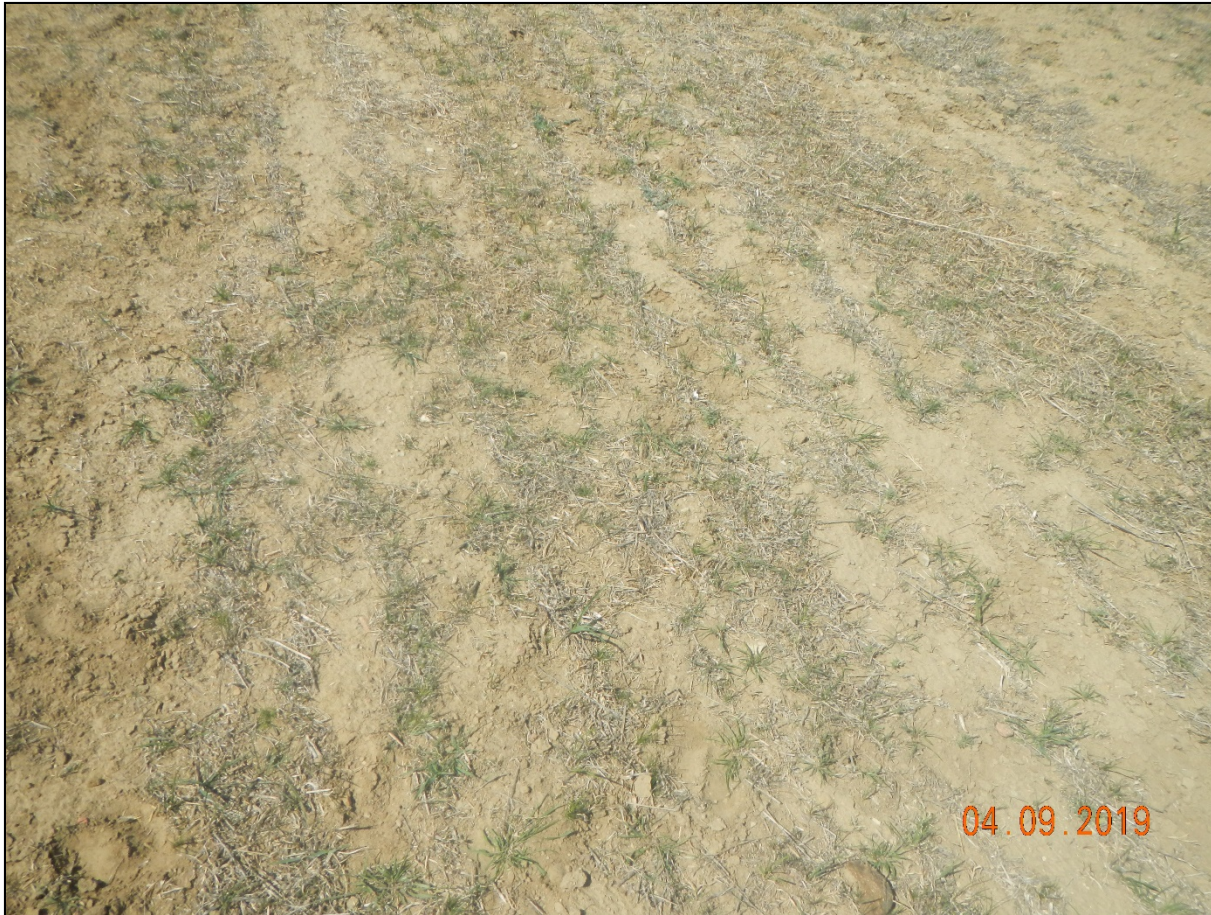
Photo 3. There is grass germination beginning to occur.

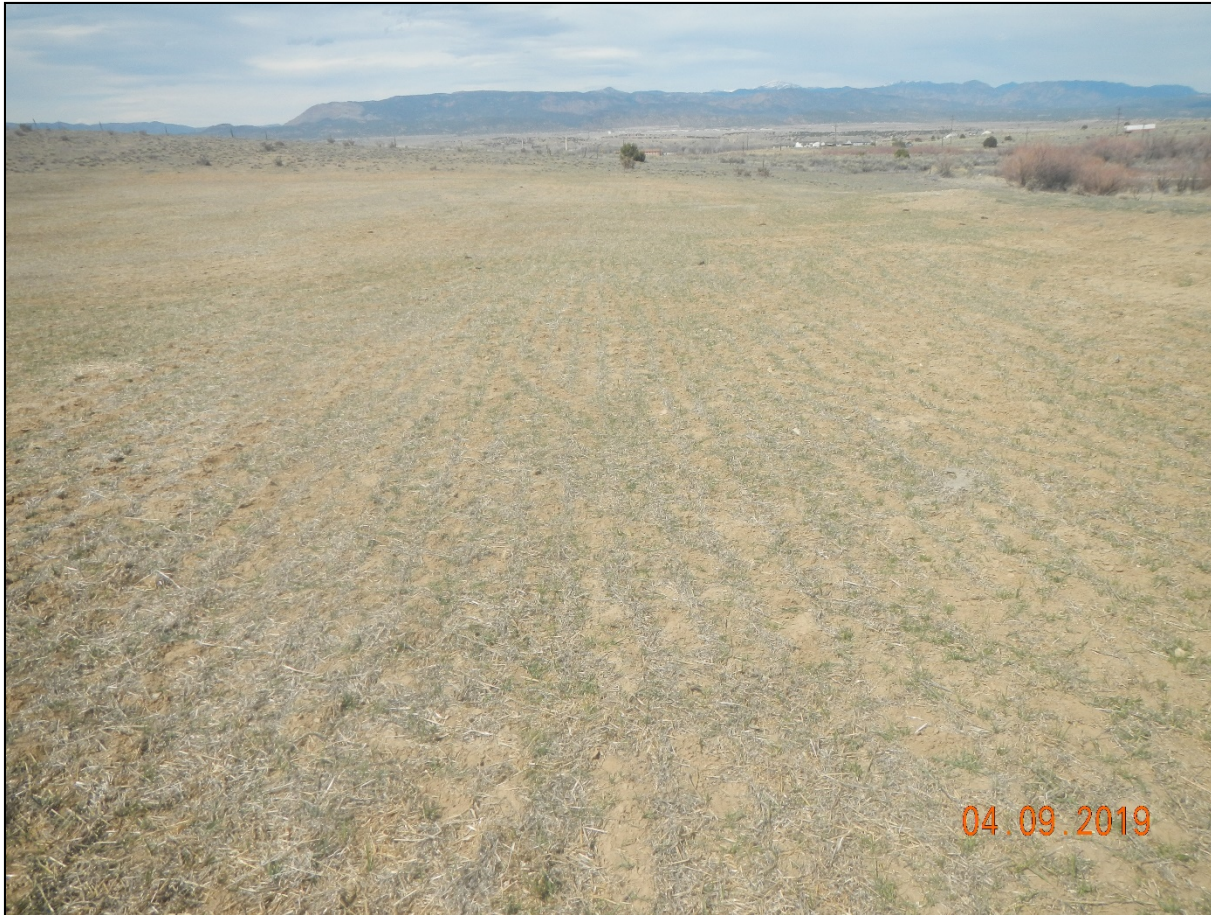
Photo 3. Facing north toward the east side of the location This area has been recontoured and reclaimed.

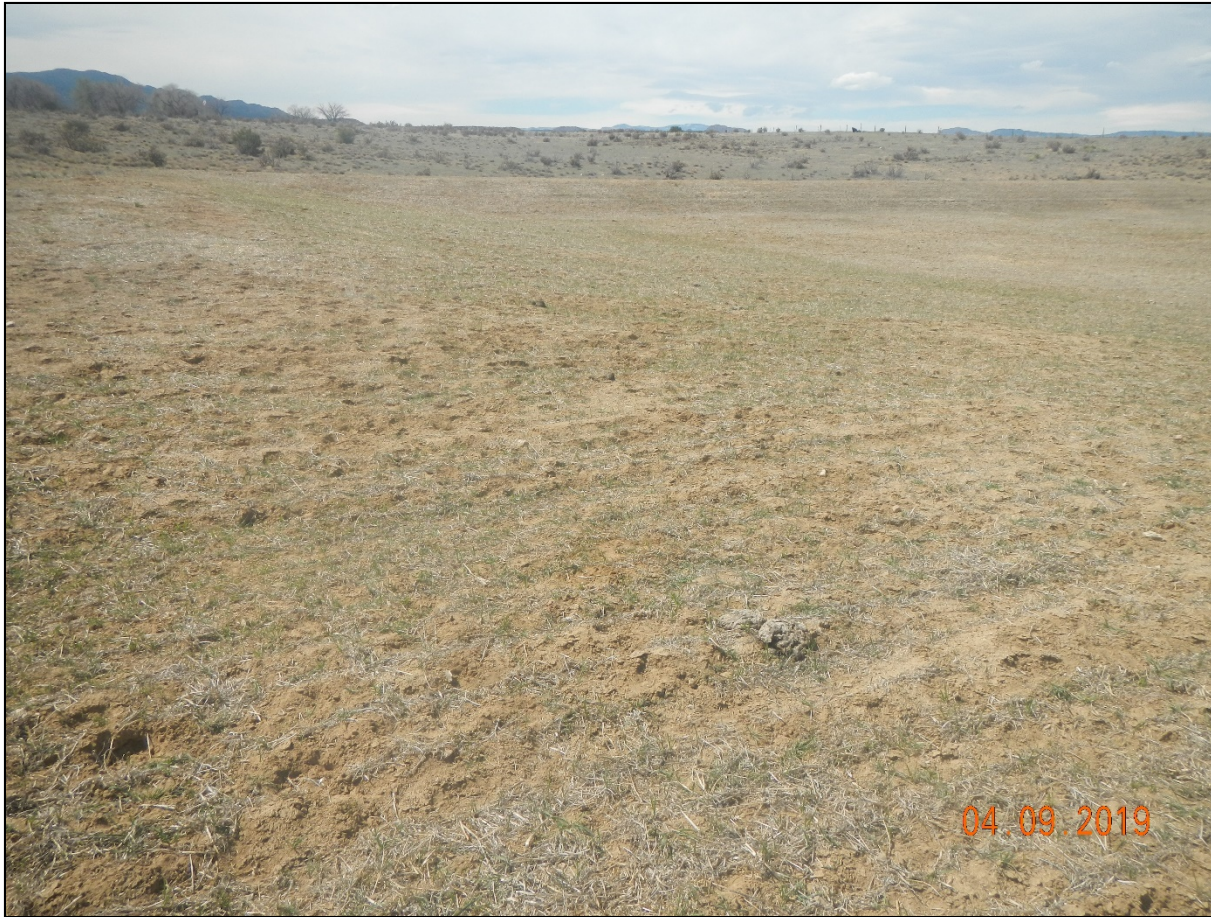
Photo 4. Facing northwest toward the location.

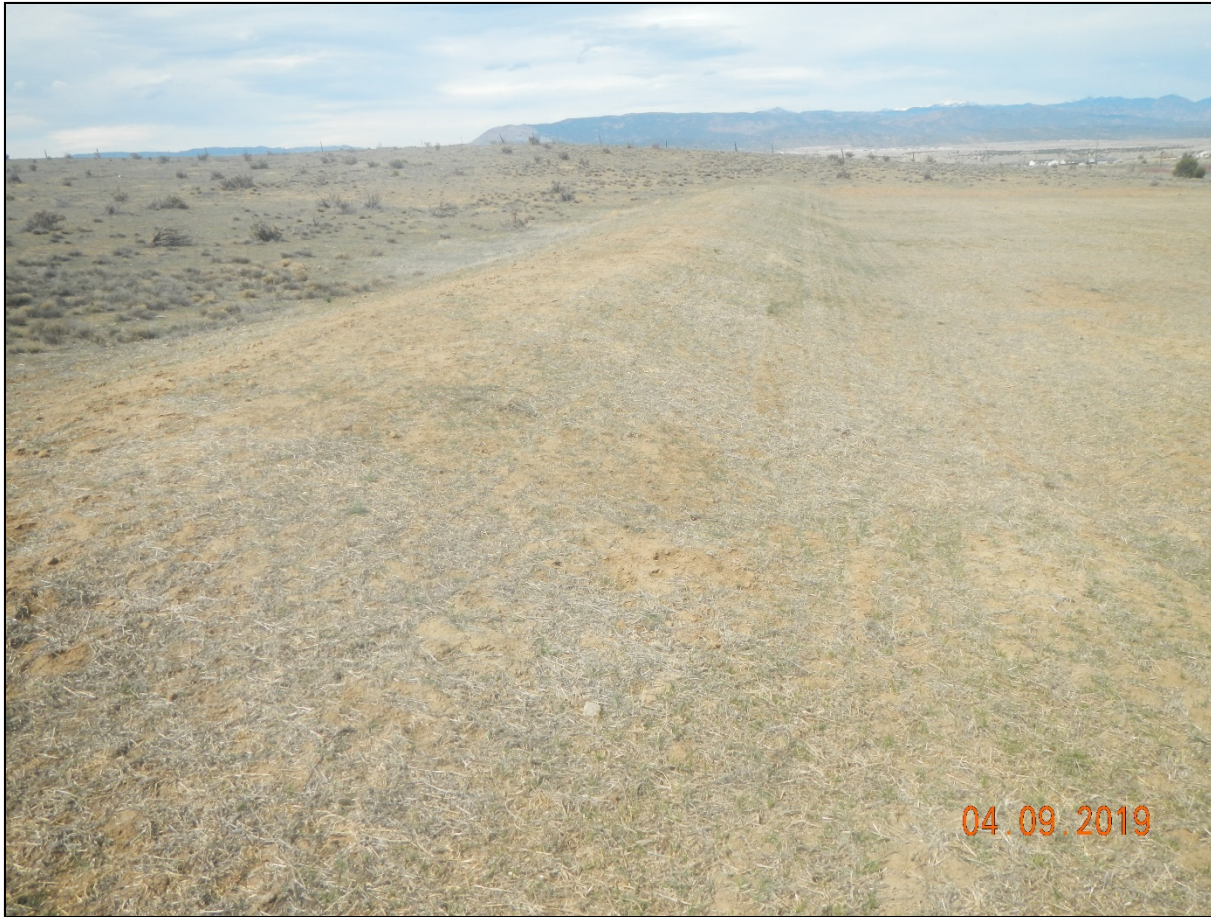
Photo 5. There is an embankment at the east side of the location that has not been recontoured.

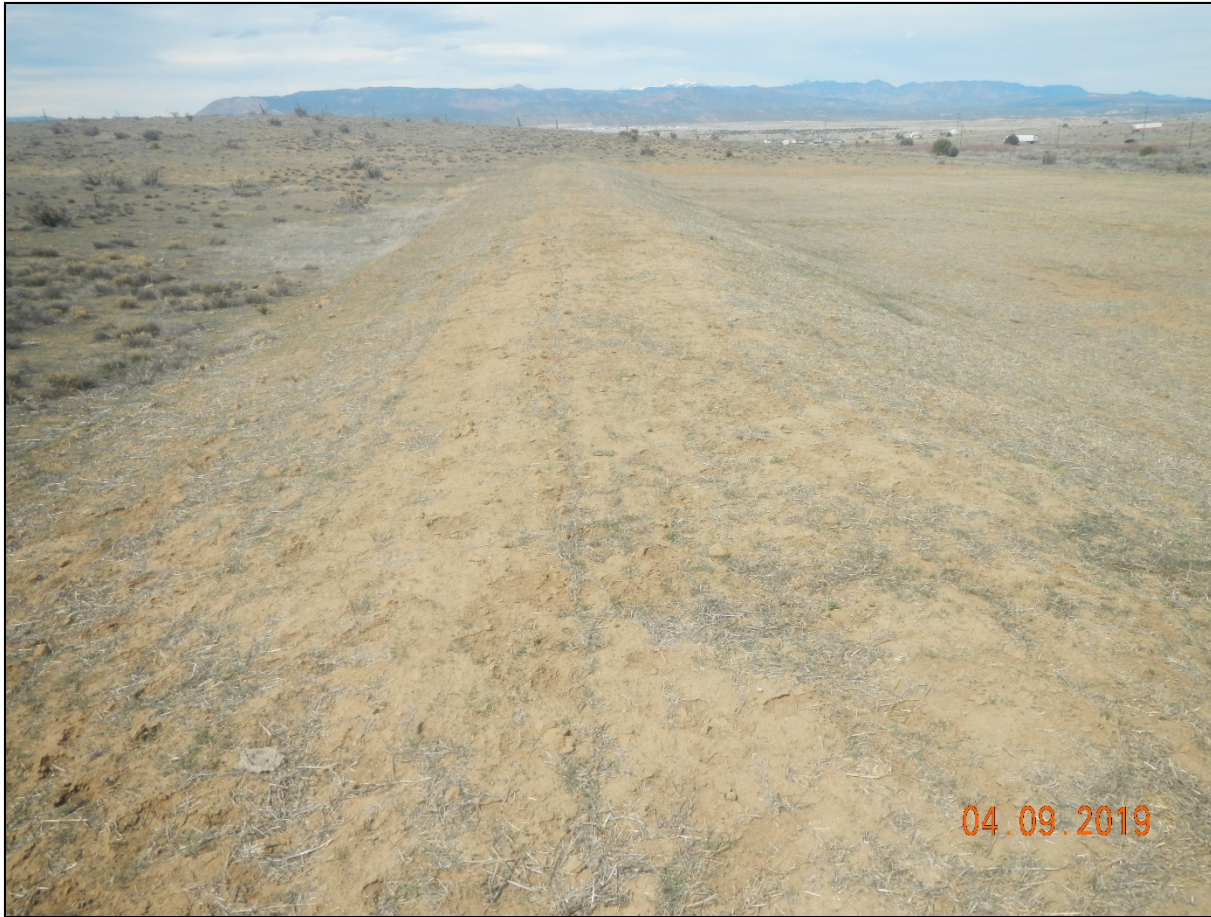
Photo 6. Facing north at the east side of the location. There is an embankment at the east side of the location that has not been recontoured. Approximately 8'h x15'w.
