PIT STATUS EVALUATION FORM

Facility ID: 115133

Pit Name: RUNNING CREEK 15-5

June 3, 2008

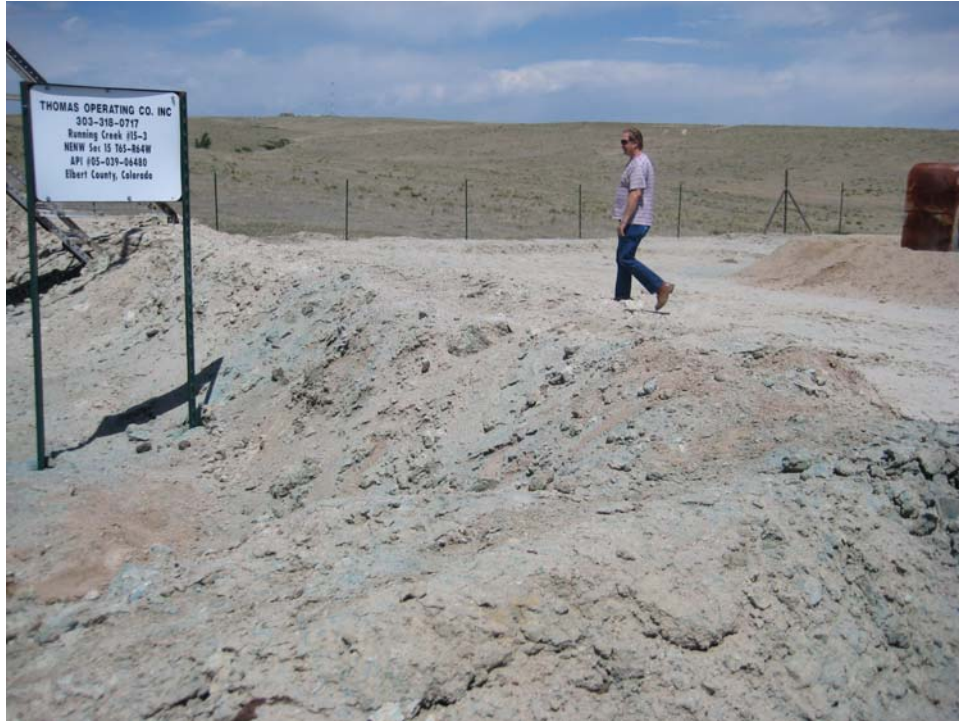
Photo 1. Lease sign for Running creek 15-3 and former pit site beyond berm

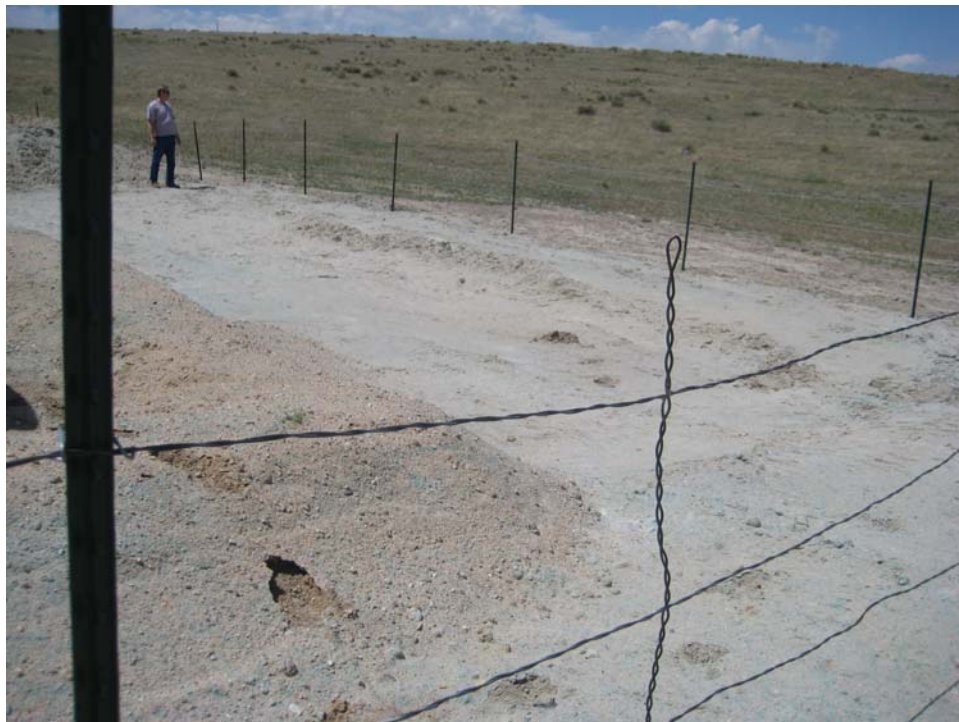
☐ Other documentation LIE (1987) "no earthen pits but guess there is a large UST"☐ Abandoned☐ Possible un-reclaimed pit(s) or adverse conditions, no closure docs☒ Site Visit☐ No Site Visit☐ Add'l Review☐ UnknownNotes: Common Use with Running Creek 15-3, 15-6, 15-5 battery tank site.FIELD VISIT 6-3-2008: PIT BACKFILLED

Photo 2. Looking southwest showing recently backfilled pit inside fence
