Inspection Photos
Location Name: GE# 20-05X
Location ID: 308792

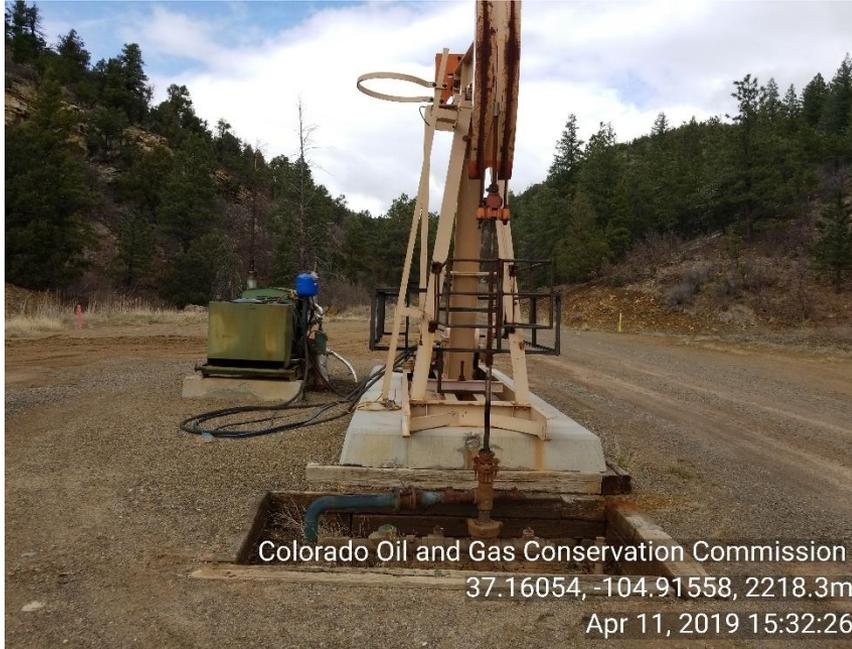
Photo 1 PU and HYD motor skid

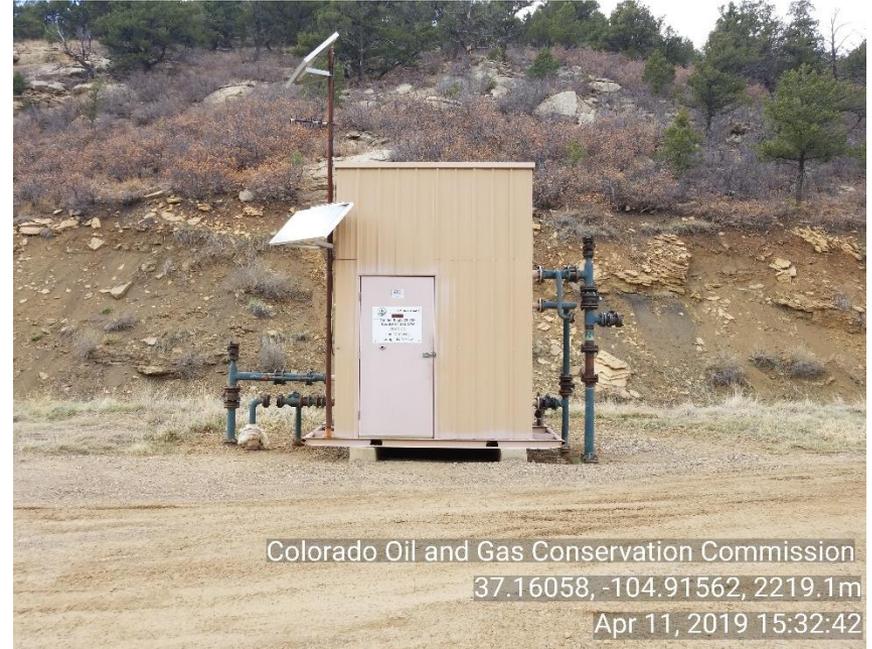
Photo 2 Sep/meter house

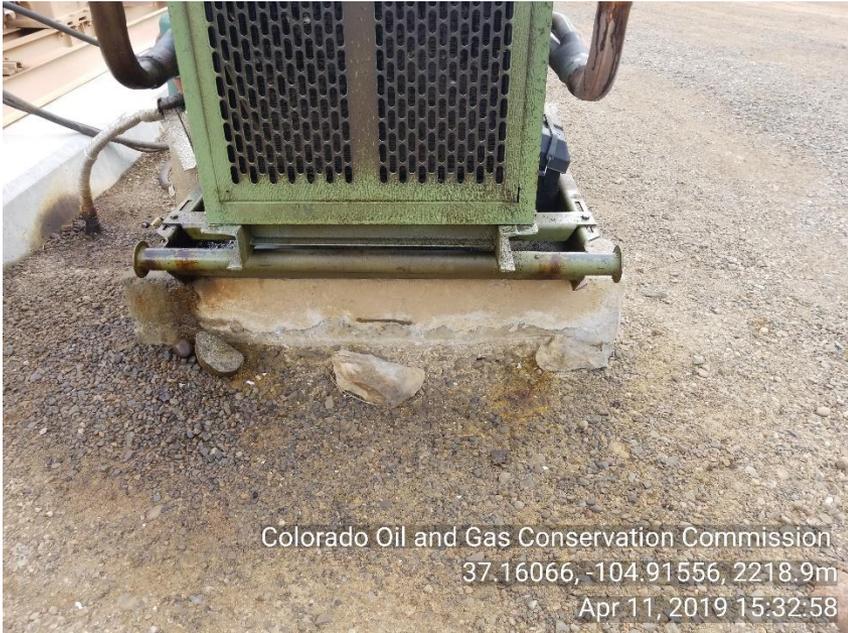
Photo 3 Stained soil around HYD skid

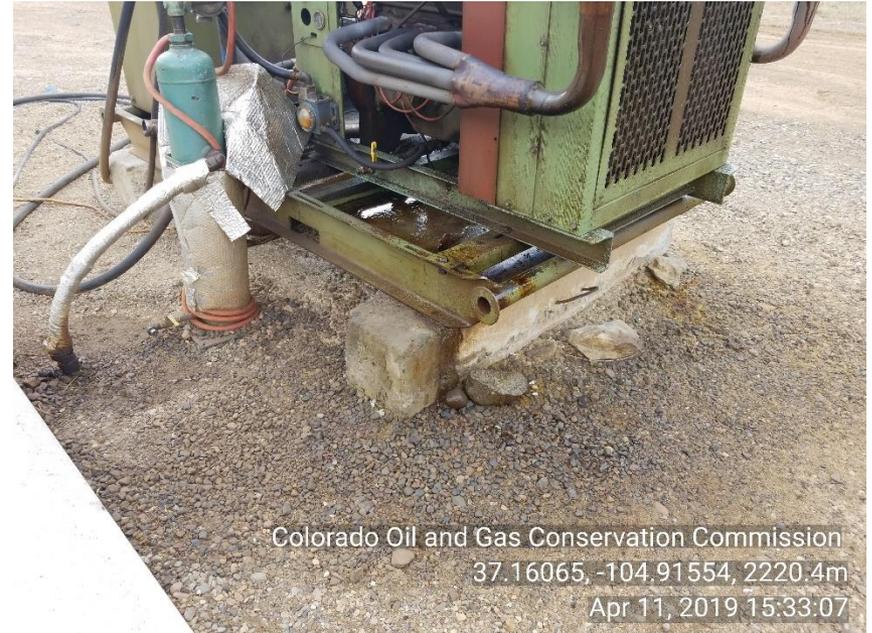
Photo 4 Stained soil around HYD skid

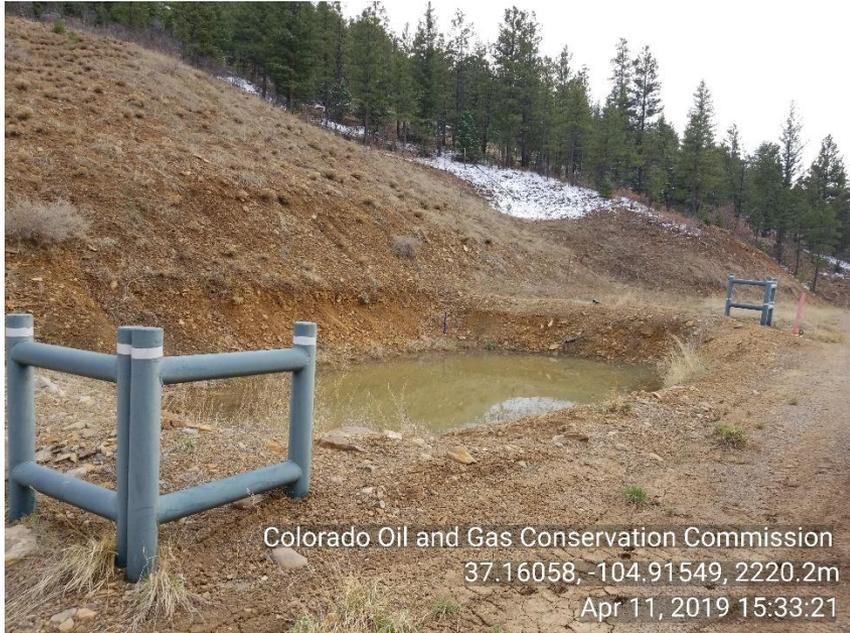
Photo 5 Production pit
