Inspection Photos
Location Name: GE#20-03
Location ID:308859

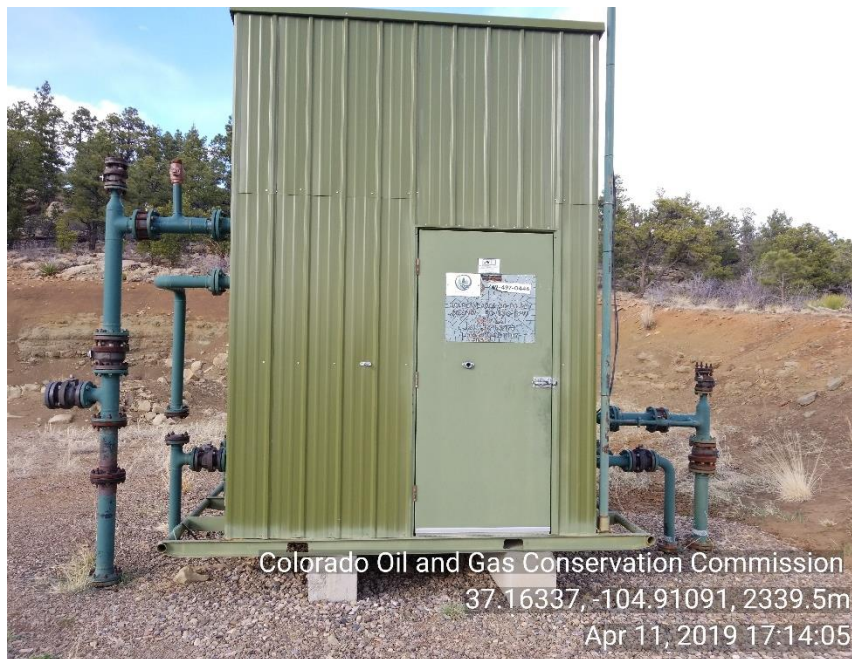
Photo 1 sep/meter house. Location sign is faded and not legible.

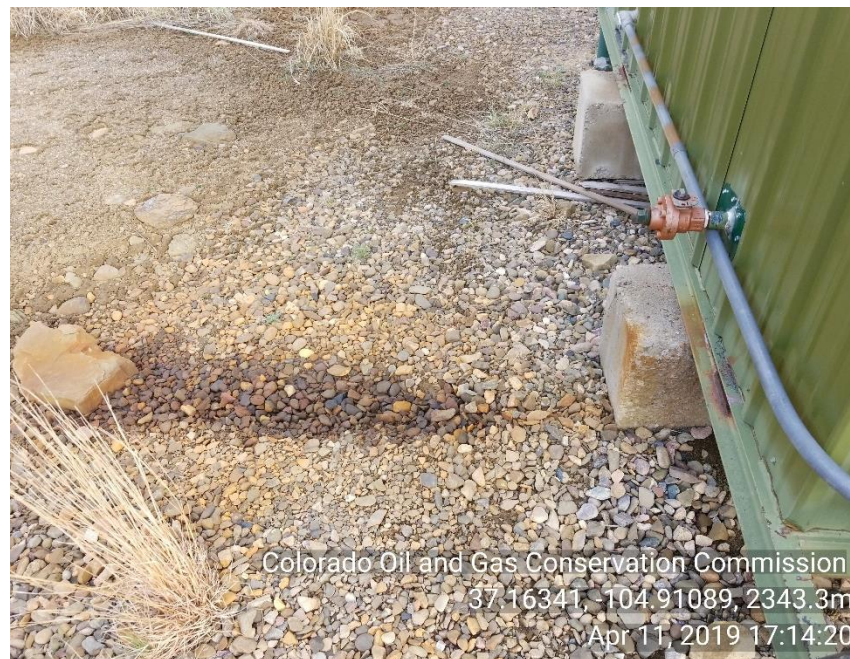
Photo 2 Stained soil under drain line for separator.

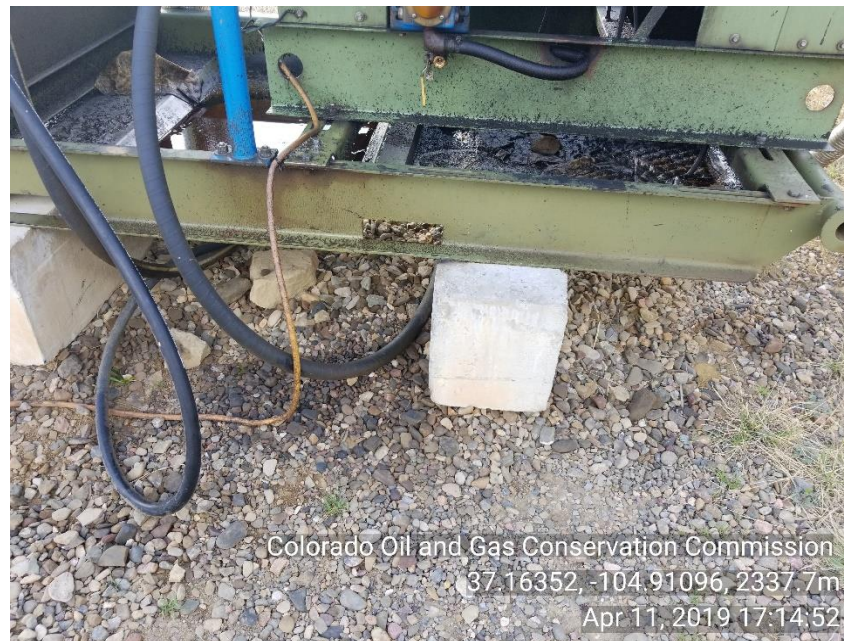
Photo 4 Stained soil around HYD motor skid

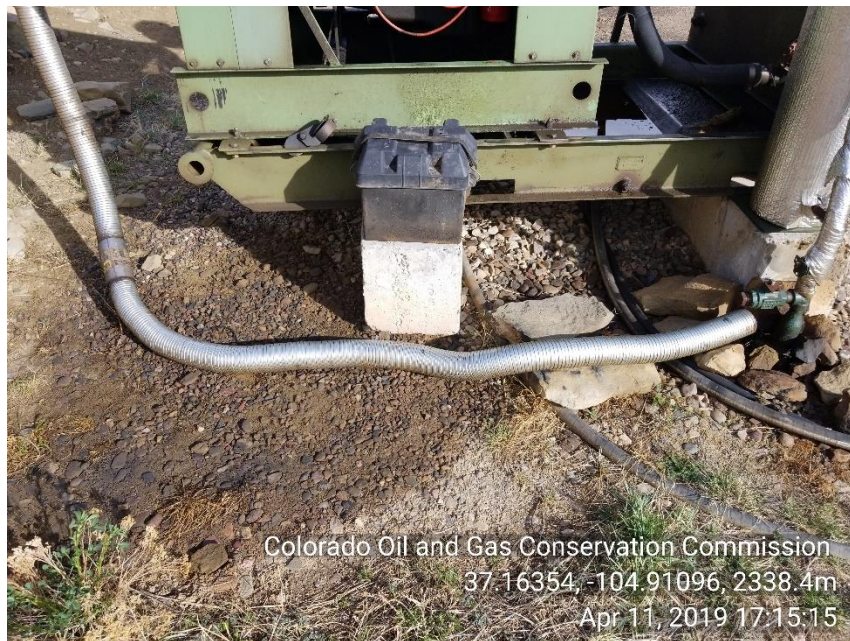
Photo 5 stained soil around HYD motor skid

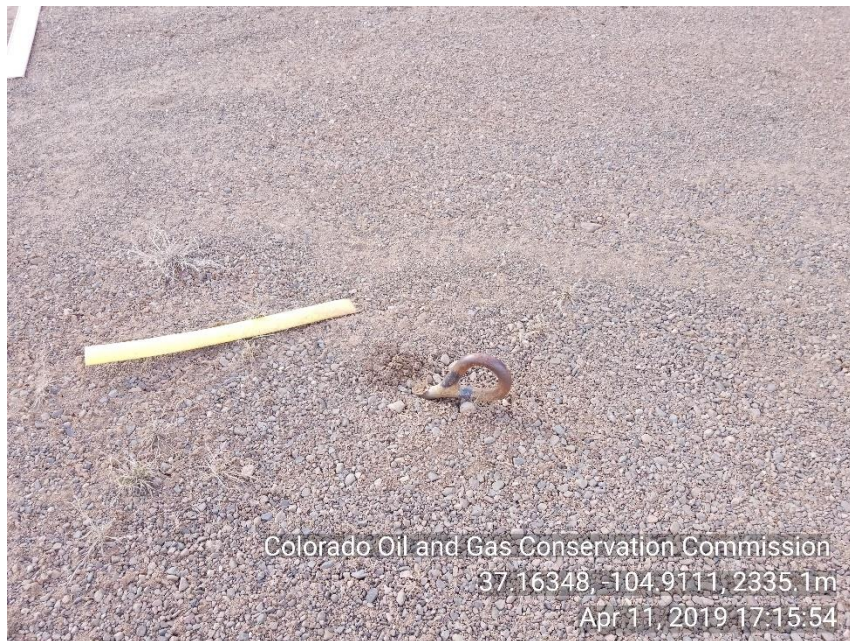
Photo 7 Unmarked guy line anchor.

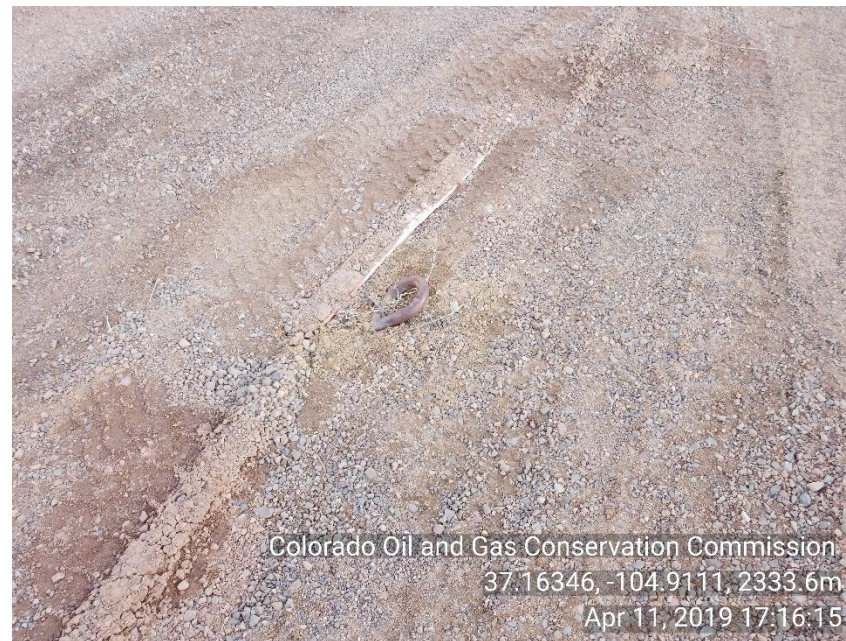
Photo 8 unmarked guy line anchor/
