Inspection Photos
Location Name: William D. Landsdown #1
Location ID: 317613

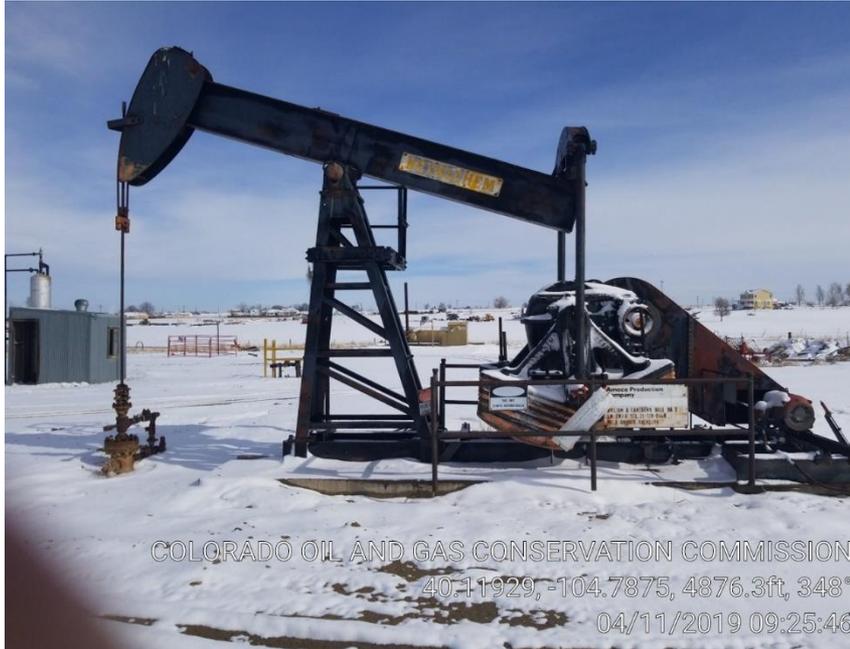
Pic 1 1 WH/PU sign faded and in disrepair

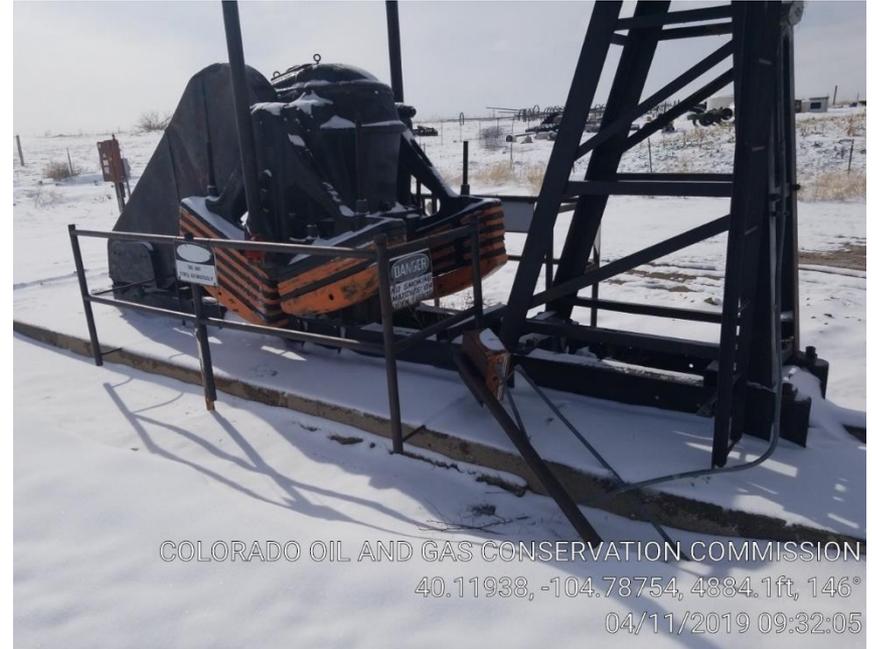
Pic 2 Electric panel knocked over

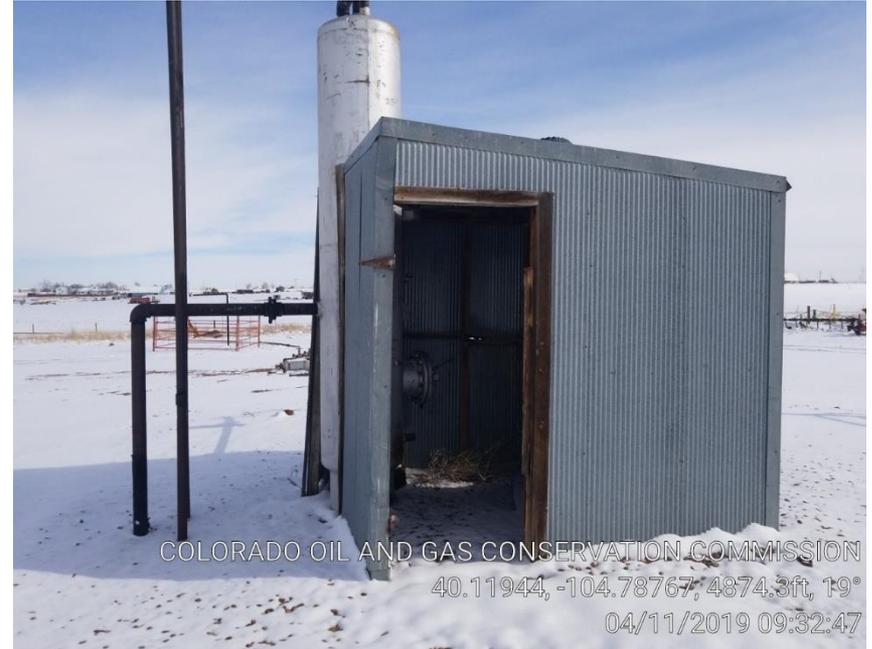
Pic 4 Vert sep building in disrepair, not plugged line.

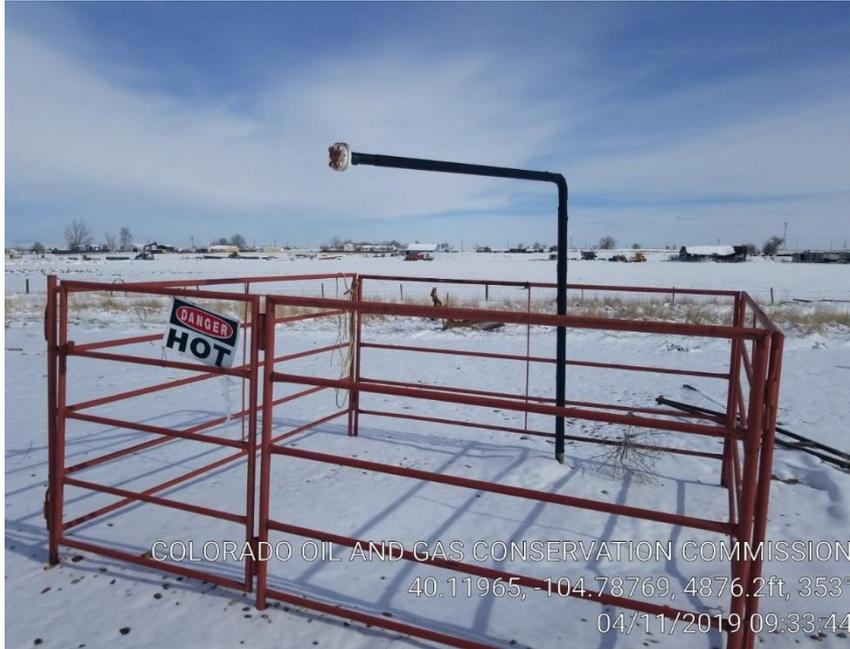
Pic 5 unused unmarked and not LOTO riser

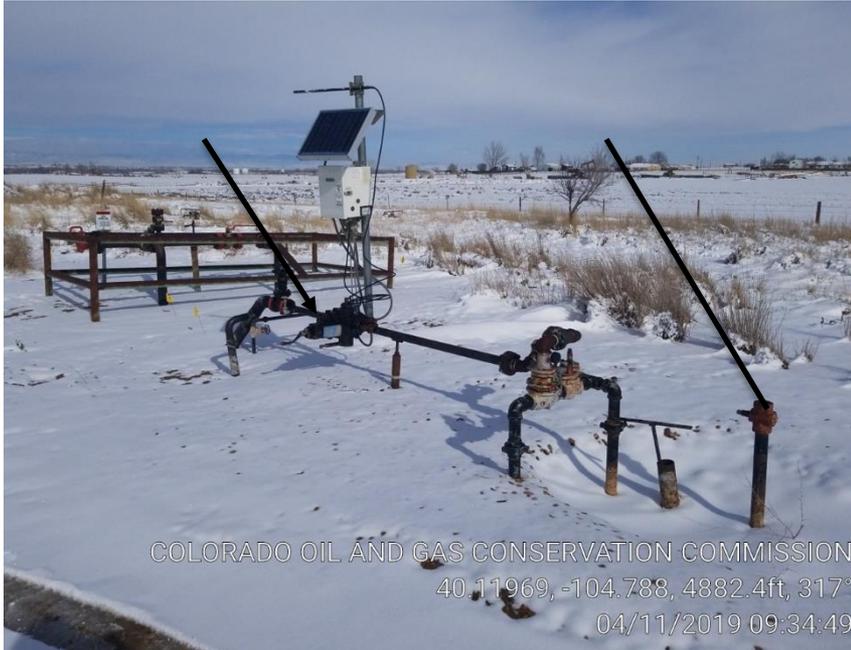
Pic 7 Gas meter run unused. Unmarked and not LOTO risers

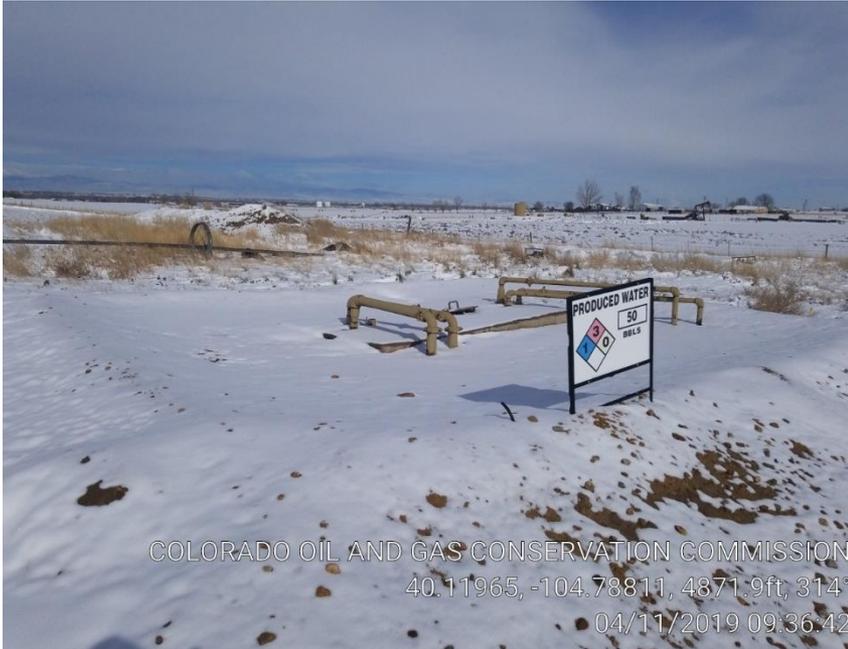
Pic 9 Produced water tank, berms not adequate and in disrepair

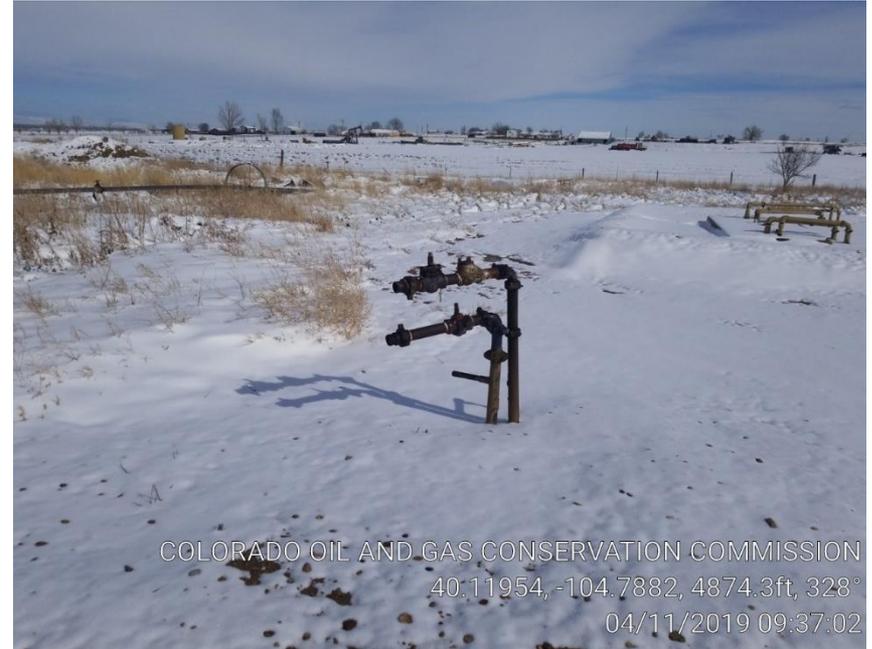
Pic 10 unused unmarked and not LOTO rises, and stained soil.

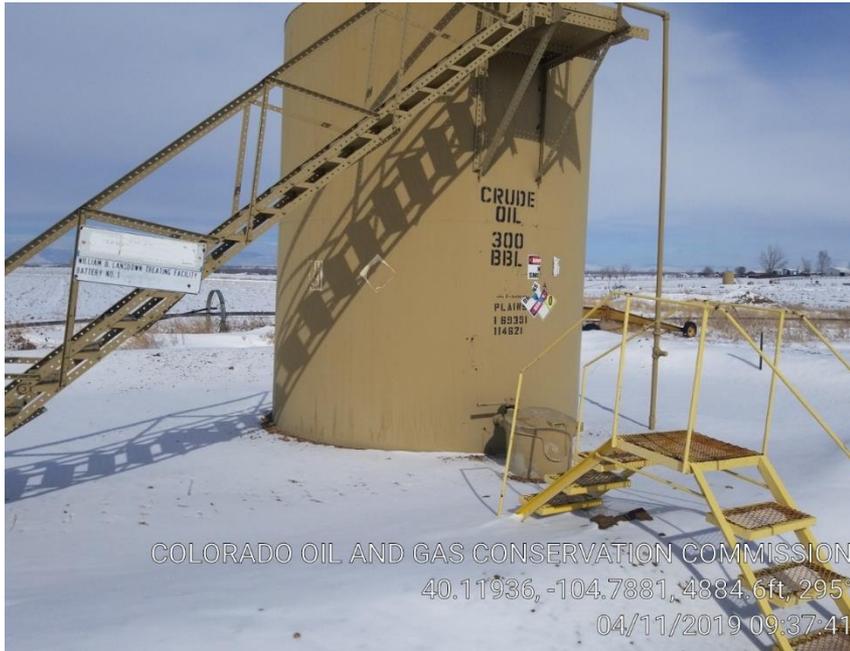
Pic 11 Tank loc sign faded, NFPA placards torn off

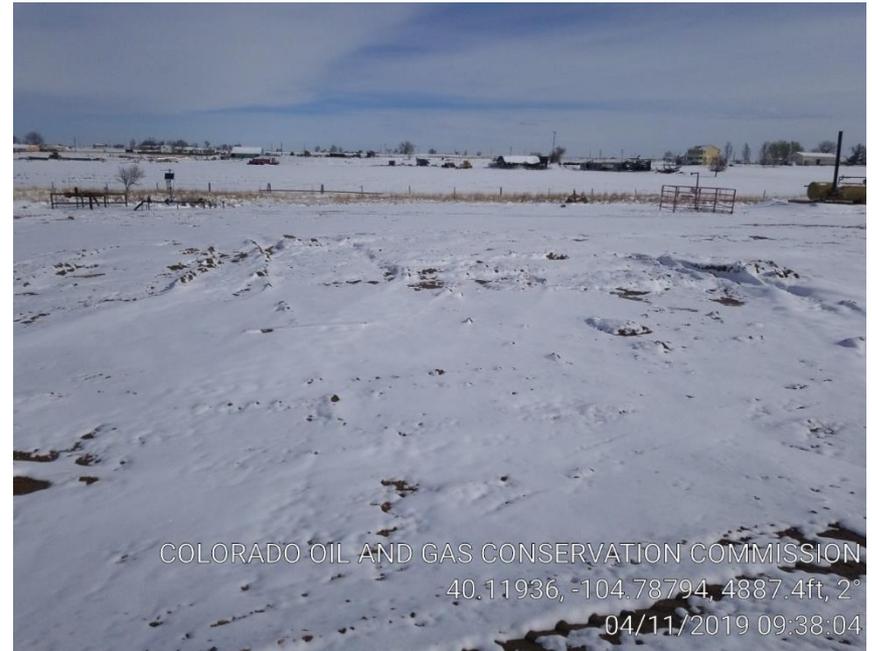
Pic 12 Location does not have proper drainage reeling across location

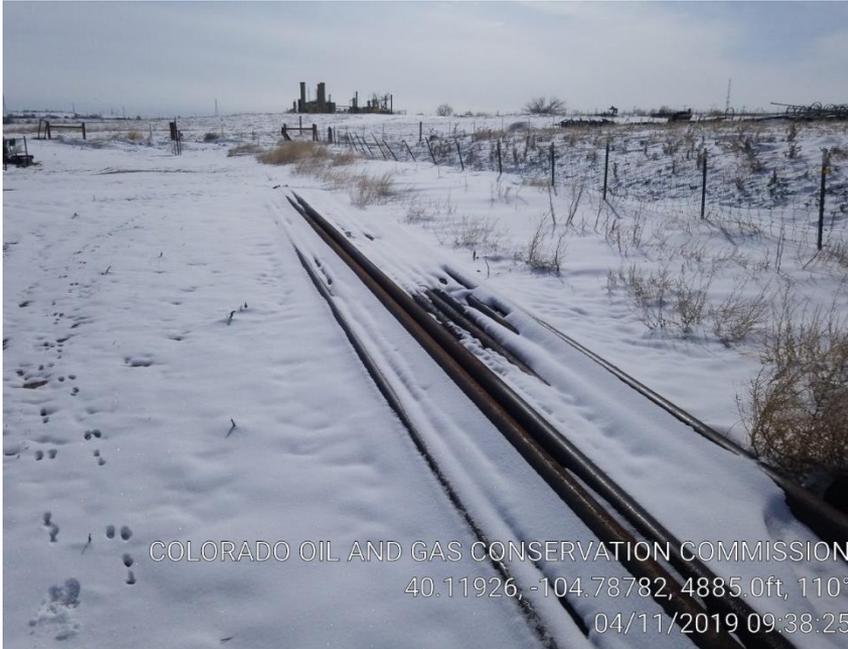
Pic 13. Unused equipment what appears to be casing on location

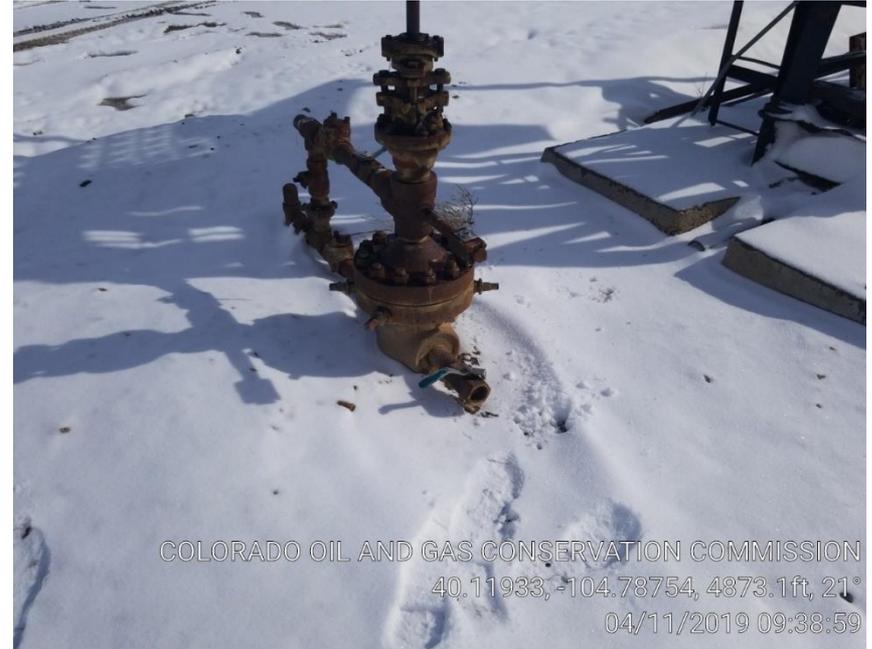
Pic 14 no bull plug installed in production casing valve.
