# Inspection Photos

API: 05-071-06435

Operator: TIMBER CREEK OPERATING LLC

Inspection Date: 4/12/2019

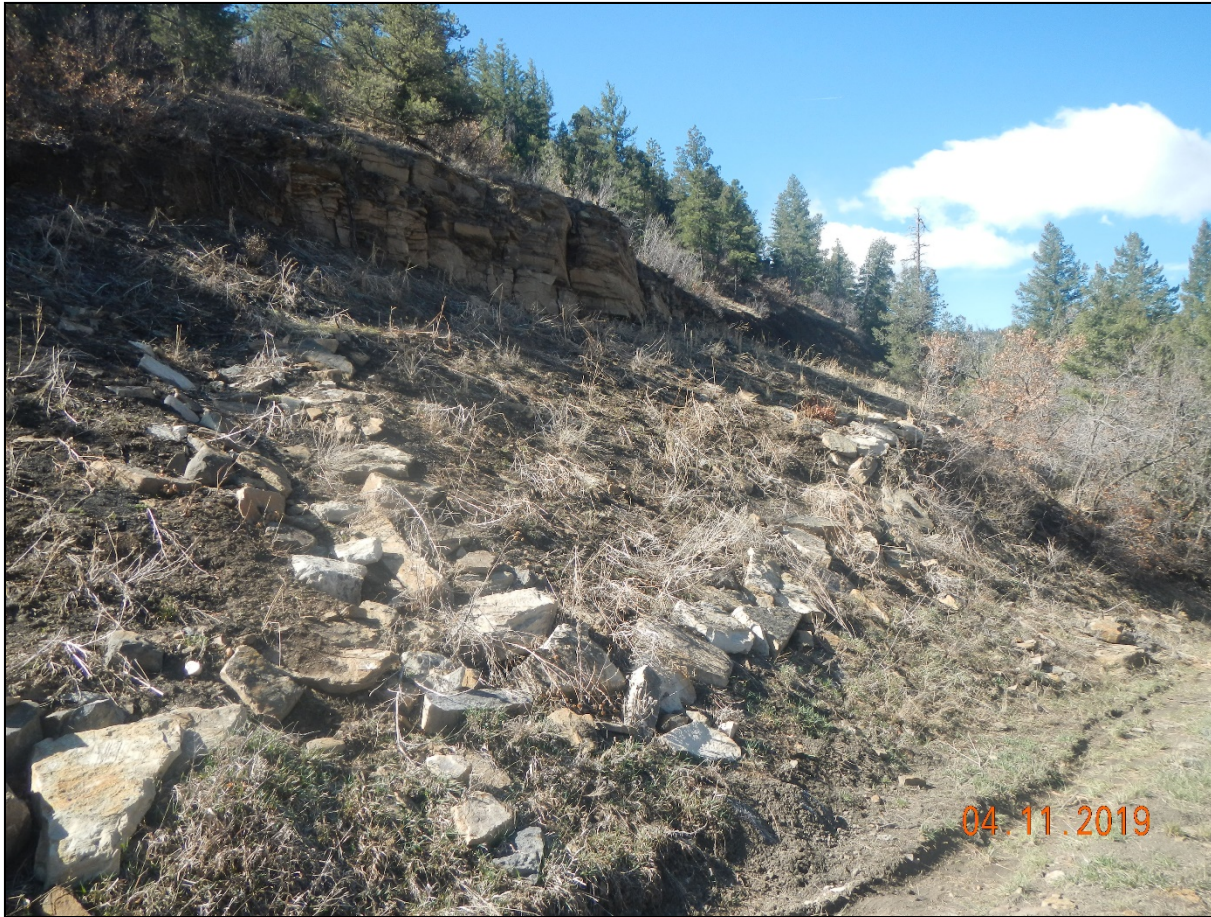
**Photo 1.** Facing toward the access road which has been recontoured and reclaimed.

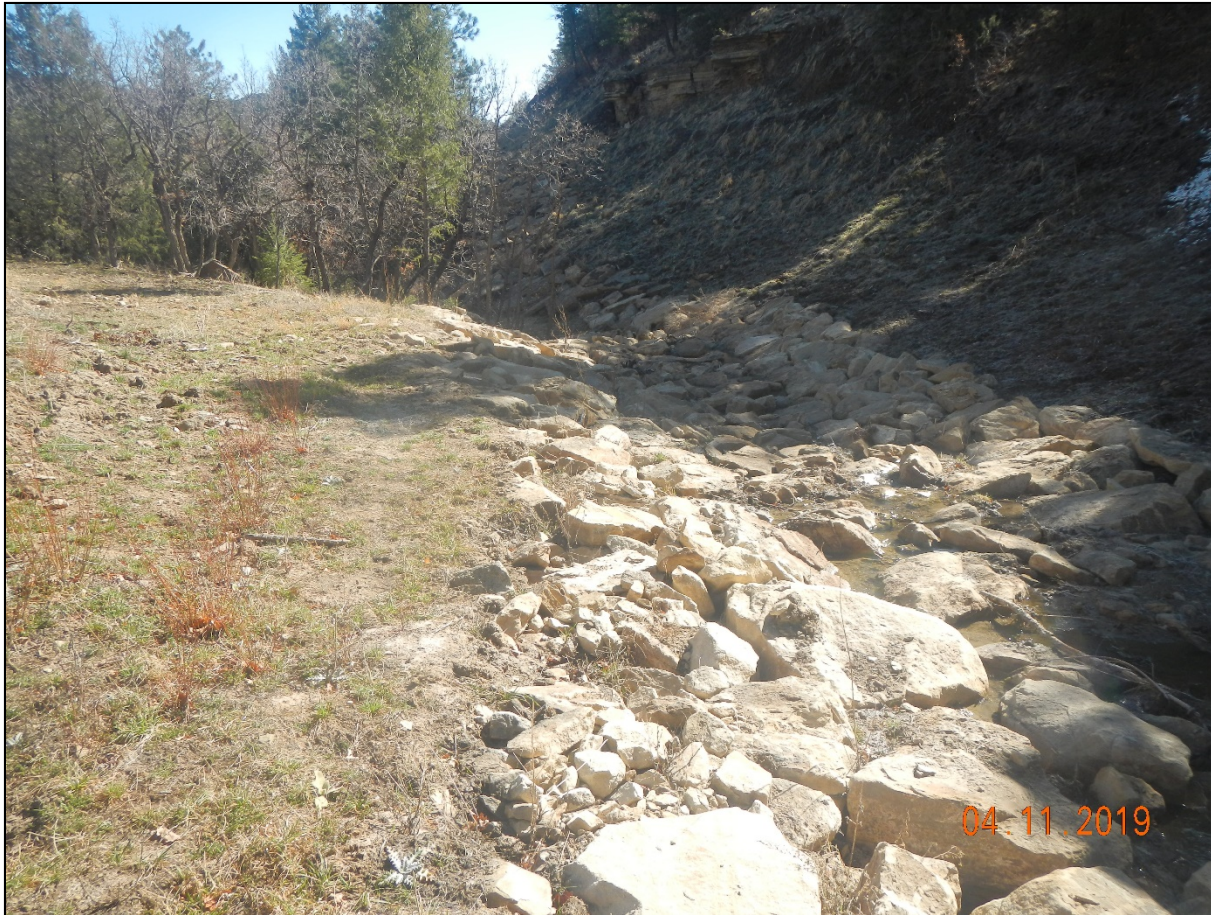
**Photo 2.** Pipe has been removed from this area. Rock rip/rap has been placed in the drainage for stabilization.

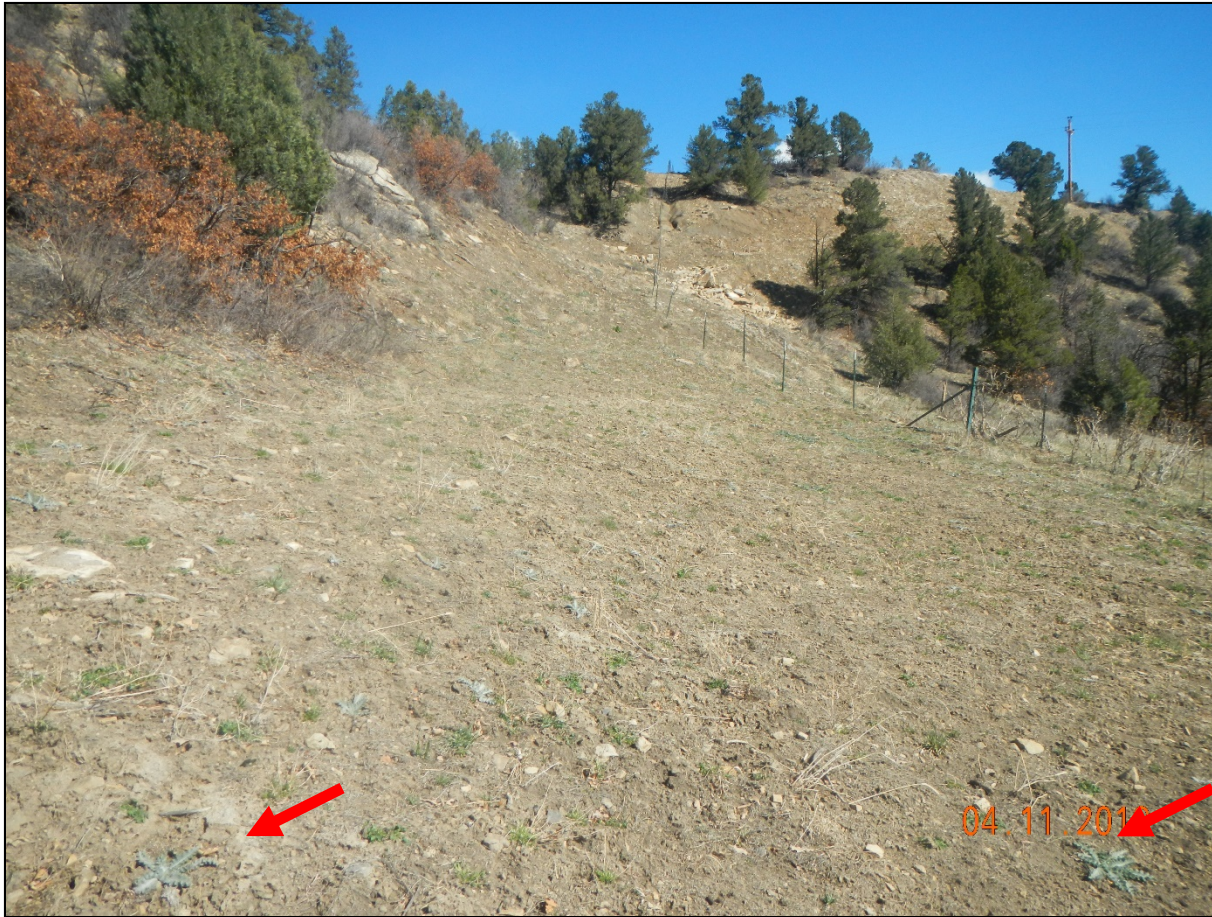
**Photo 3.** Facing toward the access road which has been recontoured and reclaimed.

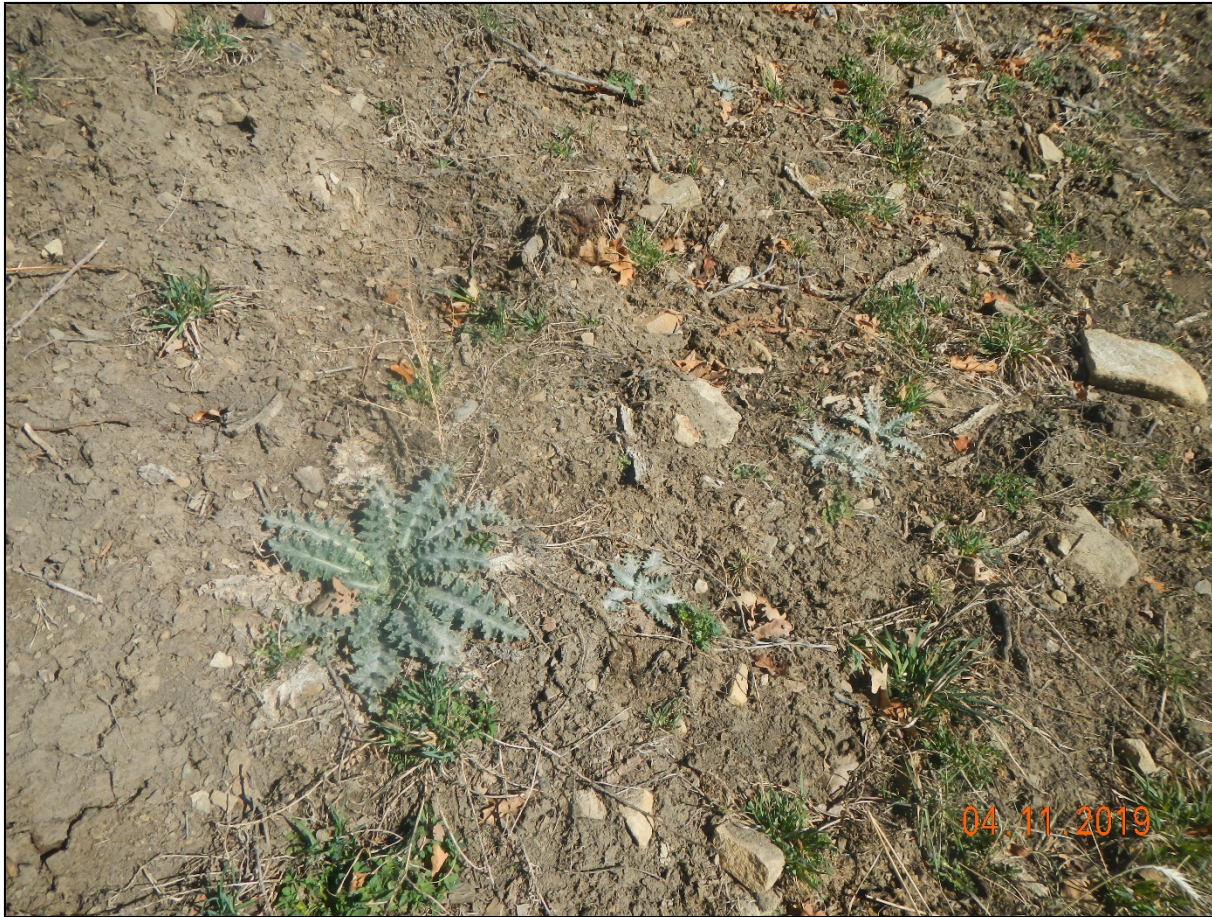
**Photo 4.** There is numerous Scotch thistle plants emerging in the area of photos 4.
