Inspection Photos
Location Name: AC#19-16
Location ID: 308967

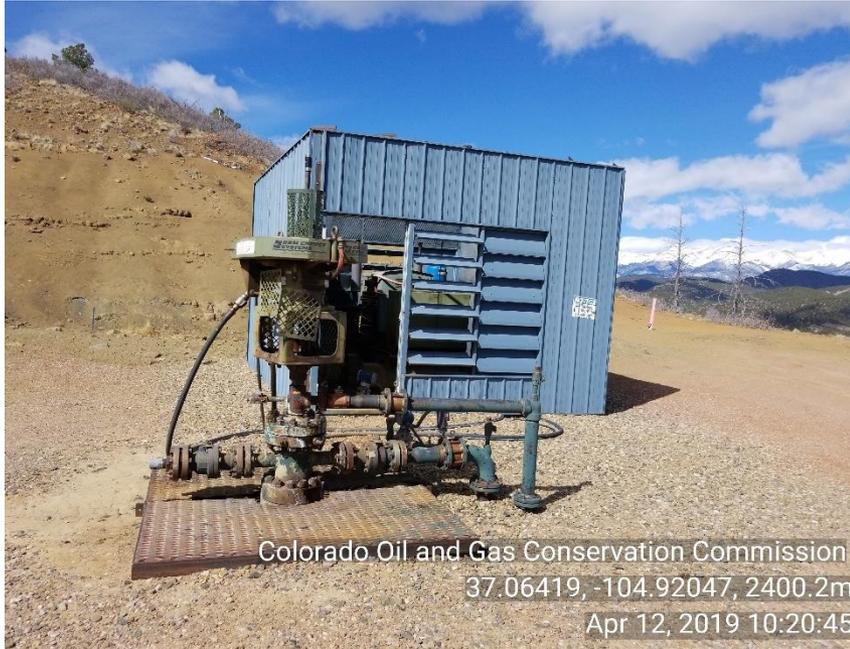
Photo 1 WH and HYD sound walls

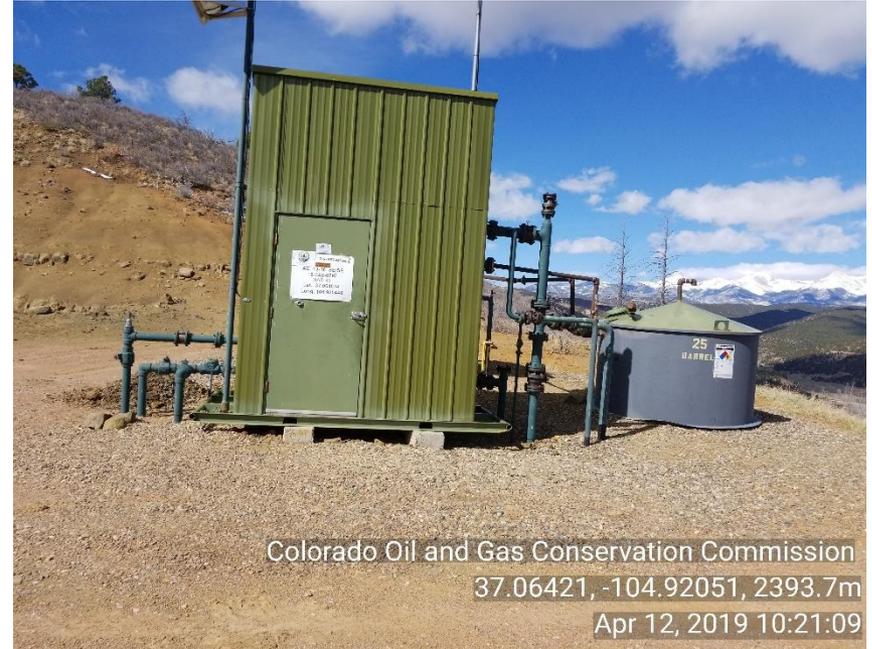
Photo 2 Sep/meter house and 25bbl produced water tank.

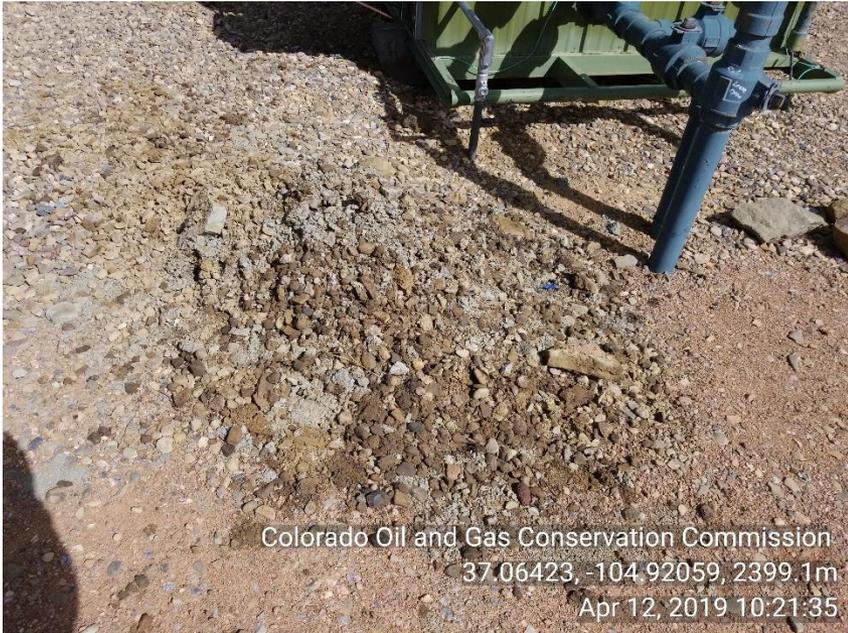
Photo 3 A pile of what appears to stained soil.

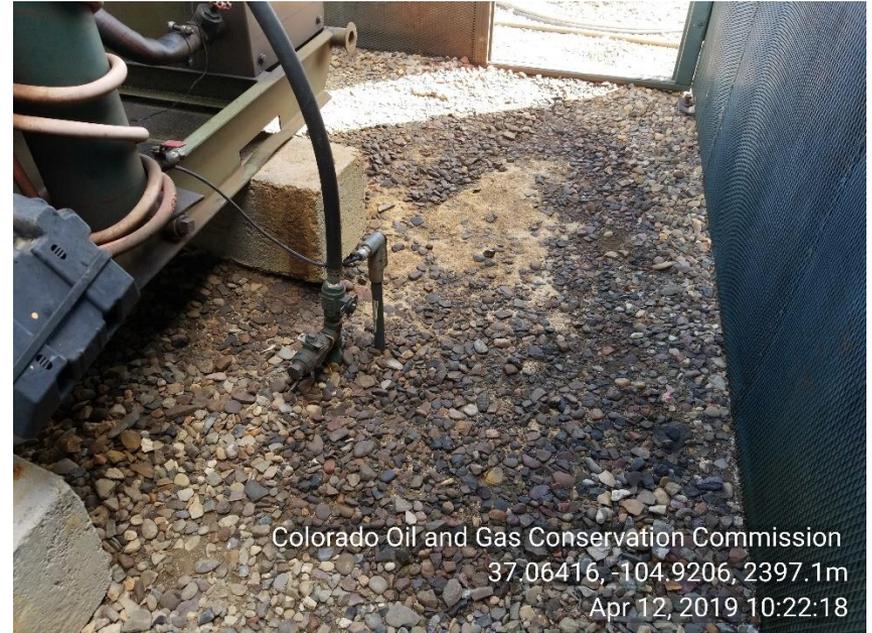
Photo 4 Stained soil around HYD motor skid.

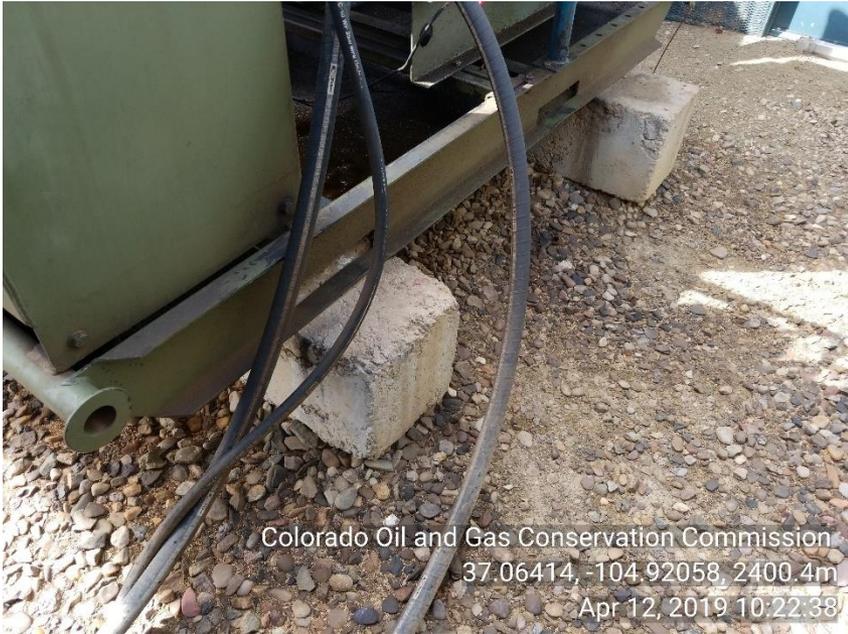
Photo 5 Stained soil around HYD motor skid.

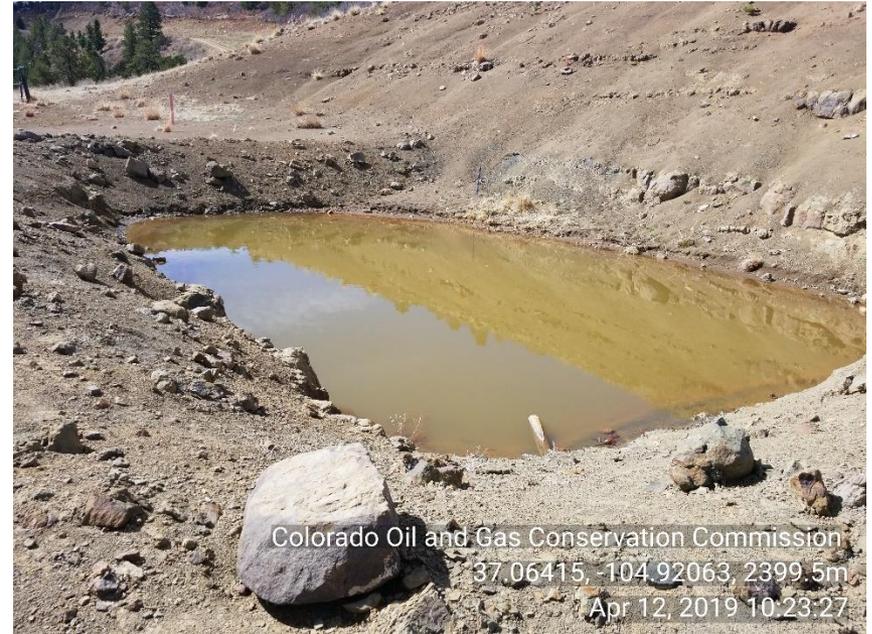
Photo 6 Production water pit.
