**Inspection Photos**  
**Location Name: HR#33-06V and HR#33-06-02**  
**Location ID: 333874**

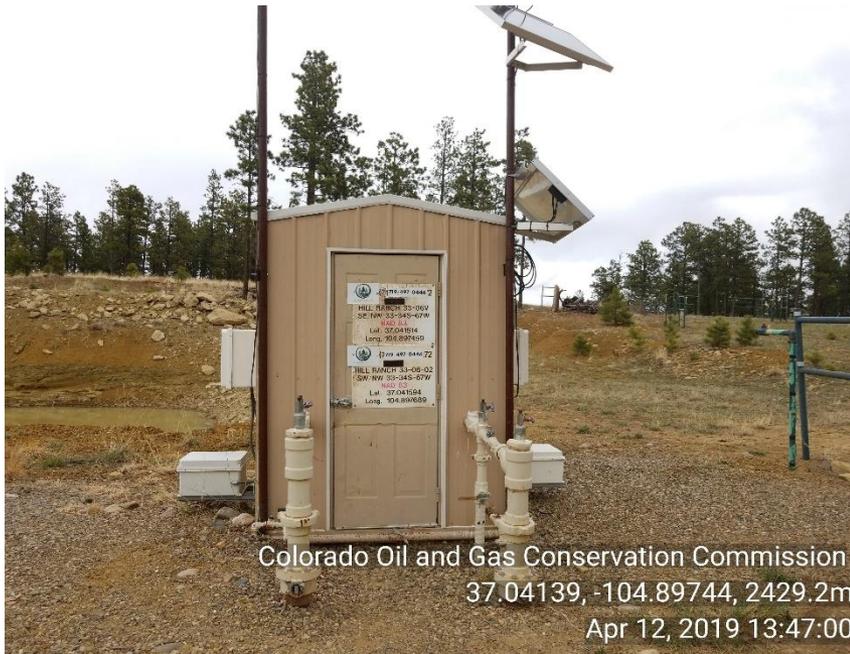
**Photo 1 HR#33-06V and HR#33-06-02 Dual sep/meter house.**

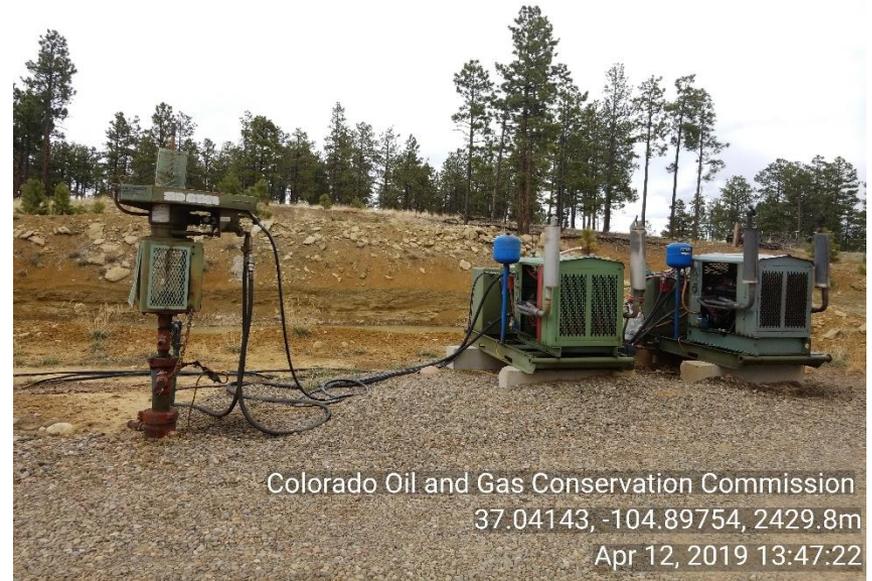
**Photo 2 HR#33-06V WH and HYD motor skids for both wells.**

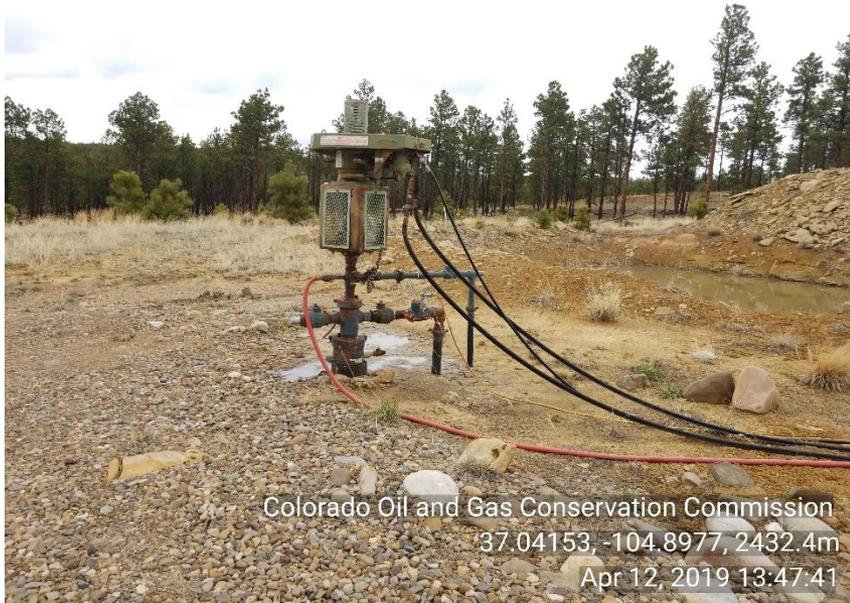
**Photo 3 HR#33-06-02 WH.**

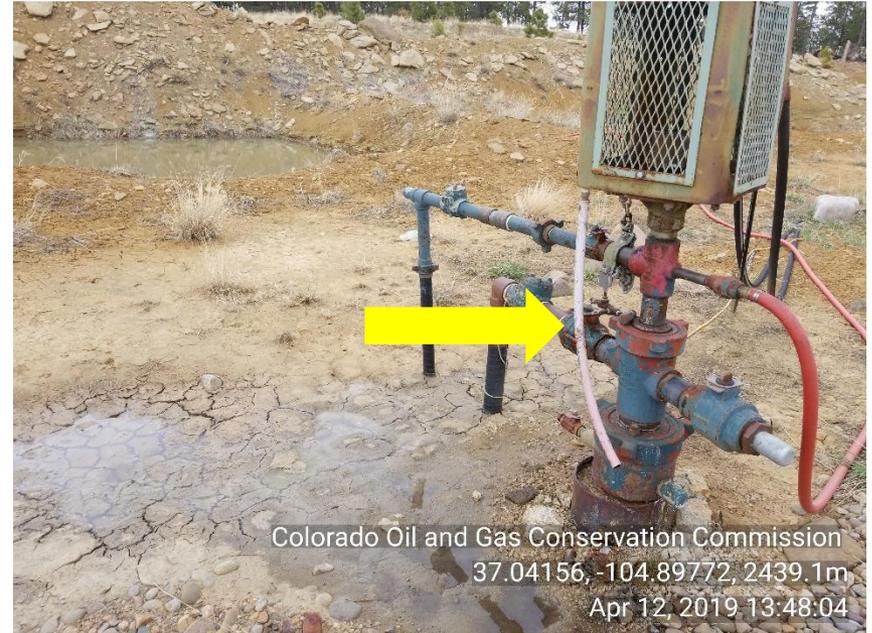
**Photo 4 HR#33-06-02 Mechanical issue packing leaking and being drained through hose onto ground.**

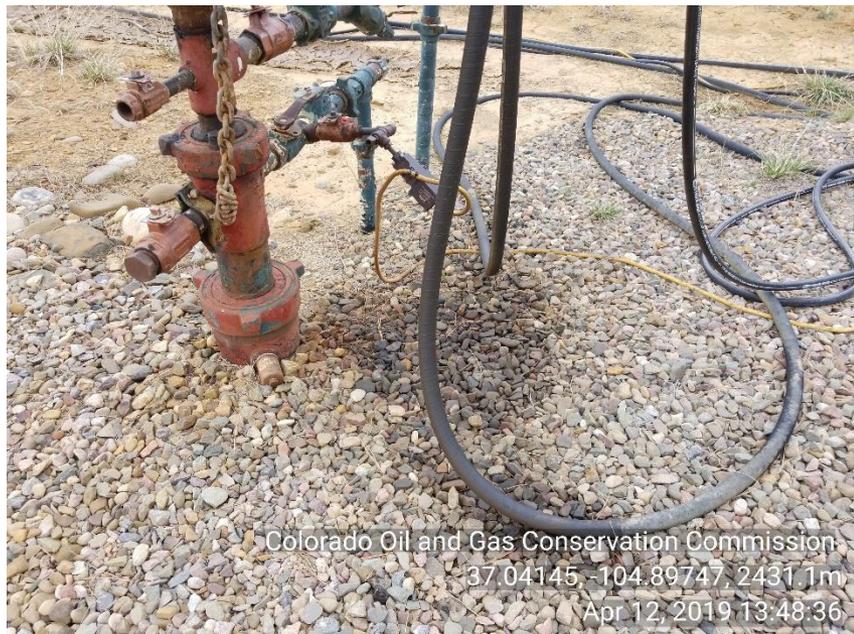
**Photo 5 HR#33-06V Stained soil around WH.**

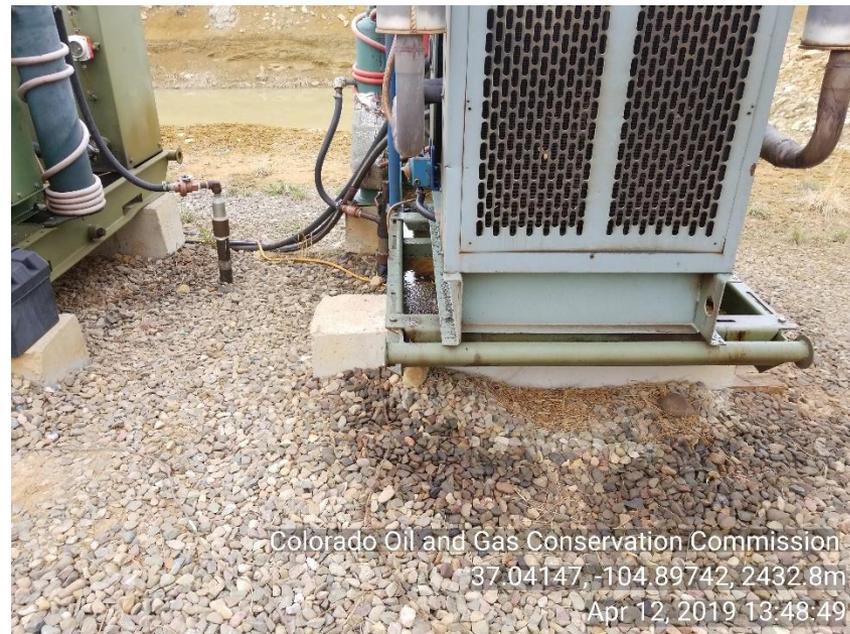
**Photo 6 stained soil around both wells HYD motor skids**

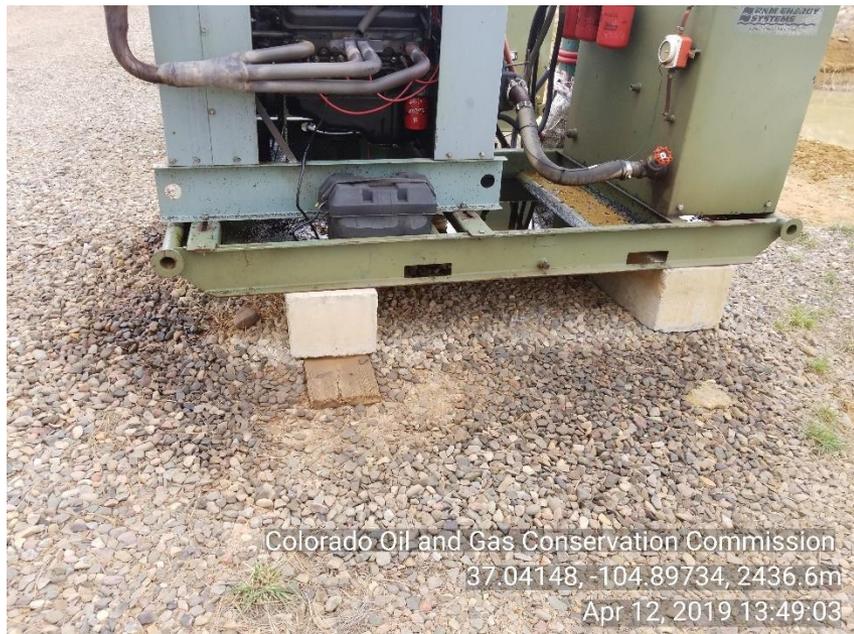
**Photo 7 stained soil around both HYD motor skids.**

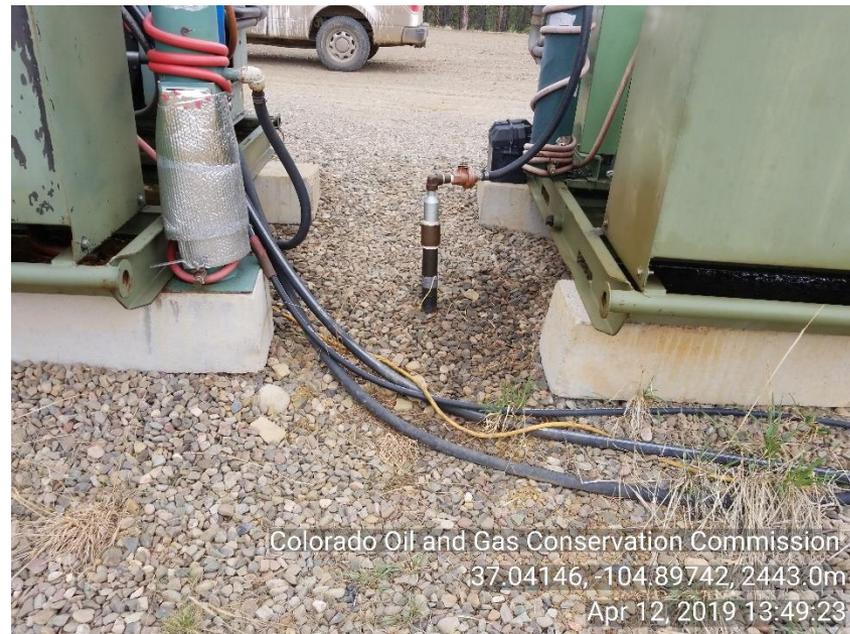
**Photo 8 stained soil around both wells HYD motor skids**

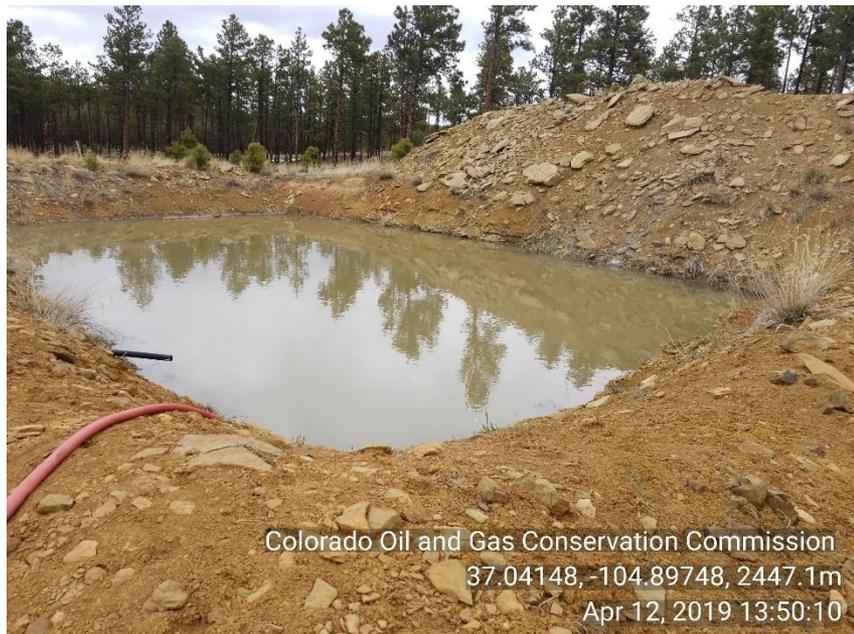
**Photo 9 Produced water pit #1**

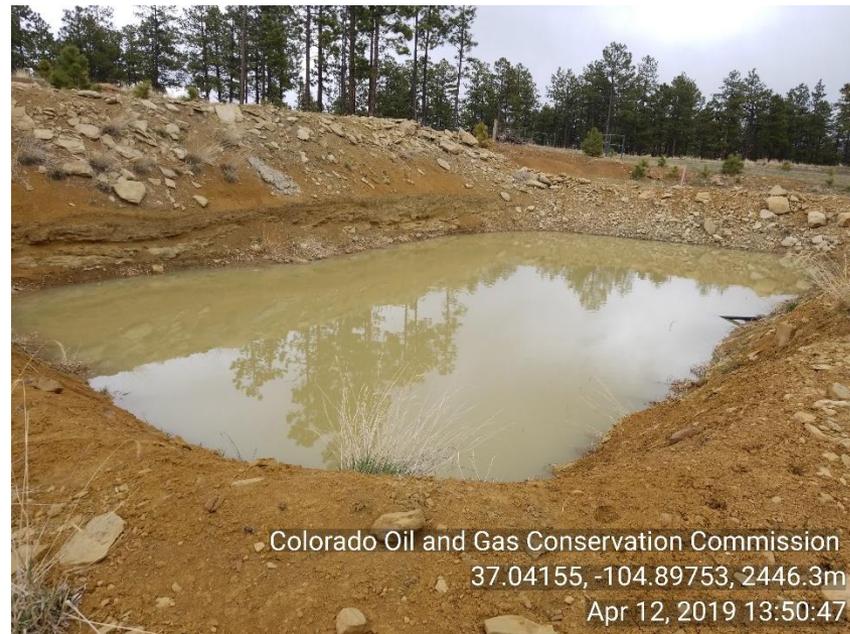
**Photo 10 Produced water pit #2**
