Inspection Photos
Location Name: HR#05-01R
Location ID: 333914

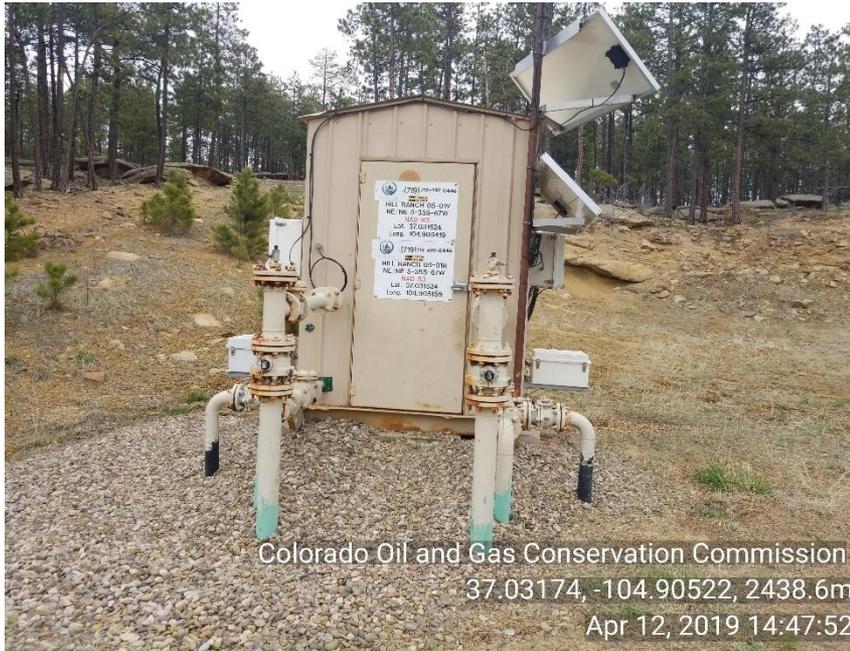
Photo 1 Sep/meter run Dual sep

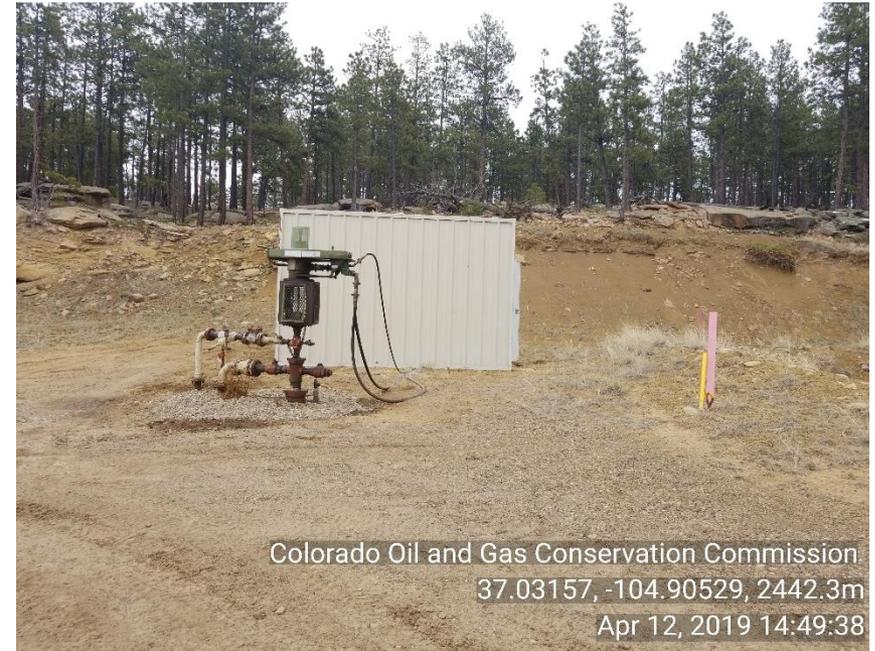
Photo 2 WH and HYD motor skid sound walls

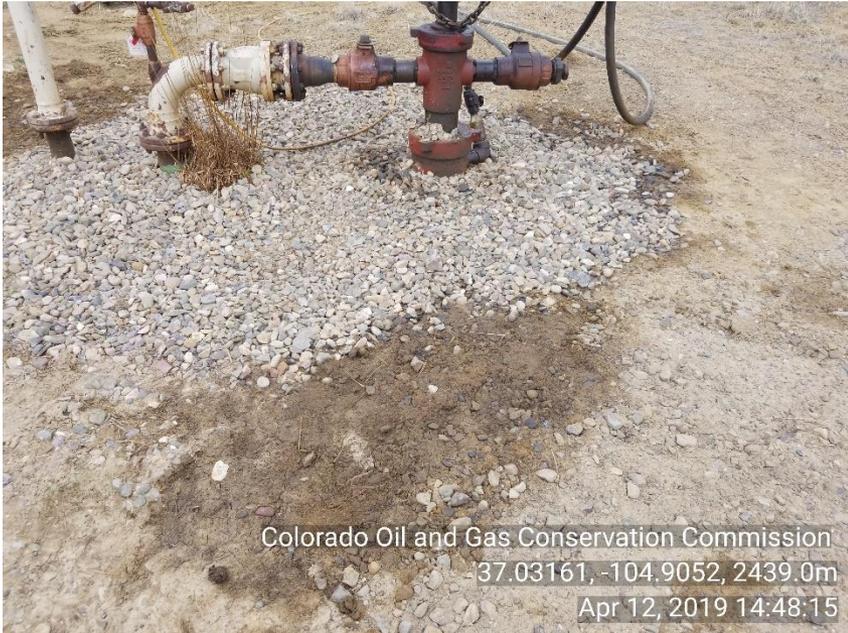
Photo 3 Stained soil; it appears gravel has been placed over stained soil by WH

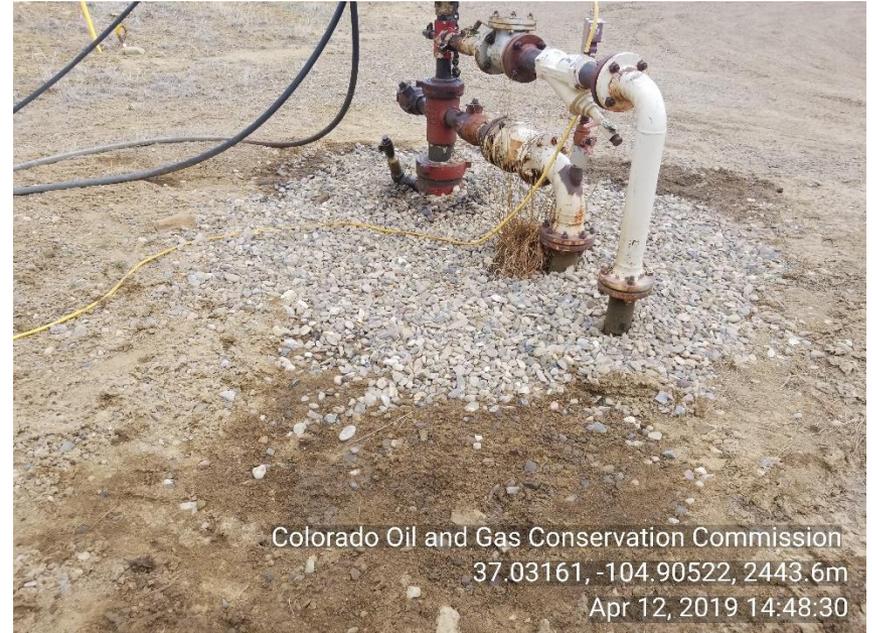
Photo 4 Stained soil around WH

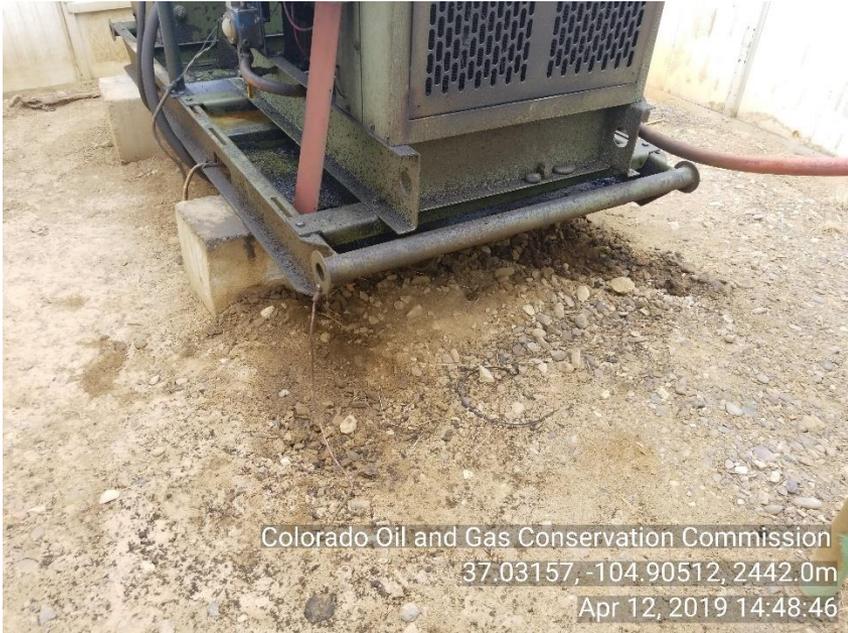
Photo 5 Stained soil; Around HYD motor skid

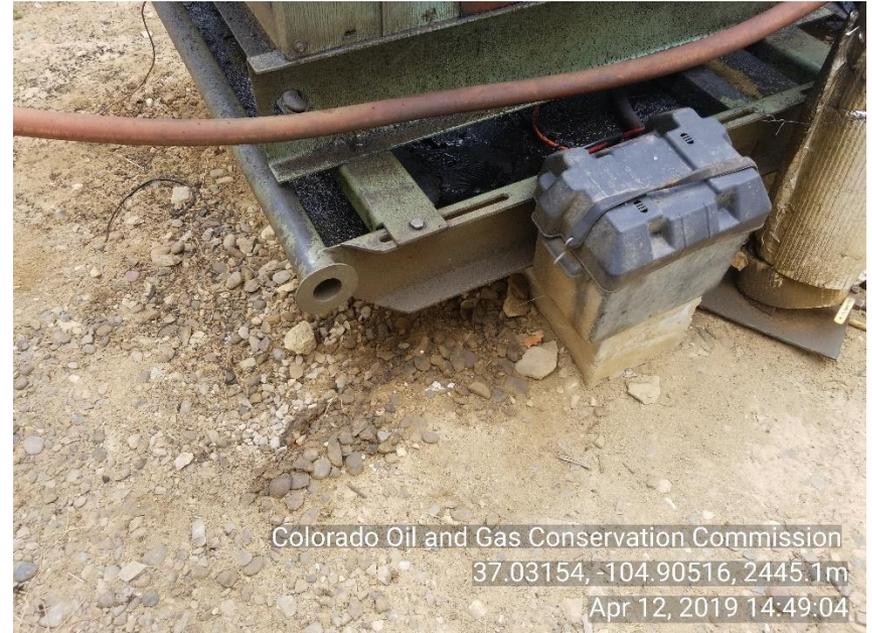
Photo 6 Stained soil around HYD motor skid
