Inspection Photos
Location Name: APACHE CANYON 26-08 V
API #: 05-071-07559
Insp. Doc. # 695100493

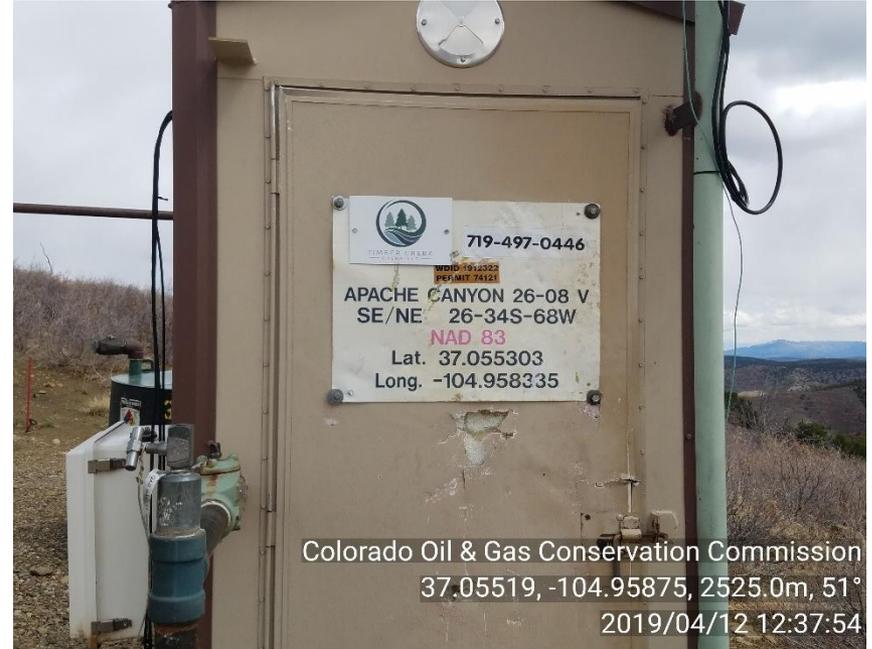
PHOTO 2: METER HOUSE/WELL SIGN

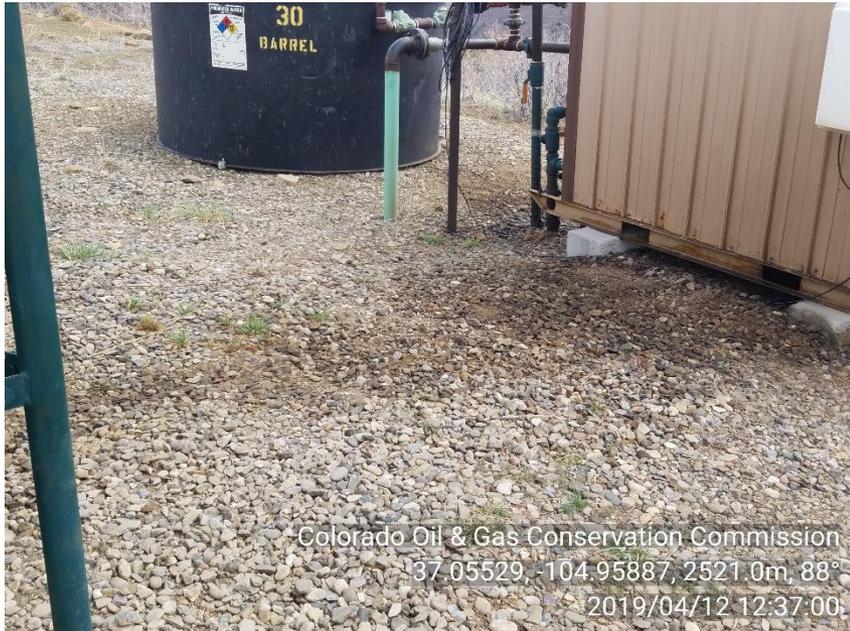
PHOTO 3: IMPACTED SOIL FANNING OUT FROM FUEL GAS SCUBBER ON COMPRESSOR OVER TO METER HOUSE APP. 5" AT ITS NARROWEST POINT (NEXT TO SCUBBER ON COMPRESSOR SKID) AND APP. 3.5' AT IS WIDEST POINT (AGAINST THE METERHOUSE). THERE IS ALSO A FILM OF OIL ON THE BOTTOM ¼ OF METERHOUSE WALL.

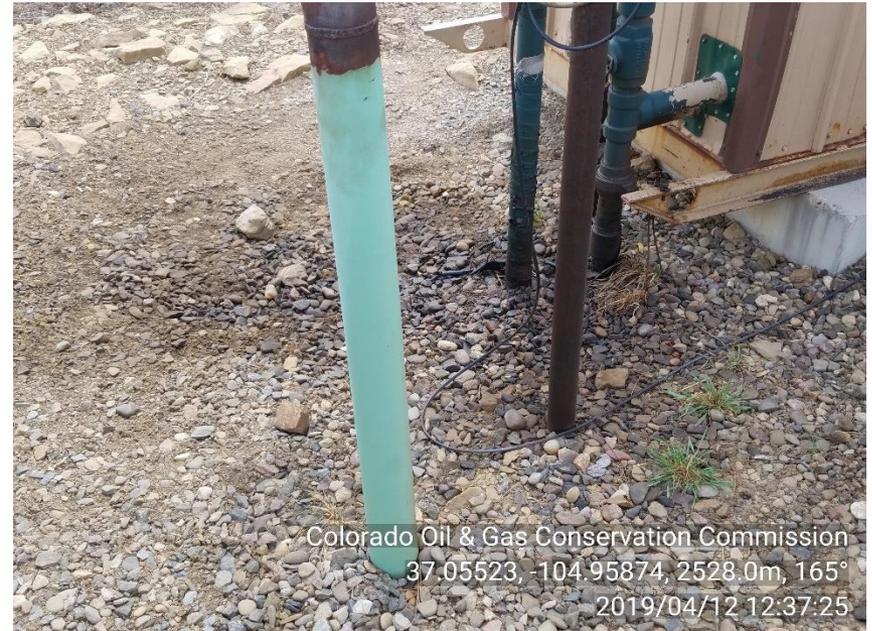
PHOTO 4: APP. 3' BY 2' AREA OF IMPACTED SOIL ON THE NORTHEAST SIDE OF METER HOUSE.

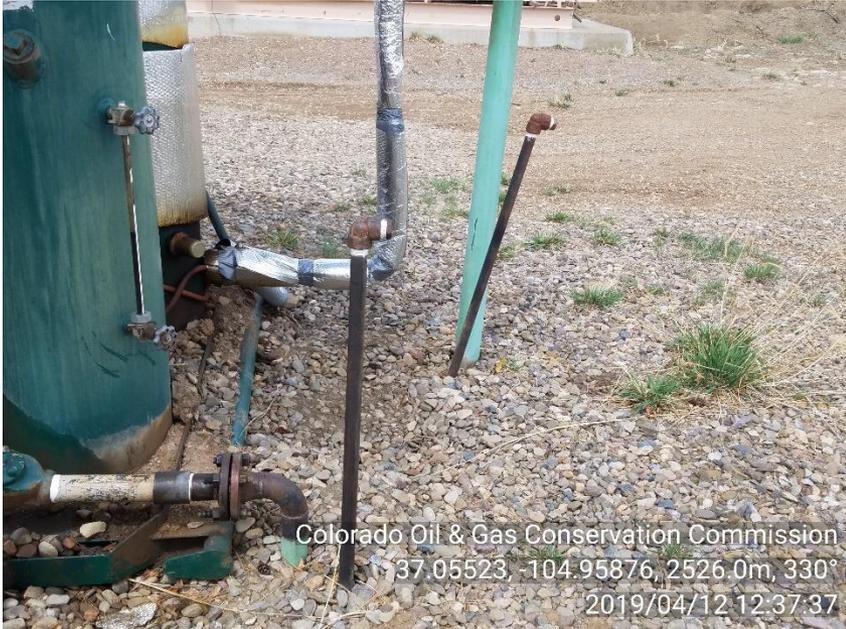
PHOTO 5: TWO UNMARKED 1" RISERS NORTHEAST SIDE OF COMPRESSOR SKID.

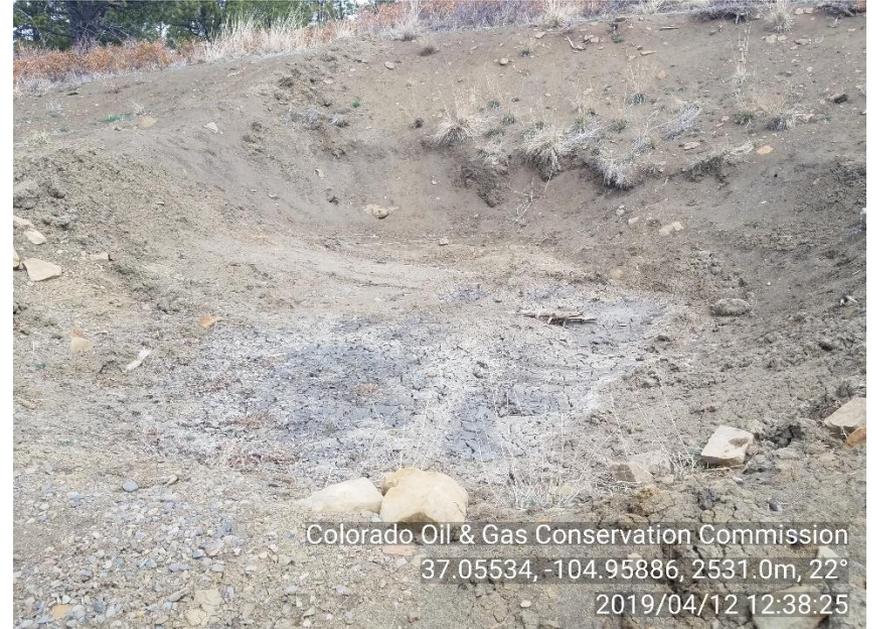
PHOTO 6: NO ACHOR MARKER IN PIT.
