SG 34-28
Api. # 05-045-15816
Inspection # 689703038

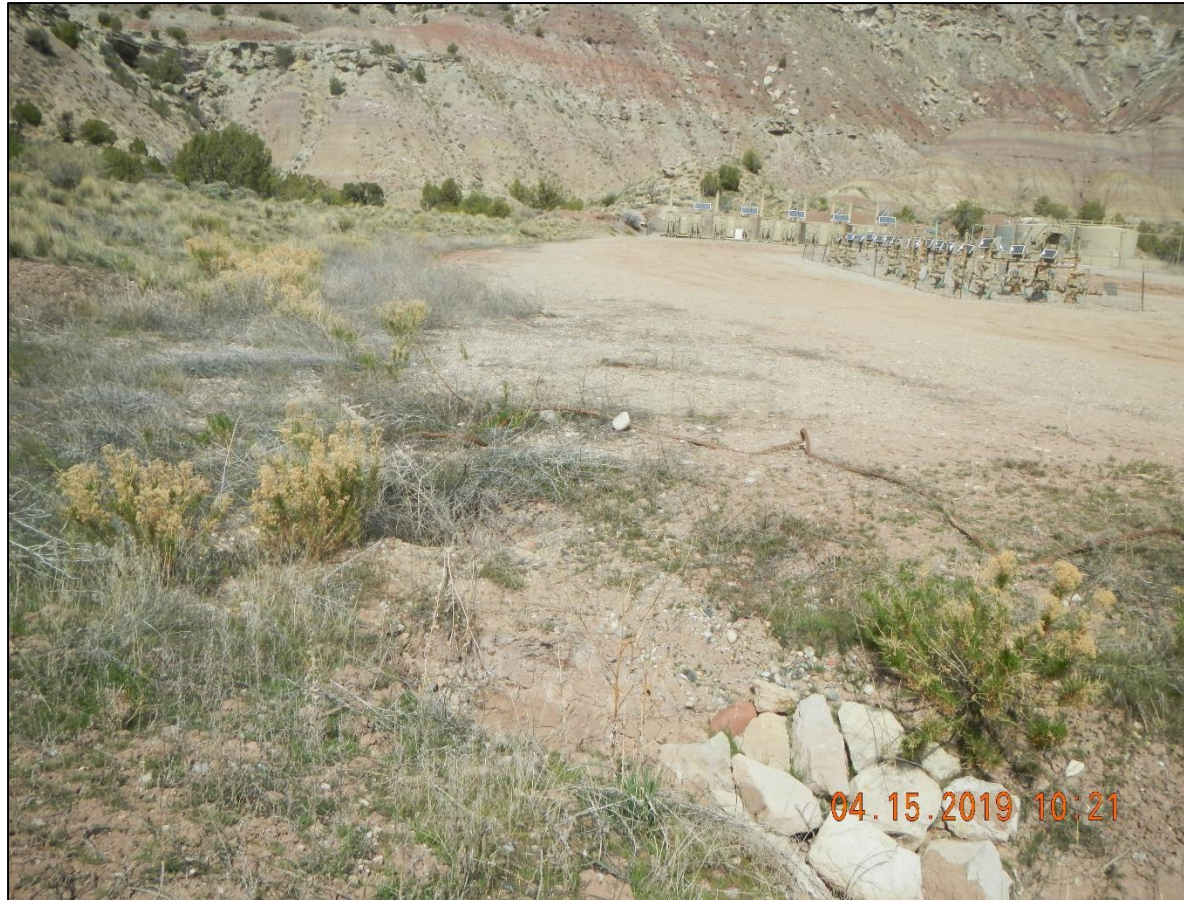
Unused cable on edge of location.

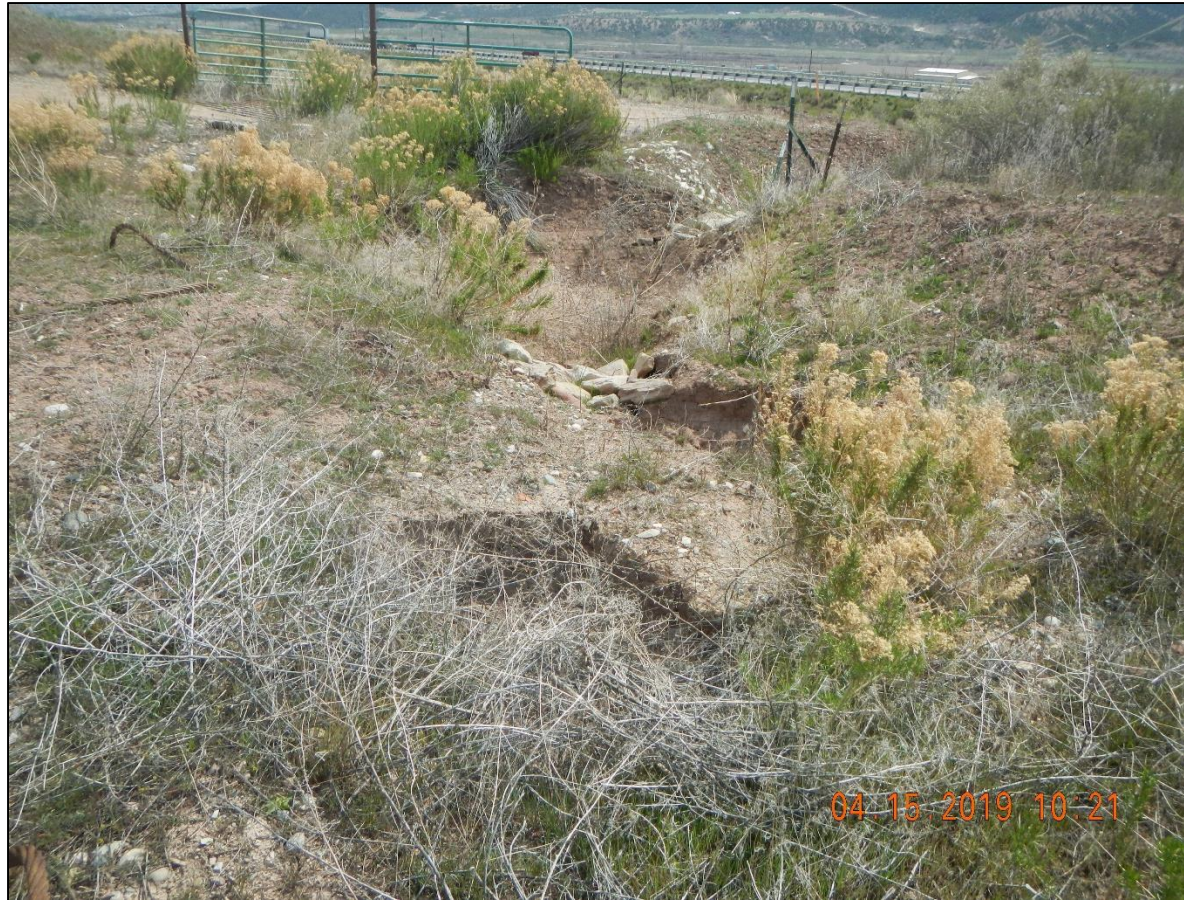
Holes in ditch going into ditch.

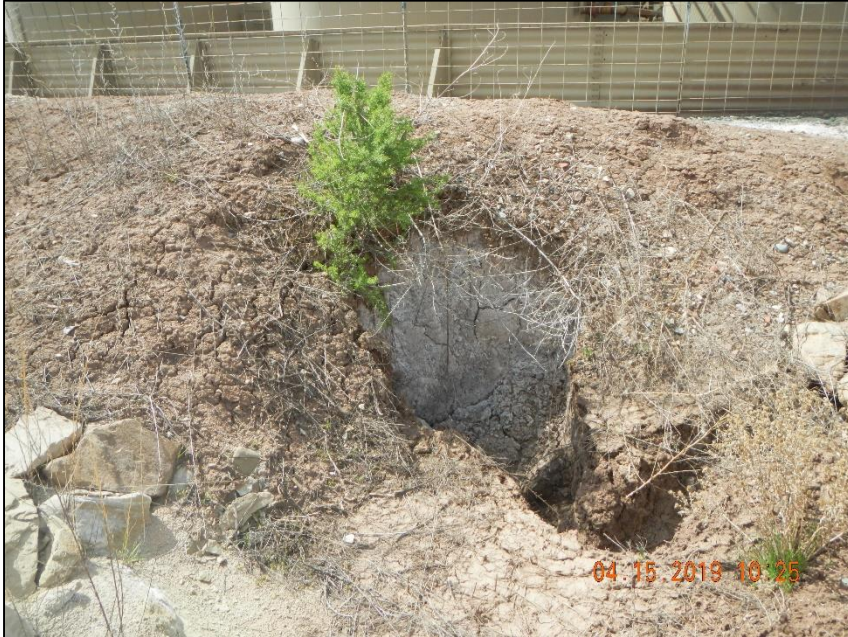
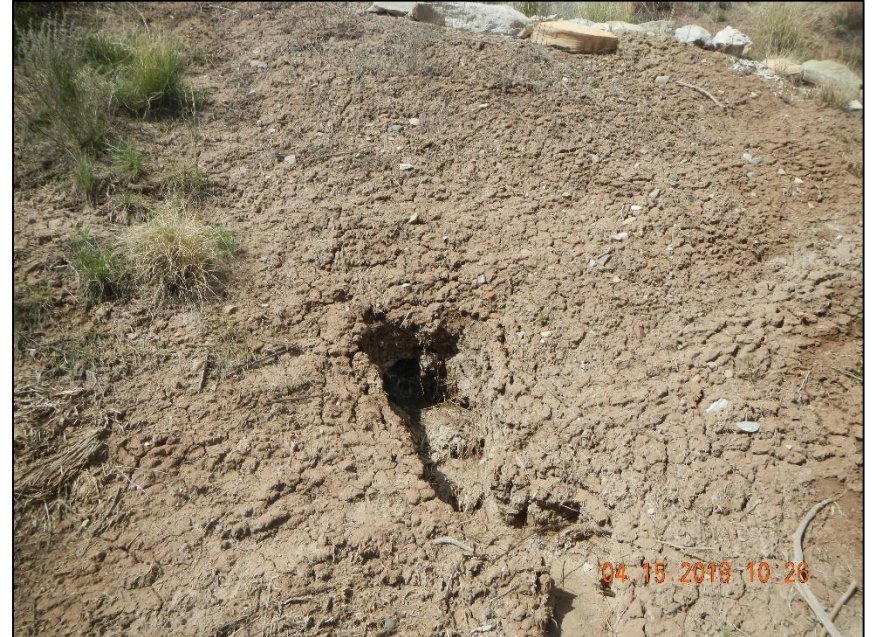
Storm water channel in check dam behind tank battery.

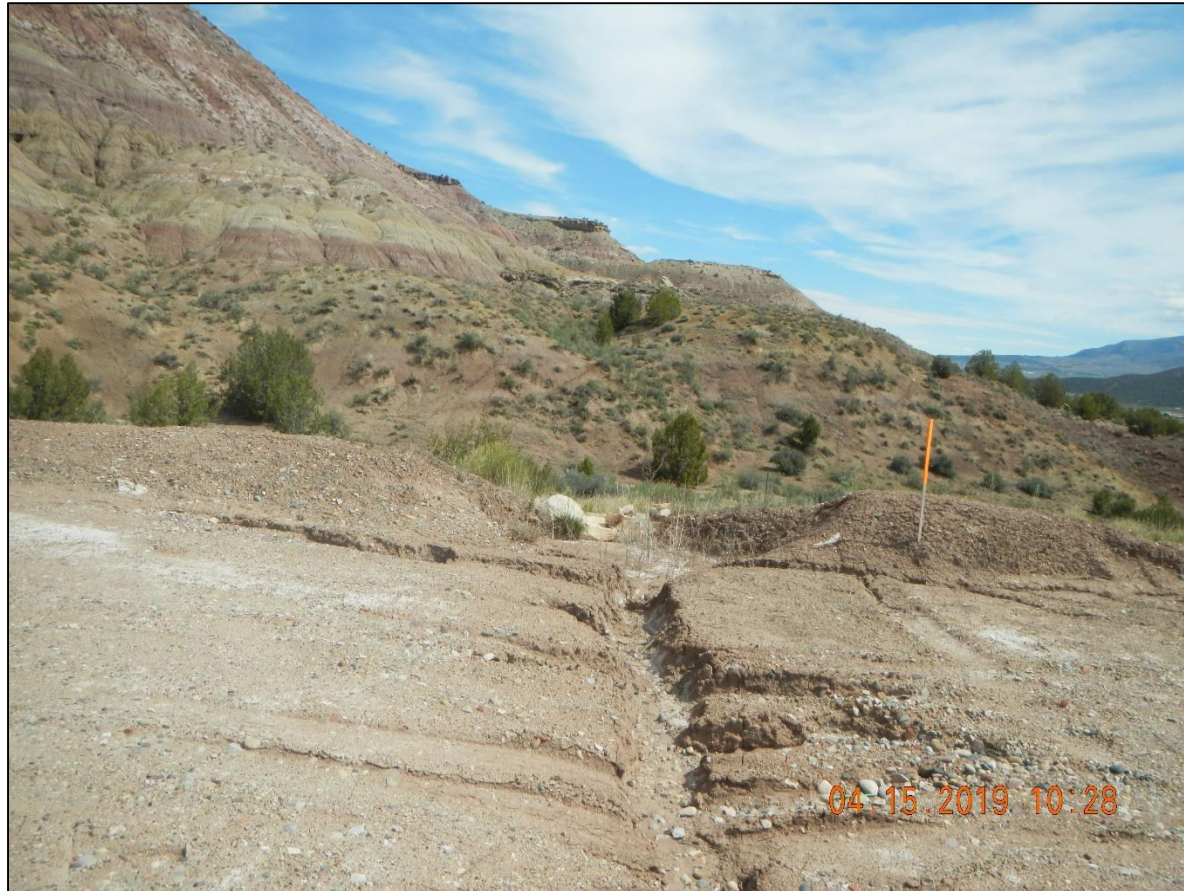
Erosion of location in drainage into check dam.

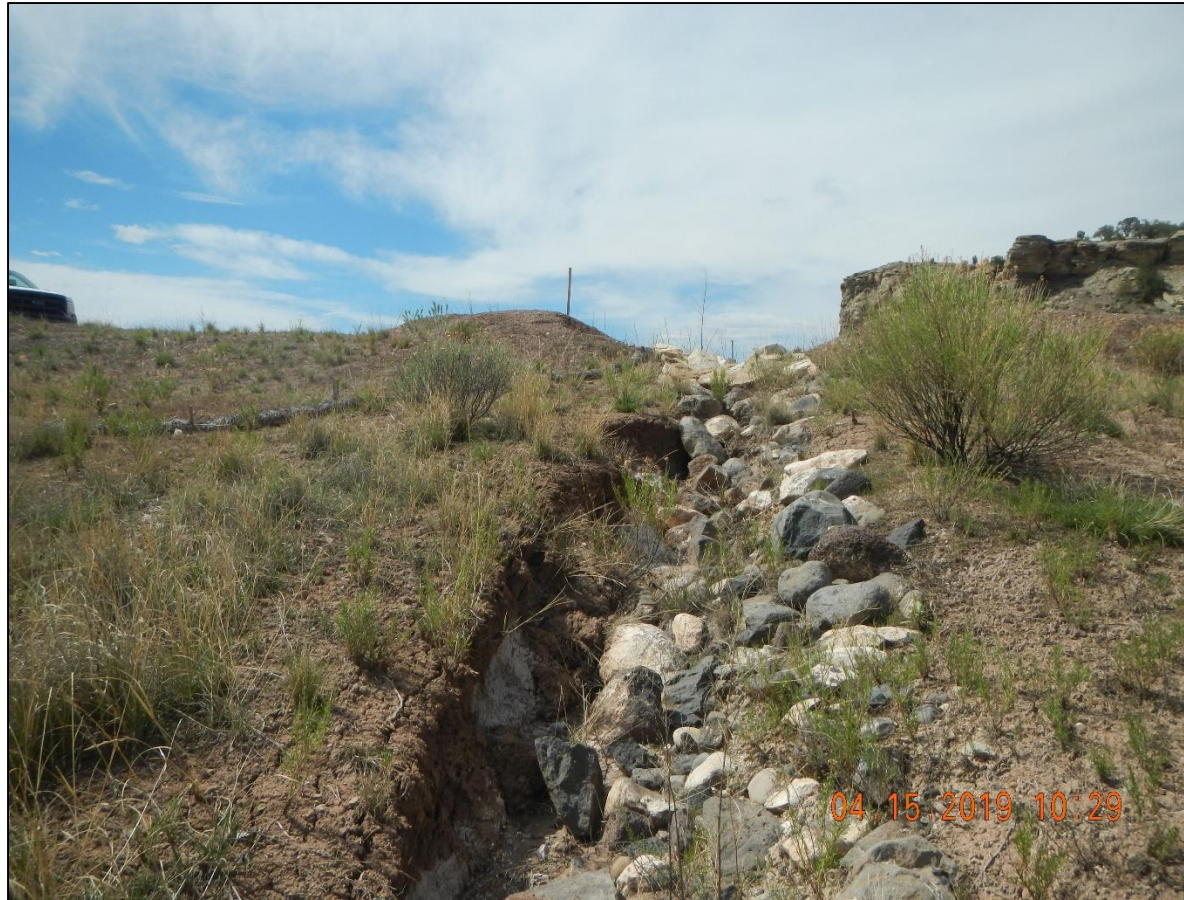
Washing of ditch from check dam.
