**Inspection Photos**  
**Operator: BP America**  
**Location/API #: 067-05157**  
**Date: 4-9-2019**

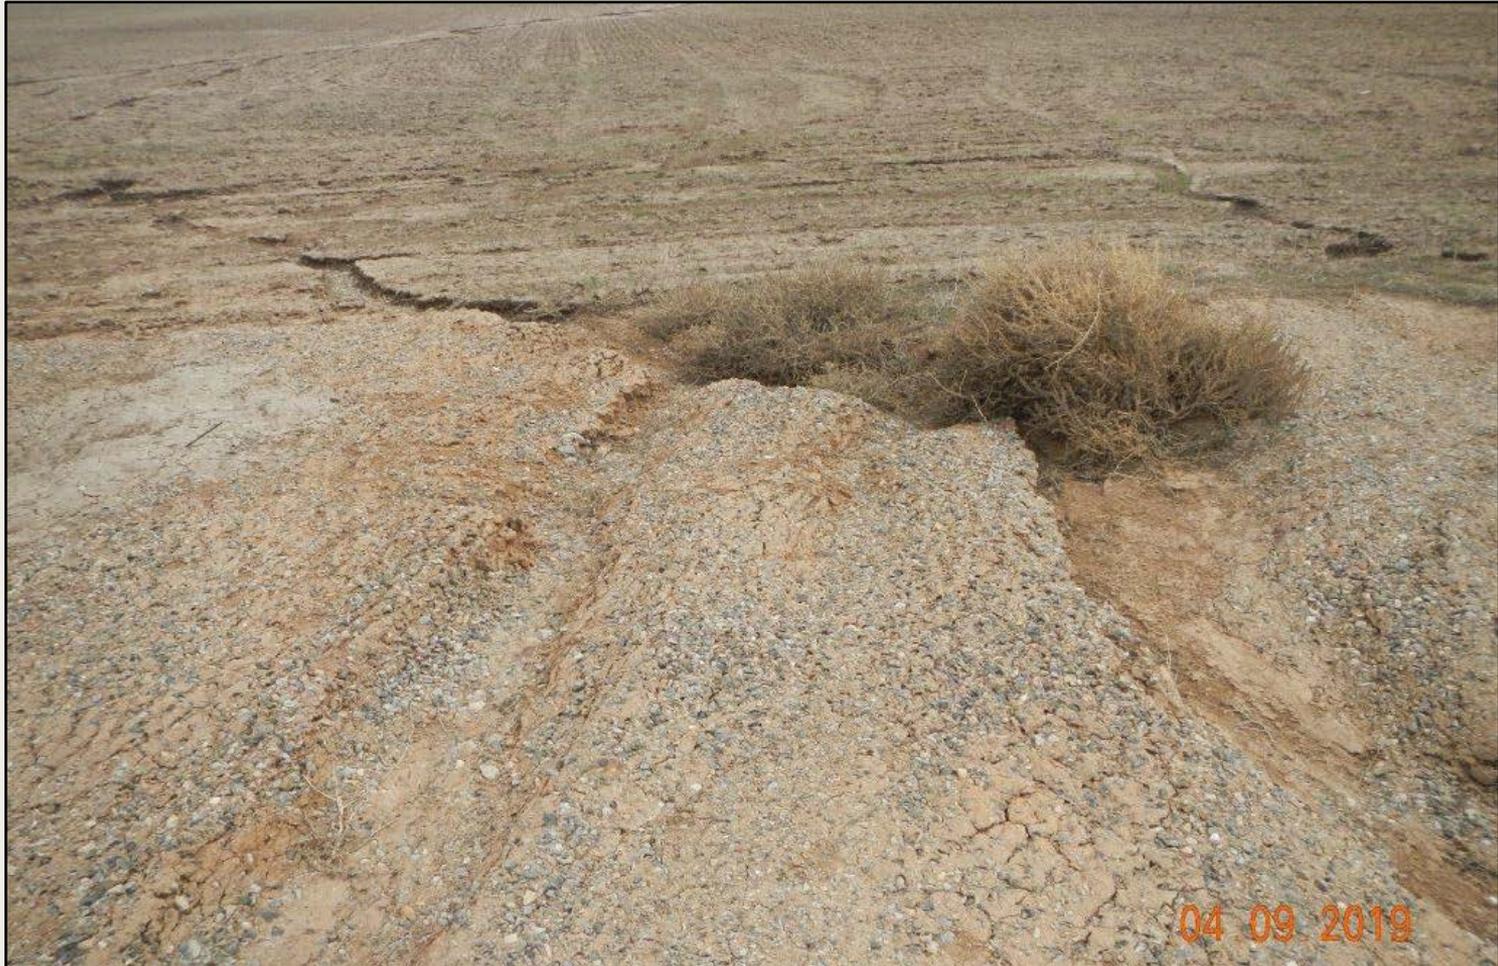
Photo 4. View of erosional channeling and sediment discharge within the eastern project area, facing eastward toward the surrounding cultivated field.

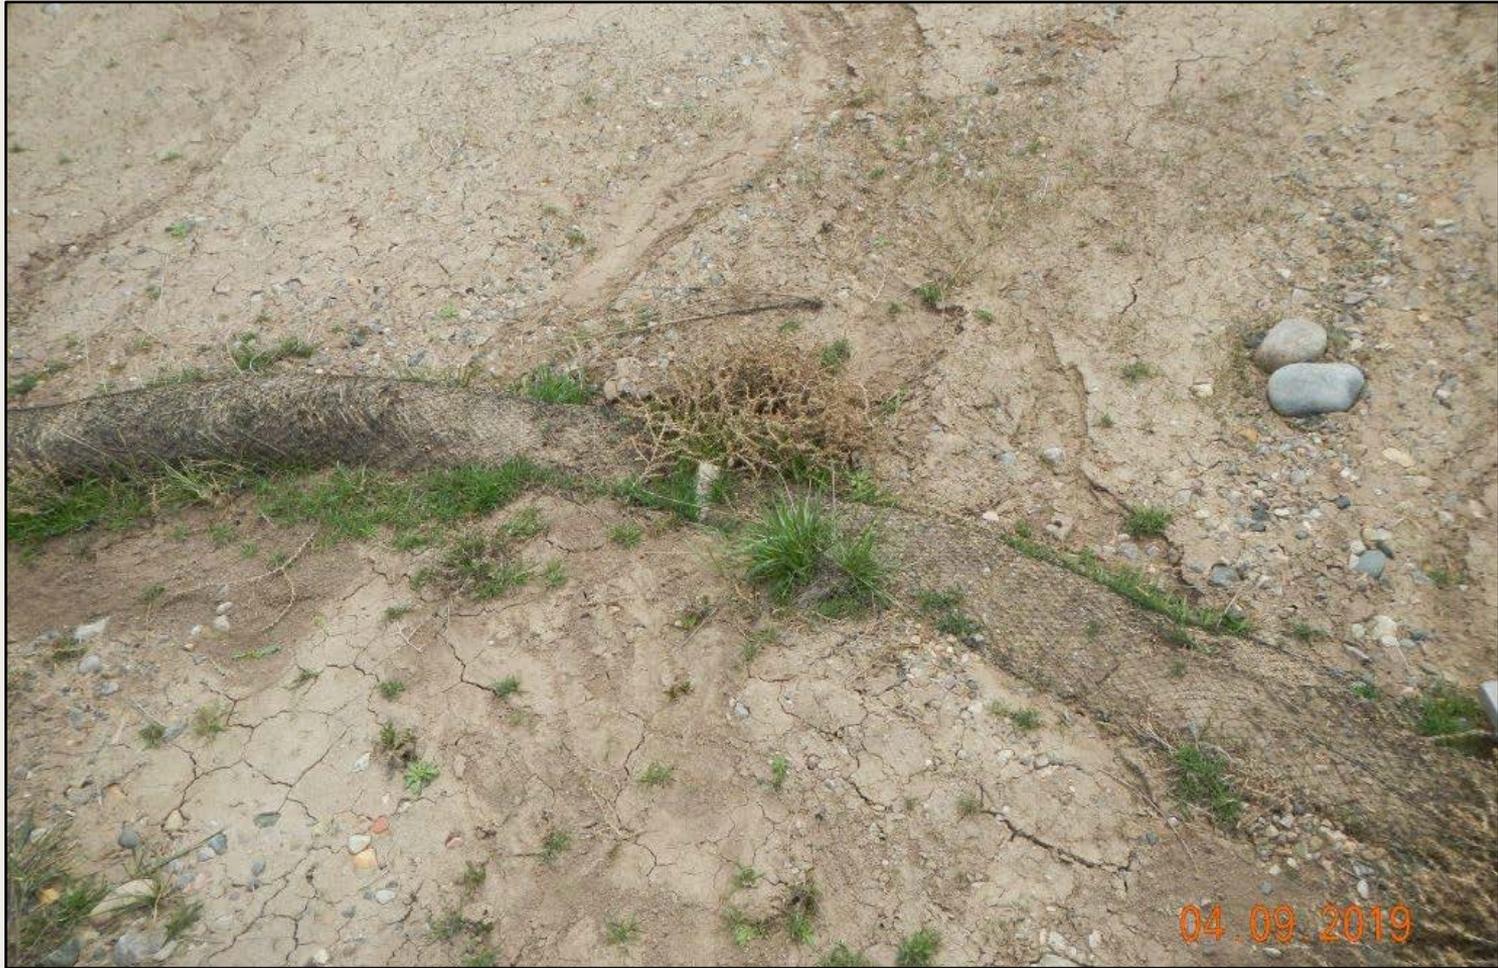
Photo 5. View of wattles no longer functioning within the eastern project area. This stormwater control is not sufficient to manage erosion within this area.

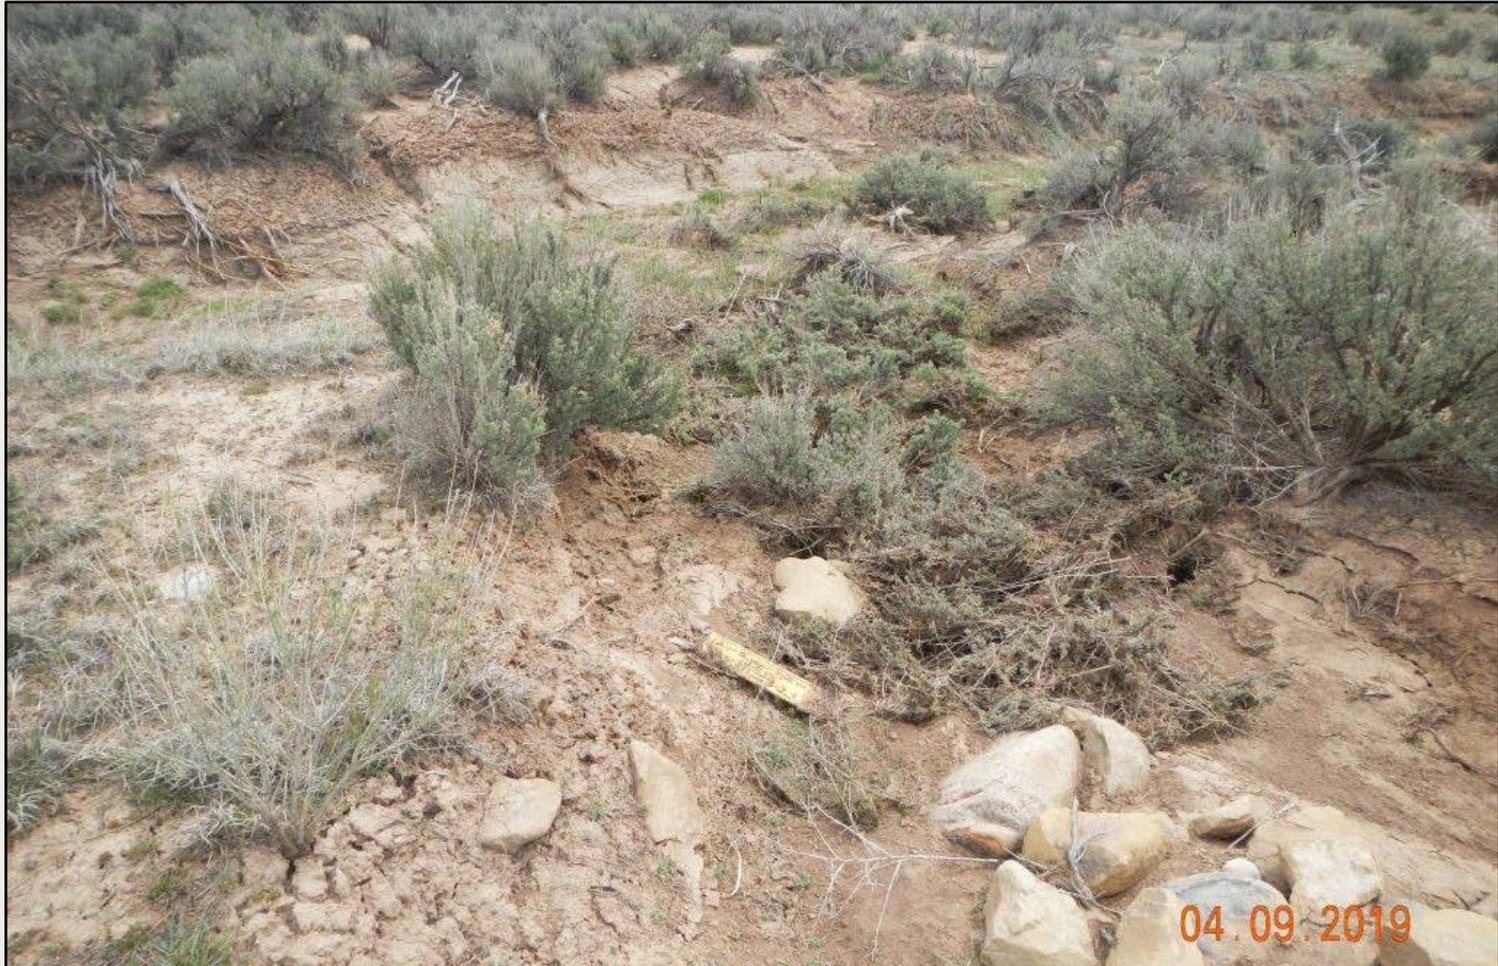
Photo 6. View of erosional scouring from stormwater flows that appear to have breached the access road and are eroding down slope.
