Inspection Photos

API: 05-071-06094

Operator: AMOCO PRODUCTION COMPANY

Inspection Date: 4/16/2019

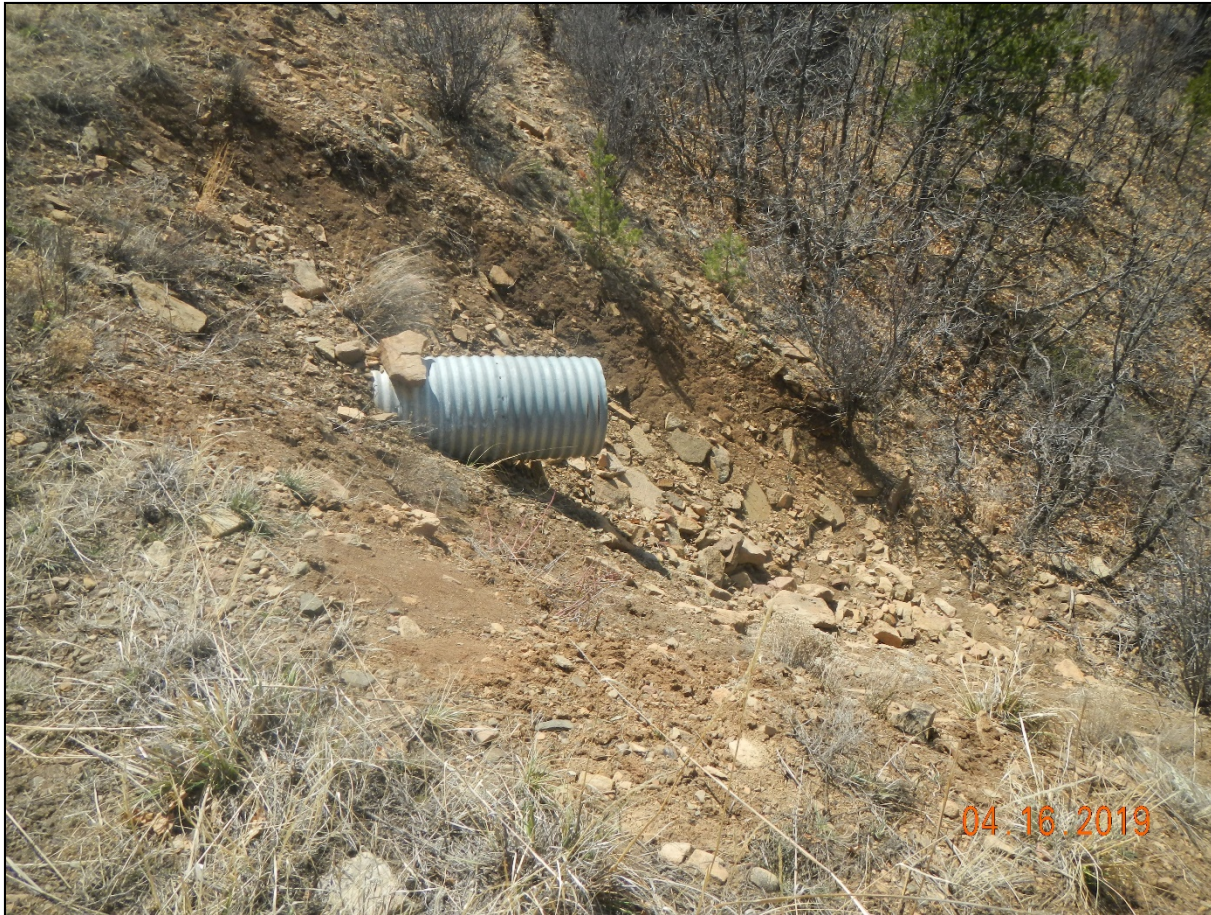
Photo 4. Culvert remains along the road. Erosion is occurring around the outlet.

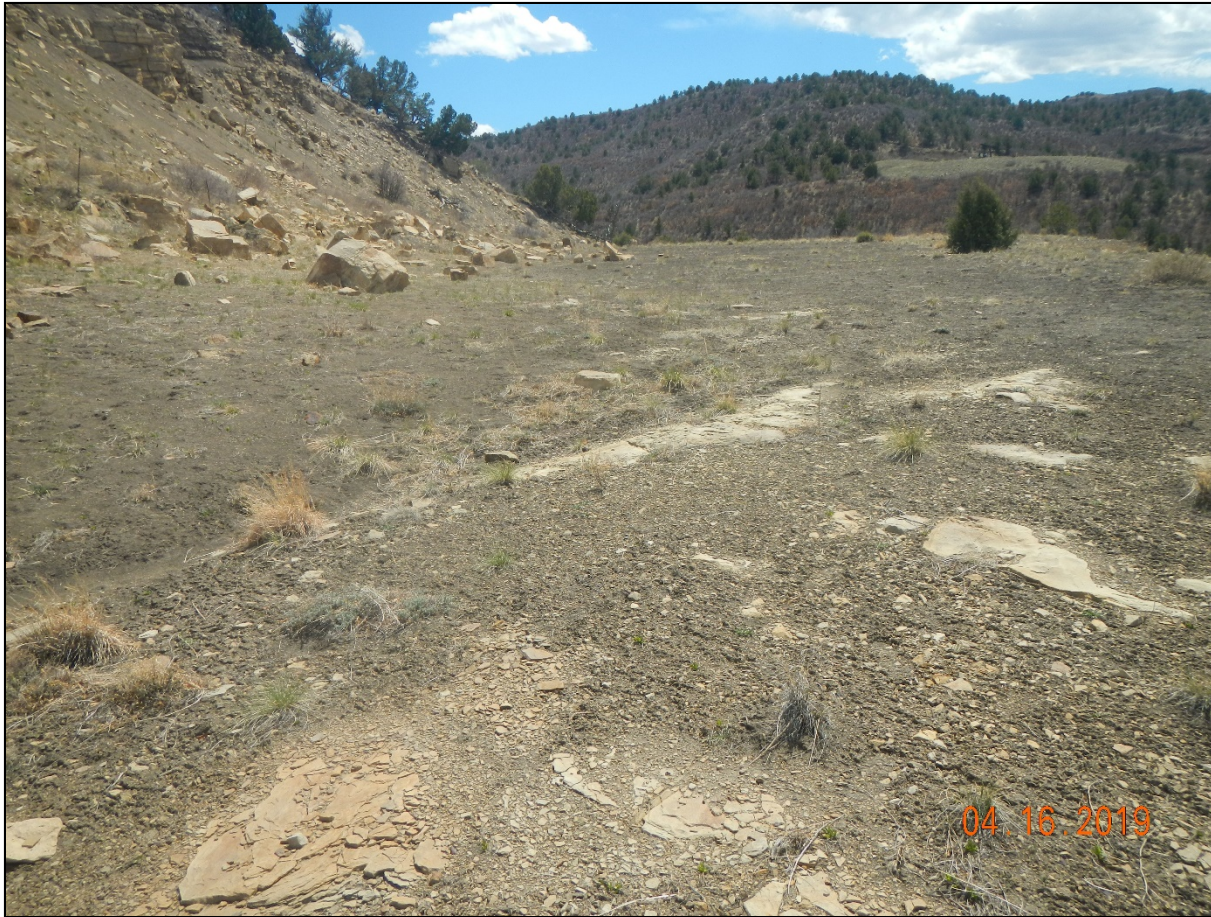
Photo 5. Facing southeast toward the location. The pad has not been recontoured.
