# Inspection Photos

API: 05-043-06216

Operator: AUSCO PETROLEUM INC

Inspection Date: 4/10/2019

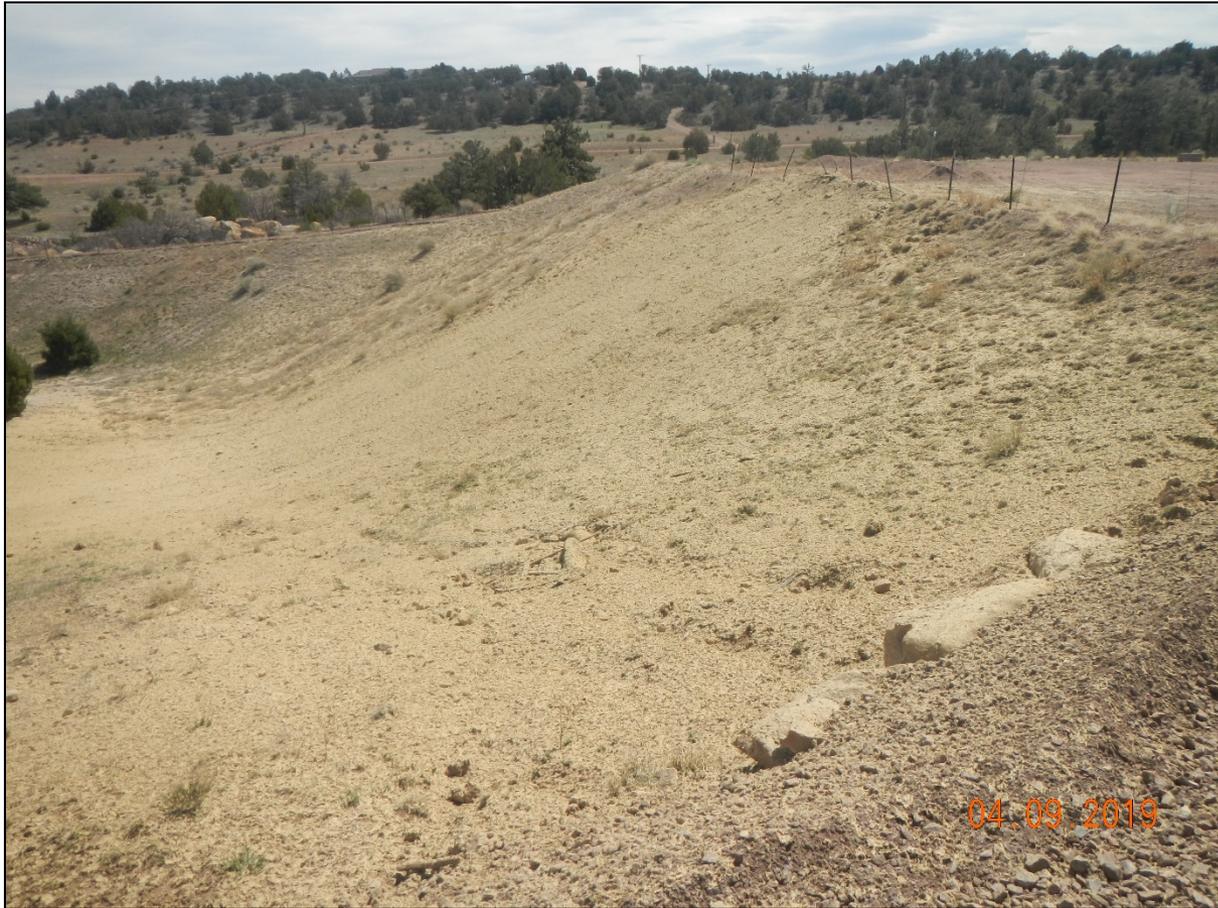
**Photo 1.** View of the northeastern project area from the access road facing eastward. This area has been seeded and hydro-mulched.

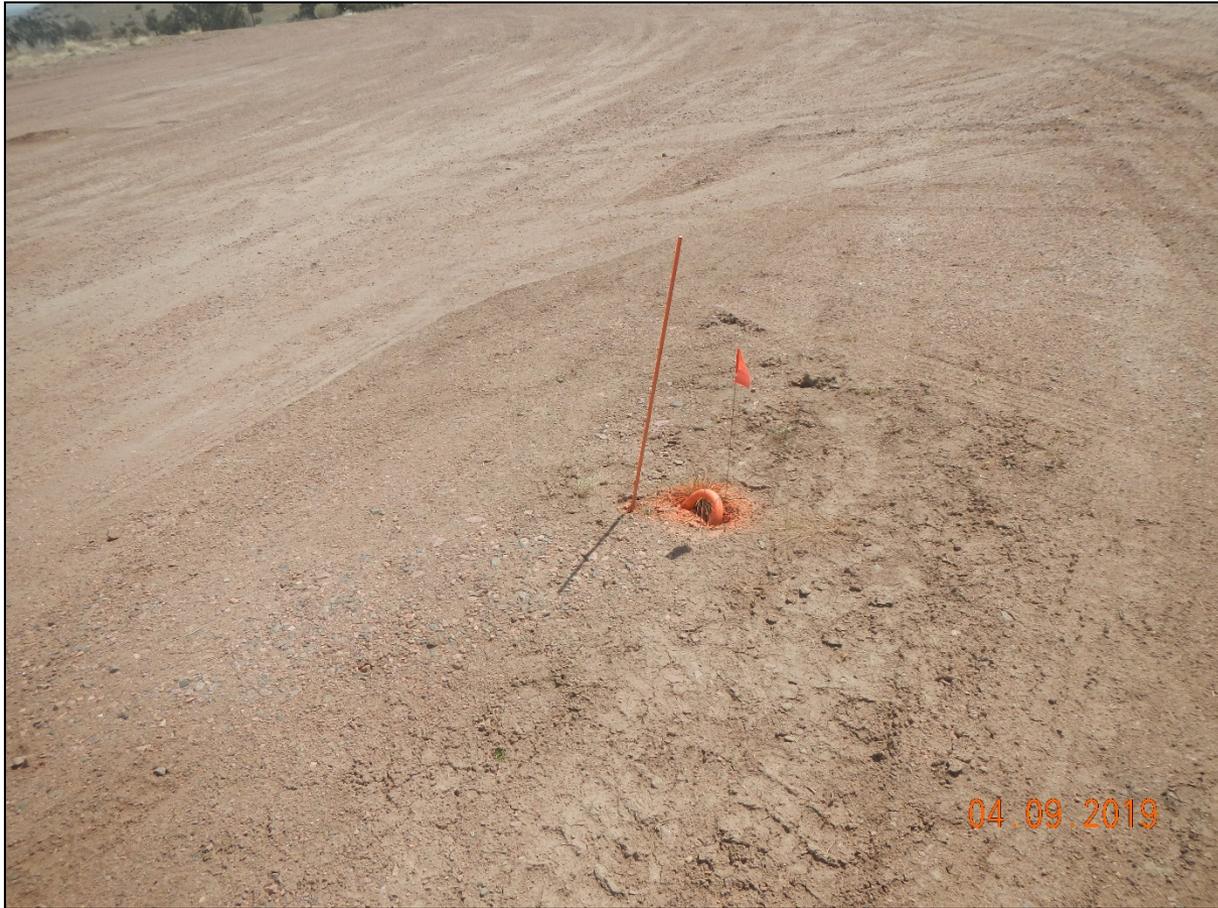
**Photo 2.** Guyline anchors have been marked, however markers should be not less than 4ft. In height.

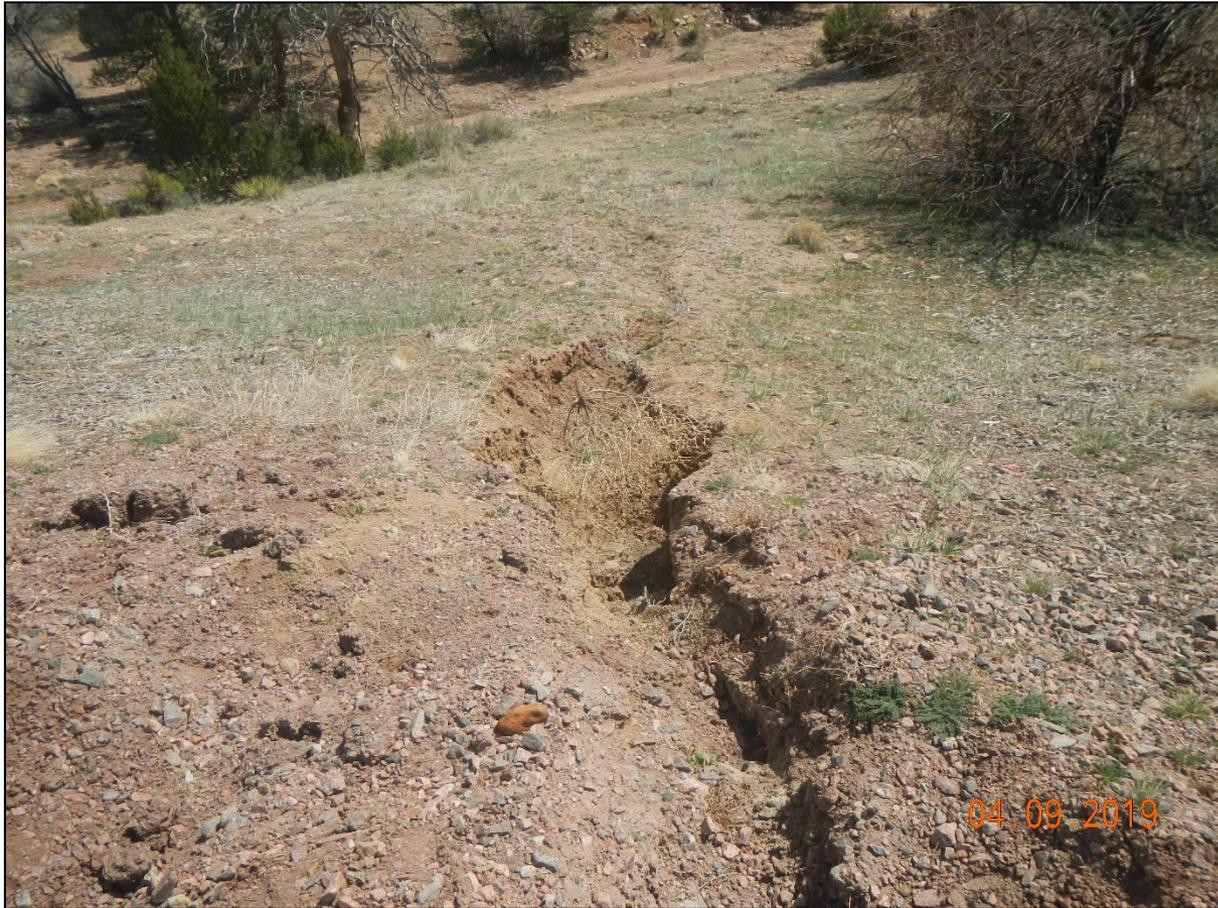
**Photo 3.** Erosion channel has not been repaired at the east side of the location.

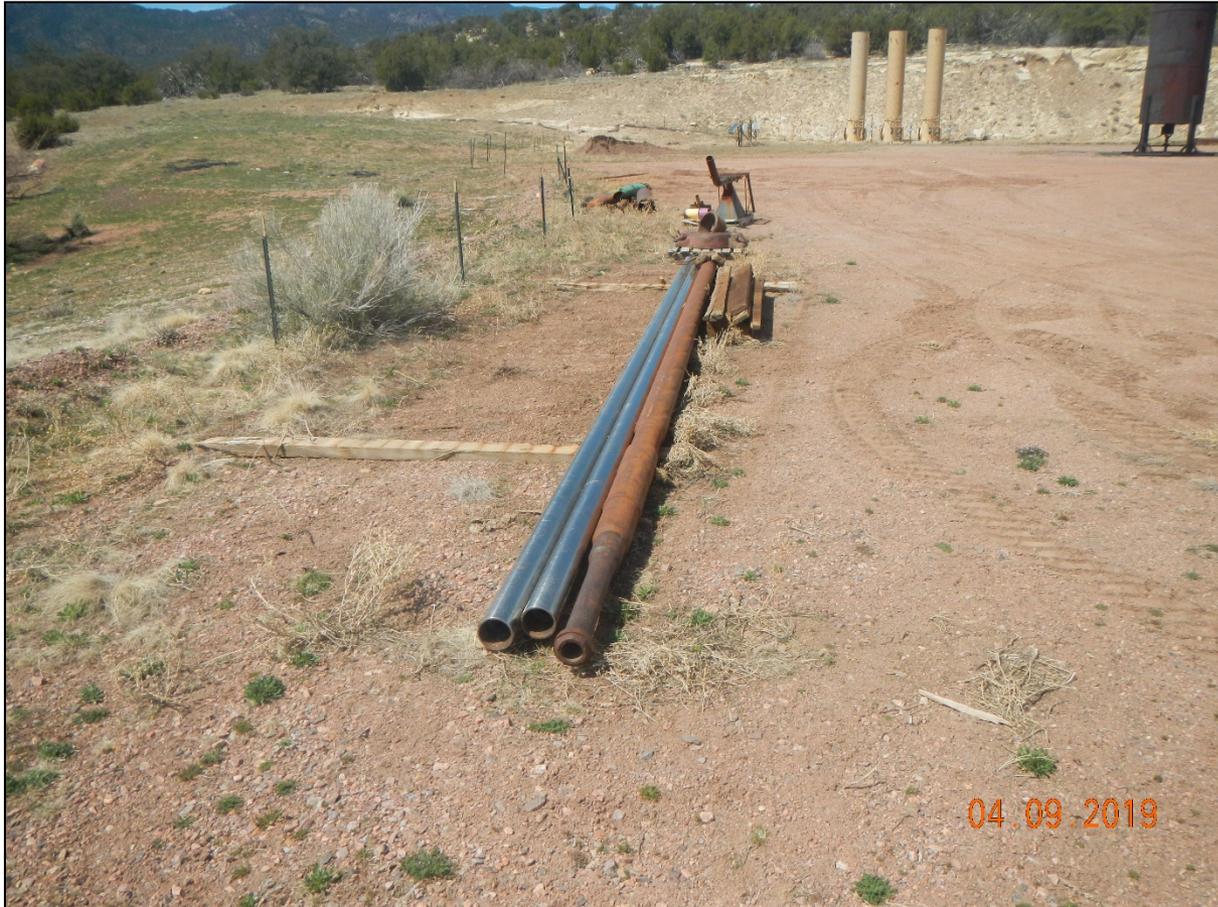
**Photo 4.** View of the southern project area from the southeastern corner facing westward. Unused equipment is stored along the outer edges of the well pad.

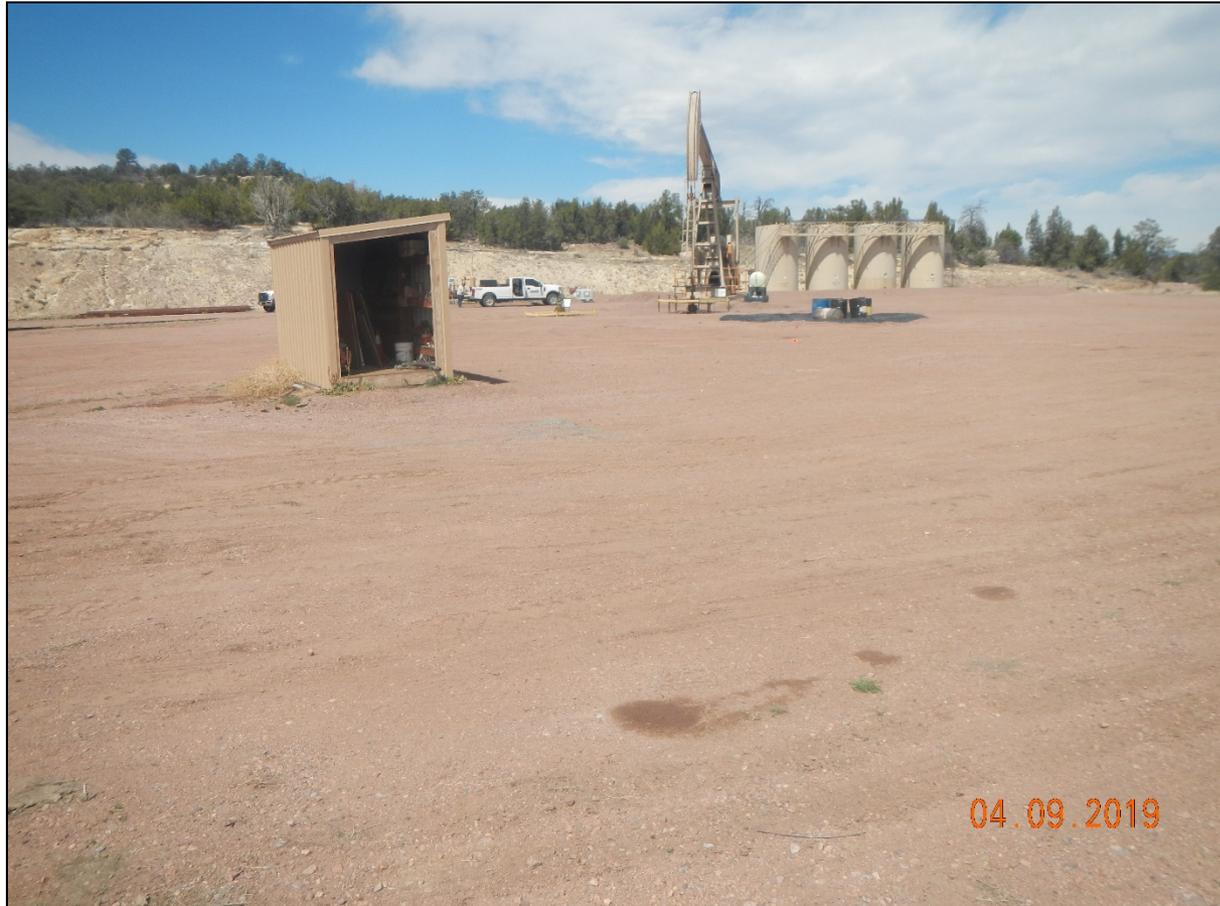
**Photo 5.** View of the project area from the southeastern corner facing center.
