Maralex Resources Inc.

Api # 05-077-08423

Inspection # 675002188

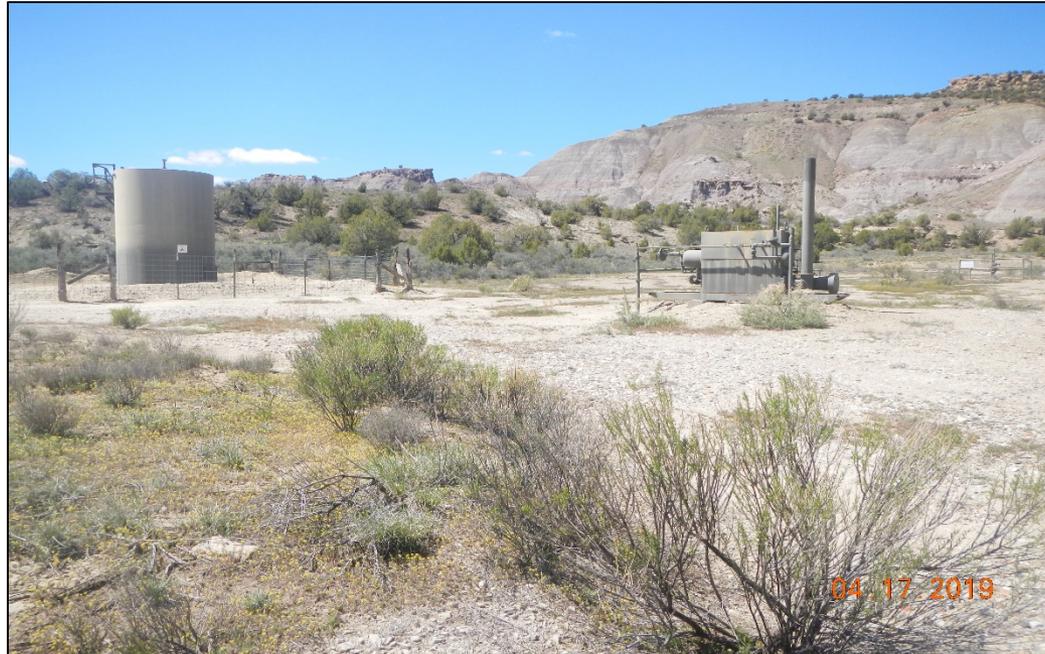
Photo of location from entrance

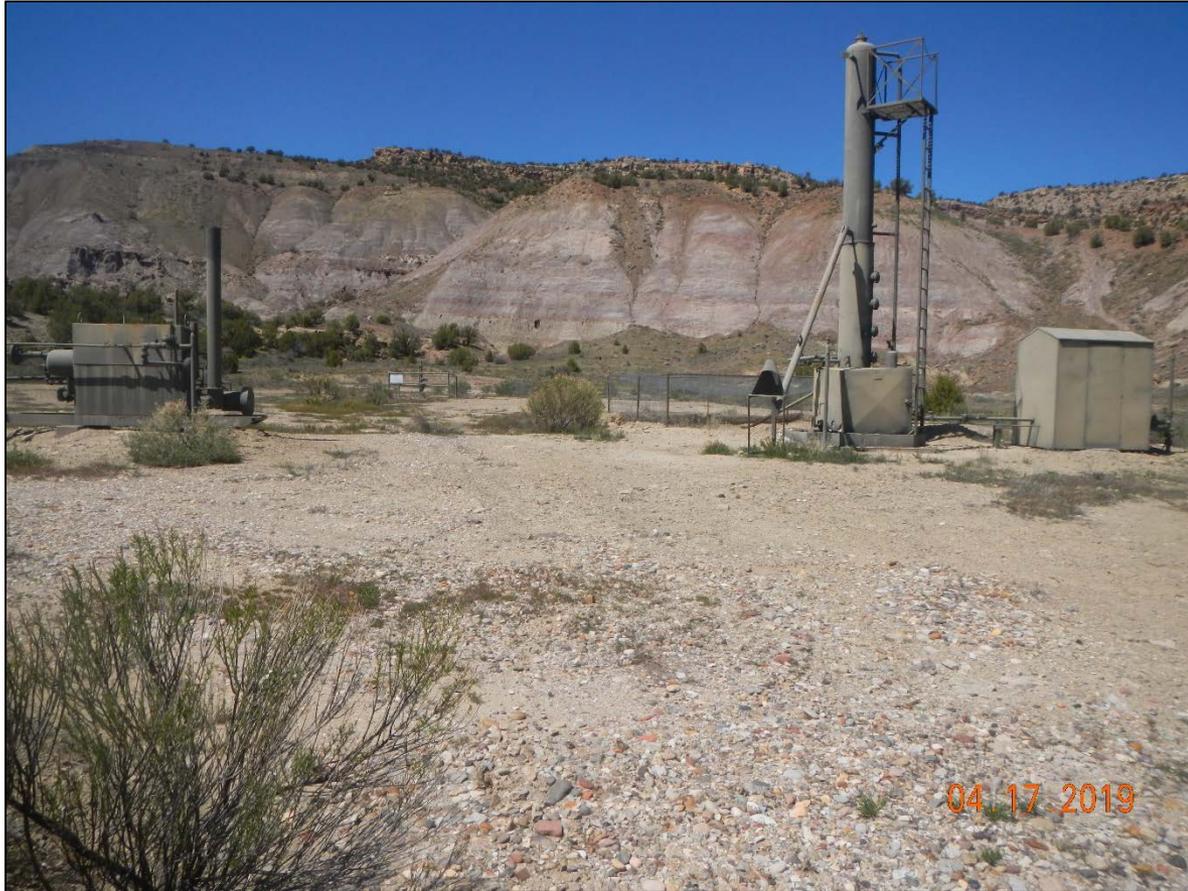
Photo of location from entrance

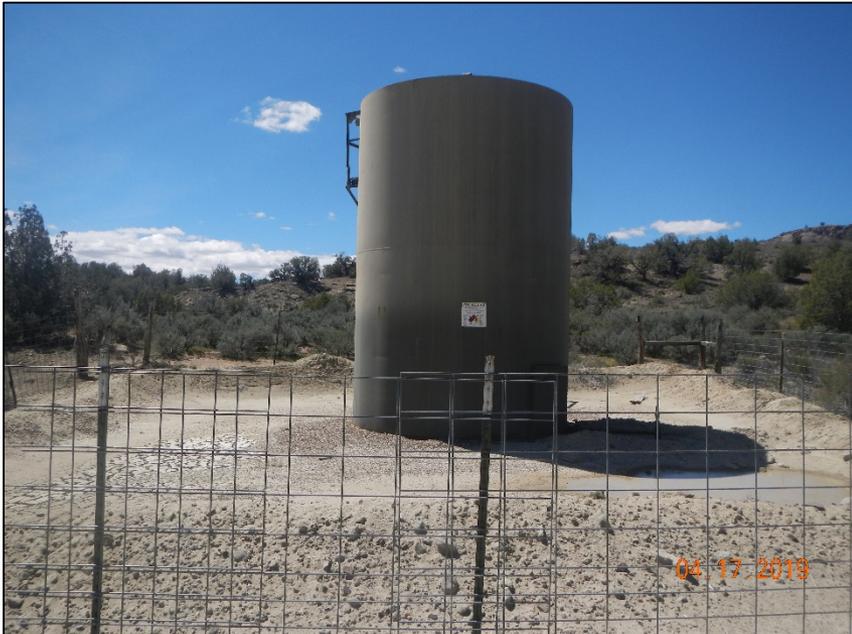
Tank Battery

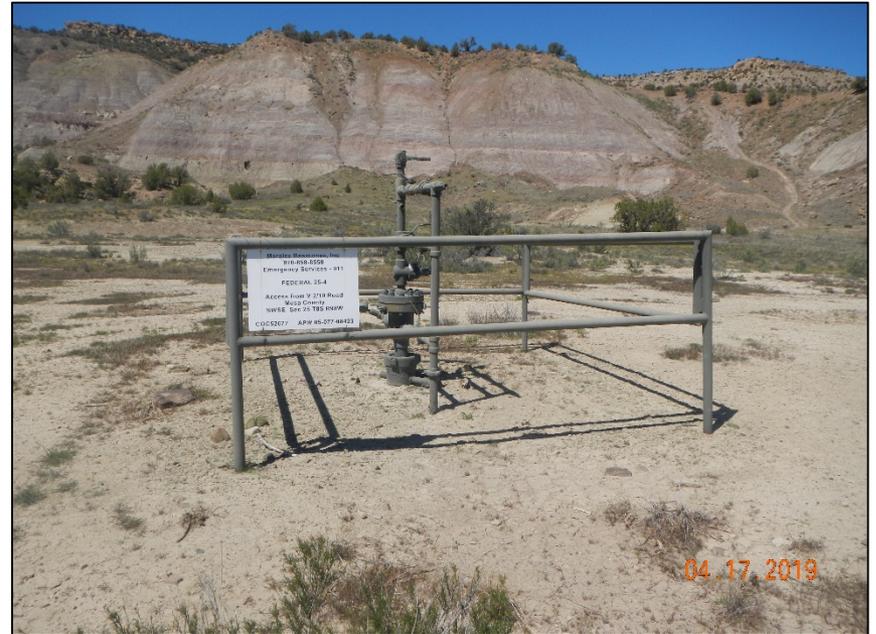
Well head

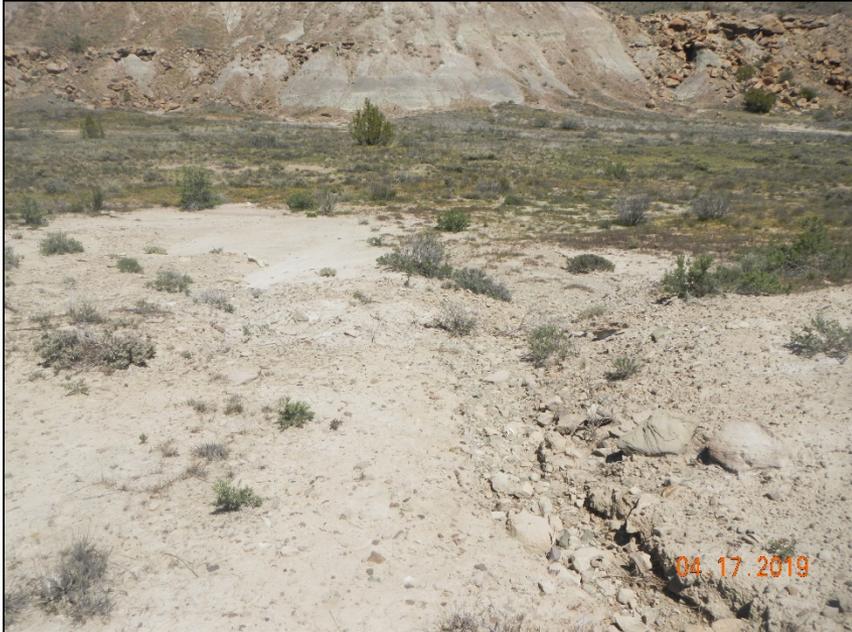
Erosion moving sediment off location

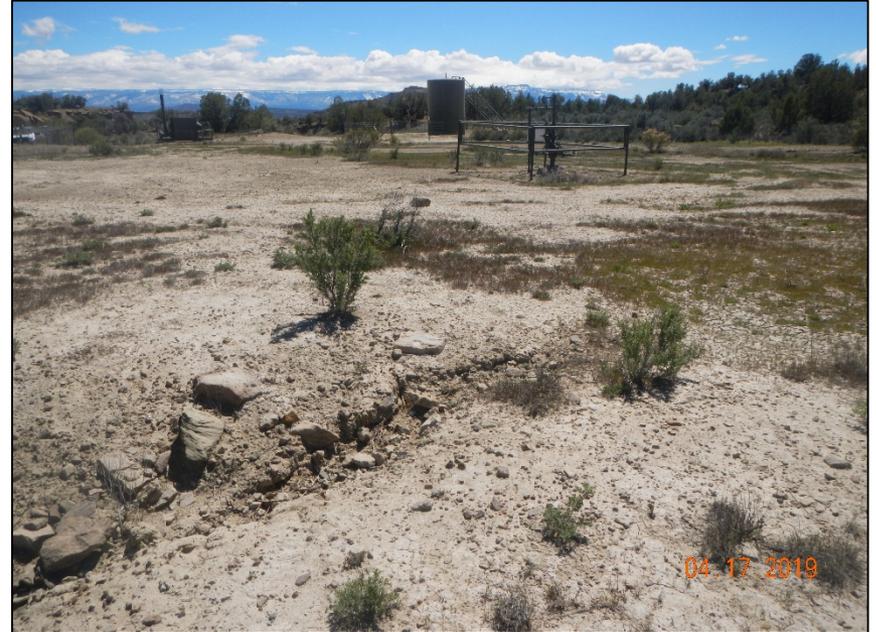
Erosion moving sediment off location

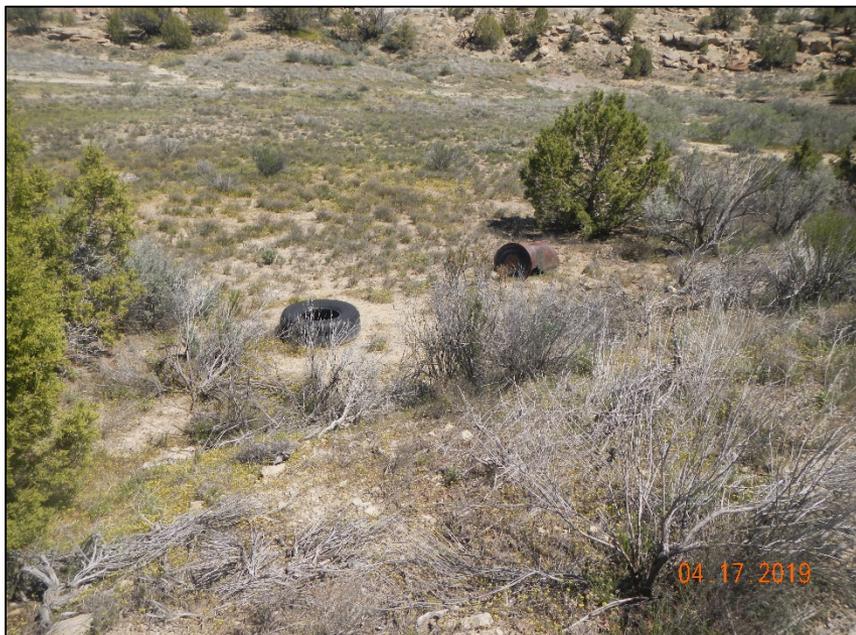
Trash on location

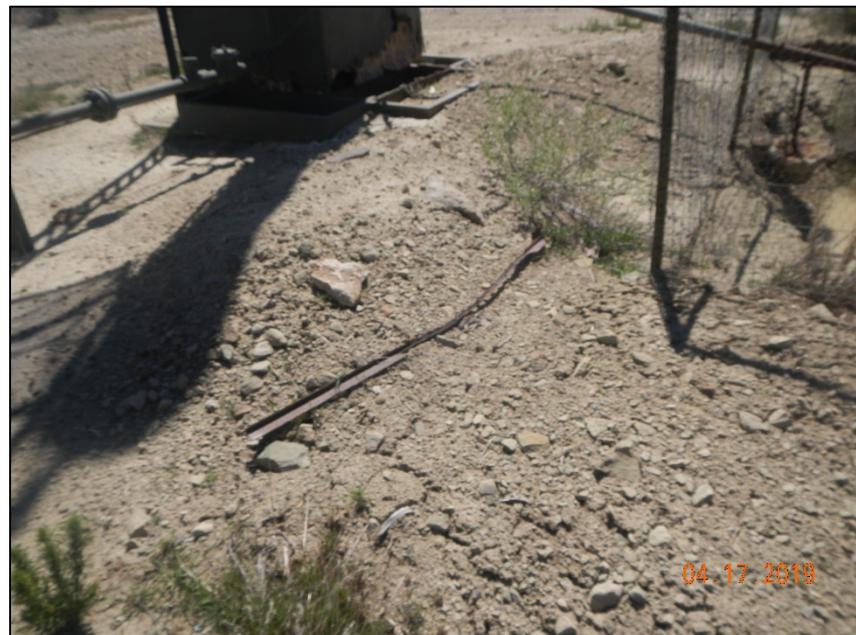
Trash on location

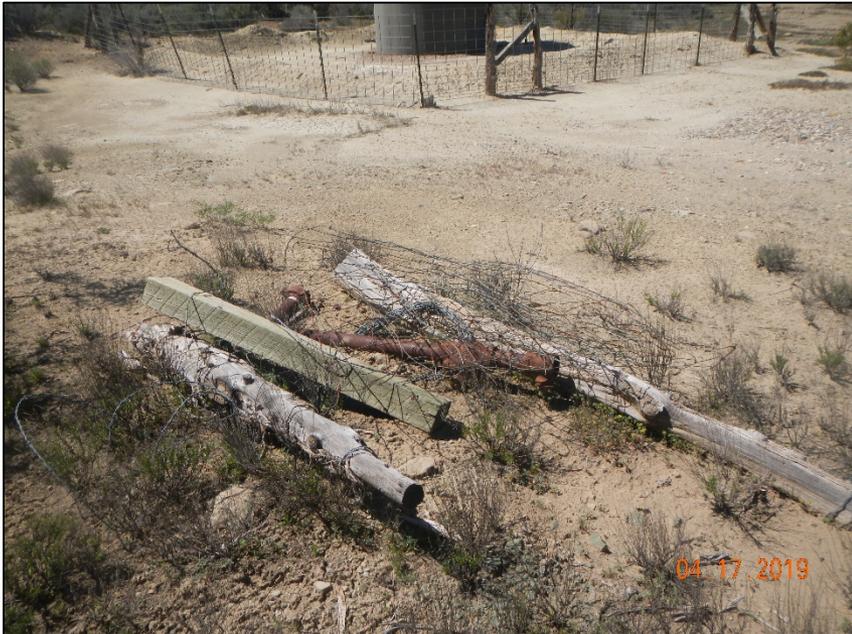
Unused equipment on location

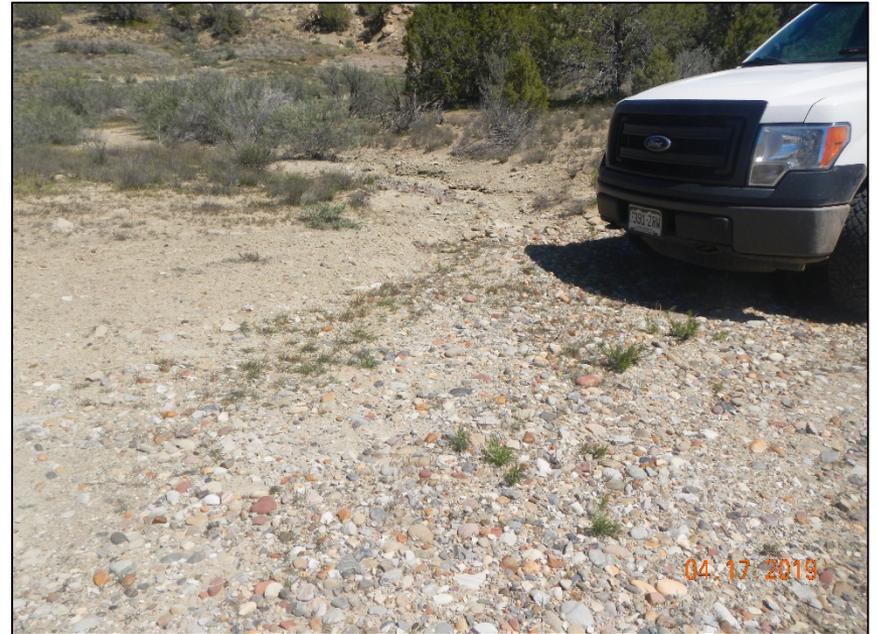
Storm water erosion moving across access entrance.

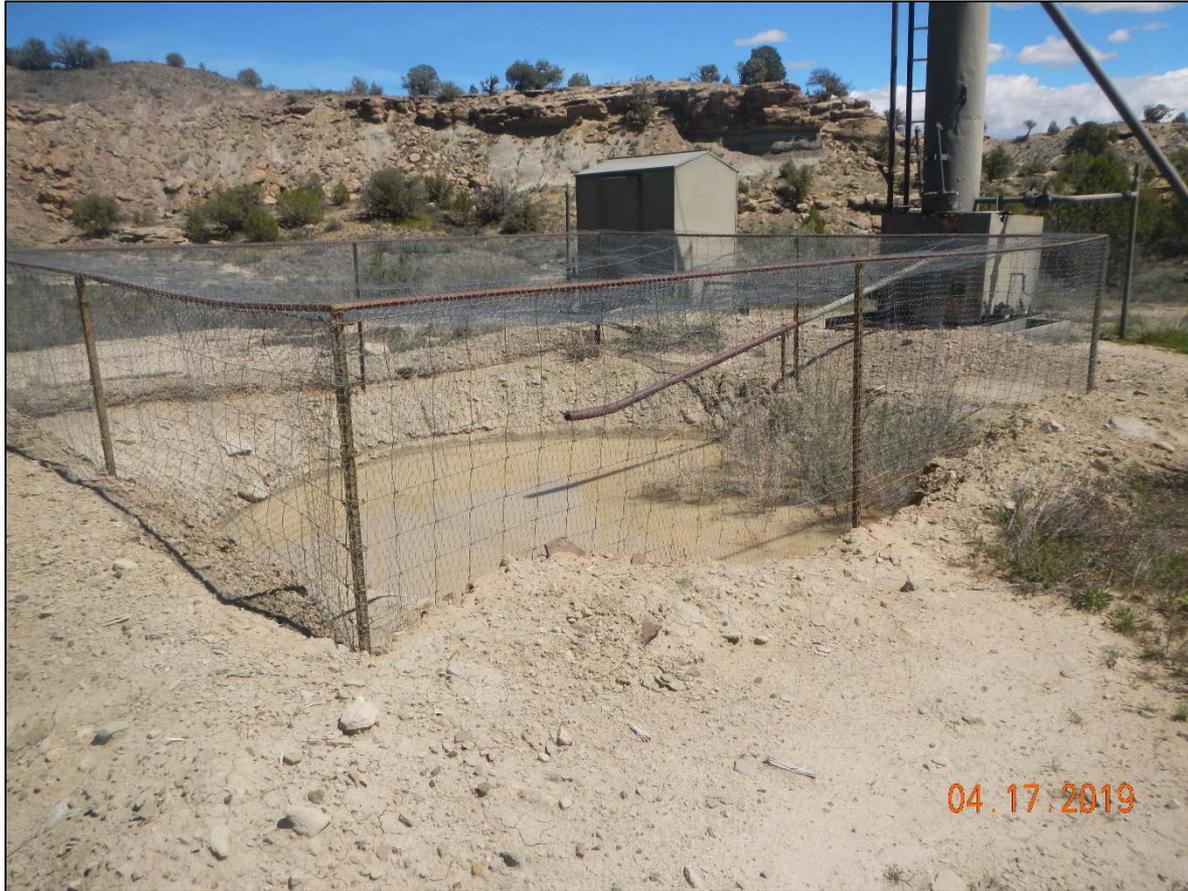
Pit on location.
